E-3 AWACS  
CORROSION PREVENTION ADVISORY BOARD  
(CPAB)

12 JULY 1990  
TINKER AFB, OK

**E-3 CORROSION PREVENTION ADVISORY BOARD MINUTES**  
**12 JULY 1990**

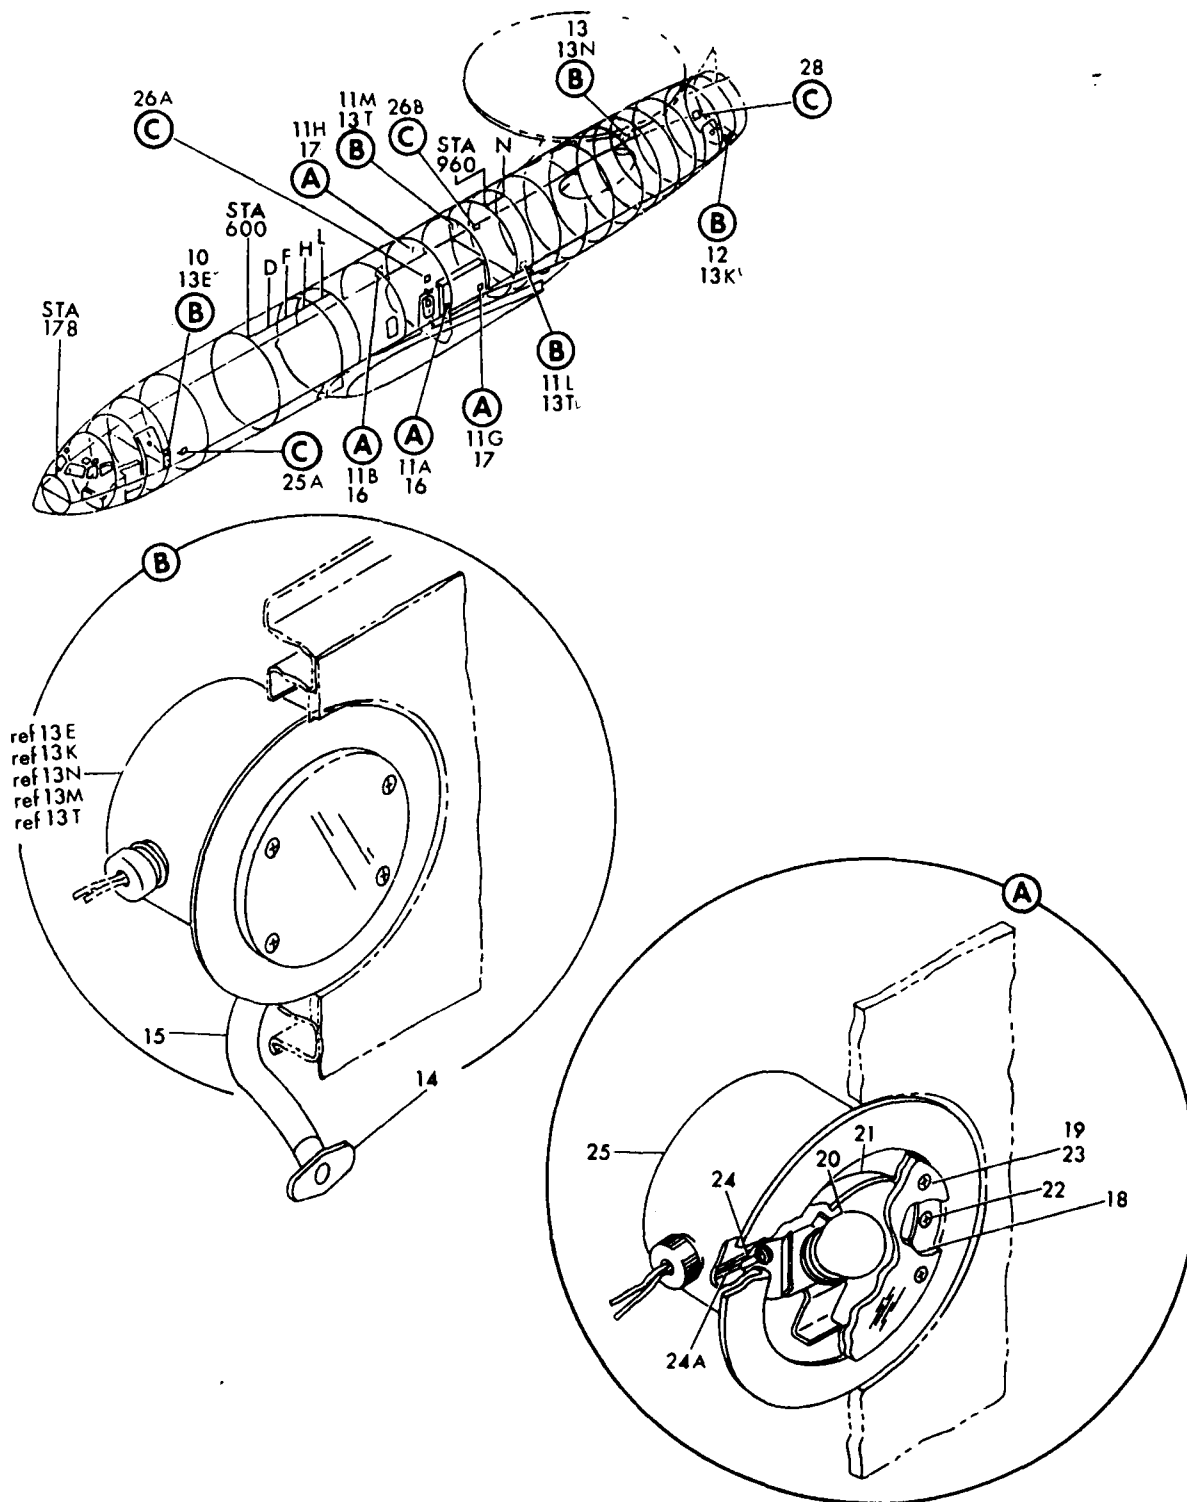
FIGURE 7. LIGHT INSTL, EXTERIOR EMERGENCY EXIT  
POWER SUPPLY INSTL, EXTERIOR EMERGENCY EXIT (SHEET 1)

| <p>STATUS:</p> <p>July 1990:<br/>TCTO has already been written by MMKRTA but currently on hold for parts. Kitproof is also on hold. Reflector assy, P/N 31-1560-1 is unavailable at this time.</p> | | |

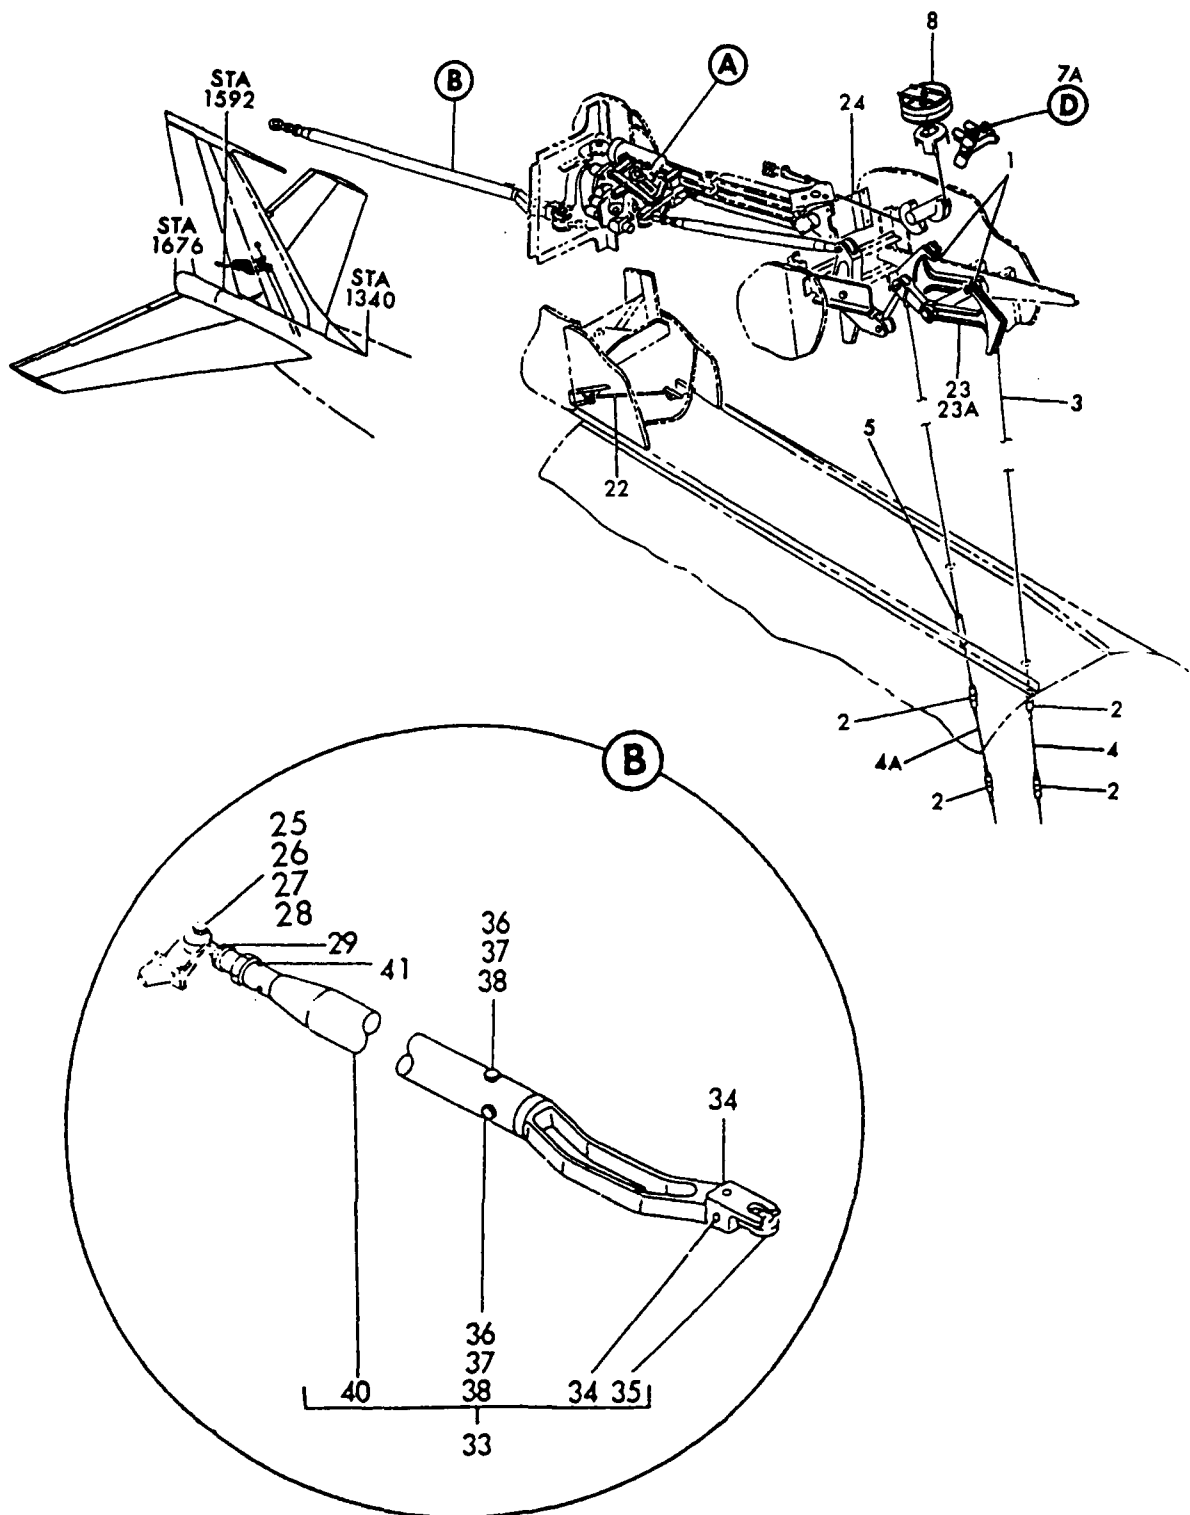
SEE NOTE ON PARTS LIST PAGES  
FIGURE 14A. CONTROL INSTL, RUDDER (SHEET 1)

TCTO has been completed and will be published soon. During kit proof, hole was too large and drilled completely through part. TCTO revised to reduce hole diameter to 3/16" and only drill lower side of rod. It was also discovered that attach hardware was loose, corroded, or missing. MMKRA will request all users initiate a one time inspection at O/I for corroded, missing, or loose hardware, and replace if necessary.

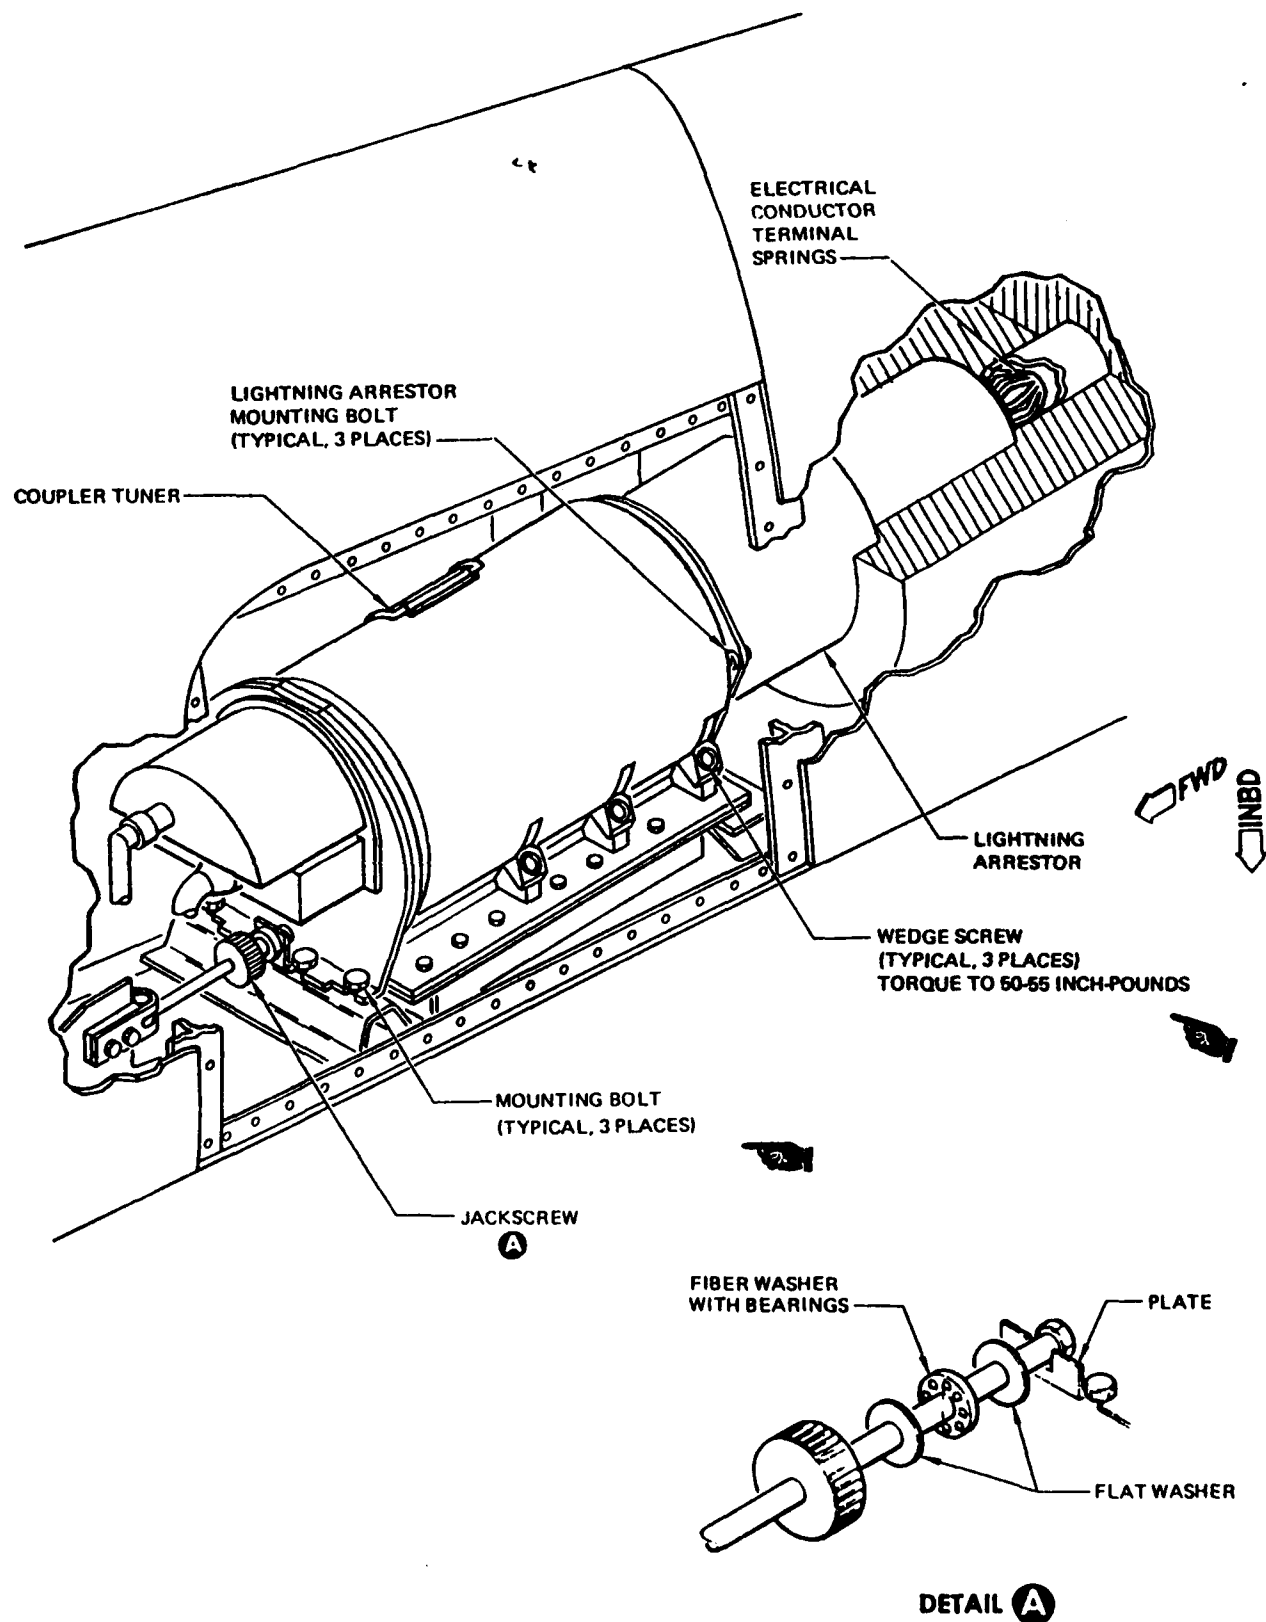
Figure 10-21. HF Transmit Components Installation, Wing Tip

Mr. Richard Elmslie from Boeing reported that EST 90-E3B2-13 has been started. Boeing will take action to investigate the need of foam surrounding HF antenna.

Reported foam cracking was investigated by MMKRA and found not to be a significant problem. EST would require an exhibit, which is unavailable. No EST will be pursued, and any future problems will be corrected on a case-by-case basis.

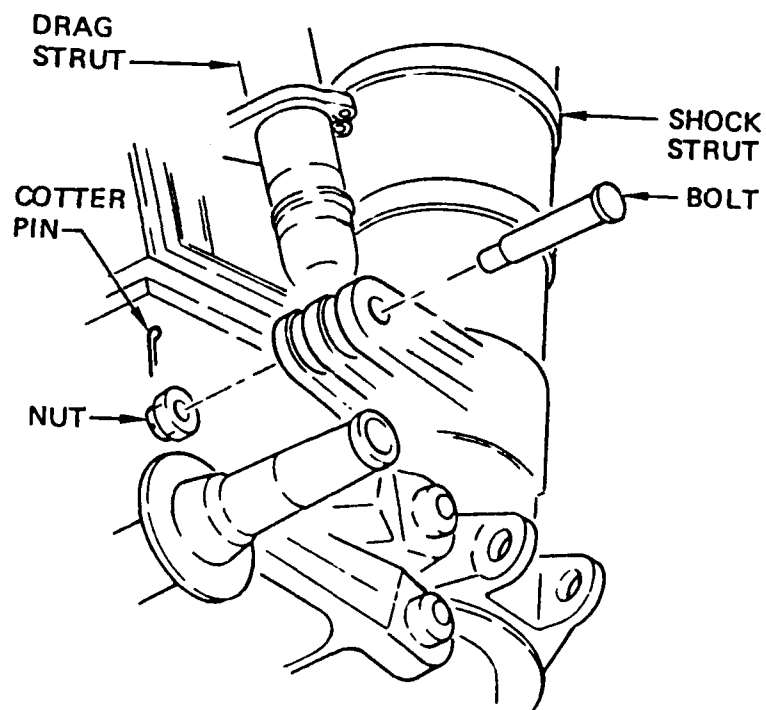
# E-3 LANDING GEAR DRAG STRUT / SHOCK STRUT BOLT

NAEWF E-3A Component has no results because it only has been approximately one year since the application of MASTINOX to landing gear bolts.

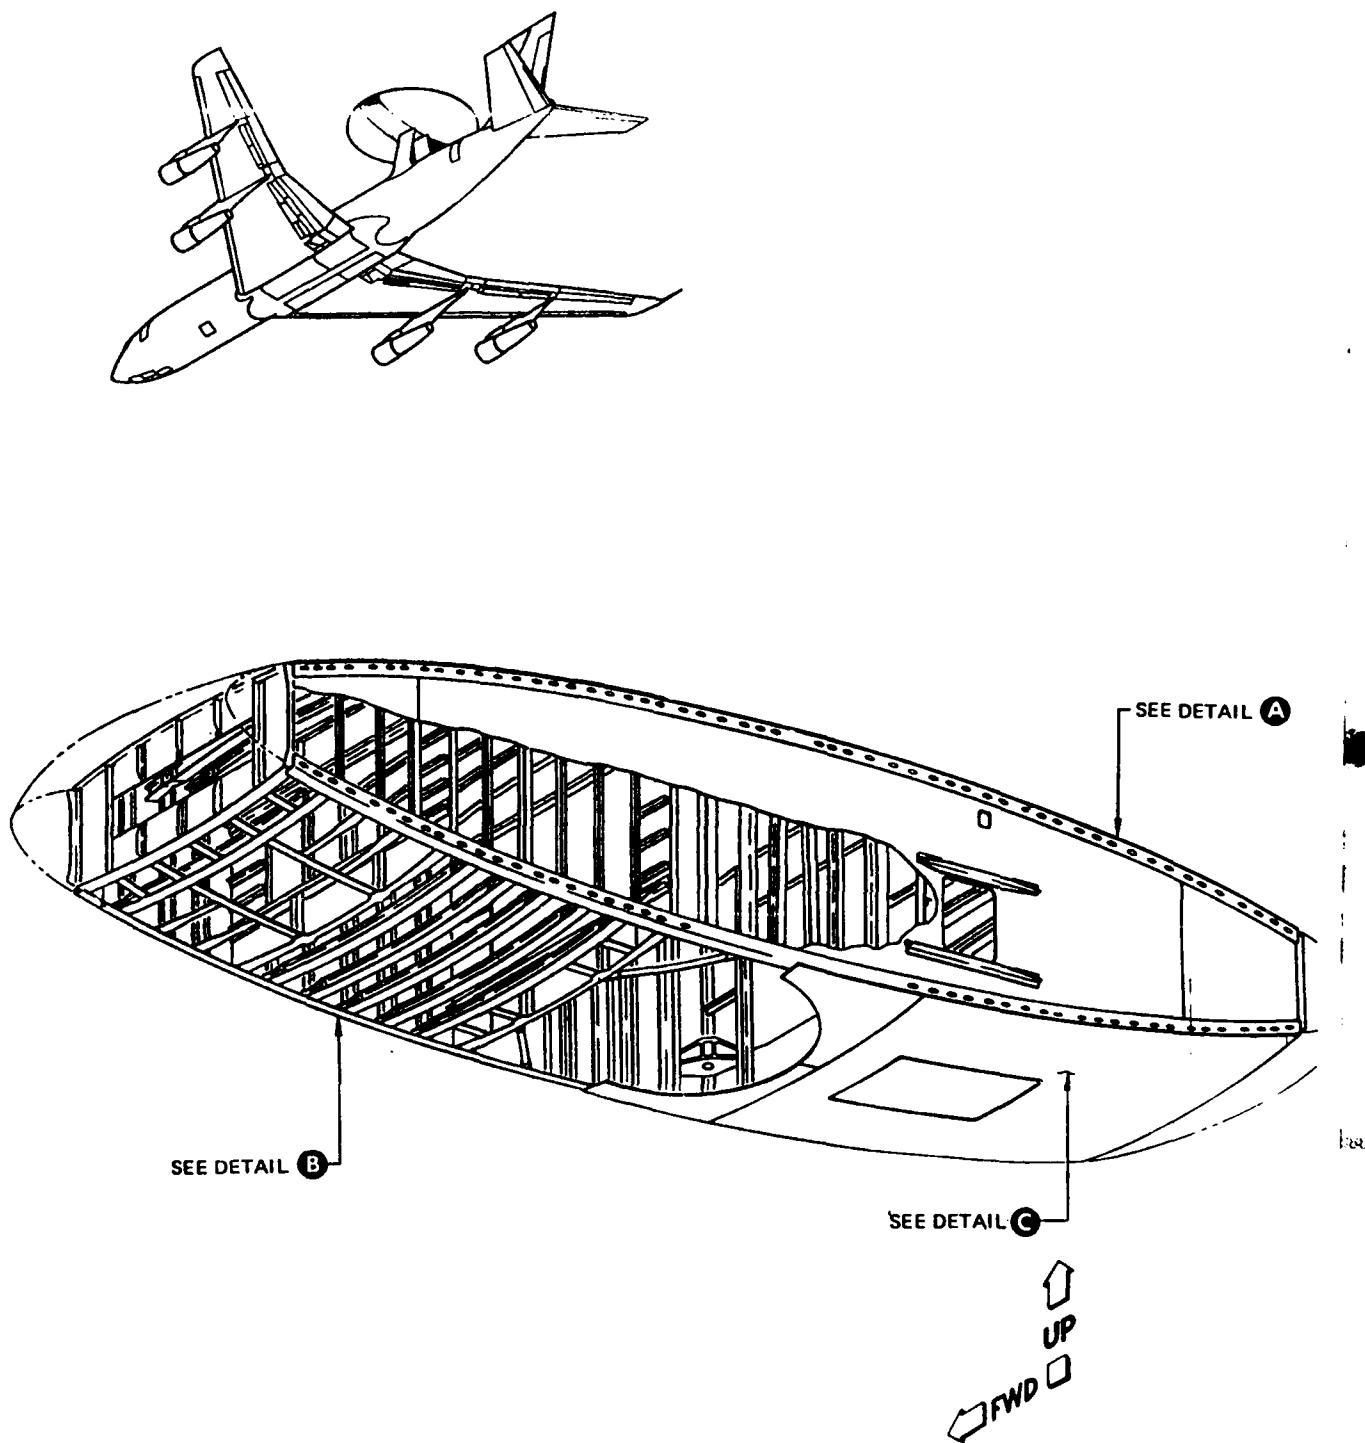
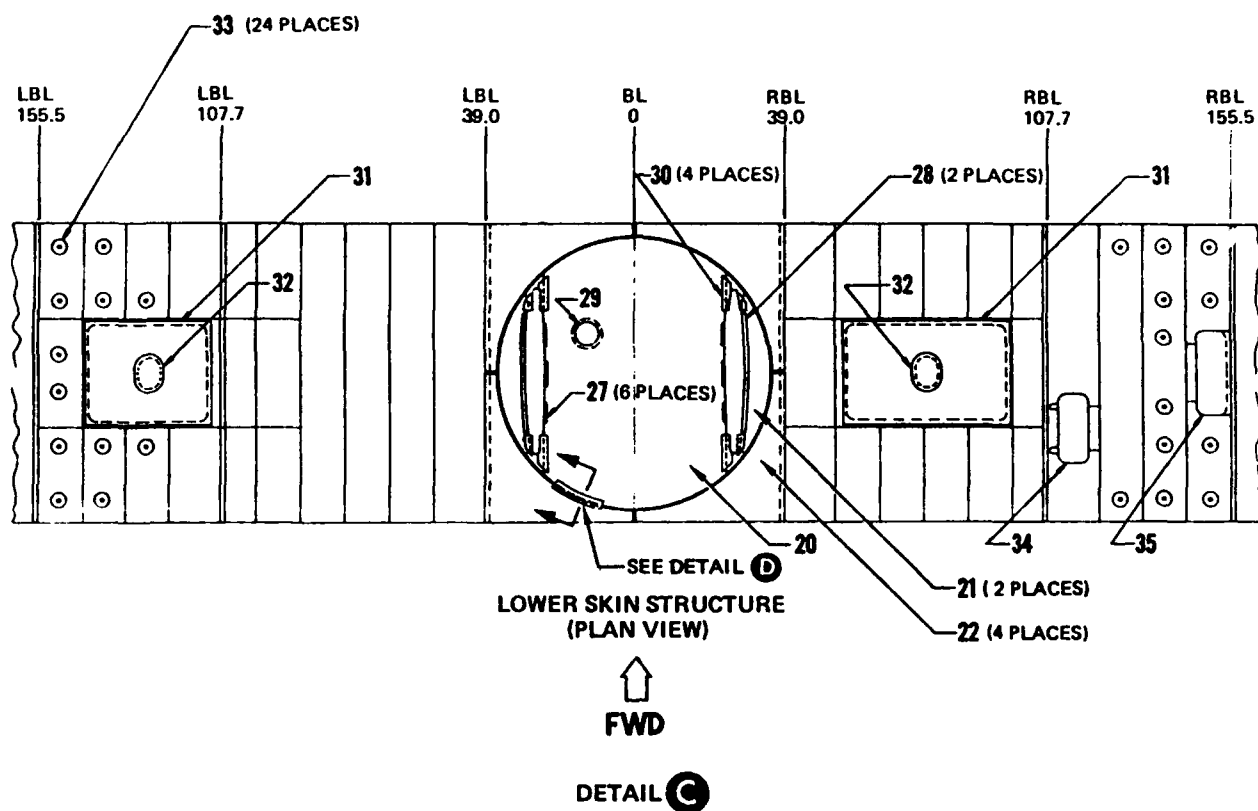
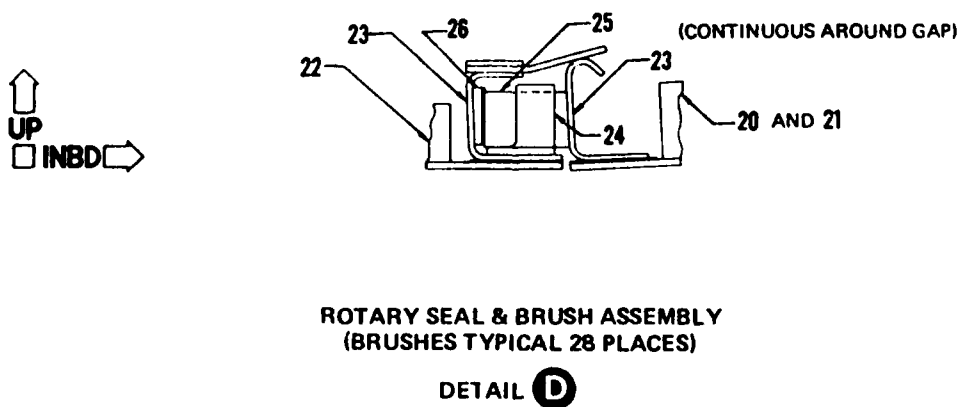
Figure 13-13A. Antenna Pedestal Center Section EMP Structural Finishes HCI (Sheet 1 of 10)

The replacement of aircraft with tin plating filler strips will be done by attrition in accordance with T.O. -3-1. 552 AWACW prefer TCTO to be generated because the fillers will corrode eventually. MMKRA will take action to investigate TCTO.

552 AWACW has not inspected cad plated filler strips for corrosion on aircraft noted in May 1989 status.

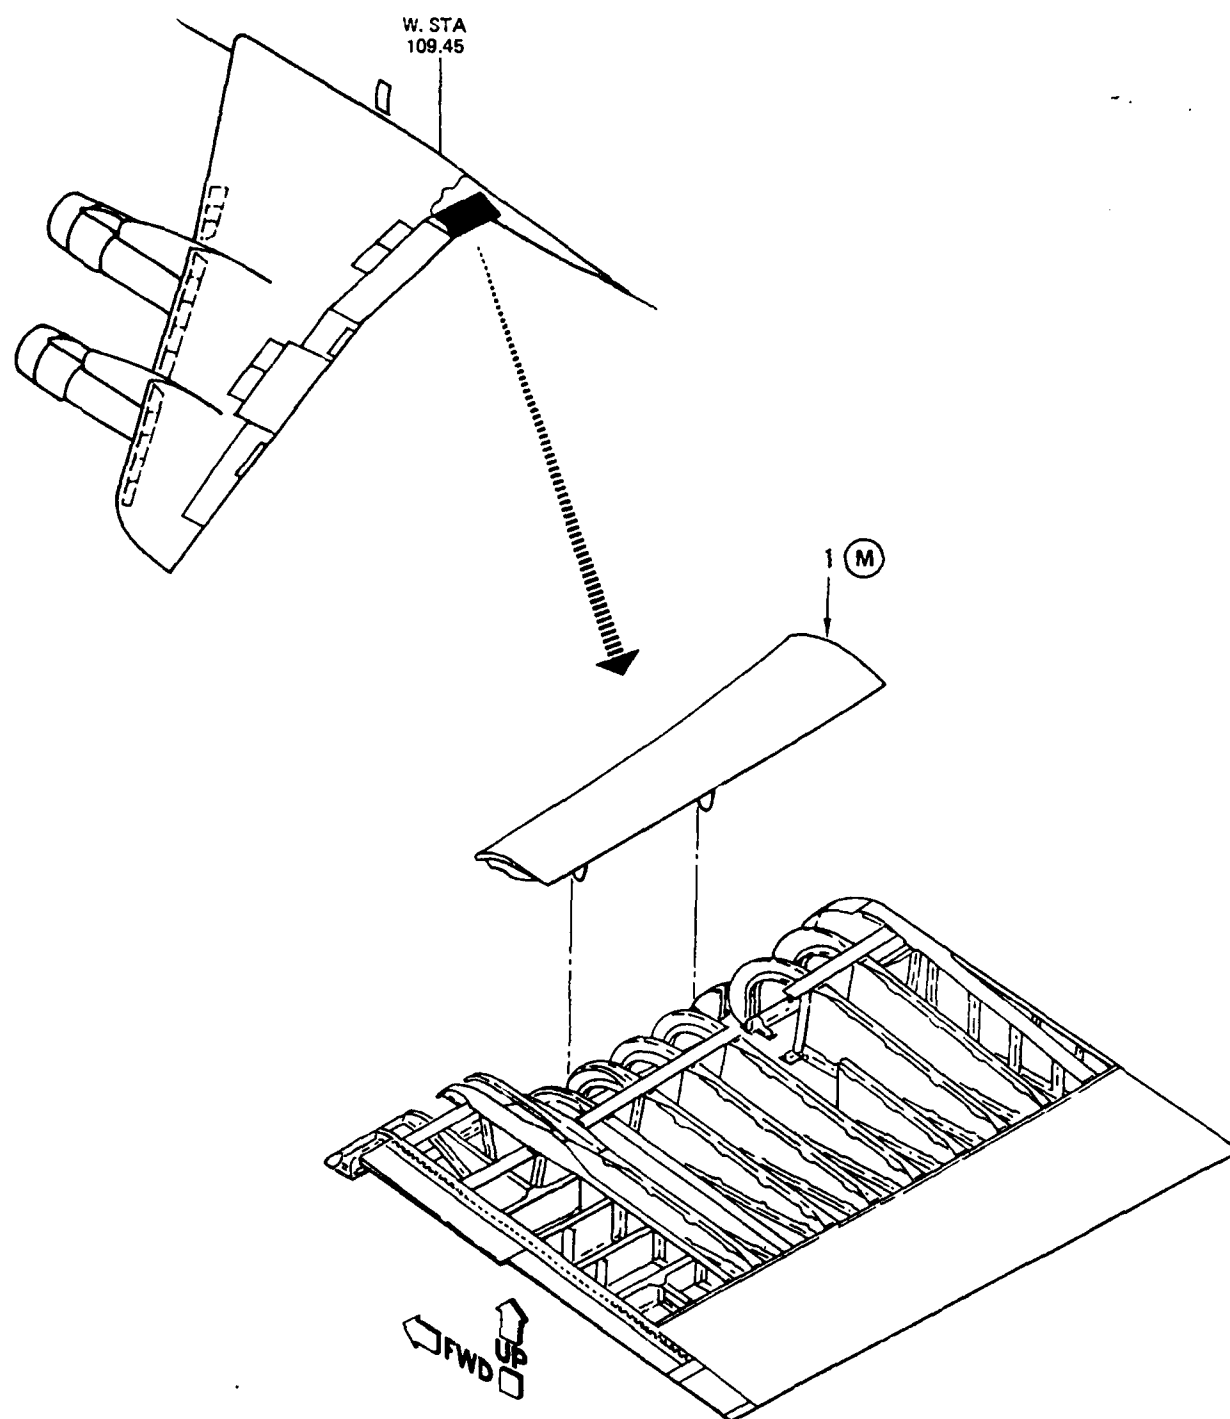
**Figure 2-5. Fillet Flap Flaperette Corrosion Inspection Guide (Sheet 1 of 2)**

NAEWF E-3A Comp. reported that A/C -0456, treated with Lixton compound with teflon coating on 30 Nov., is in good condition when inspect on 30 June. Another aircraft treated the same way on 30 Dec. is also currently in good condition. So far, the coating is adhering to the surface with Lixton. A/C -0457 will be similarly treated soon.

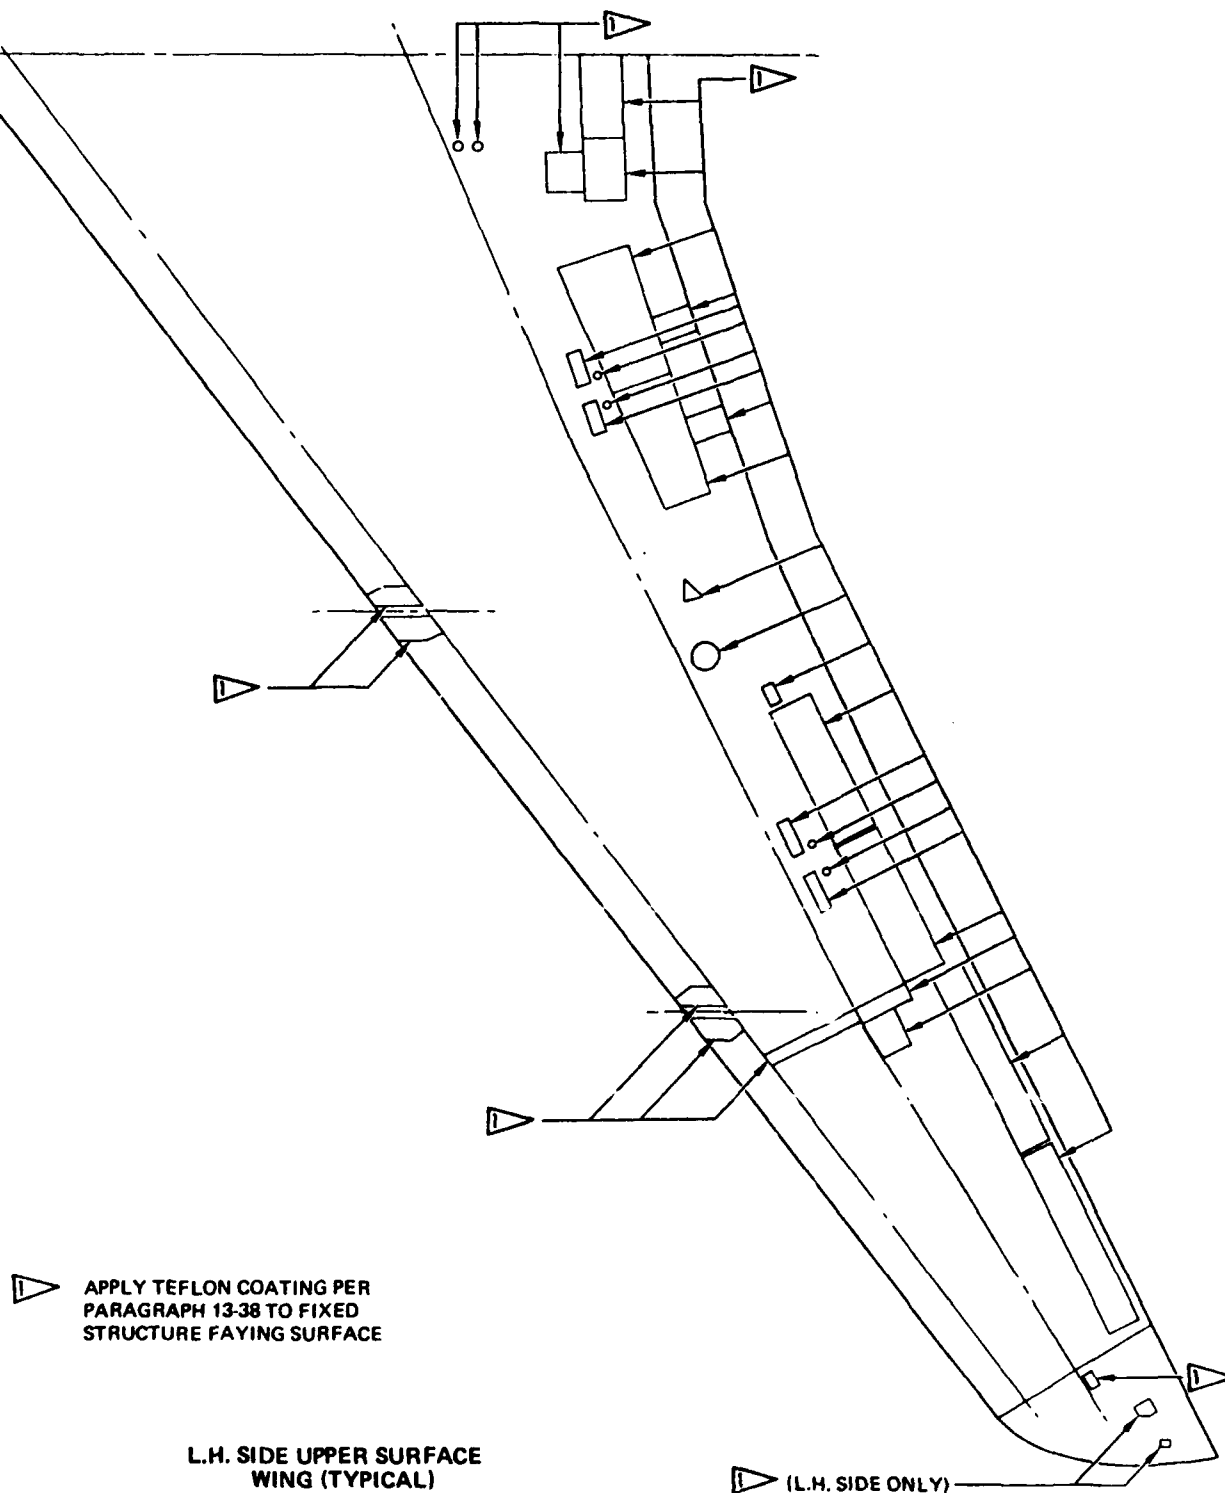
Figure 13-16. Abrasion-Resistant Teflon Coating Locations (Sheet 5 of 6)

Statement of work for a Boeing EST has already been submitted by MMKRA. Procedures for application are available in T.O. -23.

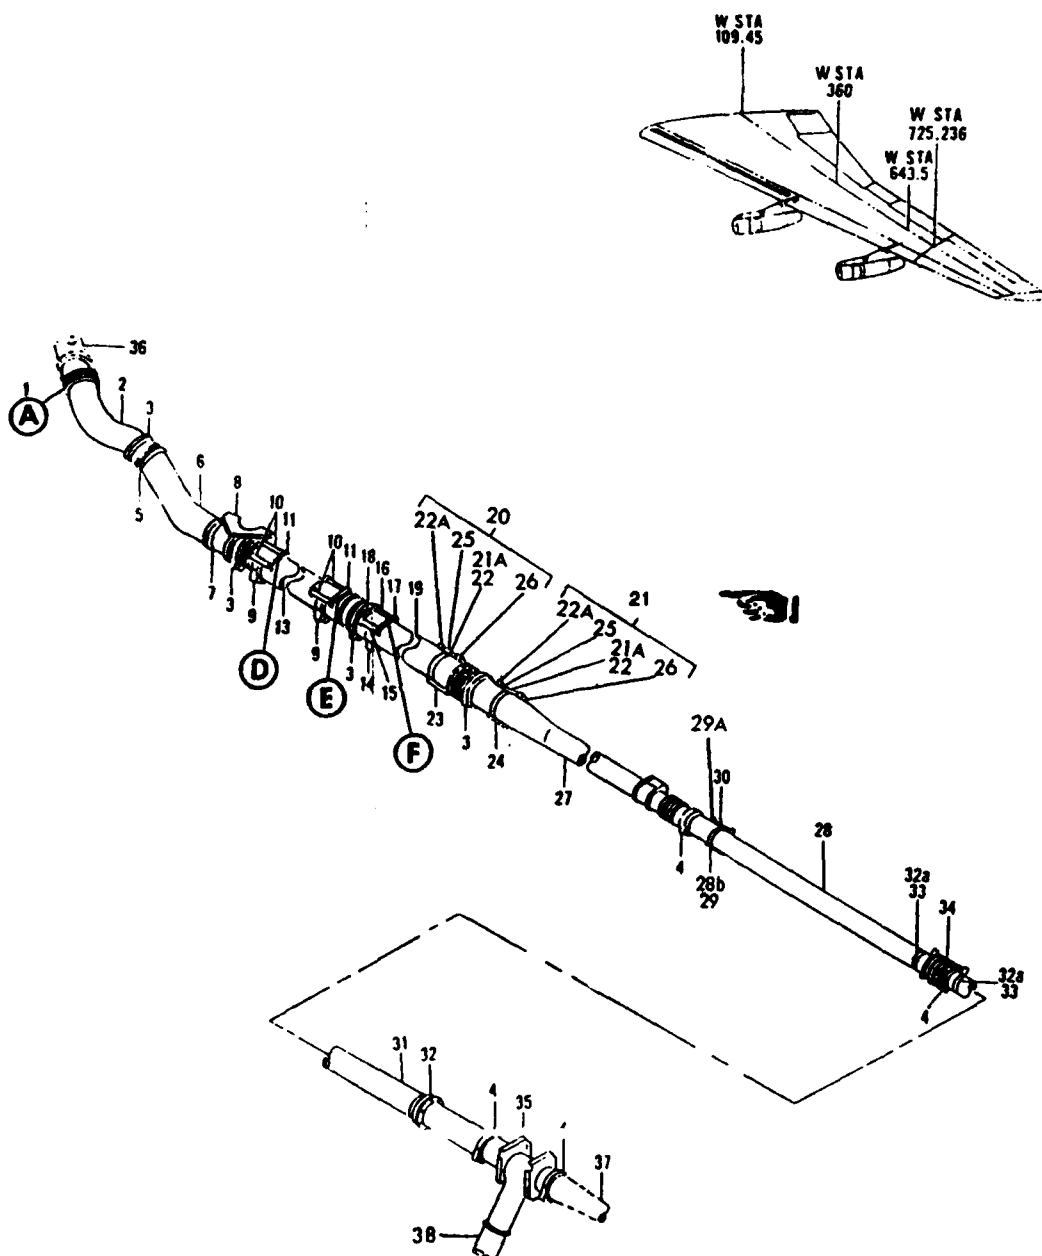
SEE NOTE ON PARTS LIST PAGES  
FIGURE 17. DUCT INSTL, WING LEADING EDGE CABIN AIR (SHEET 1)

Statement of work for L.E. skin will require removal of bleed air ducts. MMKRA will look again at bleed air ducts and replace it as necessary. The diameter for the out-board ducts are .016" and for the in-board ducts are .050". Maximum allowable pitting for out-board and in-board are .002" and .003" respectively. If replacement ducts are not available, MMKRA will generate repair procedures.

NAEWF E-3 Component reported no corrosion found on ducts.

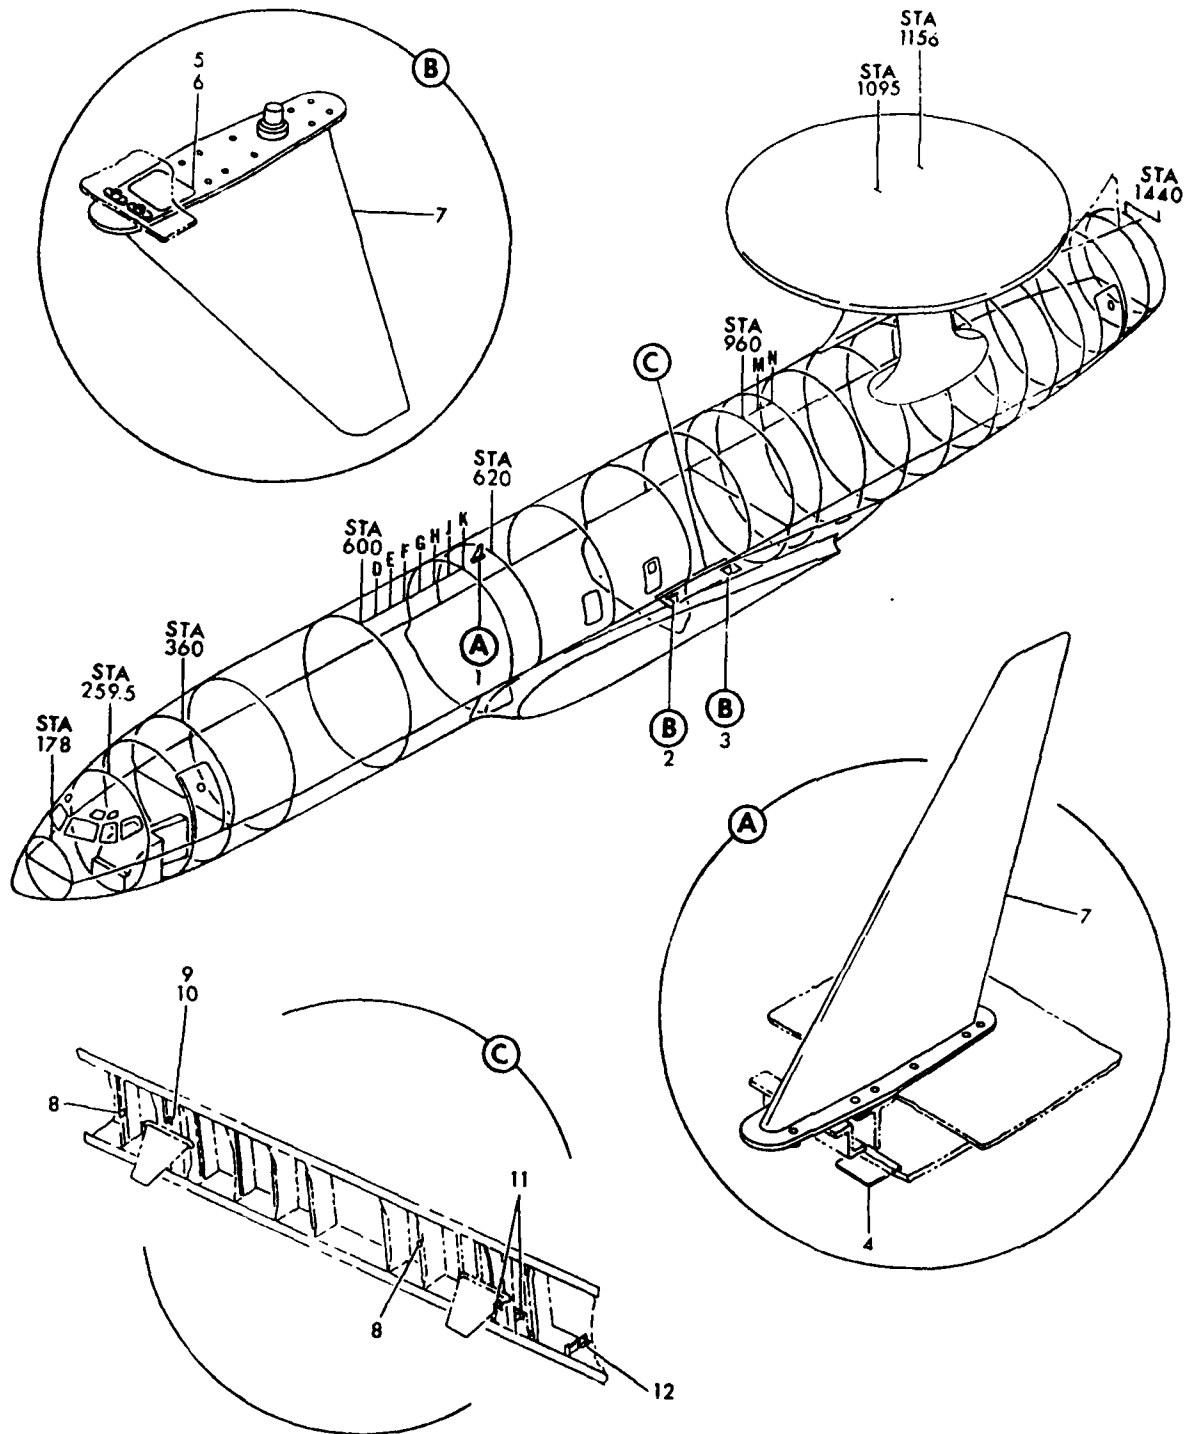
SEE NOTE ON PARTS LIST PAGES  
FIGURE 13 ANTENNA INSTL, VHF/UHF STATION 600L, 844 AND 930 BLAD

MMKRA is working on statement of work for MMKRTA to generate TCTO. 552 AWACW requested form 252 be issued if SOW is not necessary. MMKRA took action to change T.O. rather than issue TCTO.

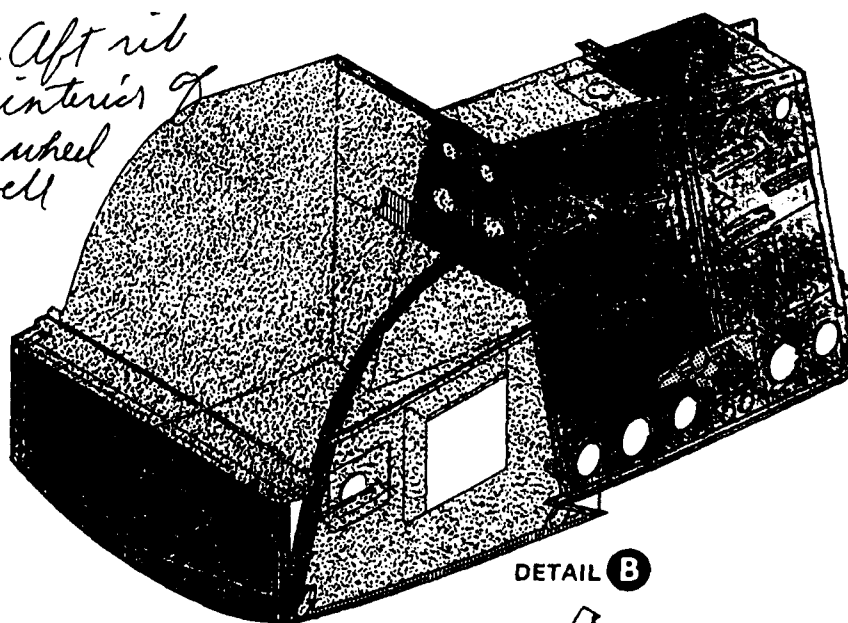
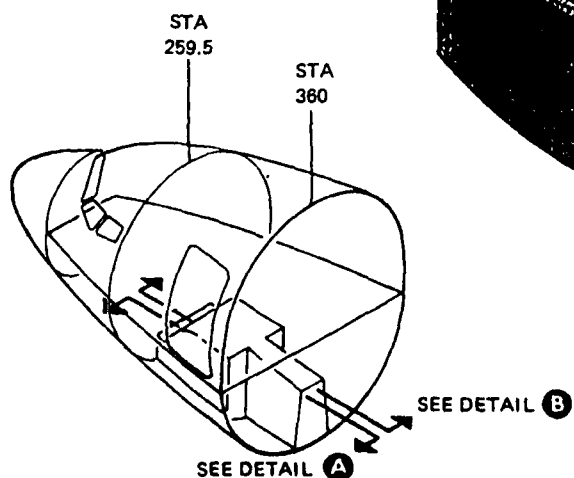
Figure 4-9. First Body Section Nose Gear Wheel Well Corrosion Inspection Guide (Sheet 1 of 2)

NAEWF E-3A Comp. reported that A/C 0442 through 0453 has no drain hole but sealant. A/C 0454 through 0459 has drain hole but no sealant. MMKRA/552 AWACW will take action to inspect USAF aircraft.

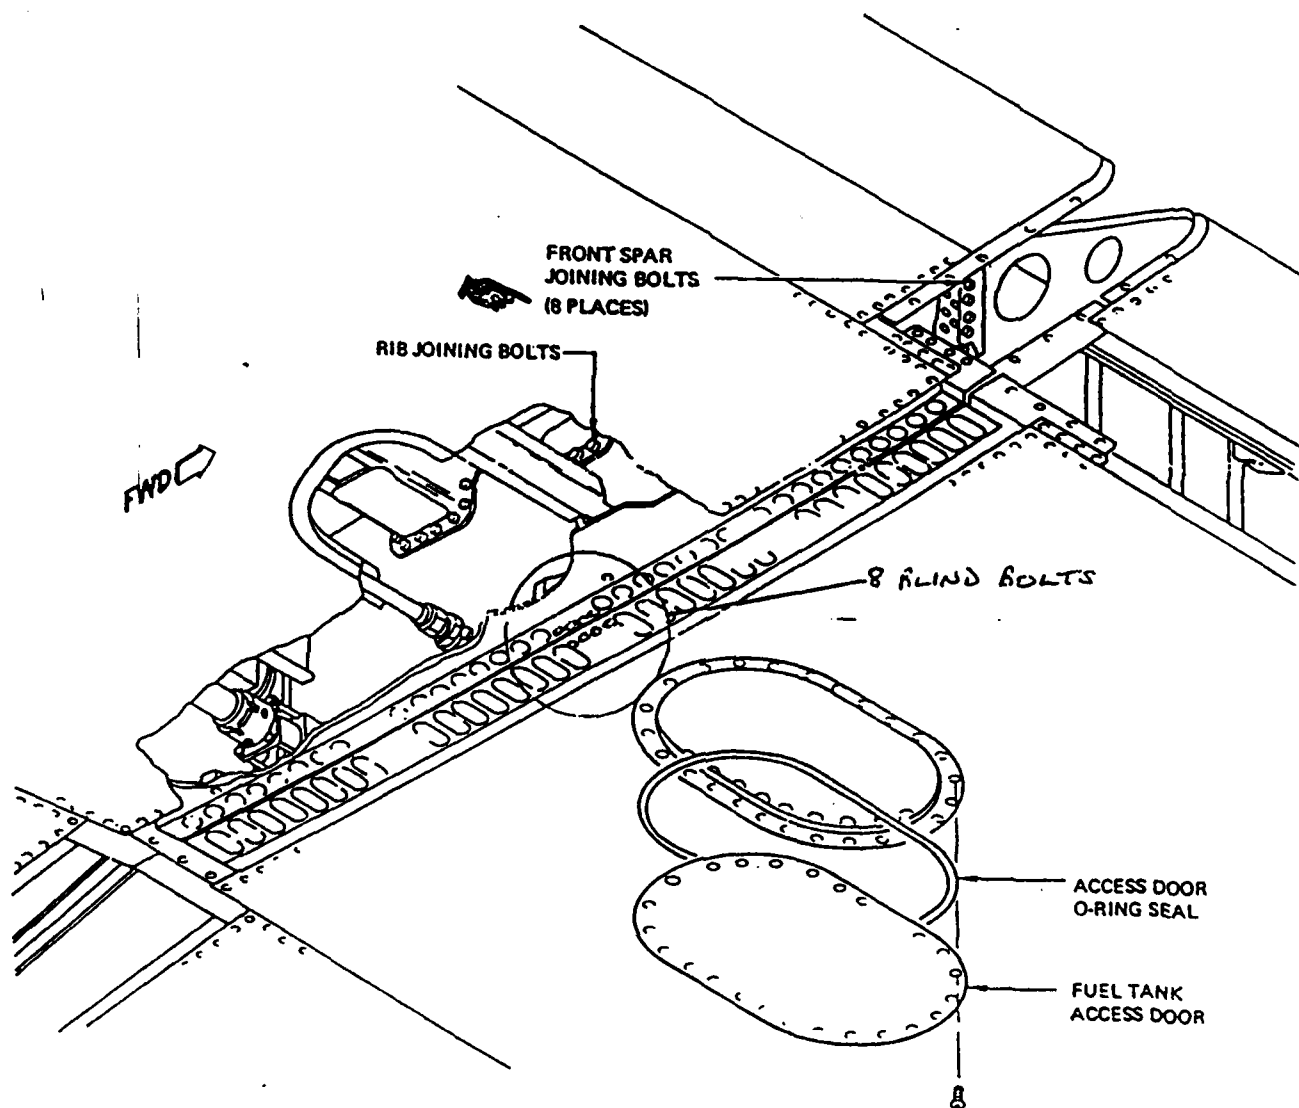
Figure 6-9. Outboard Wing Assembly

MMKRA will included inspection of the lower surface in T.O. -6 and FY91 ACI. MMKRA will take action to investigate the addition of of drain holes.
