MTL TR 90-44

# **FAILURE ANALYSIS OF A MAIN ROTOR PITCH HORN BOLT LOCATED ON THE AH-1 COBRA HELICOPTER**

VICTOR K. CHAMPAGNE, Jr.  
MATERIALS TESTING AND EVALUATION BRANCH

September 1990

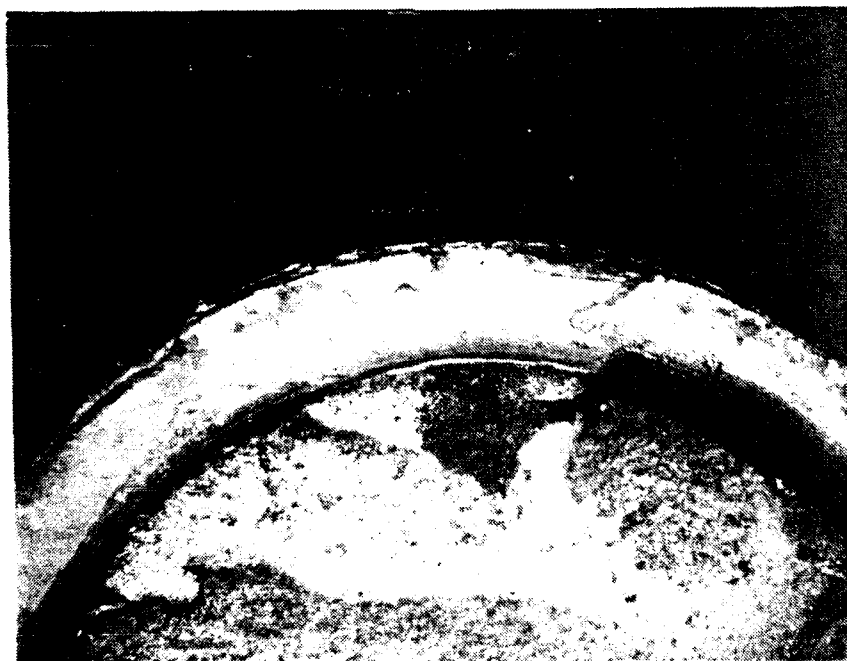
Figure 8. Optical macrograph showing the damaged cadmium plating and evidence of corrosion on the fracture face. MAG. 15X.

2. Visual inspection and light optical microscopy revealed evidence of corrosion pitting in adjacent regions to the fracture. In these locations the cadmium plating had been completely worn away during service.

A short-term prevention plan would be to insure that the protective coatings on the pitch horn bolt remain intact to combat the formation of corrosion pits, which act as crack initiation sites. In addition, the corrosion reaction is a source of atomic hydrogen. Inspect all bolt radii for deep machining marks which form stress concentration regions and act as SCC initiation sites.

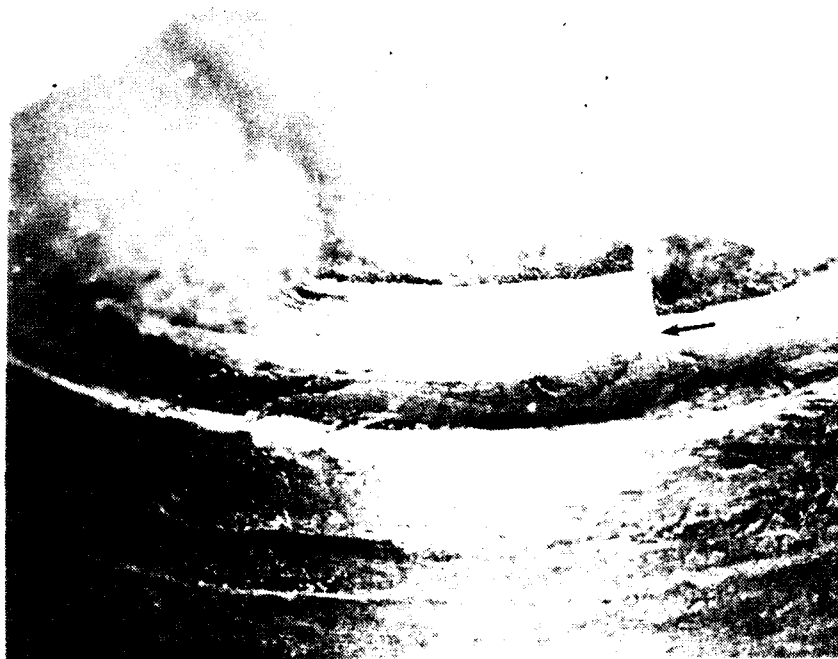
Figure 11. Optical macrograph showing deep machining marks on the radius (identified by the arrow). MAG. 15X.

- Insure integrity of surface coatings
- Never electrolytically replate bolts
- Inspect radii for deep machining marks

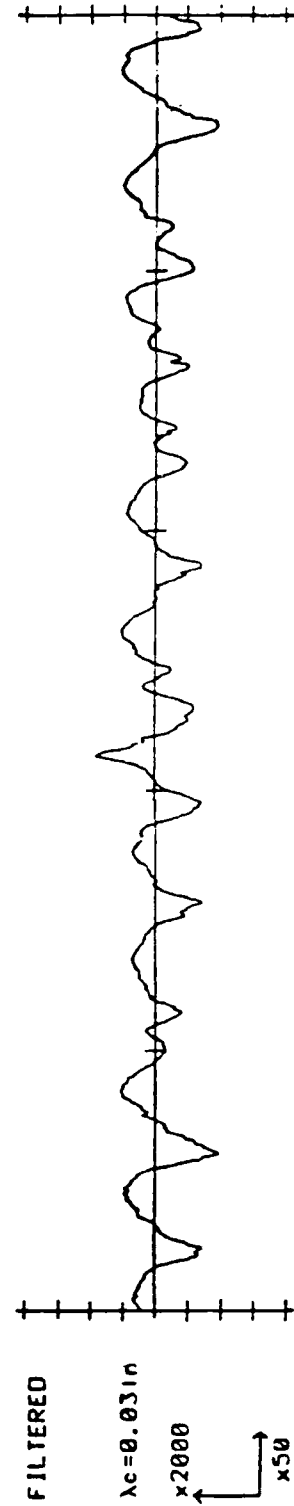
Figure 14. Topography traversed by profilometer on Area 1 (refer to Table 1). The RMS roughness value obtained was 68 microinches.

3. A Mitutoyo Surftest Analyzer was used to measure the surface finish along the upper bolt shank in three locations. The results showed that the surface profile was within the specified range.

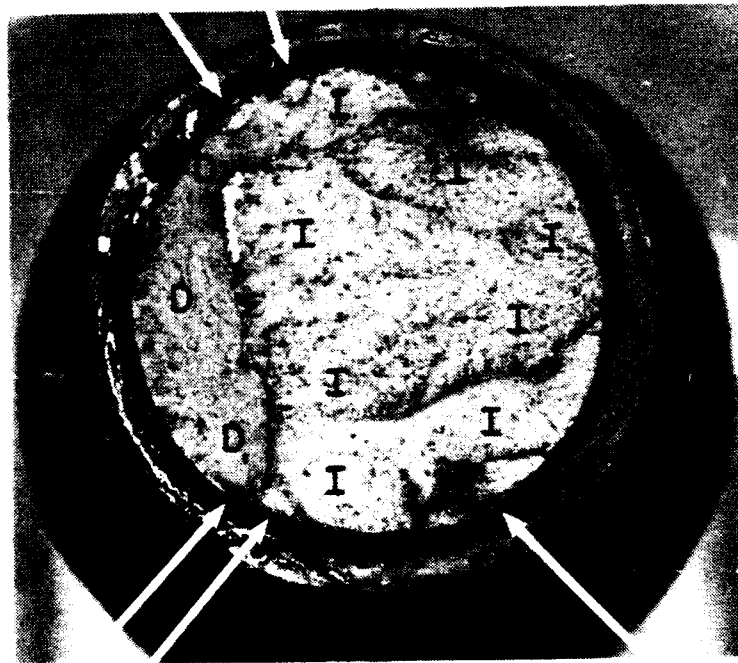
The pitch horn bolt sheared completely in half below the conical section at the threaded portion of the component while in service. Since the threaded section below the fracture which contained the nut was missing upon disassembly, only one fracture face could be examined. The scanning electron microscope (SEM) was utilized to identify the failure mode in each fracture zone identified in Figure 19. An enlargement of the fracture surface of the bolt is contained in Figure 20. Figure 19 was taken with an optical microscope, while Figure 20 is a SEM macrograph provided for comparative purposes. In many instances certain macroscopic features of the fracture are highlighted better with reflective light, such as corrosion. The cadmium plating circumventing the fracture was blistered and worn away entirely in numerous locations exposing a bare metal surface to the environment. This condition is ideal for Stress Corrosion Cracking (SCC) to occur. The arrows in both fractographs identify crack origins. These areas assumed a geometry indicative of a "thumbnail" crack, so-called because of their resemblance to a human thumbnail. The fracture path was complex and not easily discernable. The material did not exhibit much plasticity during fracture which was anticipated from an embrittlement type failure. There were also several regions darkened by corrosion that are more readily visible in Figure 19. Multiple crack origin sites are a common feature associated with SCC, whereas a failure attributed to Hydrogen Embrittlement, in which hydrogen had diffused into the material during electroplating would normally consist of a single large crack. In addition, HE fracture surfaces tend to be free of heavy oxides and corrosion in contrast to surfaces which are the result of SCC because, in the latter case, these failures are environmentally induced.

Figure 19. Optical macrograph of the fracture surface showing the various crack propagation zones. MAG. 7.5X.

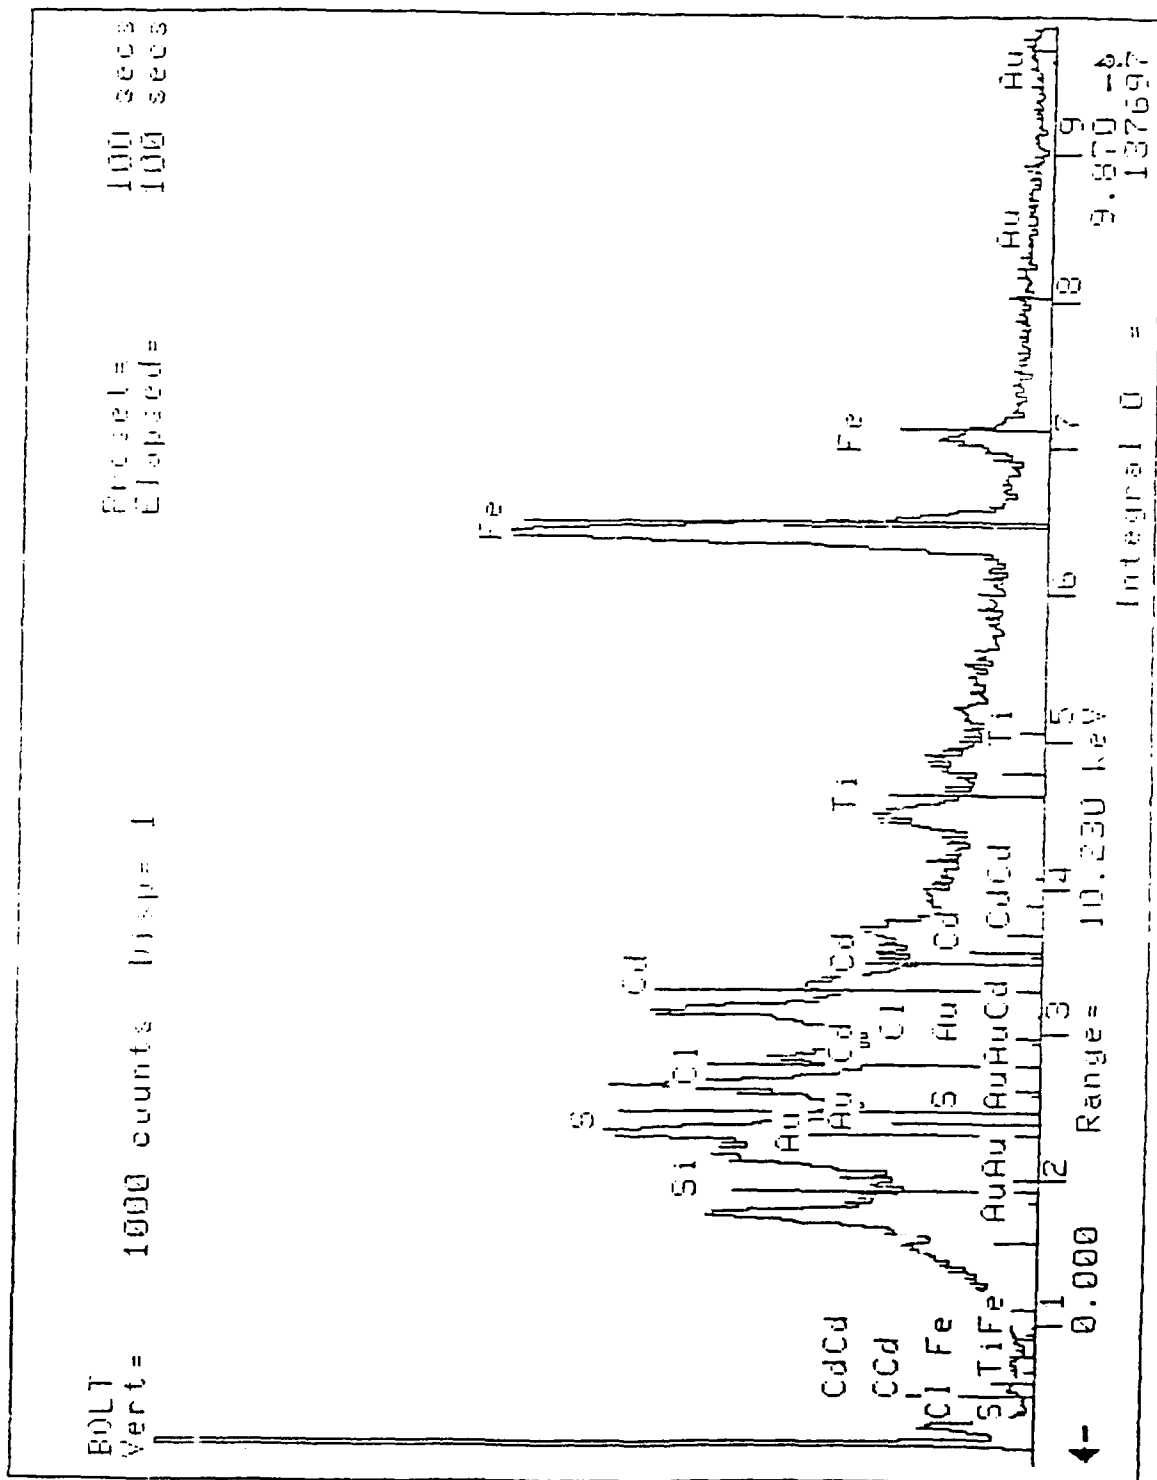
Figure 27. EDS spectra within the "thumbnail" crack region.

Energy dispersive spectroscopy (EDS) was utilized to characterize the composition of the dark corrosion layer which covered the "thumbnail" cracks. Figures 26 and 27 reveal the spectra of these regions which consisted of those elements associated with the type of steel under investigation, such as Fe, S, and Si, as well as oxygen which is indicative of a corrosion product. The Cd peaks represent traces of the cadmium plating while C and Ca may be attributed to surface oils, lubricants, or greases. Au and Pd were present because the fracture surface of the bolt had been sputtered with a fine layer of these elements for examination purposes under the SEM. Titanium dioxide is commonly used as a coloring agent in paint pigment and also exists in some lubricants. The most significant finding was that of Cl which may be found in large concentrations as a result of pitting or crevice corrosion. The environment within a pit or crevice becomes acidic with time and the pH value can decrease to approximately 1.5 to 1.0 while the pH of the bulk solution remains neutral. Since these forms of corrosion are autocatalytic in nature the degree of metal dissolution within these regions increases as does hydrogen evolution. This alteration of the bulk environment combined with internal or externally applied stress allows the formation of SCC.
