CETHA-BC-CR-90116

## Report of Sampling and Analysis Results

Holmdel Army Housing Units  
Holmdel Township, New Jersey

August 1990

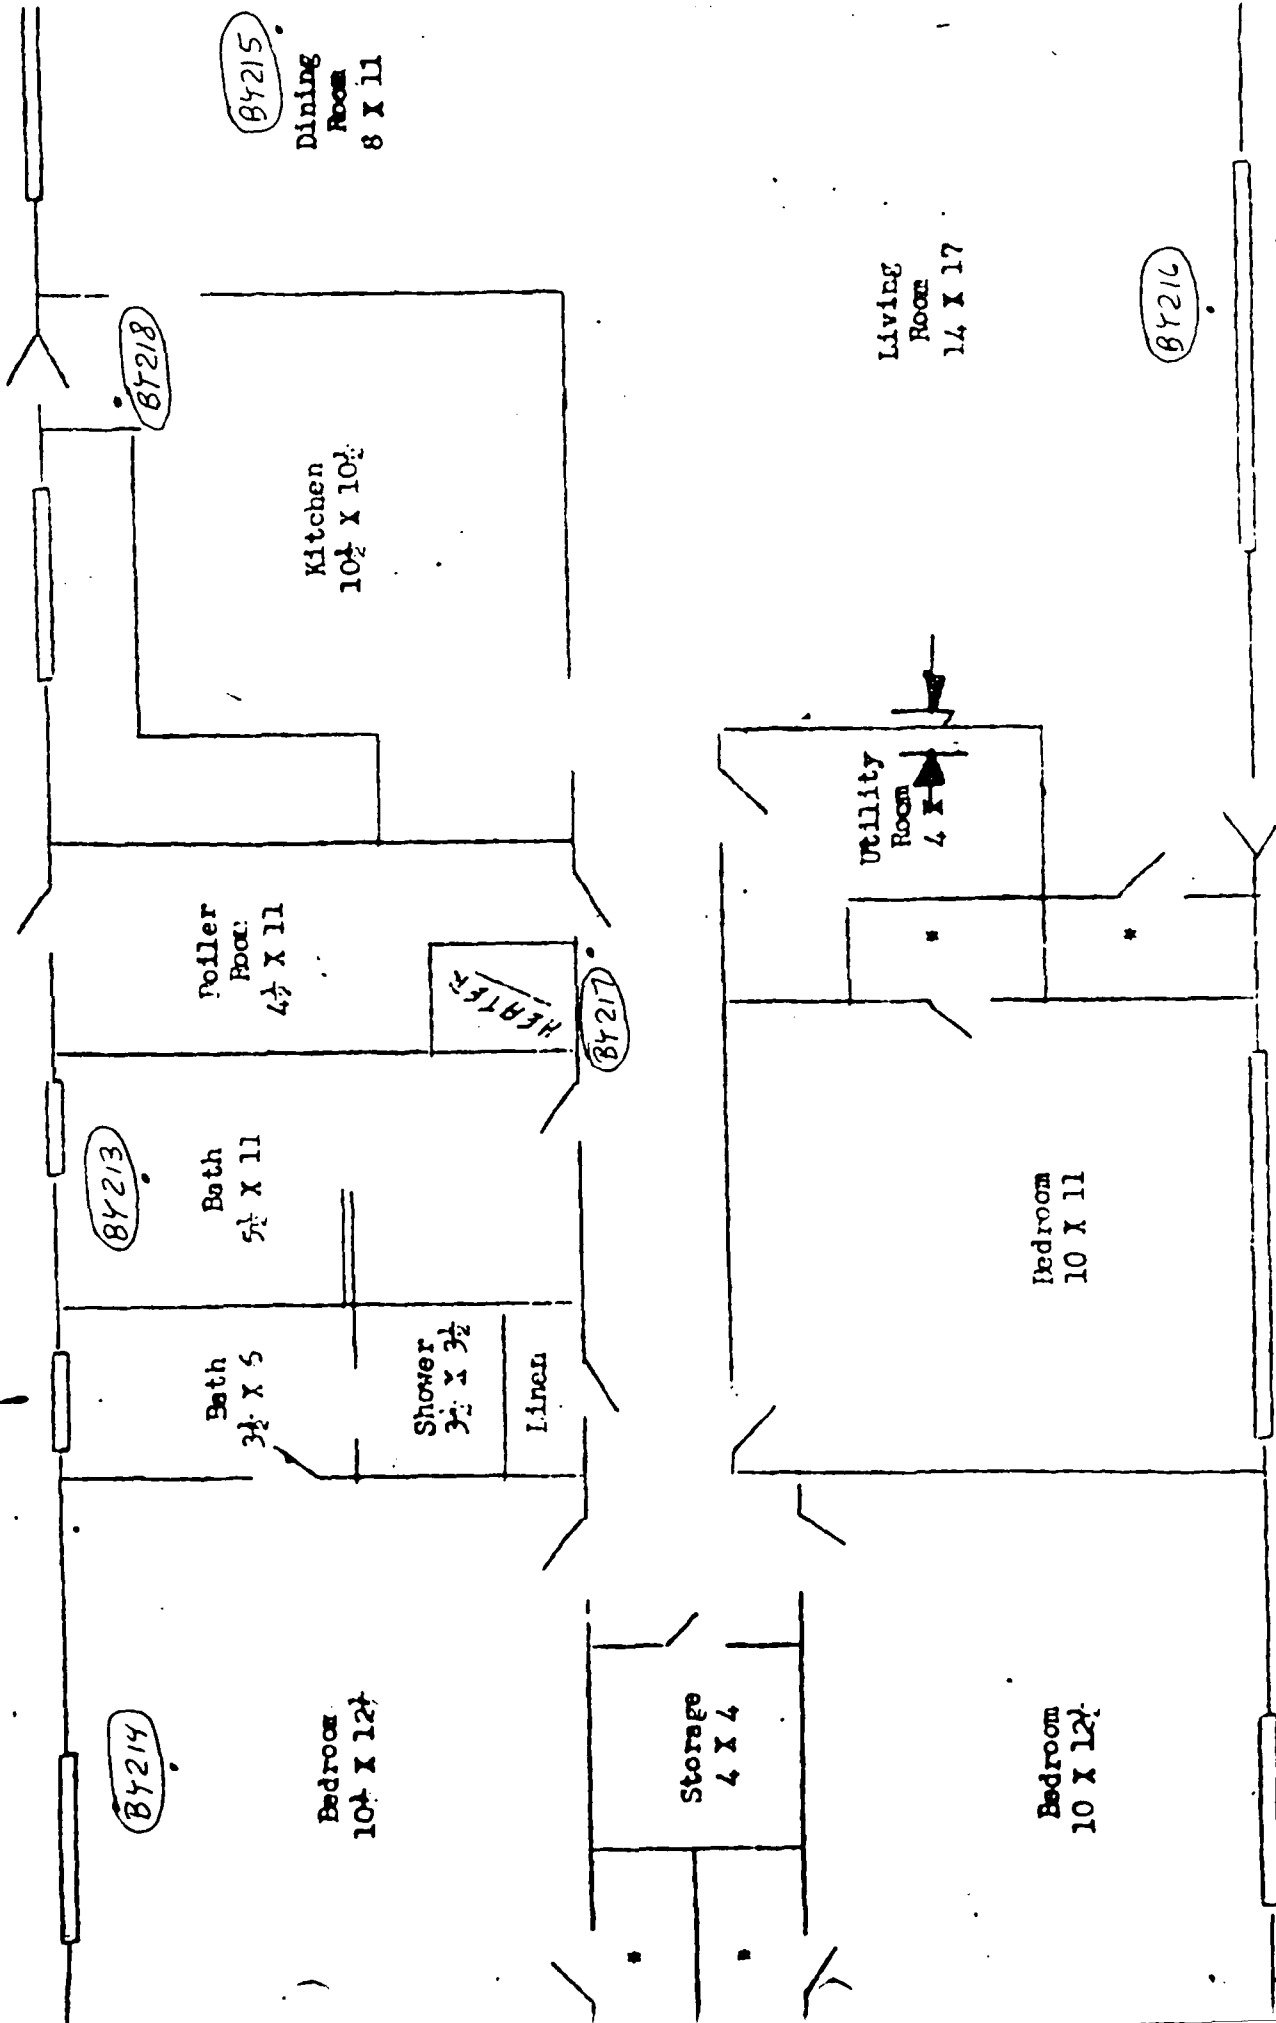
A DUSP'G FLOOR PLAN

Unit # 211 is a 3-bedroom house with a pitched shingle roof and vinyl siding. Heat is forced air oil fire. No pipe insulation was seen - piping went down into foundation. Dust samples and floor tile were taken. A suspect ACM expansion joint on the Heater in Boiler Room was noted, but not sampled. Unit was occupied at the time of our inspection.

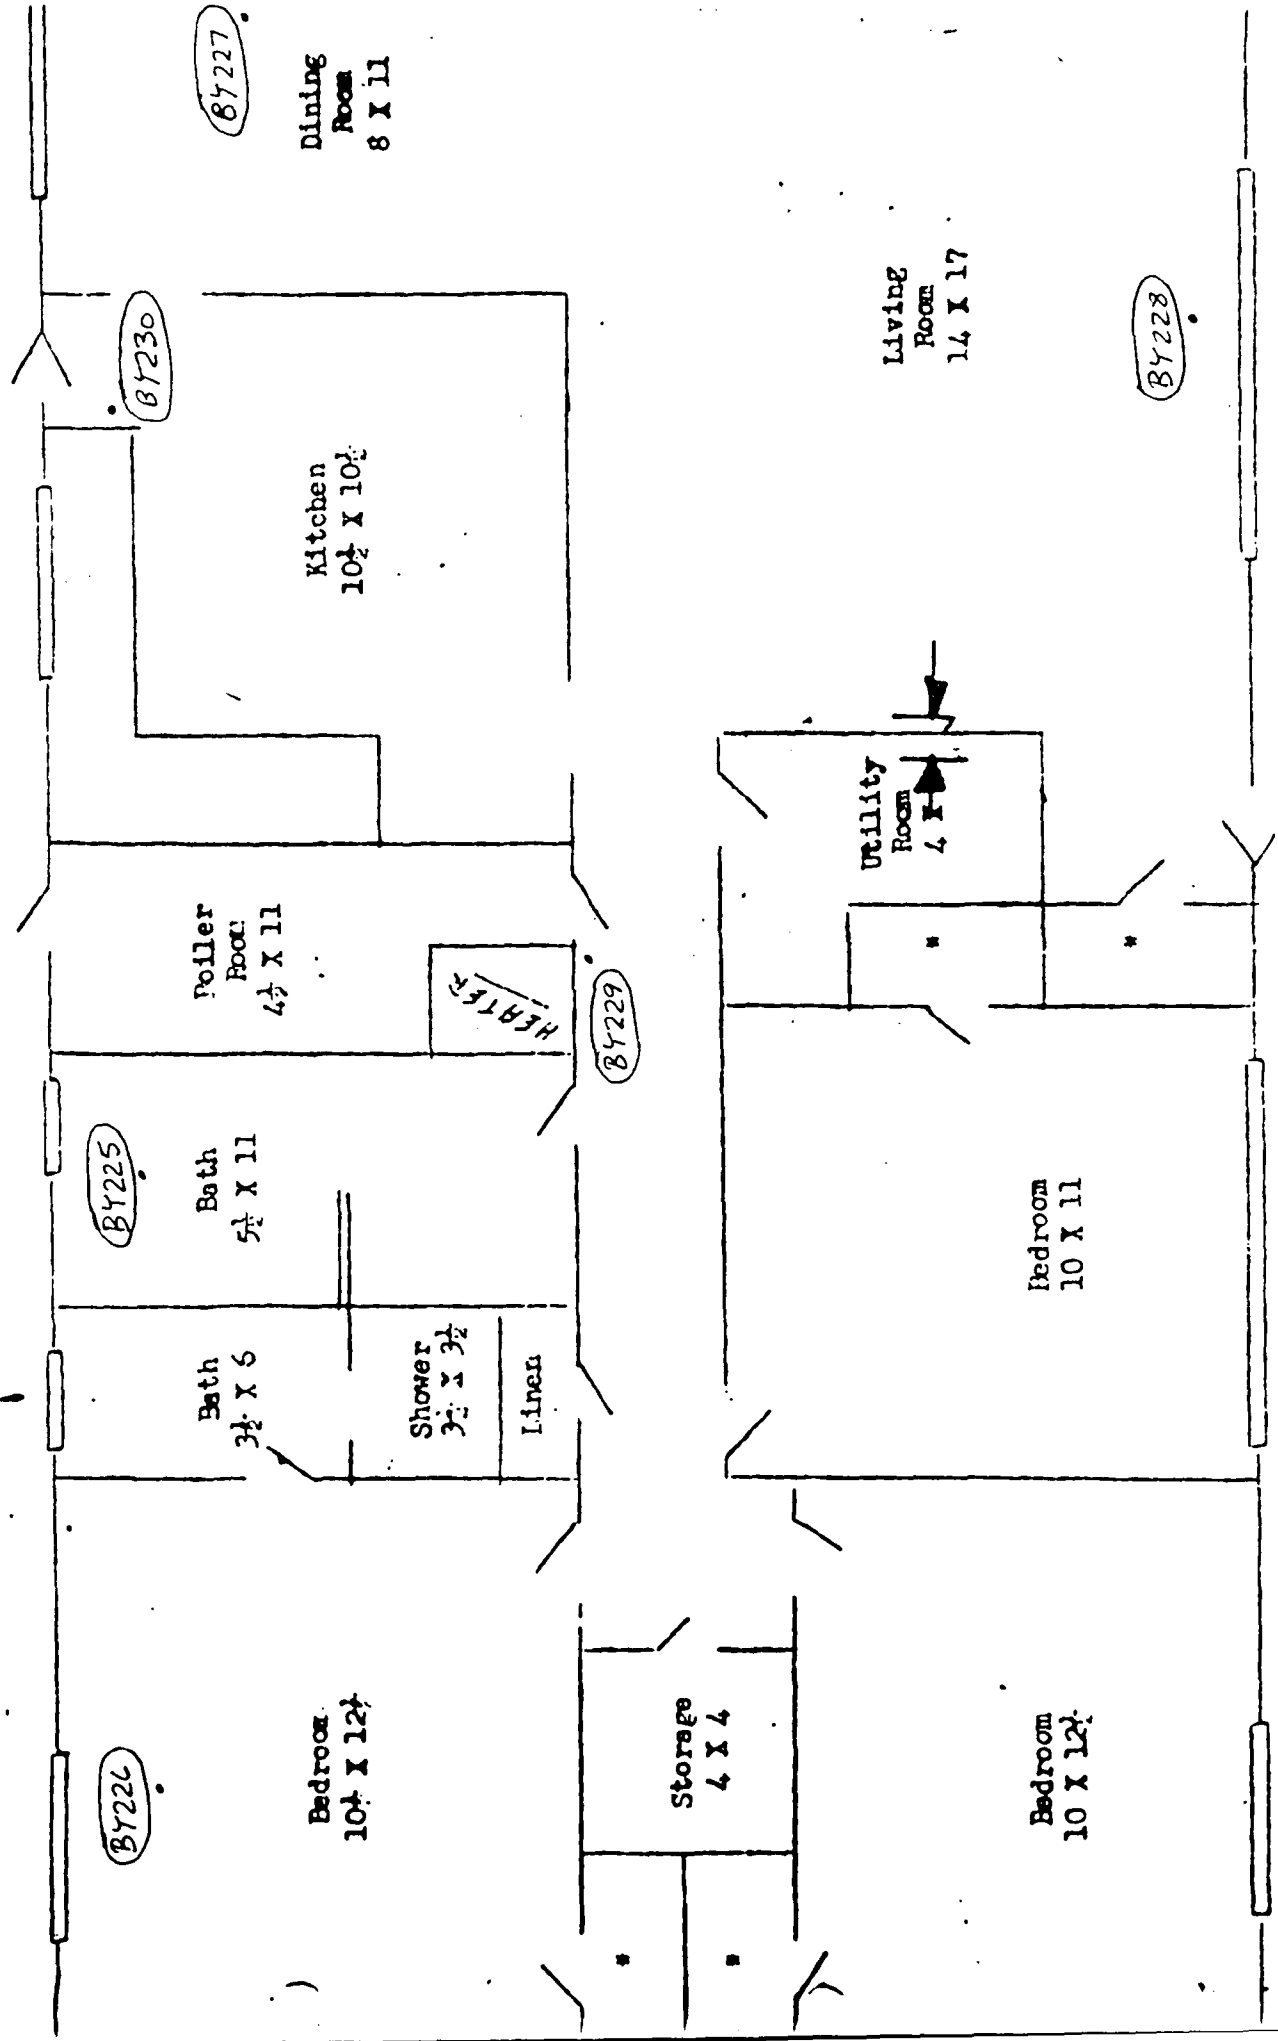
3-BEDROOM FLOOR PLAN

Unit 206 is a 3-bedroom house with a pitched, shingle roof and vinyl siding. Heat is forced air oil fire. No pipe insulation noted. Suspect ACM expansion joint on heating unit. Dust in floor vents and floor tile were sampled. Unit was occupied at the time of our inspection.

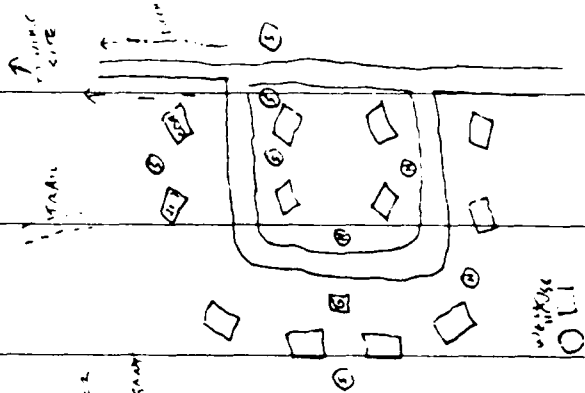
ACCESS OLD BRIDGE  
TO END OF ROAD TO APPARENT  
NIKE SITE (1/2 MI FROM FNU). NO  
SIGN OF NIKE INSTALLATION EXCEPT  
FOR METAL BUILDINGS. SITE APPEARS TO  
HAVE BEEN BUILT UP, NO SIGN OF  
UTILITIES EXCEPT FOR OLD SUPPLY  
WELL. TOPOGRAPHY IS FLAT SANDY  
COASTAL PLAIN-TYPE BEHIND ITS  
MOVES TO FNU AREA LOCATED  
ALL EVIDENCE OF POST-WAR-USE UTILITIES  
FOUND NO SIGN OF NIKE TRENCH  
COMMON WITH THE NIKE SITE.

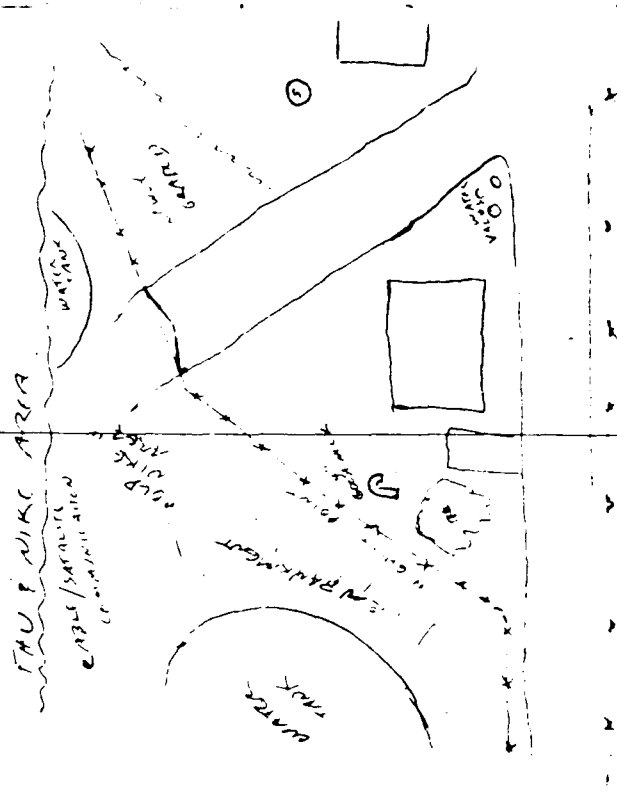
ISSUE IRRIGATED AT 101.5 PSI FNU. OLD  
NIKE AREA NOW HEAVILY DEVELOPED  
~~AREA~~ BY CABLE COMMUNICATION AND  
WATER TRENCHES. THE FENCE BETWEEN THE FNU  
AND NIKE SITE RUNS ALONG CREST OF  
HILL ESSENTIALLY DEFINING A DRAINAGE  
DIVIDE BETWEEN THE TWO SITES. A  
RECON. OF THE AREA REVEALED A  
4" GROUNDWATER BUT PIPE AT HOUSING  
UNIT #201, A SCOUR MARKER AT #202  
AND WATER VALVES AT THE INTERSECTION  
IN FRONT OF #201. NO EVIDENCE  
OF A COMMON TRENCH BETWEEN  
FNU & NIKE AREA
