MISCELLANEOUS PAPER GL-90-21

## EFFECTS OF VARIABLE TIRE PRESSURE ON ROAD SURFACINGS

September 1990

Final Report

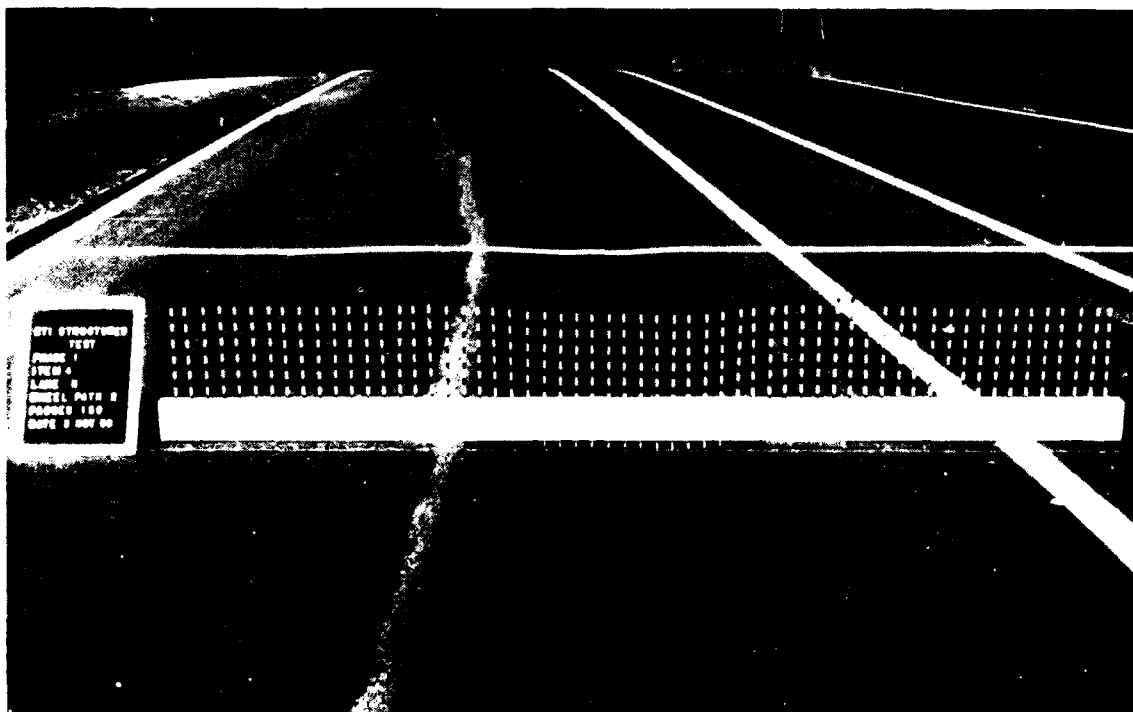
19. At the beginning of traffic, slight pumping of the surface was observed as the high-tire-pressure truck traversed the 2-in.-thick AC sections. Surface deformation and pumping was most evident in the outside wheelpaths of the horizontal curves. After about 71 passes, distinct rutting and hairline longitudinal cracking along the outside edges of wheelpath 2 were noticed in section 4. As traffic continued, the rutting and cracking in section 4 became more severe; one area was rated as failed after 158 passes. Figure 9 depicts a general view of this initial failure in the AC portion of the rest road. The maximum rutting in this area was 2.3 in. deep, and the cracking had progressed into alligator cracking. After an additional 165 passes, for a total of 323 passes, a second failure occurred in section 4, wheelpath 2. Figure 10 shows a general view of this second failure. It

Figure 9. High-tire-pressure lane, section 4, general view of initial failure, 158 passes

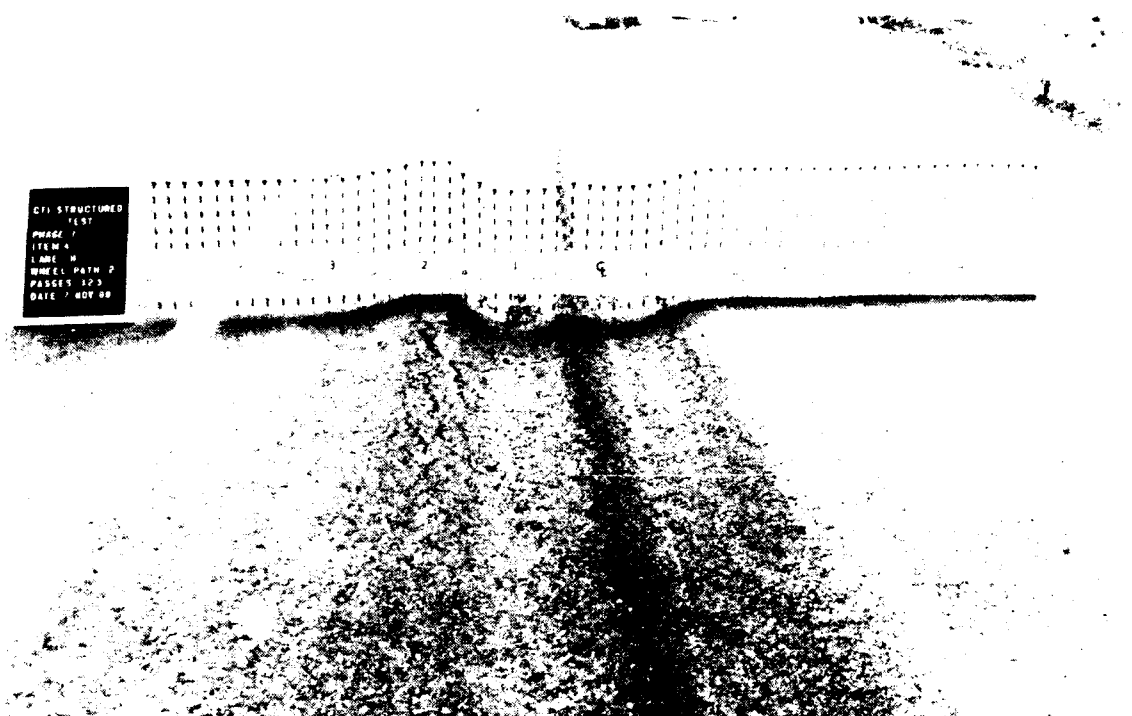
should be noted that again the majority of the rutting occurred in wheel-path 2, and very little distress had occurred in wheelpath 1. Wheelpath 1 in section 4 is located in the inside portion of the curve. This failure is attributed to overloading or failure of the subgrade. Figure 11, which is a view of a test pit excavated in the failed area, indicates severe rutting of the subgrade. At the time of this second failure in the high-tire-pressure lane (323 passes), very little distress was present in the low-tire-pressure lane. There was no cracking evident, and the maximum rut depth was only 0.5 in. The rate of pavement deterioration with traffic decreased after the second failure. The next failures occurred after 1,104 and 1,414 passes in wheelpath 1 of sections 6 and 5, respectively. When these sections were judged failed in the high-tire-pressure lane, only hairline cracking and minor rutting were detected in the low-tire-pressure lane. The average rut depth in the low-tire-pressure lane of section 6 after 1,104 passes was about 0.7 in. and in section 5 about 0.4 in. after 1,414 passes. Throughout the remainder of traffic in the high-tire-pressure lane (6,764 loaded passes), only two additional failures occurred, one in section 5, wheelpath 1 after 2,210 passes and another in section 10, wheelpath 1 at 2,210 passes also. The mode of failure in section 5 was the same as the previous failures, and the section 10 failure was attributed to severe shoving of the top lift of AC after 1,812 passes (see Figure 12) and then severe cracking and rutting of the surface as shown in Figure 13. The failure in section 10 occurred in an area where the traffic was entering a horizontal curve and at the beginning of warm weather traffic. Test traffic was applied to the AC section during two periods, from October 1988 to February 1989 and from June to November 1989. The shoving, shown in Figure 12, occurred after 245 passes had been applied in June 1989. Shoving (Figure 14) was detected in the low-tire-pressure lane of section 10 after 1,200 passes of warm weather traffic or a total of 4,200 passes.

Figure 10. High-tire-pressure lane, section 4, second failure, 323 passes

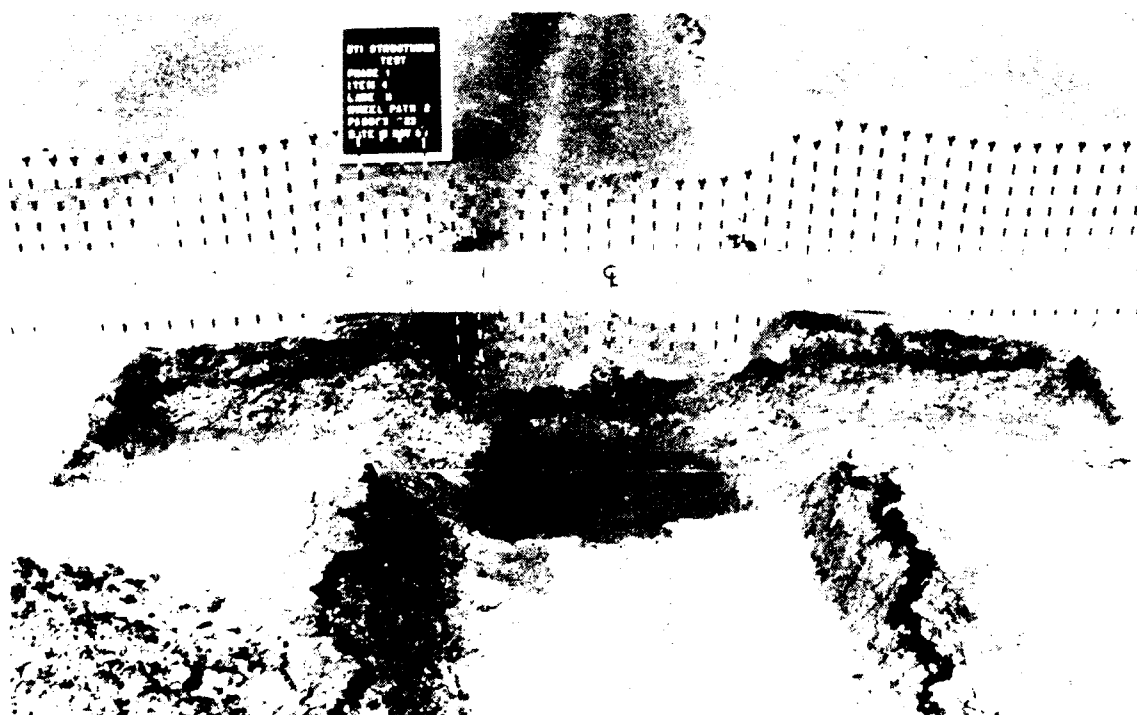
Figure 11. High-tire-pressure lane, section 4, test trench after 323 passes

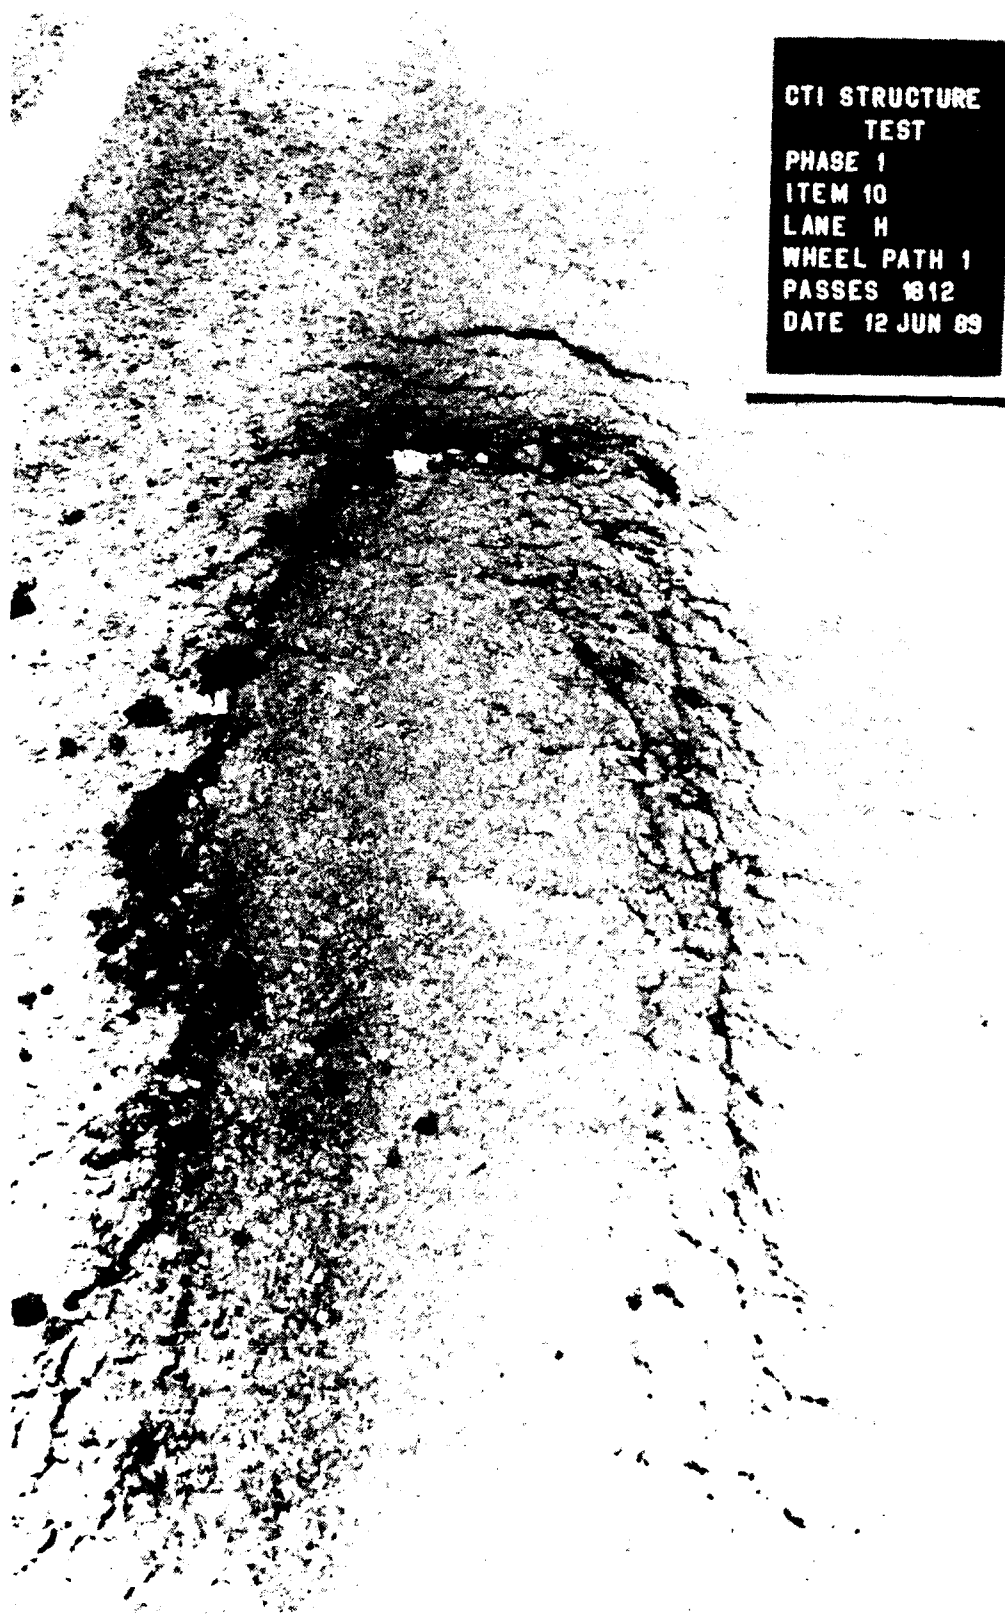
Figure 12. High-tire-pressure lane, section 10,  
showing after 1,812 passes

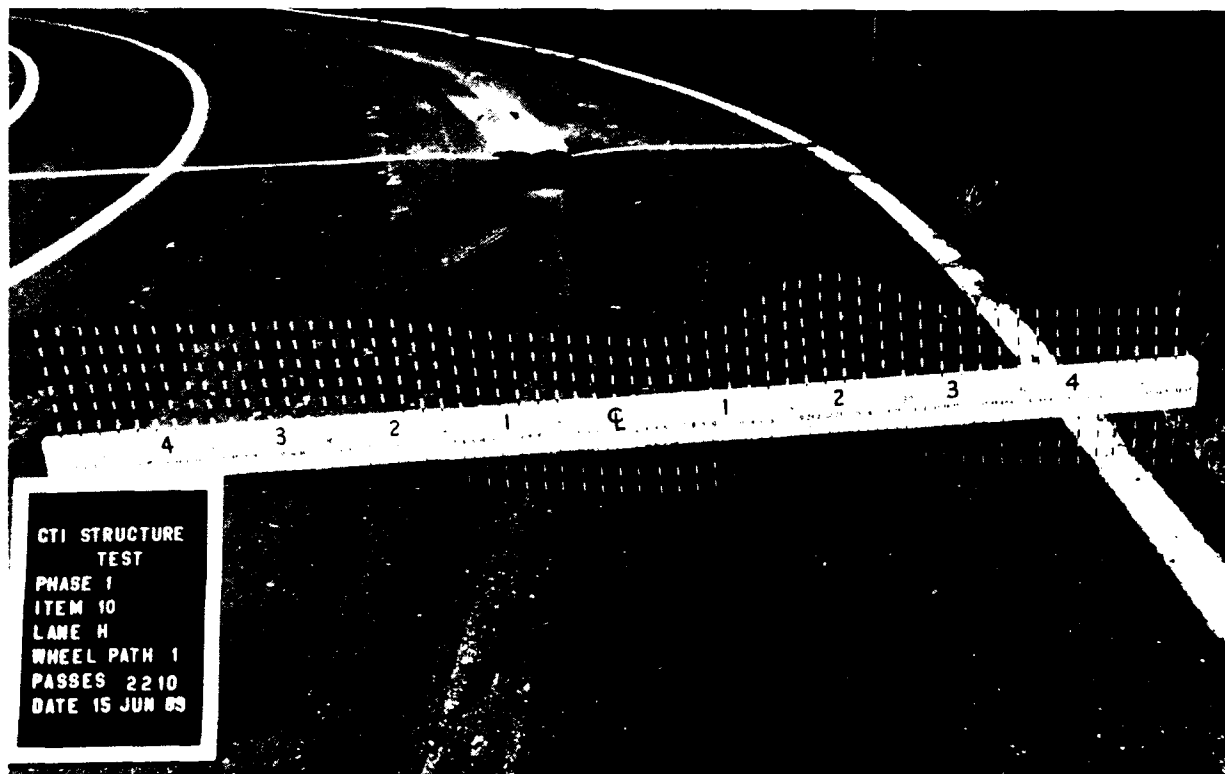
Figure 13. High-tire-pressure lane, section 10,  
failure after 2,210 passes

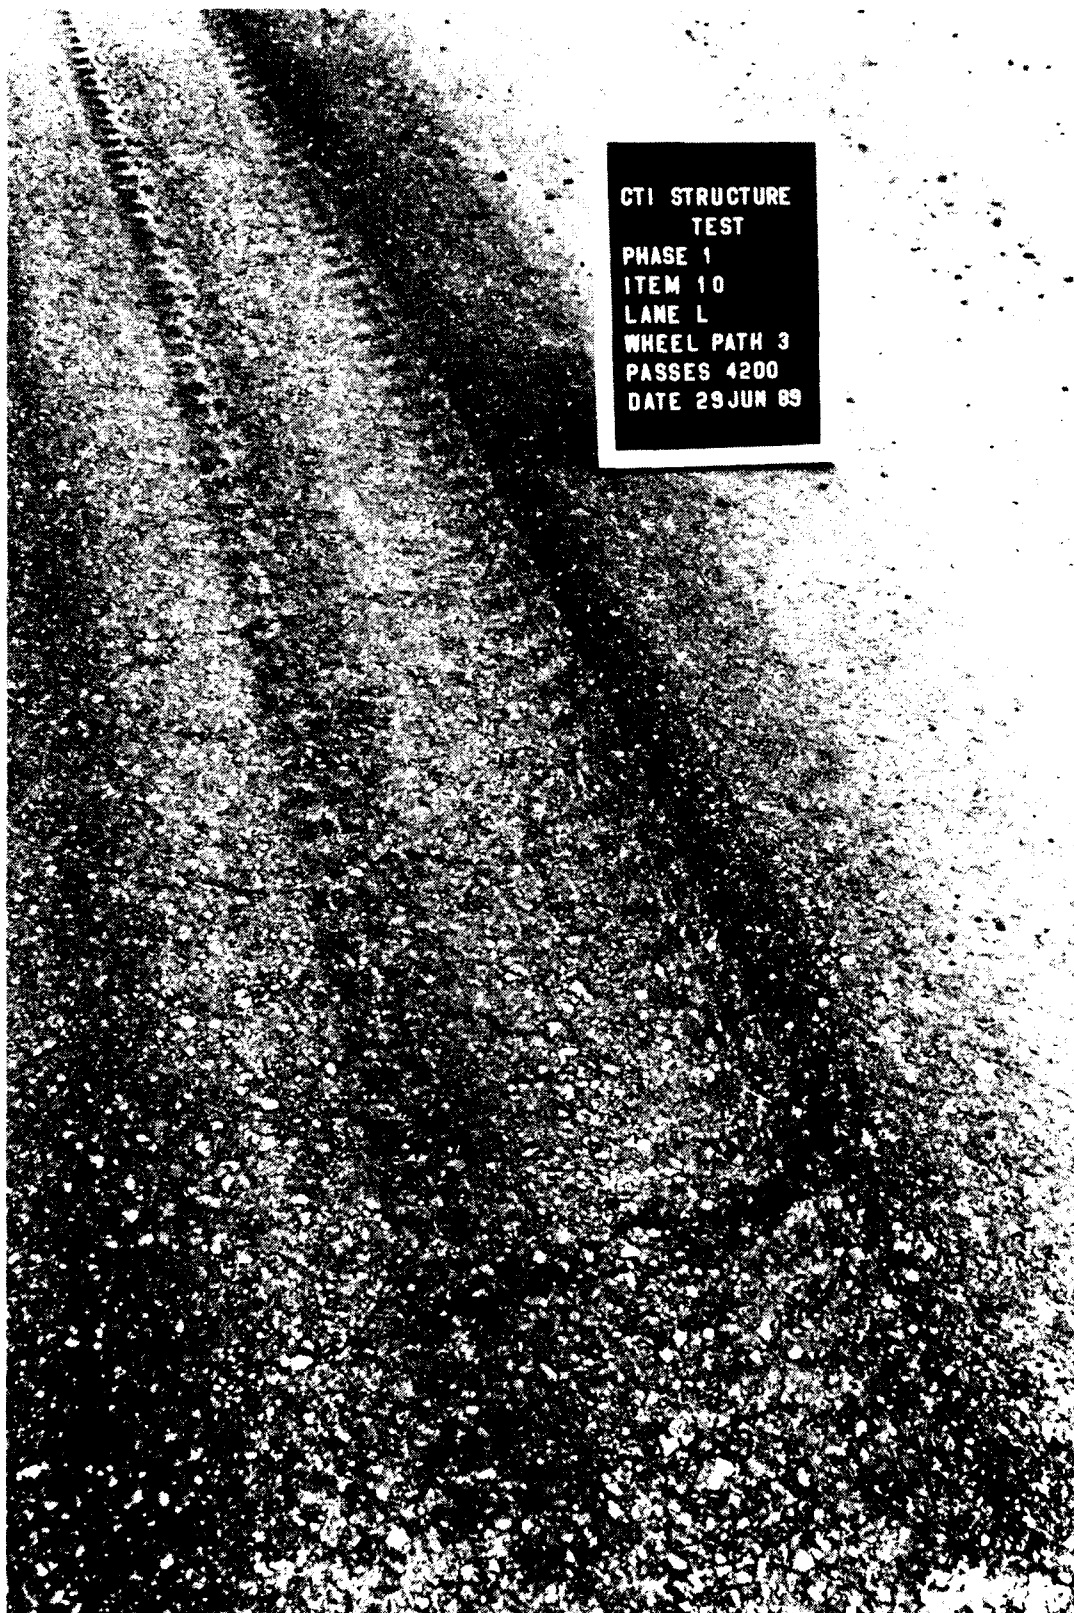
Figure 14. Low-tire-pressure lane, section 10, low severity shoving after 4,200 passes

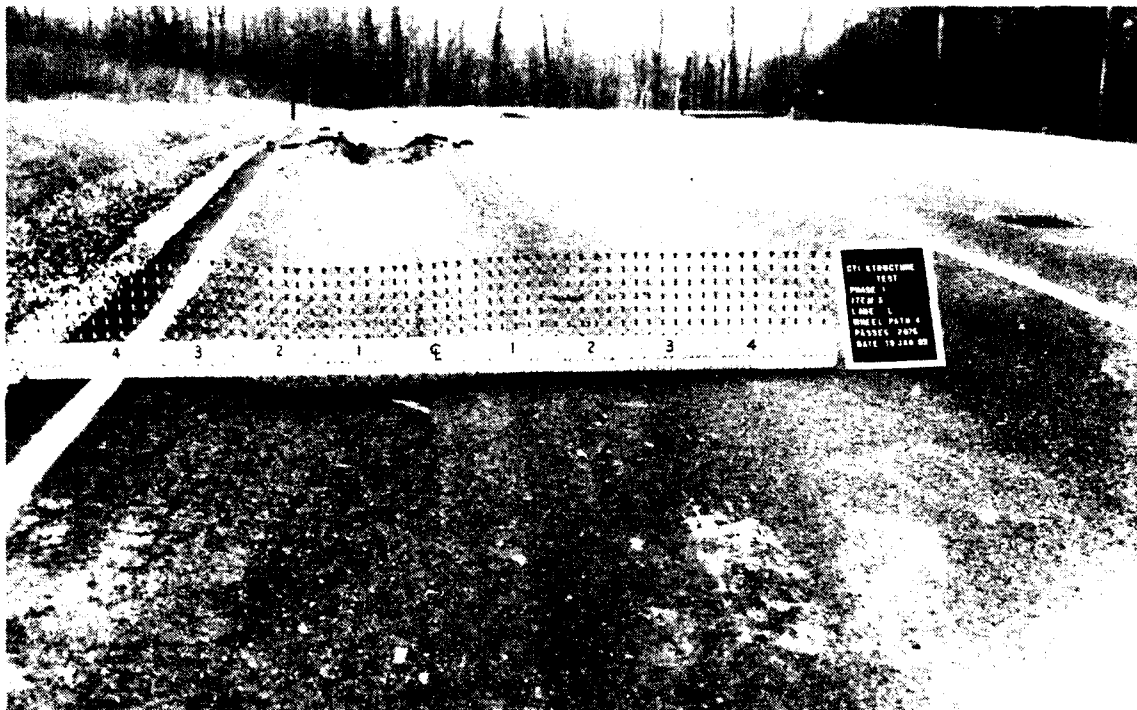
20. Four failures, two in section 4 and one each in sections 5 and 6, occurred in the low-tire pressure lane. The failures in sections 5 and 6 were judged as failed after 2,076 passes and those in section 4 after 3,324 and 3,845 passes. Severe cracking and rutting were the mode of each of these failures. A general view of the portion of section 5 was failed after 2,076 passes as shown in Figure 15.

Figure 15. Low-tire-pressure lane, section 5, failure after 2,076 passes

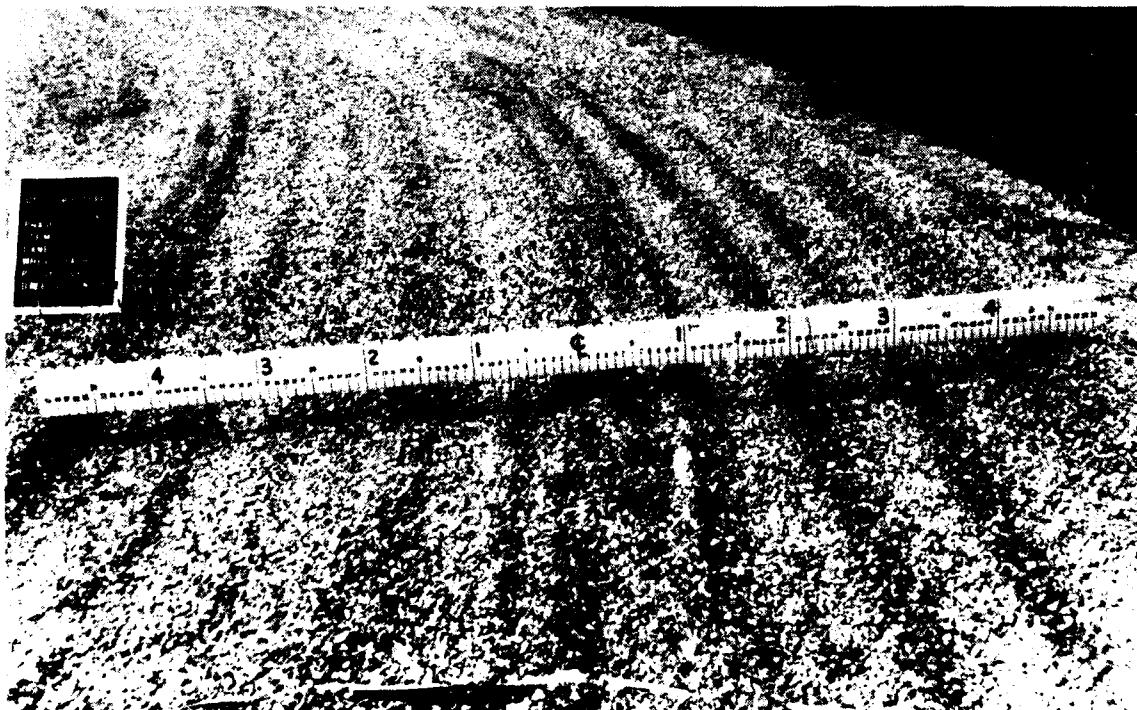
Figure 16. Low-tire-pressure lane, section 1, failure after 66 passes

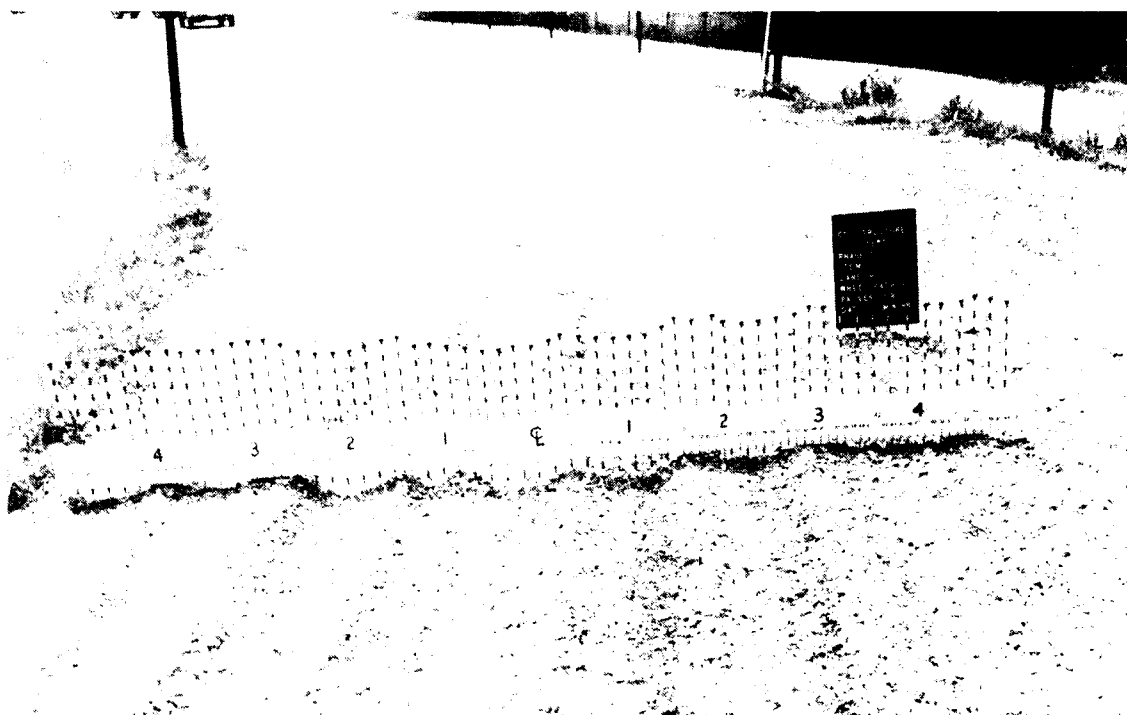
Figure 17. High-tire-pressure lane, section 1, failure after 58 passes

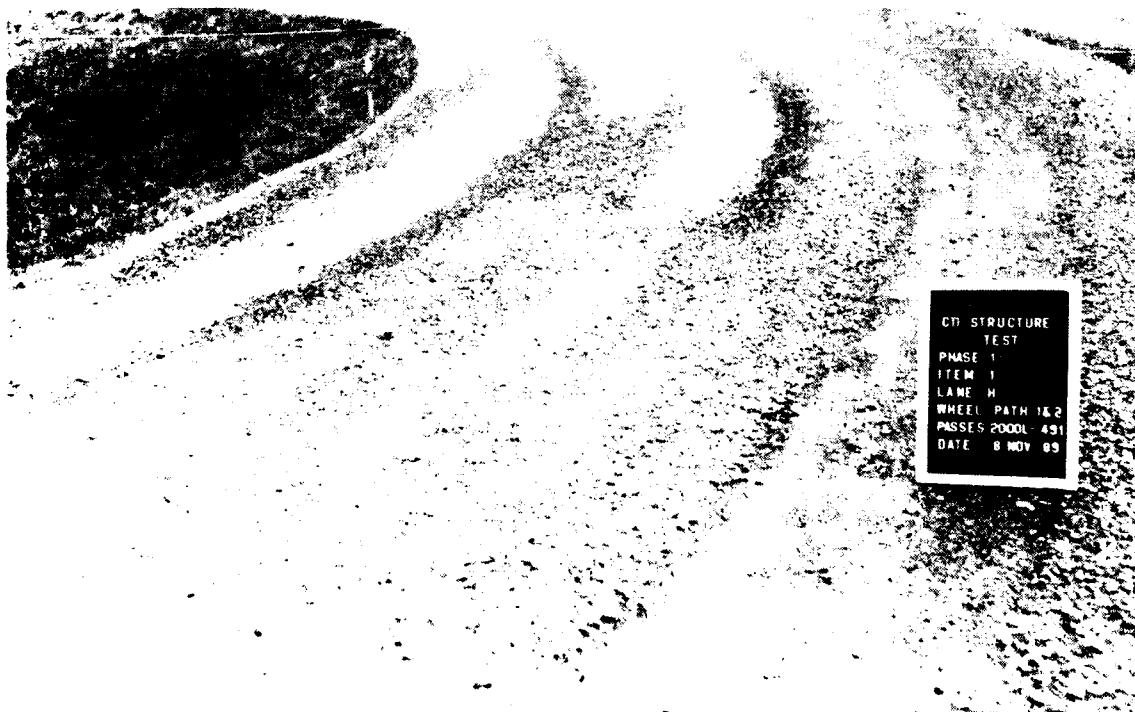
Figure 20. High-tire-pressure lane, section 2, low severity rutting and corrugation

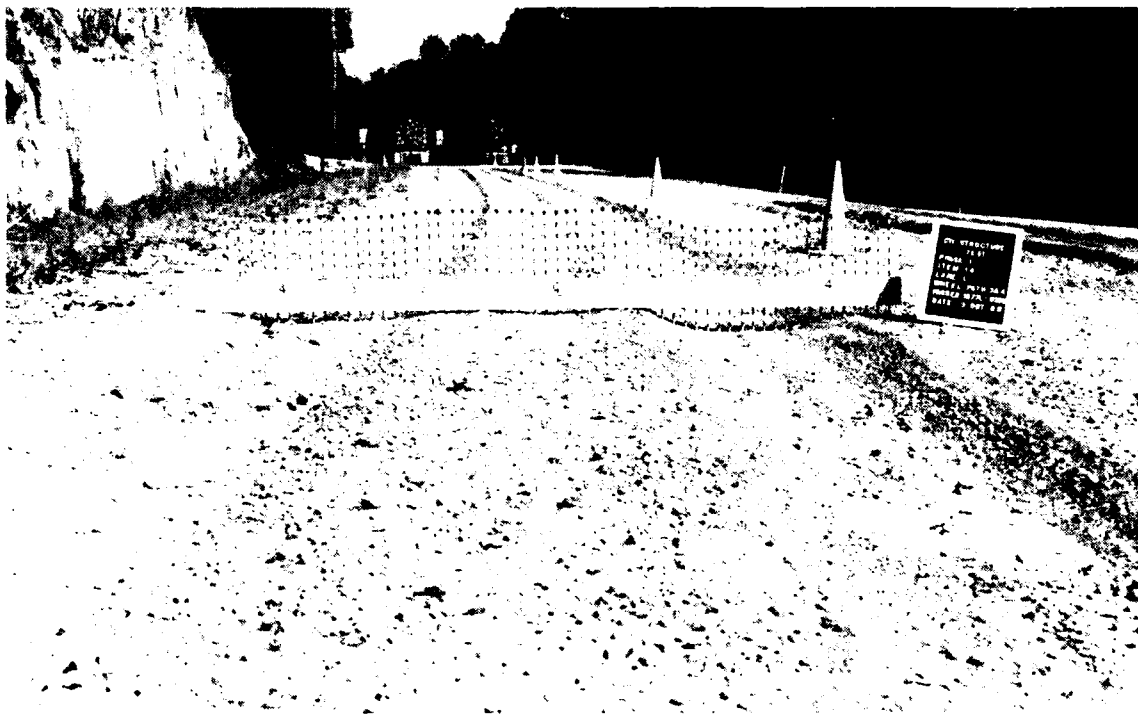
Figure 23. Low-tire-pressure lane, section 14, high-severity rutting after 90 passes in the rain

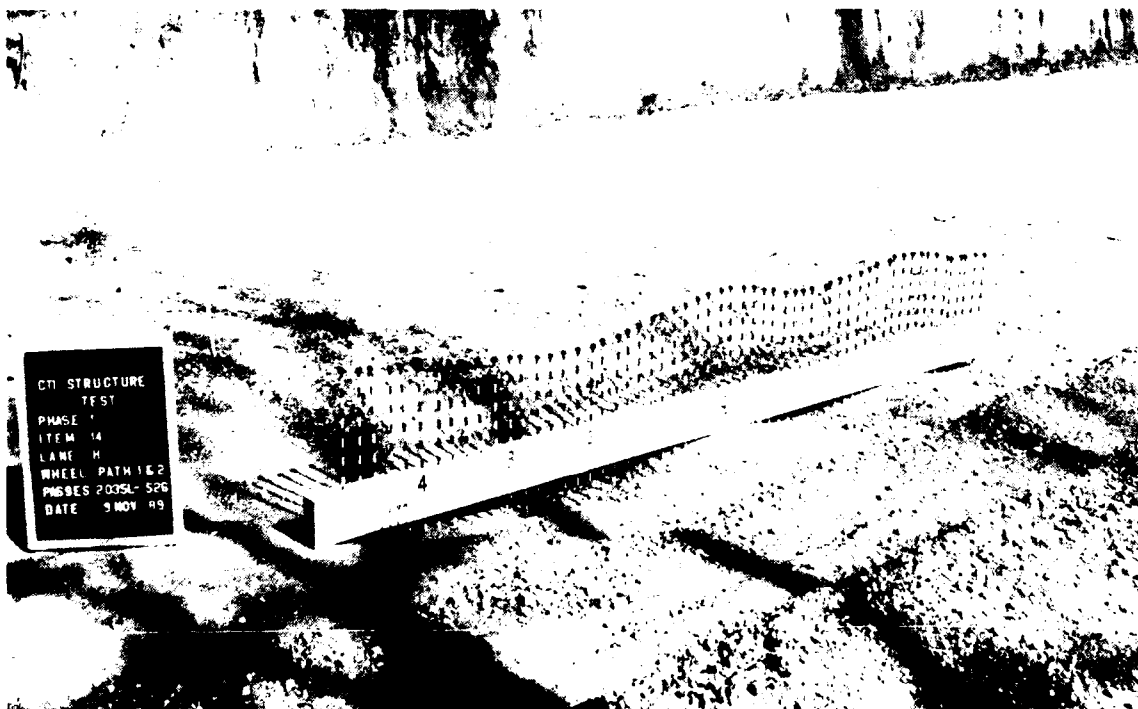
Figure 24. High-tire-pressure lane, section 14, high-severity washboarding

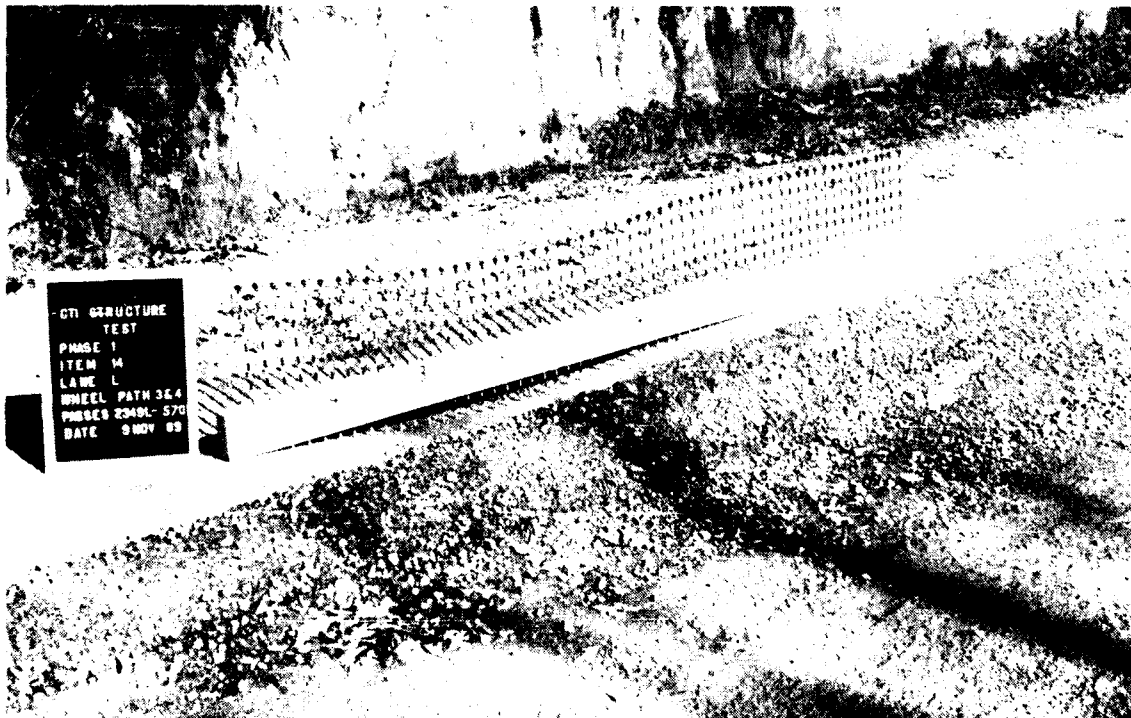
rainfall and weaken the pavement structure at a controlled rate. As water was applied, drop cone penetrometer measurements were taken in order to monitor the aggregate and subgrade strengths. As traffic was applied, failure was reached once it entered into the high-tire-pressure lane of section 14 and three times in section 15 due to rutting and severe washboarding. No failures were recorded in the low-tire-pressure lane. Figure 24 shows the high-severity washboarding in the high-tire-pressure lane of section 14 at failure. For comparison purposes, a view of the maximum distress in the low-tire-pressure lane of section 14 at the same time the high-tire-pressure lane was rated failed is shown in Figure 25.

Figure 25. Low-tire-pressure lane, section 14,  
low-severity depression
