**US Army Corps  
of Engineers**

USACERL Technical Report M-91/02

October 1990

# **Exterior Insulation and Finish Systems (EIFS) on U.S. Army Facilities: Lessons Learned**

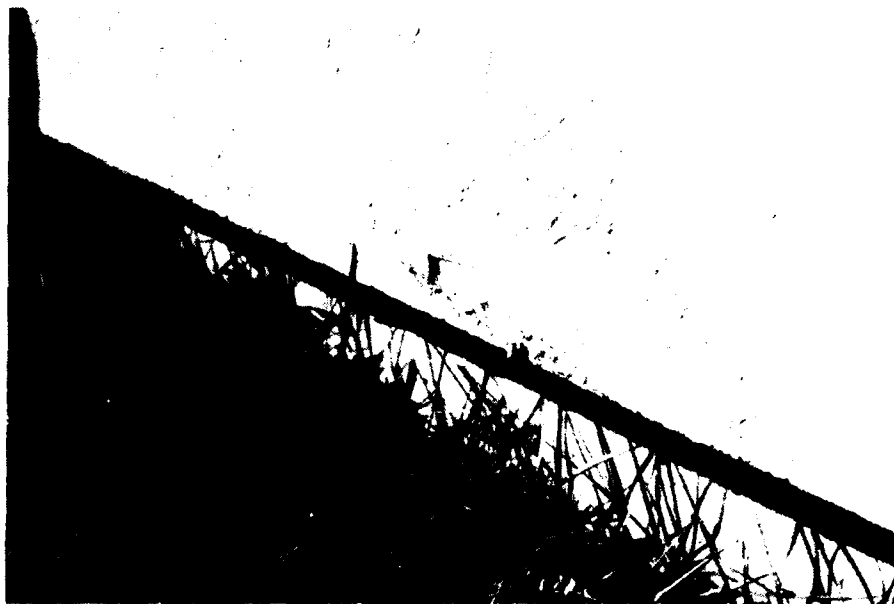
Probably the most common example of unintentional damage is that caused by lawnmowers or other maintenance equipment scraping or striking the wall (Figure 9). Rocks and other debris thrown by mower blades have even been observed embedded in the system.

Figure 9. Damage caused by lawnmower.

Damage caused by lawnmowers or other yard maintenance equipment can be lessened by providing a gravel rock border around the buildings as shown in Figure 17. Shrubbery can also be used as long as it is not of the climbing variety, which can actually penetrate into some systems.
