Multiple-Purpose Project  
Little Blue River Basin  
East Fork Little Blue River  
Missouri

# Blue Springs Lake

## Operation and Maintenance Manual

# Construction Foundation Report

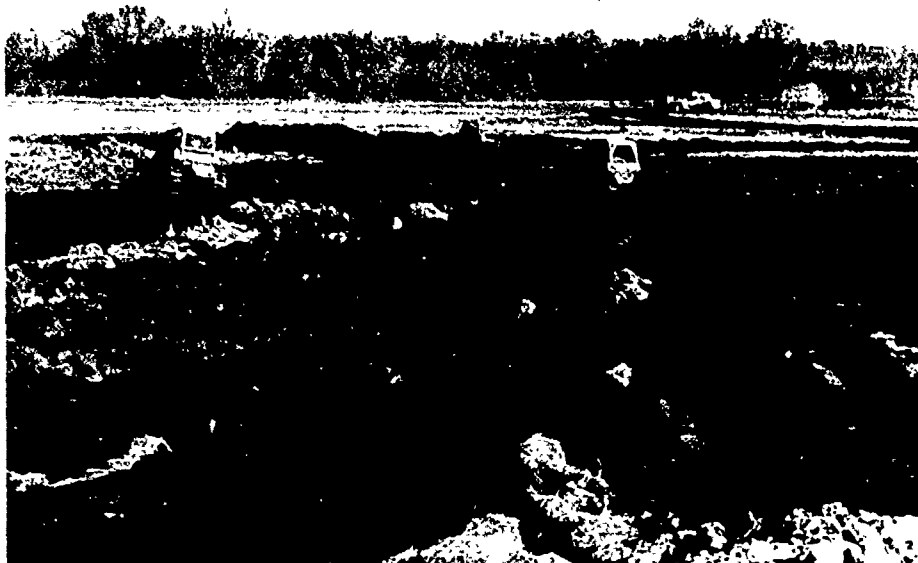
5. Blue Springs Lake, 15 November 1982, Neg. No. 52.  
Dam foundation at station 92+00. Removing objectionable material, looking north.

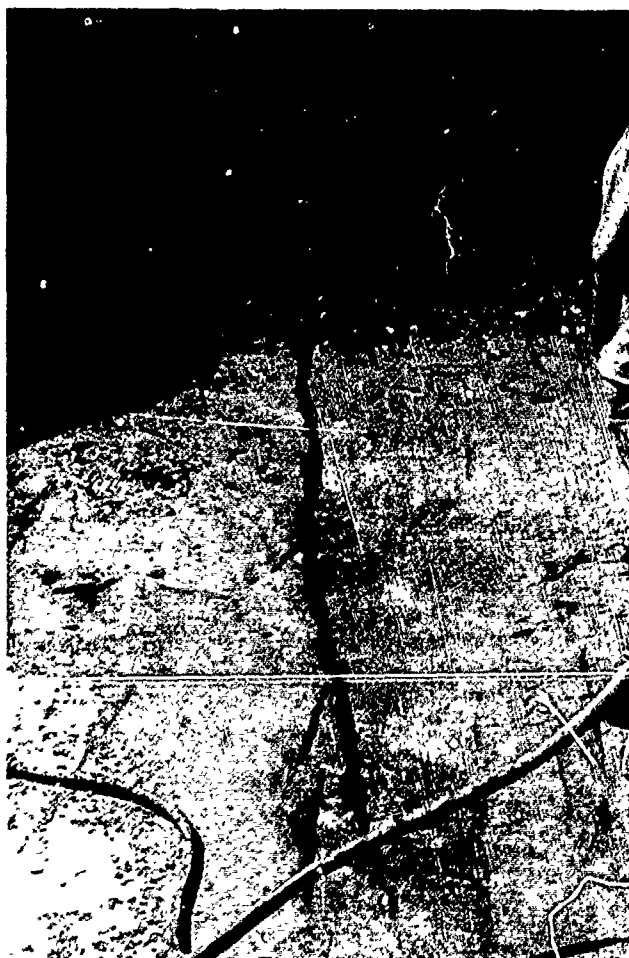
24. Blue springs Lake,  
11 July 83,  
Neg. No. 147.  
Tower excavation.  
Open joint in floor  
bearing surface from  
station 47+57.1 to  
station 47+73.4.  
Looking downstream.

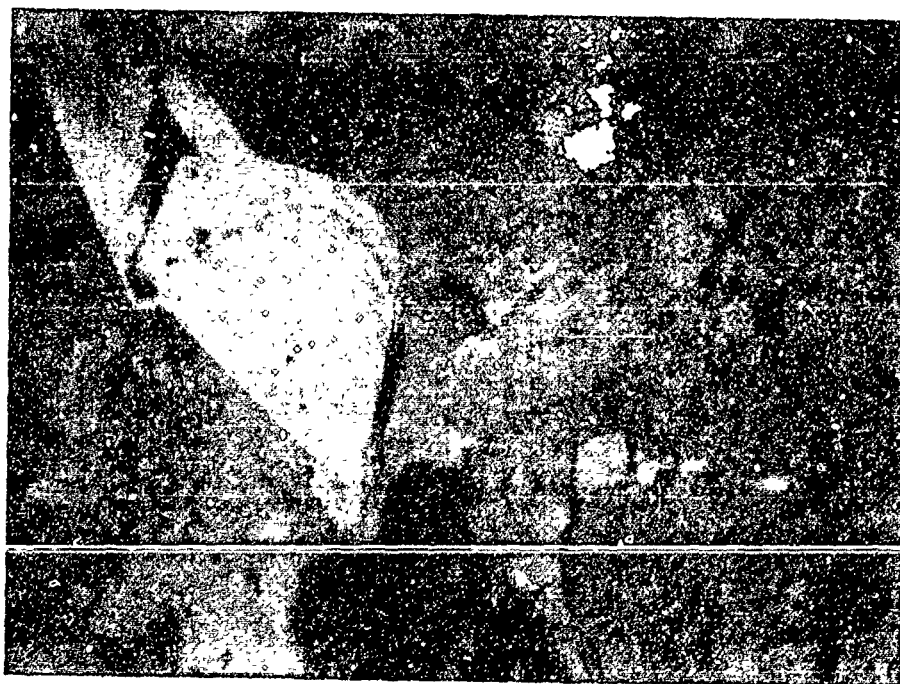
66. Blue Springs Lake, 26 November 1984, Neg. No. 396.  
Backhoe removing rock along right abutment, east  
of conduit, which separated as a result of stress  
release. Loosened zone ran from station 48+65 to  
station 49+09 center line of conduit.

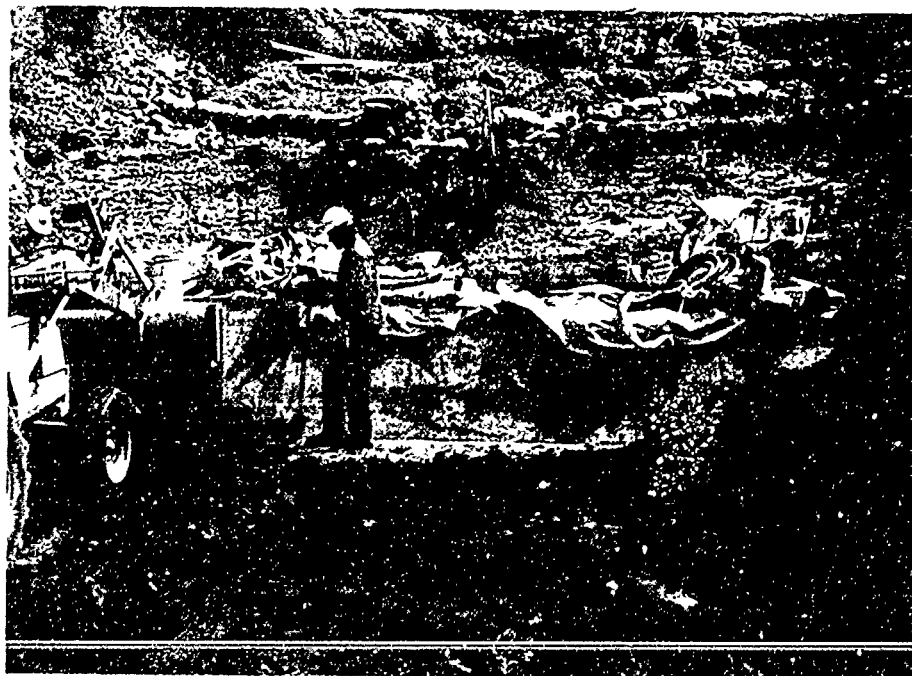
126. Blue Springs Lake, 19 August 1986, Neg. No. 679.  
Right abutment, cutoff trench. Slope constructed  
with concrete from station 74+10 to station 74+07  
and from El. 802 to El. 805. From station 74+50  
looking east.
