REPAIR, EVALUATION, MAINTENANCE, AND  
REHABILITATION RESEARCH PROGRAM

TECHNICAL REPORT REMR-CO-15

FIELD EVALUATION OF PORT EVERGLADES,  
FLORIDA, REHABILITATION OF SOUTH JETTY  
BY VOID SEALING

October 1990

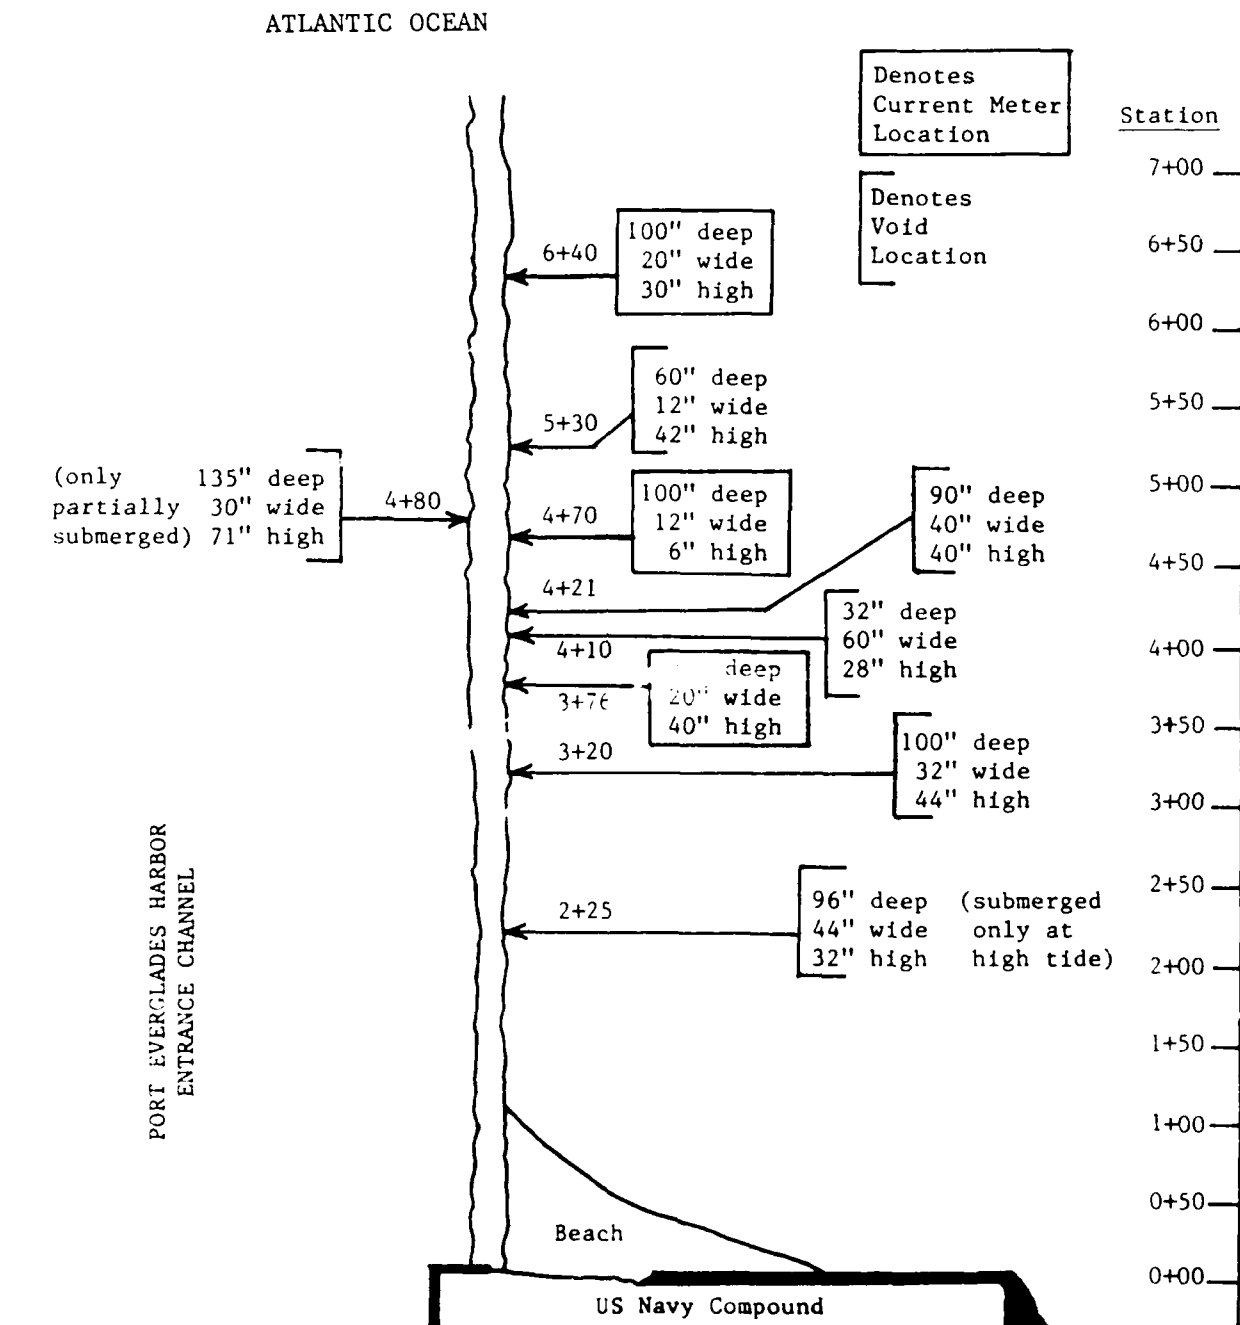
Figure 18. Locations and dimensions of larger structure voids along south jetty at entrance to Port Everglades, Florida

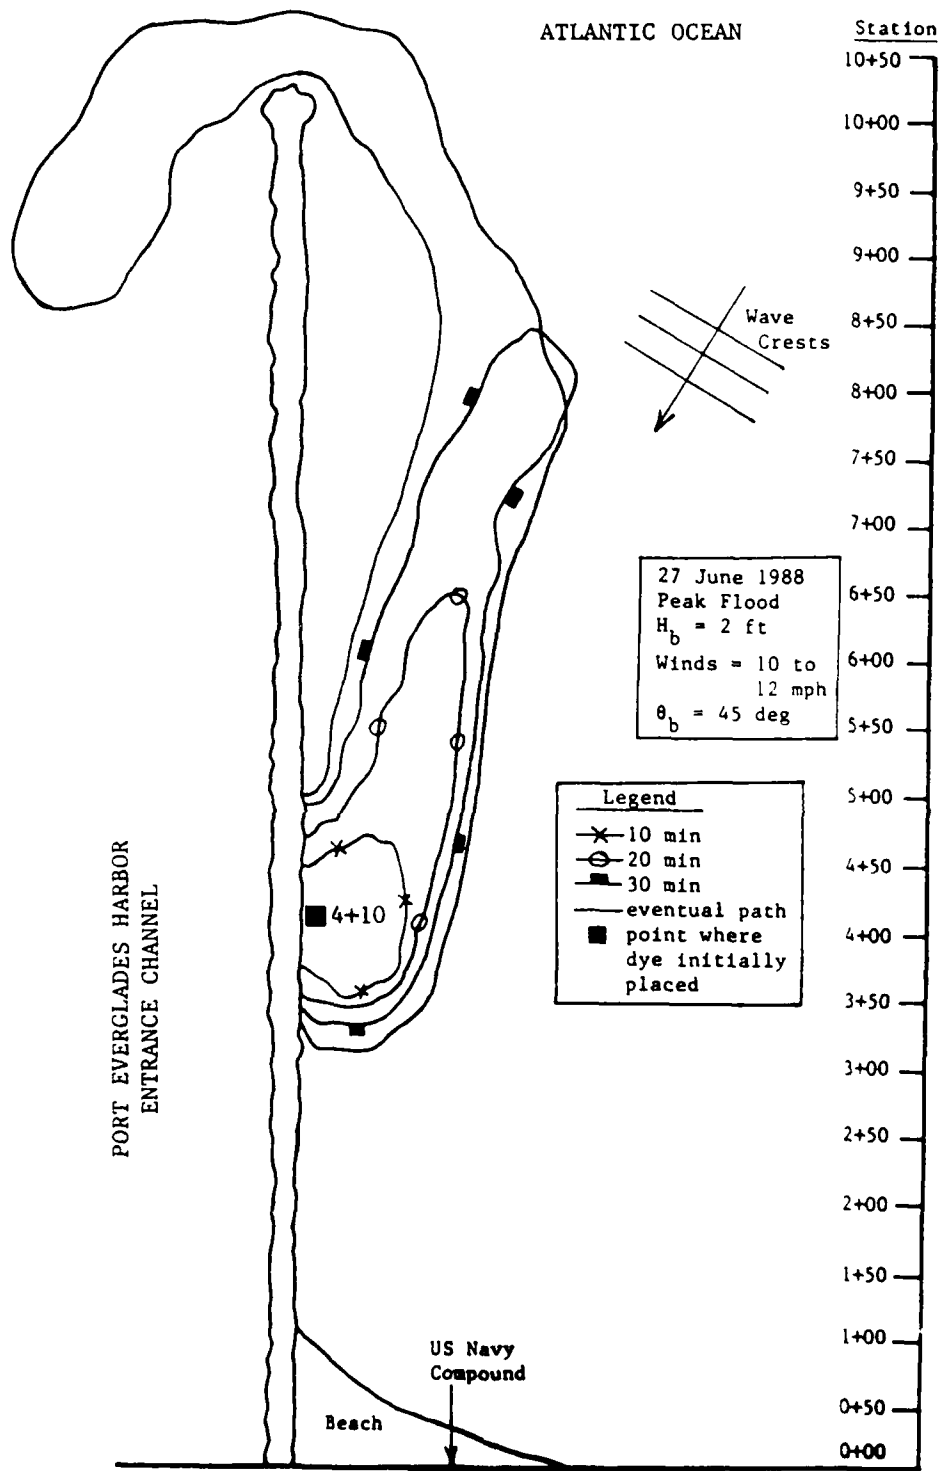
Figure 19. Visually observed dispersion of dye through south jetty at entrance to Port Everglades, Florida, peak flood flow, 27 June 1988

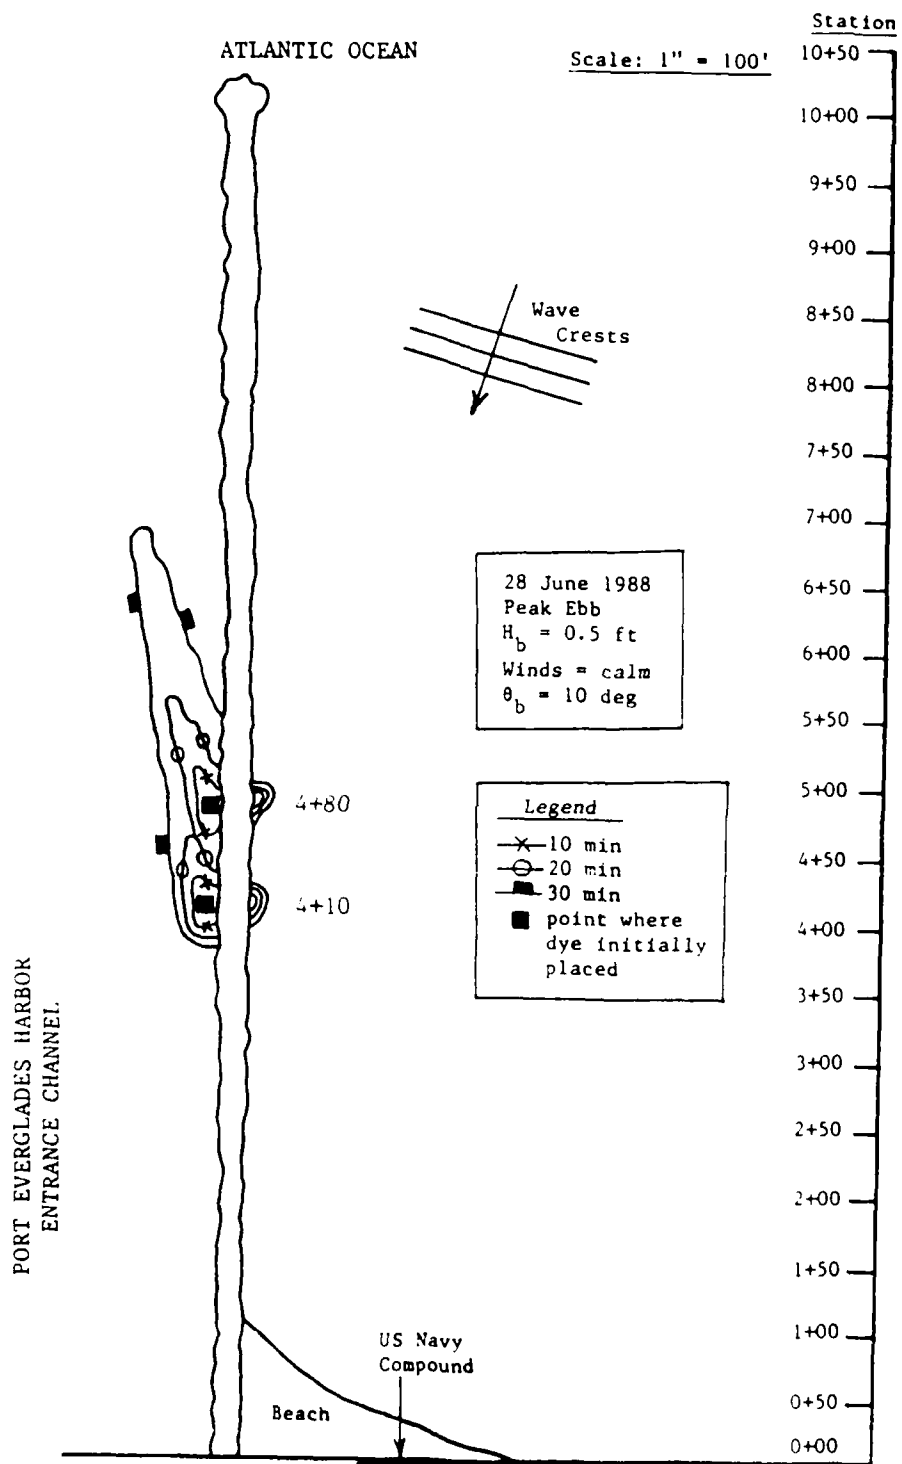
22. The dispersion of dye placed at two voids on the north side of the south jetty (Sta 4+10 and Sta 4+80) 10 min prior to peak ebb flow (1.1 ft/sec) on the morning of 28 June 1988 was documented with oblique aerial photography for an hour after peak ebb flow. The dispersion of dye through time is mapped in Figure 20. The dye passed through the structure to the south side at two locations within 10 min. Winds were calm, with a breaking wave height of about 0.5 ft at approximately 10 deg to the shoreline from the southeast.

Figure 20. Visually observed dispersion of dye through south jetty at entrance to Port Everglades, Florida, peak ebb flow, 28 June 1988

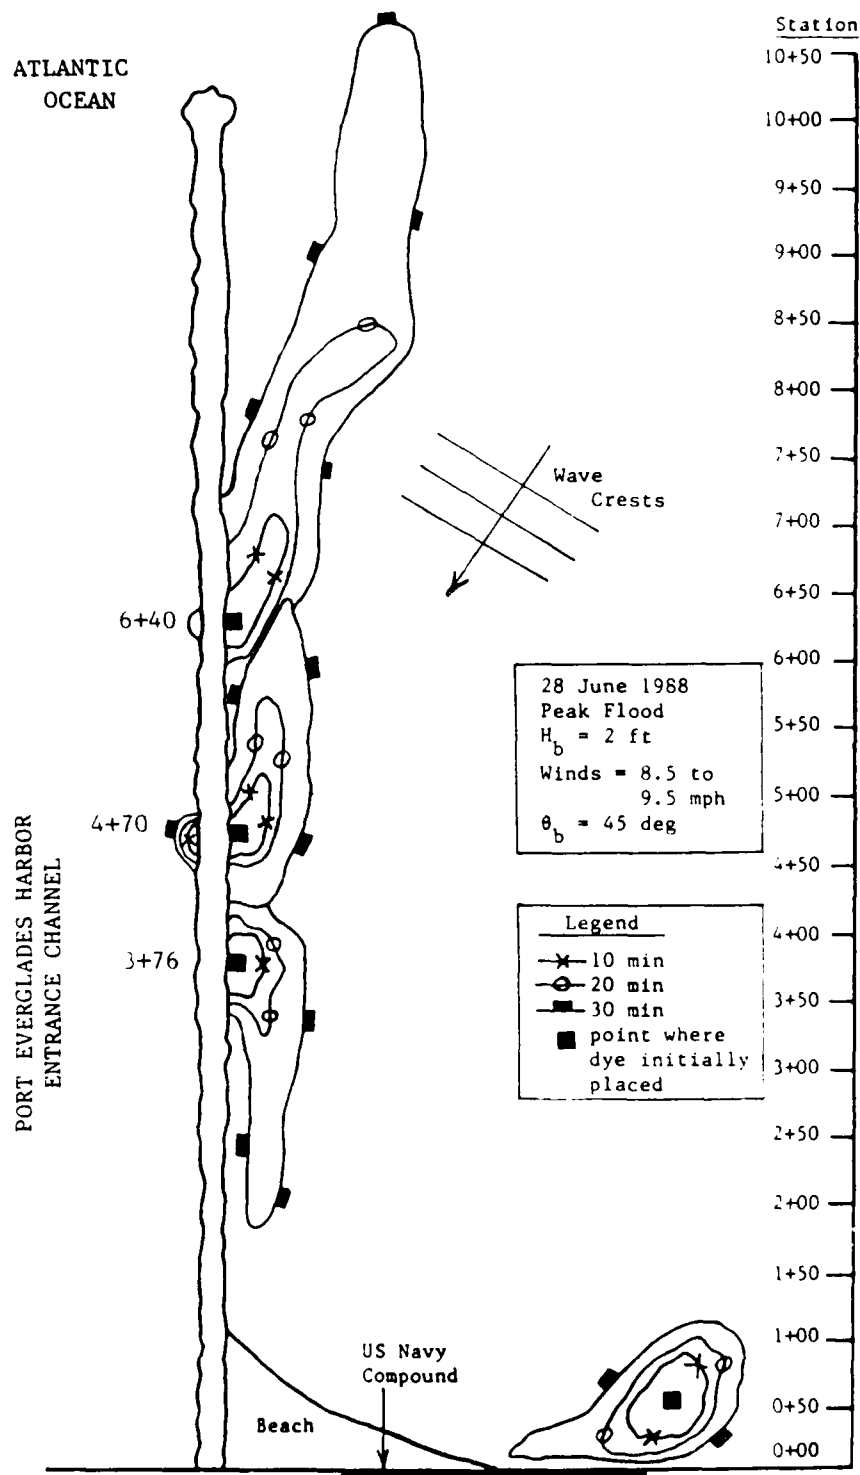
23. The third dye dispersal test was conducted on the afternoon of 28 June 1988 at peak flood velocity (1.1 ft/sec). Winds were approximately 8.5 to 9.5 mph, and 2-ft-high waves from the southeast were breaking at a 45-deg angle to the shoreline. The dispersal of dye was documented with oblique aerial photography for approximately an hour after dye release. Weighted sand sample bags partially filled with powdered dye were placed as close to the structure as possible in voids at Sta 3+76, Sta 4+70, and Sta 6+40 on the south side of the structure. A weighted dye packet was also thrown into the surf zone from the south end of the Navy Compound to indicate the direction and relative magnitude of any longshore current. The dispersion of dye from the structure voids was similar to that observed on the afternoon of 27 June 1988, with the same tendency for offshore movement of dye along the length of structure (Figure 21). Dye passed through the structure voids at

Figure 21. Visually observed dispersion of dye through south jetty at entrance to Port Everglades, Florida, peak flood flow, 28 June 1988

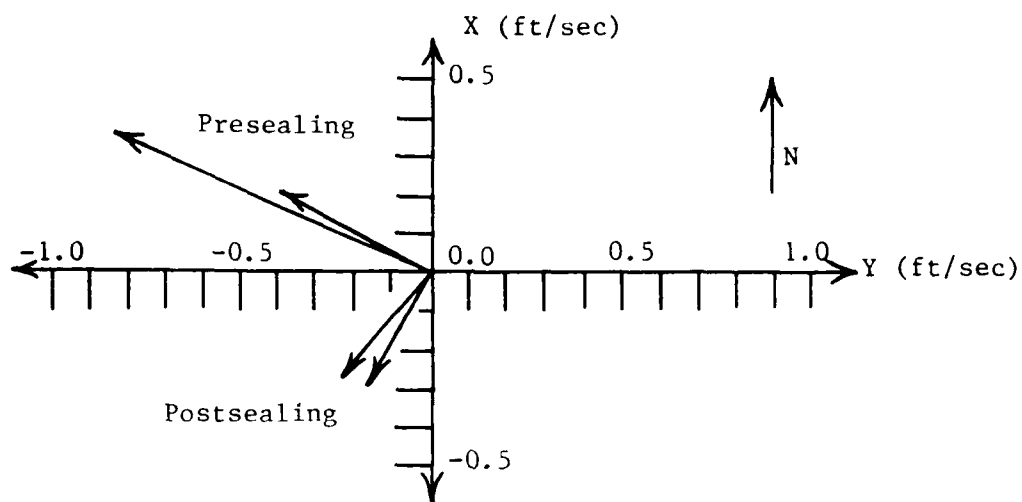
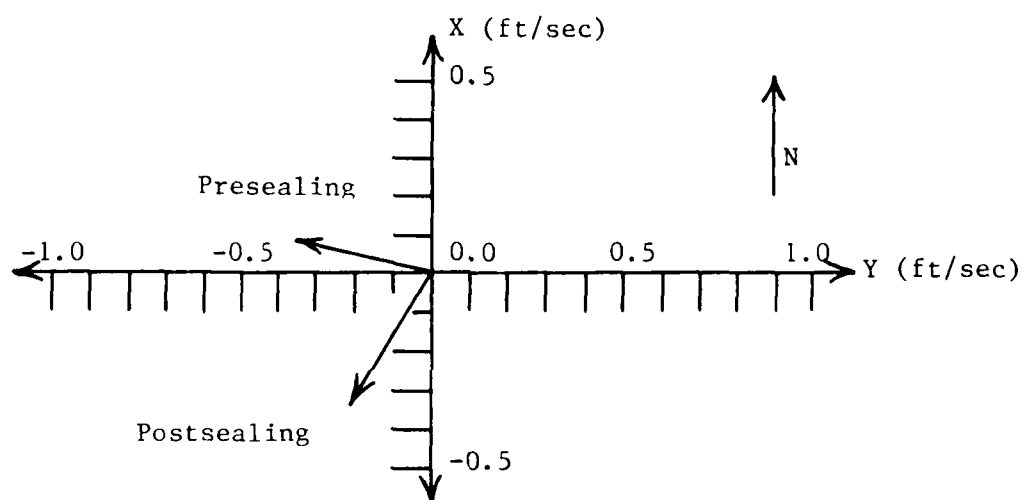
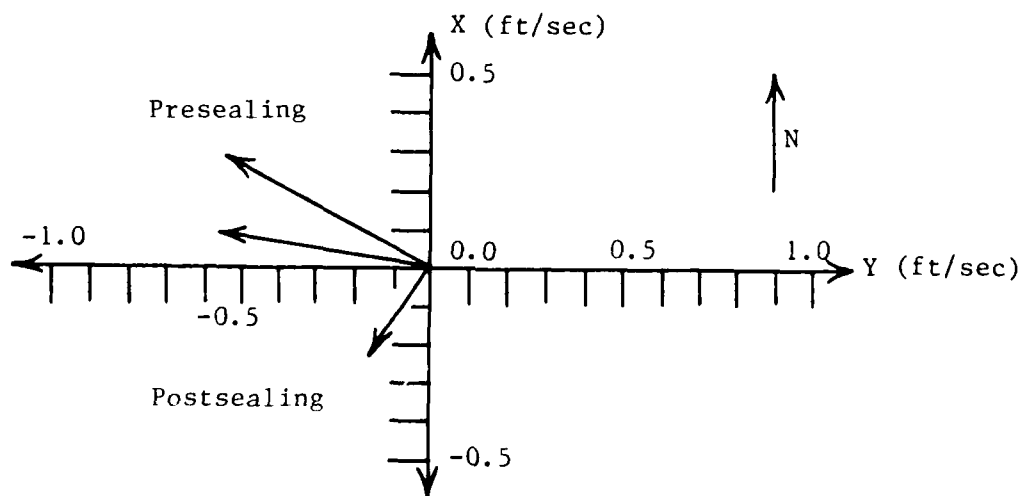
46. Averaging the x- and y-components of the flow for the three current meters deployed during a test results in average magnitude and direction vectors for the pre- and postconstruction experiments. These components are presented in Table 6, and the vectors are displayed in Figure 25 for the peak flood, high-water slack, and peak ebb tests. For the preconstruction tests, average currents move through the structure into the channel for all three flow test conditions. However, the vectors are directed away from the structure in the postconstruction tests, nearly perpendicular to the preconstruction vectors. This change in vector direction demonstrates a deflection in current flow and wave action, indicating a more reflective (hence, less transmissible) cross section.

Figure 25. Average currents measured in structure voids for pre- and postsealing conditions at south jetty, Port Everglades, Florida
