USS Princeton (CG 59): Impact of Marine Macrofouling (Mussels and Hydroids) on Failures/Corrosion Problems in Seawater Piping Systems

Dr. Joanne M. Jones and Dr. Brenda J. Little

# The First Annual Navy *Corrosion Control* Workshop

USS PRINCETON (CG 59): IMPACT OF MARINE MACROFOULING (MUSSELS AND HYDROIDS) ON  
FAILURES/CORROSION PROBLEMS IN SEAWATER PIPING SYSTEMS

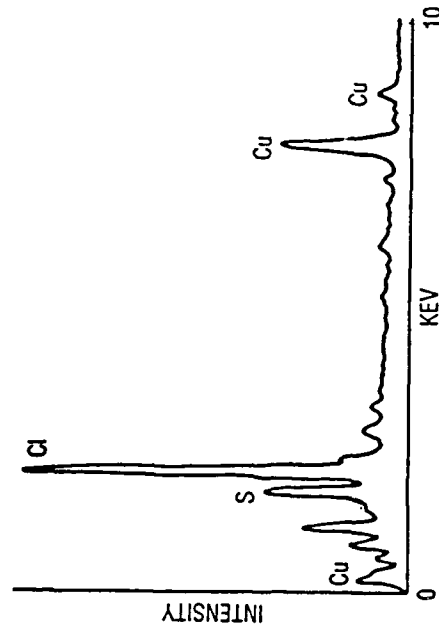
The hydroids had collected large amounts of chlorine, sulfur and copper as demonstrated by EDAX (energy dispersive X-ray) analysis.

EDAX SPECTRUM OF THE HYDROIDS REMOVED FROM CG 59 SEAWATER PIPING SYSTEMS SHOWED LARGE AMOUNTS OF CHLORINE, COPPER AND SULFUR

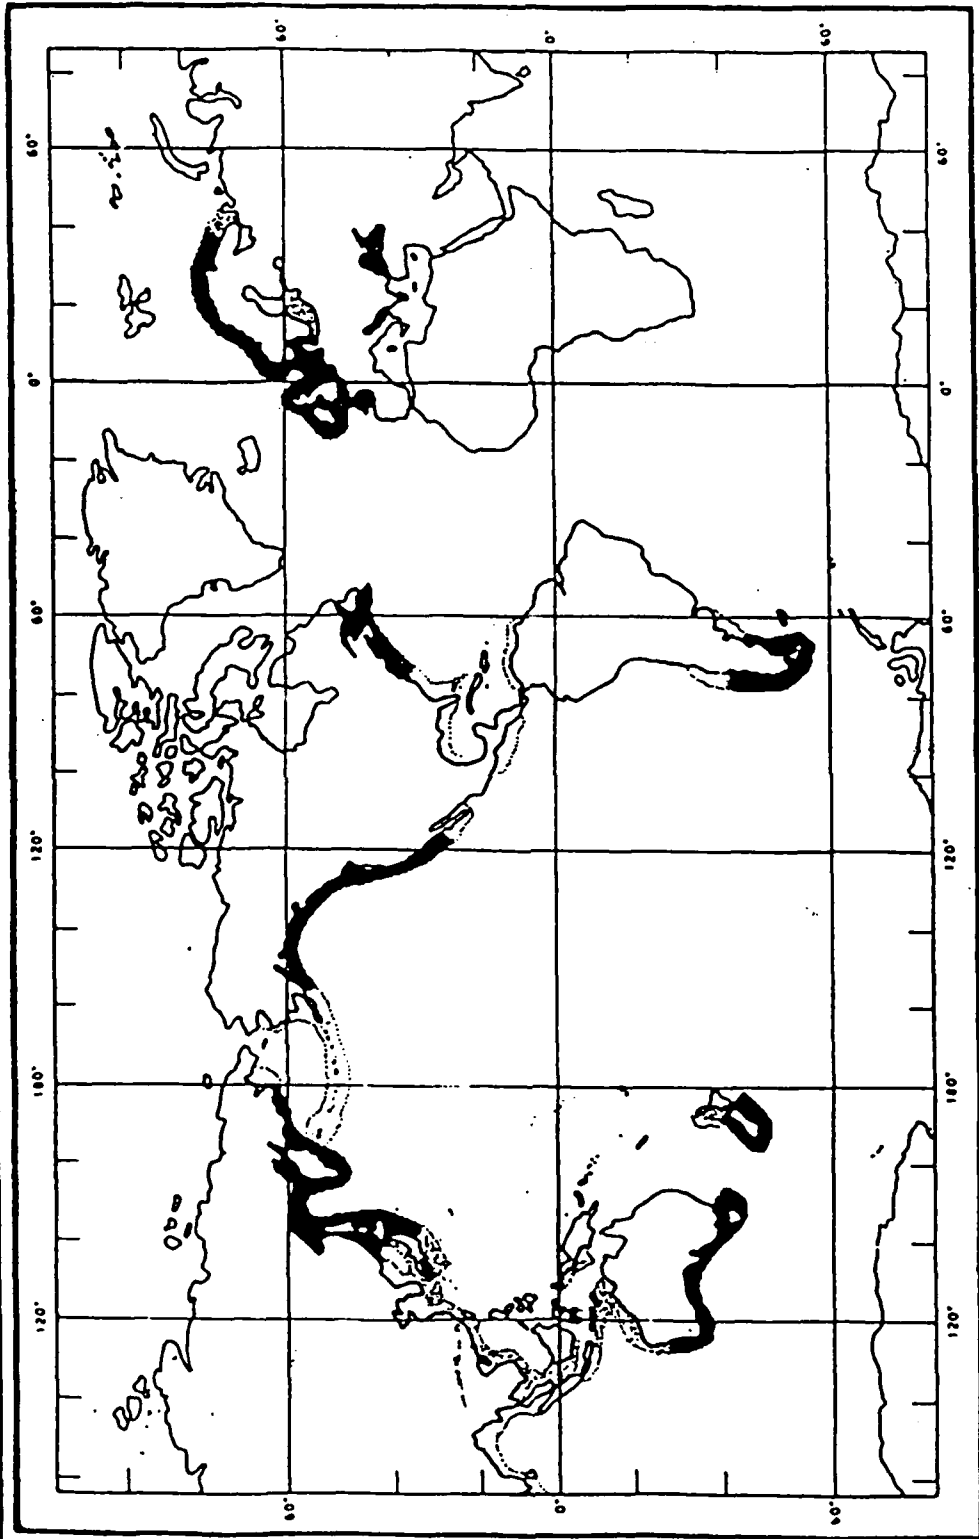
DISTRIBUTION OF MYTILUS MUSSEL BEDS SHOWN HERE INDICATES THAT MUSSEL FOULING CONDITIONS ARE MORE SEVERE IN HIGH AND MIDDLE LATITUDES WHERE THESE MUSSELS ARE THE DOMINANT FOULING SPECIES (FROM LITTLE AND DEPALMA, 1988)

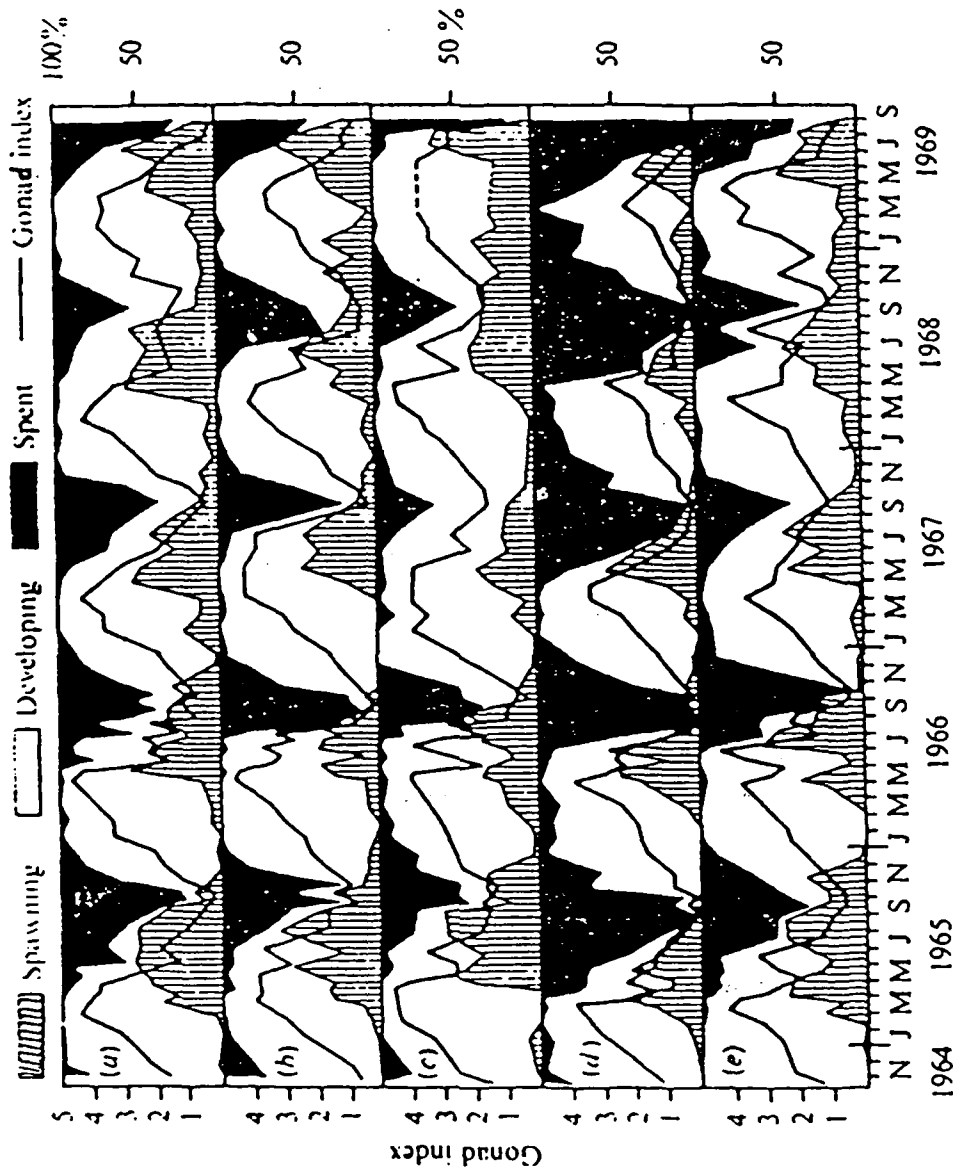
The gonad index and the percentage distribution of spawning, developing and spent individuals of *Mytilus edulis* in five populations over five years.

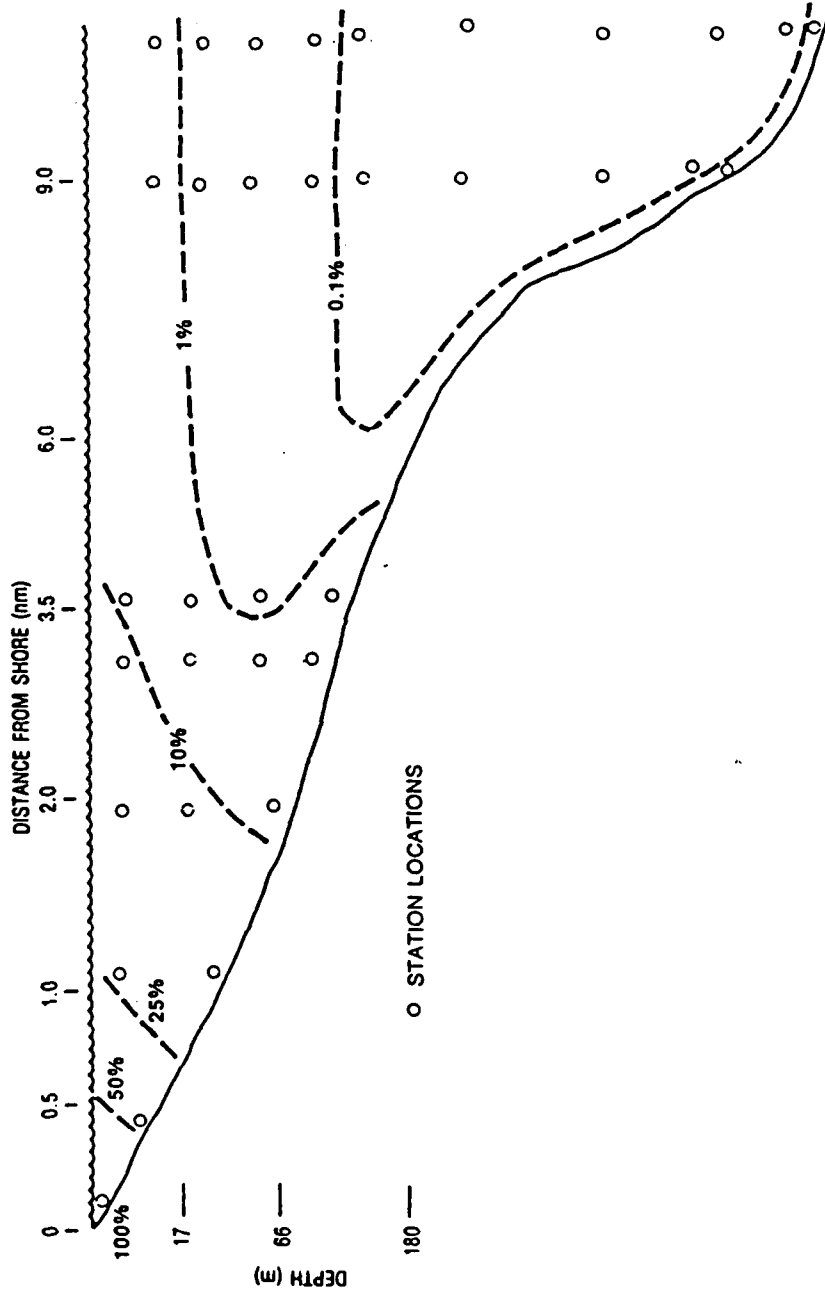
NUMBER OF MYTILUS MUSSELS THAT COULD CAUSE FOULING PROBLEMS  
DECREASES WITH THE DISTANCE FROM THE SHORE (FROM LITTLE AND  
DEPALMA, 1988)
