INVESTIGATION OF FATIGUE DAMAGE  
MECHANISMS IN A METAL MATRIX COMPOSITE  
UNDER ELEVATED TEMPERATURE

THESIS

Barry D. Portner  
Captain, USAF

December 1990

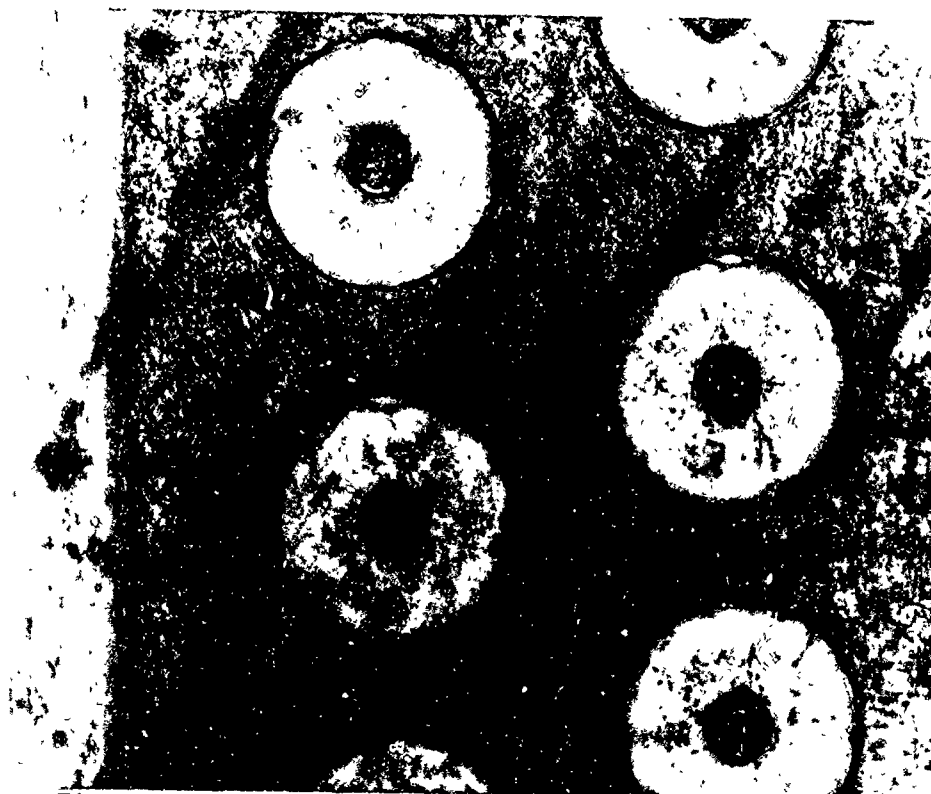
Figure 15. Transverse Cracking Between 90° Fibers and to 0° fibers. (375 MPa 0.0208 CPS, 42000 cycles )

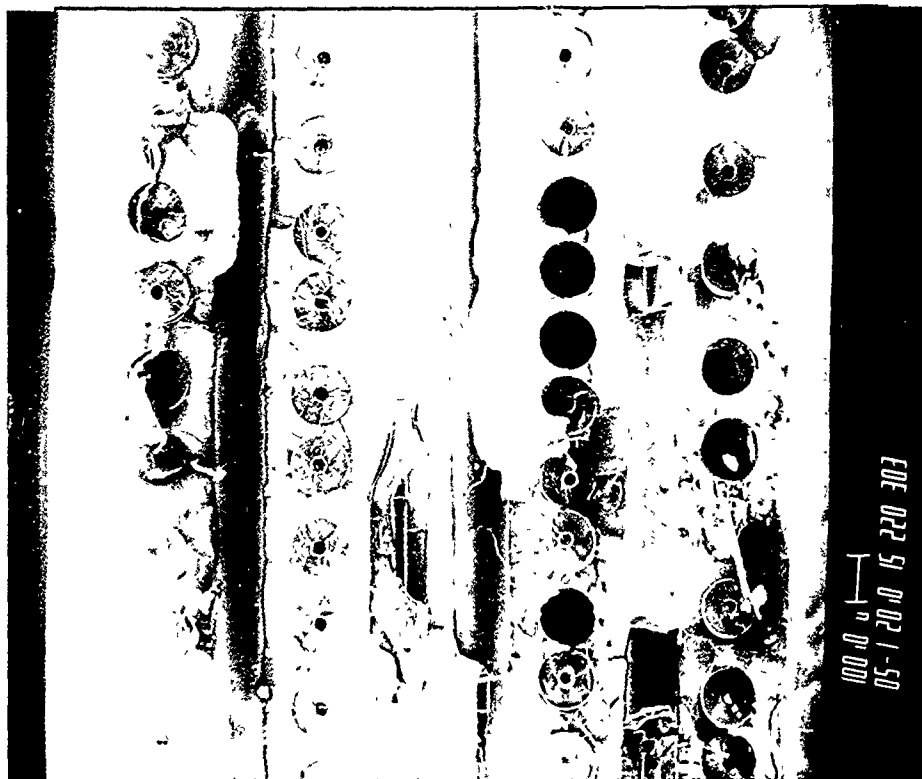
Figure 16. Fracture Surface of the 2.0 cps, 375 MPa Specimen

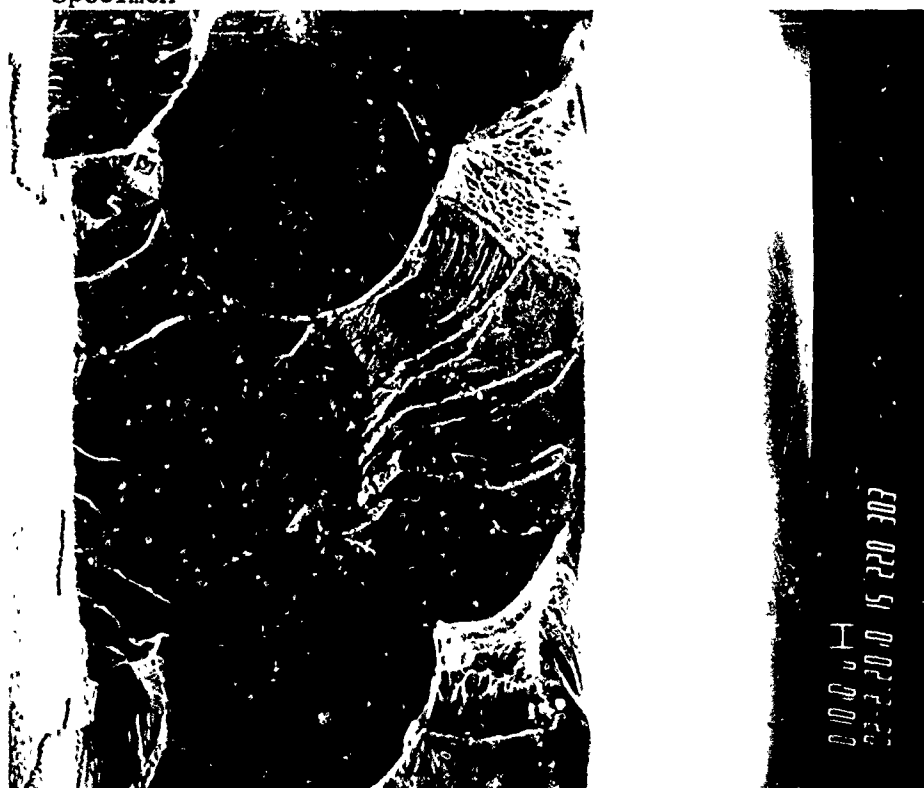
Figure 17. Matrix Crack Initiating at the 90° Fiber-Matrix Interface Then Propagating to the Surface. (Magnification of Figure 16, Center)

increase in the number of cleavage lines in the vicinity of the surface indicates the rate of propagation increases toward the surface. In the outer plies, the cracks began "jumping" by passing around the 0° fibers without cracking the stiffer fibers and then propagating to the surface. The final crack pattern is clearly characterized in Figure A-1.

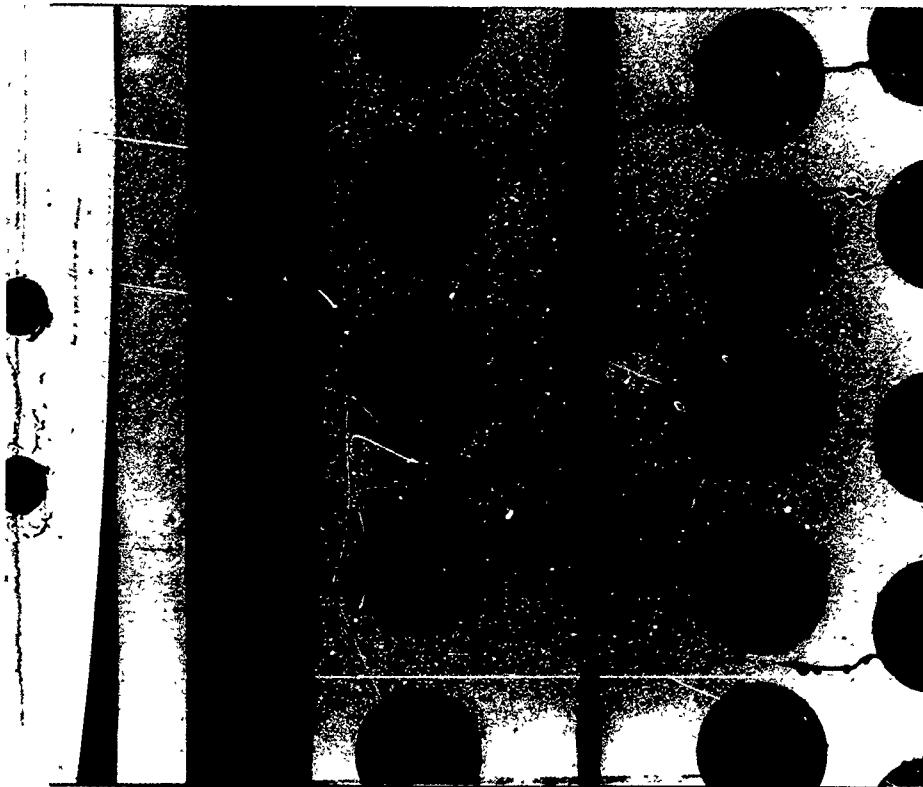
At the higher stress levels, 438 to 625 MPa, crack initiation commonly occurred at 2 locations depending upon the frequency of the test. The reaction zones were one of the locations of crack initiation. However, higher stresses increased the amount of fiber damage within the specimen. At the higher stresses, extreme stress concentration may exist between transverse matrix cracks and fractured fibers causing longitudinal cracking along the 0° fiber-matrix interface. In addition, higher stresses and longer exposure times to temperature are expected to cause degradation of the fiber-matrix interface region setting a path of least resistance between fractured fibers and transverse matrix cracks. This type of crack progression pattern can be seen at 2 locations along the 0° fiber on the left side of Figure 18. (Figure 18 also shows a number of 90° transverse matrix cracks coalescing.) Figure 19 is a photograph of a cross-section of the 0.0208 cps, 438 MPa specimen depicting transverse cracking initiated at the 90° fiber (bottom left), propagating to the 0° fiber, then propagating longitudinally along the 0° fiber to coalesce

Figure 18. Coalescing of 0° and 90° Fiber Interface Initiated Cracks. (500 MPa 0.0208 CPS)

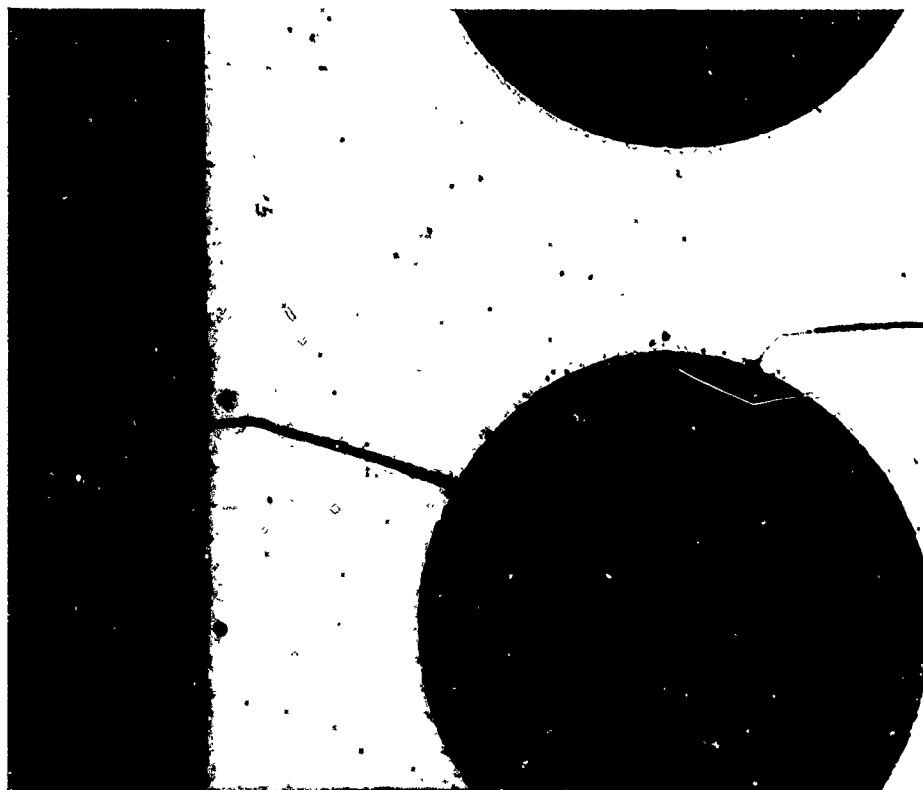
Figure 19. Transverse and Longitudinal Cracking Between 0° and 90° Fibers. (438 MPa 0.0208 CPS)

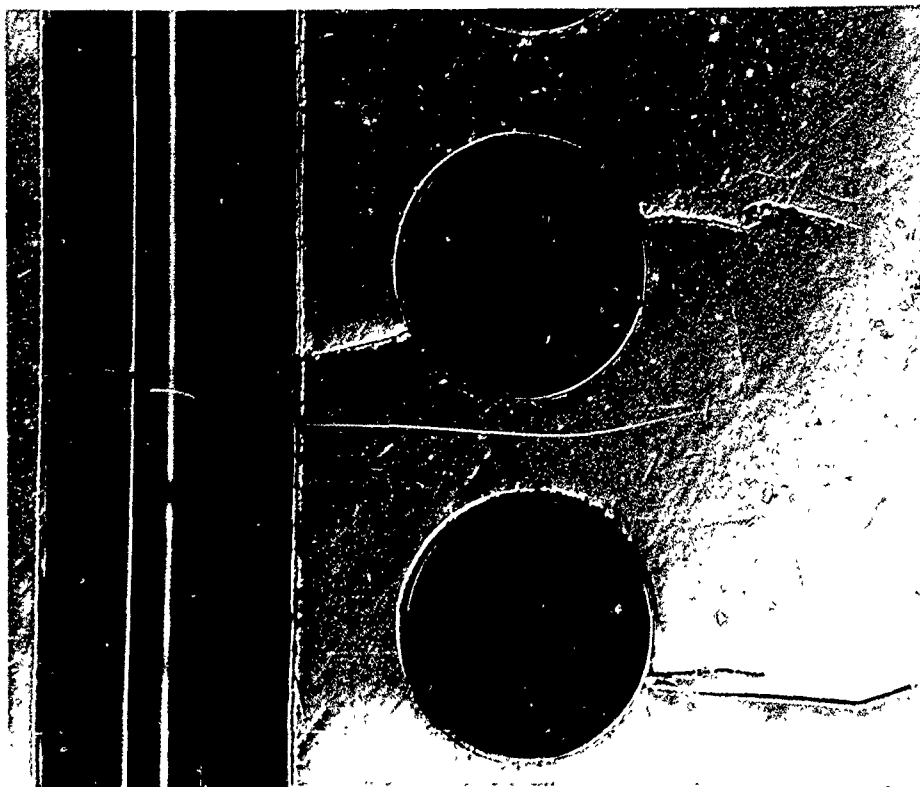
with the damaged  $0^\circ$  fiber. This type of crack propagation can also be seen in Figure 20. While the cracks are propagating outward from the 2 inner  $90^\circ$  fibers there are also cracks progressing between these plies and eventually coalescing. The SEM micrographs in Figures 21 and 22 show inner ply cracks coalescing combined with debonding between the fiber-matrix interface.

Figure 20. Coalescing of 0° and 90° Fiber Initiated Cracks. (542 MPa 0.0208 CPS)

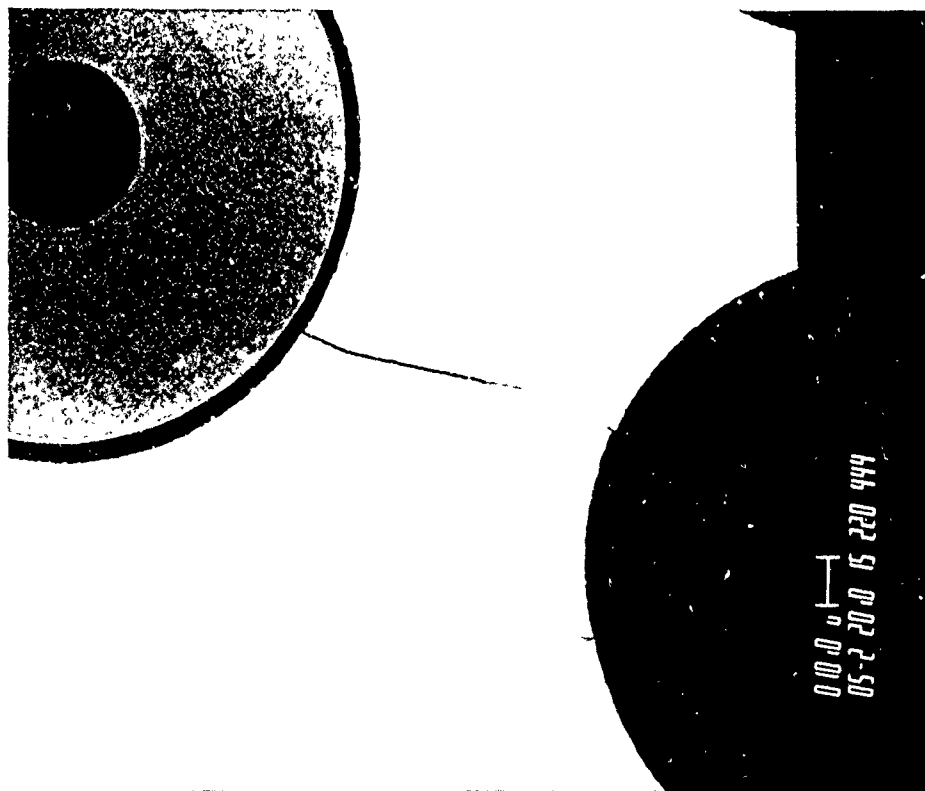
Figure 21. Inner Ply Cracks Coalescing and Debonding of 90° Fiber-matrix Interface. (438 MPa 0.0208 CPS)

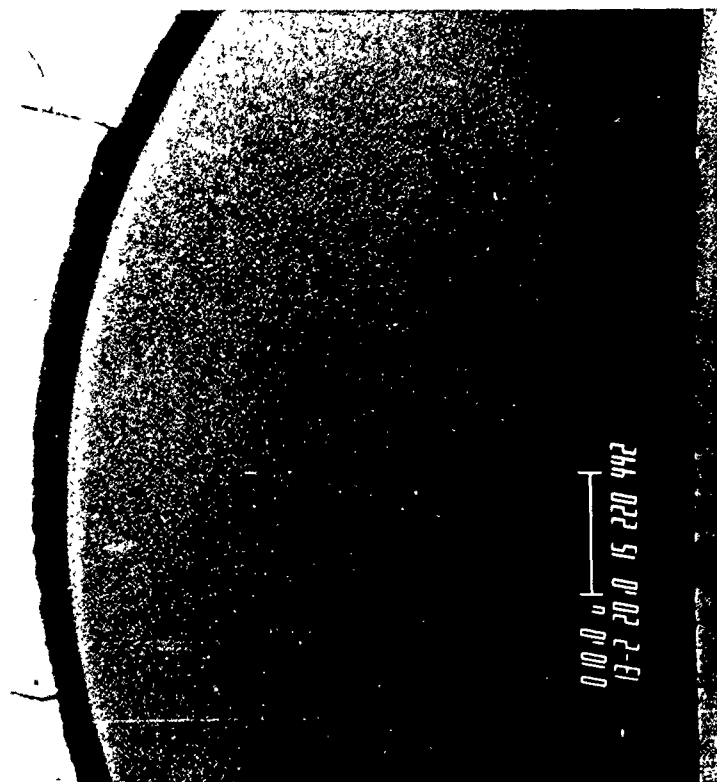
Figure 22. 90° Fiber-matrix Interface Separation.  
(438 MPa 0.0208 CPS)

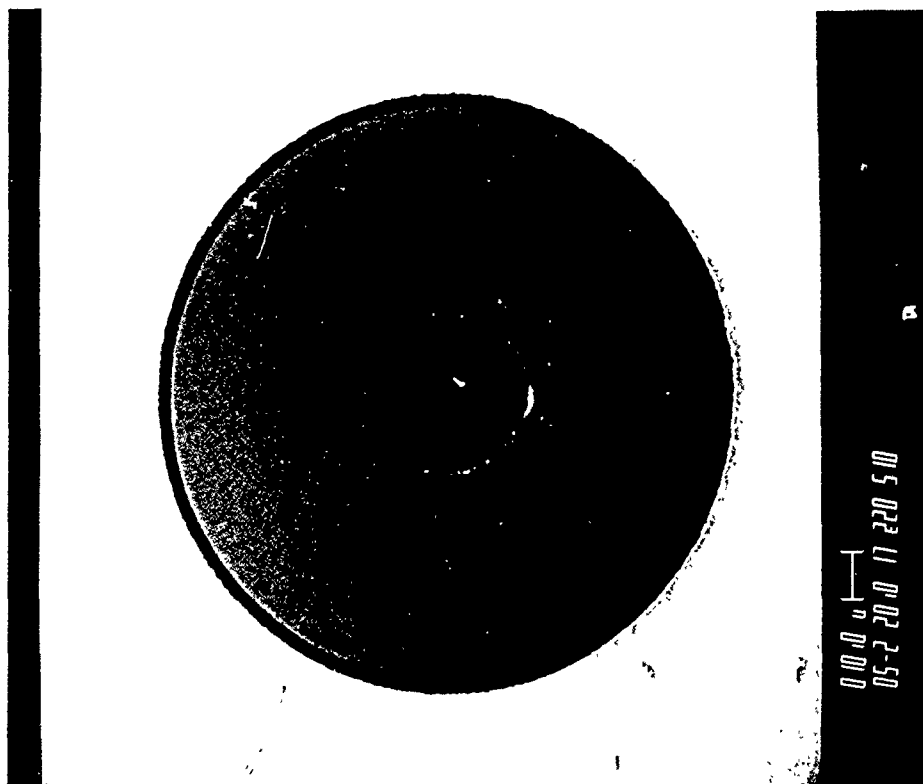
These types of fractures were revealed during microscopic examination of the sections. Eventually, these longitudinally fractured fibers initiate some matrix cracking. Figure 25 shows such a crack propagating through about 80% of the bulk SiC. Figures 26 and 27 also show crack propagation from the carbon core through the fiber-matrix

Figure 25. Crack Propagating From Inner Carbon Core of 0° Fiber. (500 MPa 2.0 CPS)

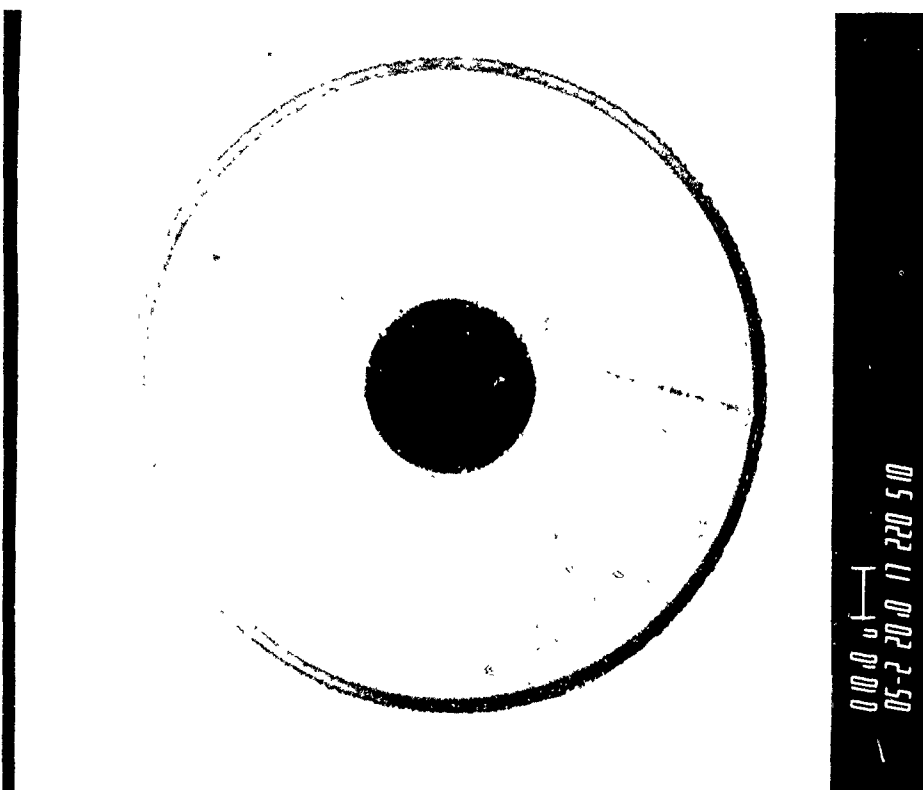
Figure 26. Crack Propagating From Inner Carbon Core of 90° Fiber to Titanium Matrix. (500 MPa 2.0 CPS)

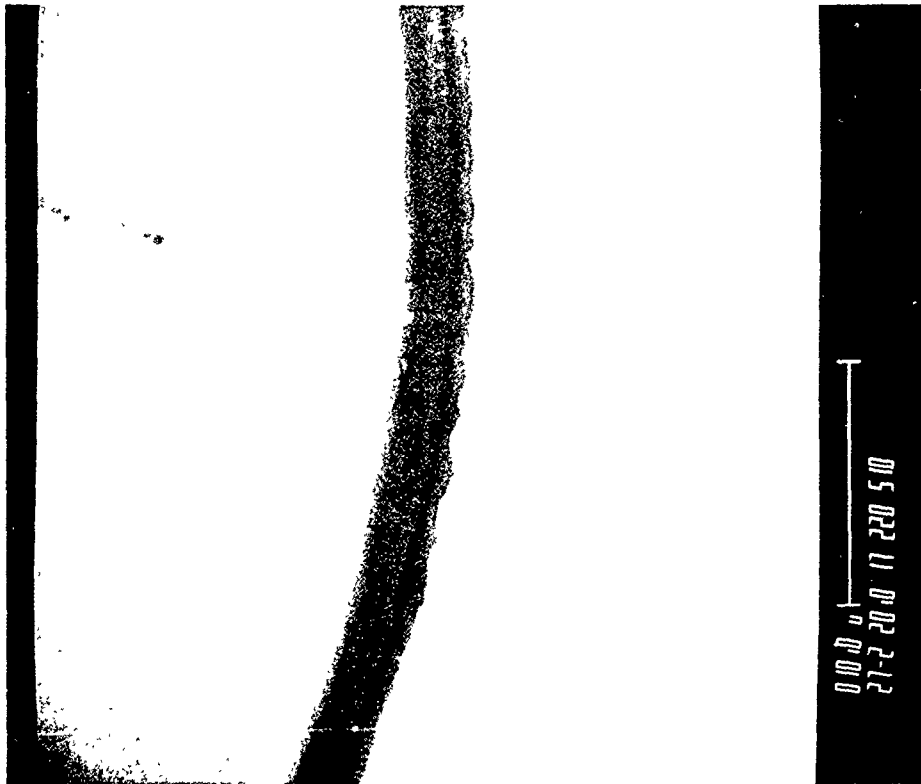
Figure 27. Magnification of Figure 26 (Right).  
(500 MPa 2.0 CPS)

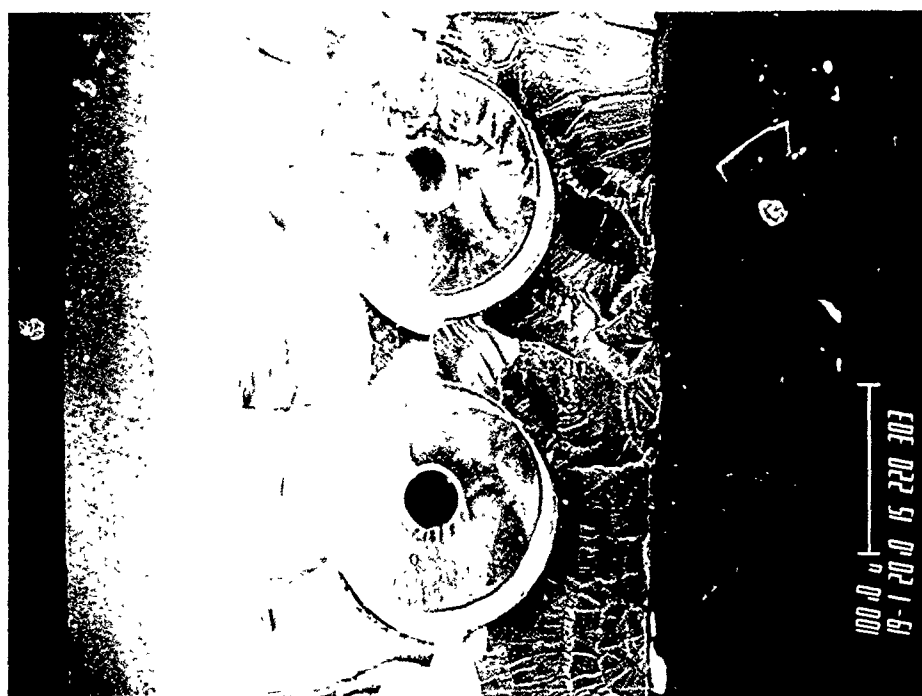
Figure 29. Magnification of Figure 28 (Center).  
(375 MPa 2.0 CPS)

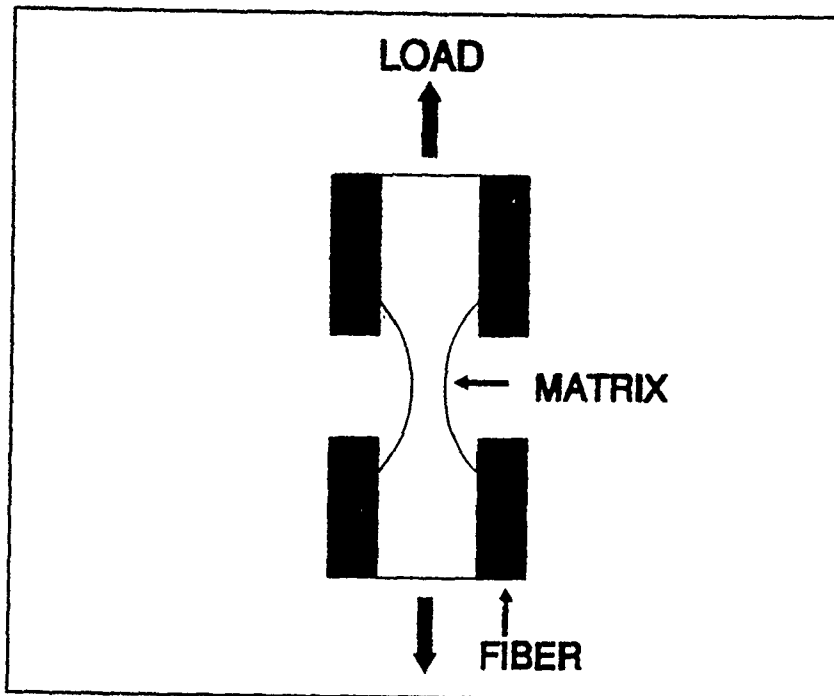
On the other hand, the low frequency group of fatigue test specimens witnessed a considerable number of fractured 0° fibers along with fiber-matrix interface initiated matrix cracks. For this group of tests, primary failure was due to ductile void coalescence preceded by fractured fibers. Figure 30 depicts the type of matrix deformation (necking) due to fractured fibers common with this group of specimens. Figure 31 is a SEM micrograph of a fractured surface showing this type of ductile void failure. This figure also indicates that substantial plastic straining has occurred over a "large" volume of material (the matrix surrounding the fiber). This ductile fracture region is characterized by dimples. Since plastic straining predominated, as opposed to the brittle cleavage type fracture that occurred with the

Figure 30. Matrix Necking (Plastic Deformation) Due to Fractured Fibers

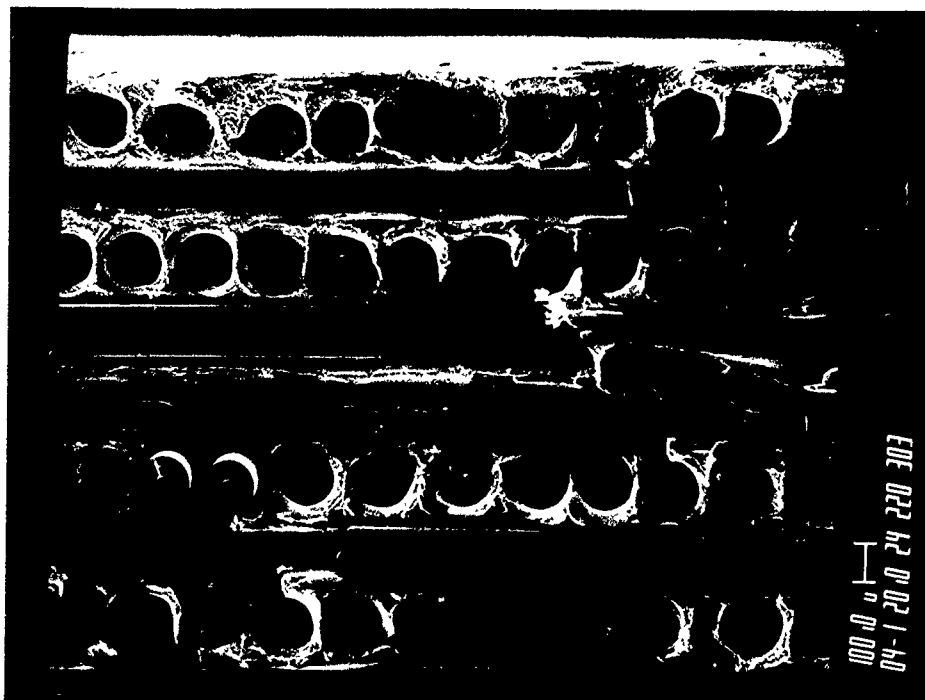
As previously mentioned, the primary mode of matrix failure of the high frequency specimens was cleavage fracture in the brittle mode. the exception was the specimen tested at 625 MPa. The fracture surface of this specimen exhibited a combination of ductile matrix failure and

Figure 32. Fracture Surface of 427°C Tensile Tested Specimen

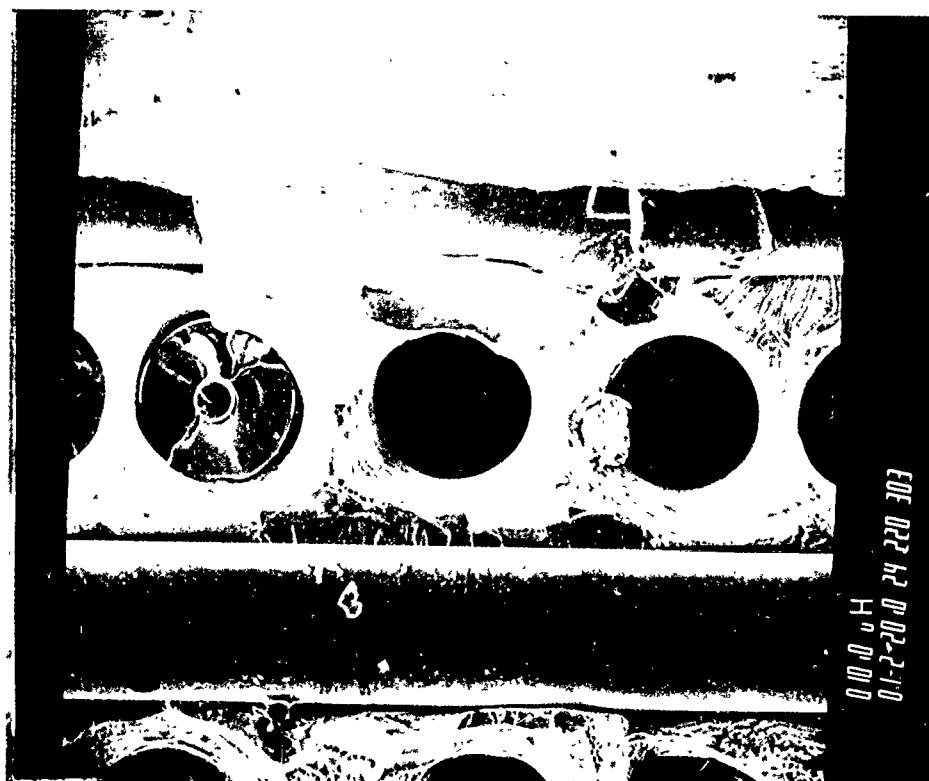
Figure 33. Magnification of Figure 32. Failure by Ductile Void Coalescence.

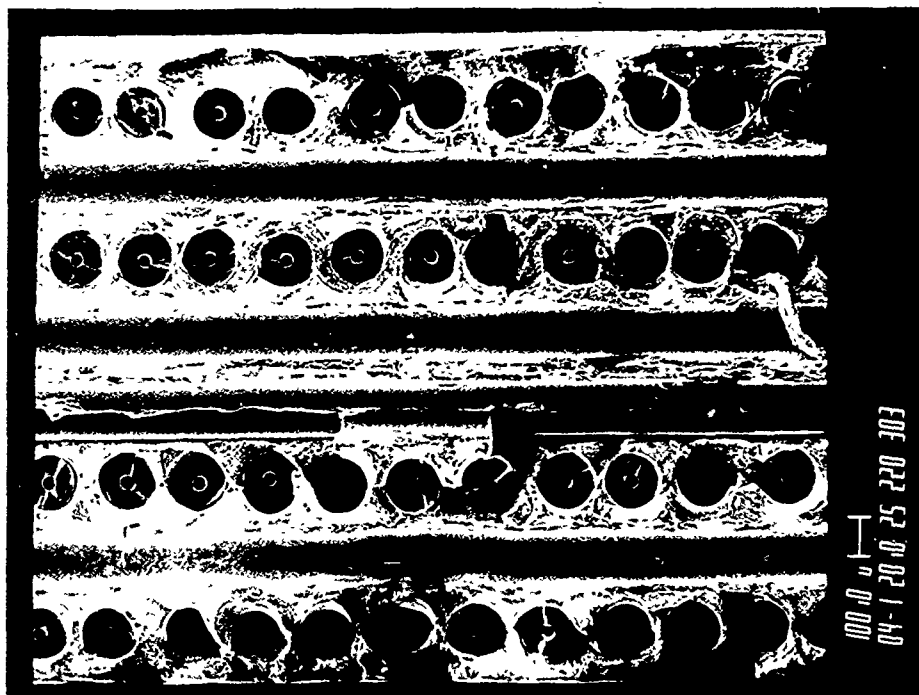
The specimen tensile tested at room temperature exhibited a slightly different type of fracture surface than the specimen tensile tested at 427°C. This matrix failure mode was primarily ductile void coalescence failure. Figures 34 and 35 are SEM micrographs of the fracture surface of this tensile tested (ambient temperature) specimen. Figure 35 is a magnification of Figure 34, bottom right. These micrographs show less debonding of the fiber-matrix interface: therefore, less fiber pullout as compared to the specimen tensile tested at 427°C. The micrographs also

Figure 34. Fracture Surface of Specimen Tensile Tested at Room Temperature

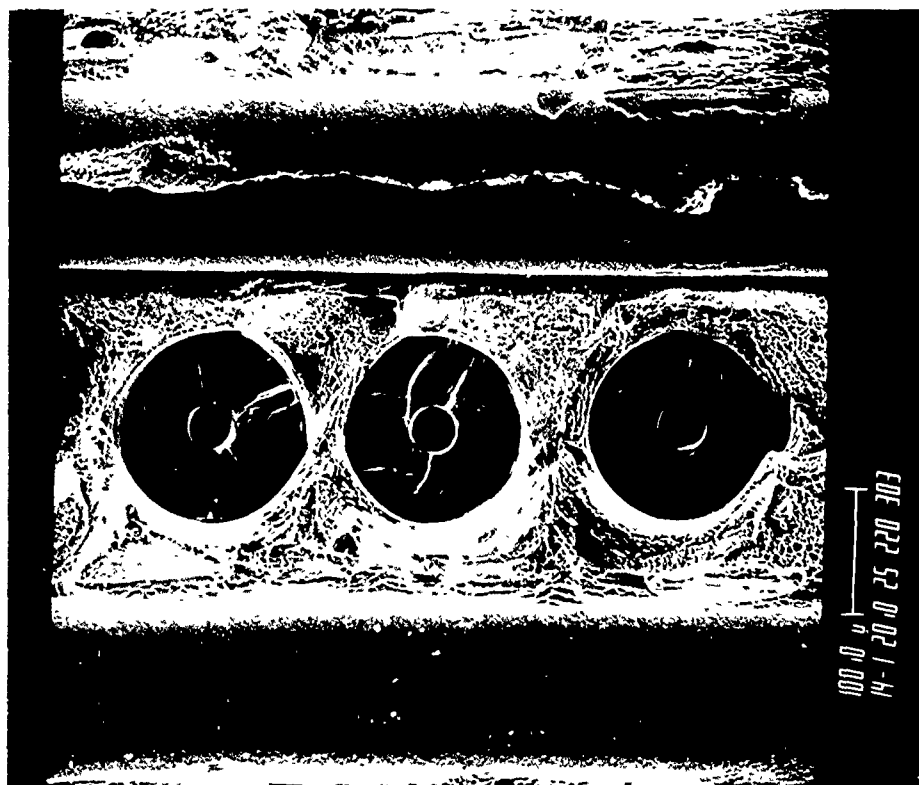
Figure 35. Magnification of Figure 34. Failure by Ductile Void Coalescence.

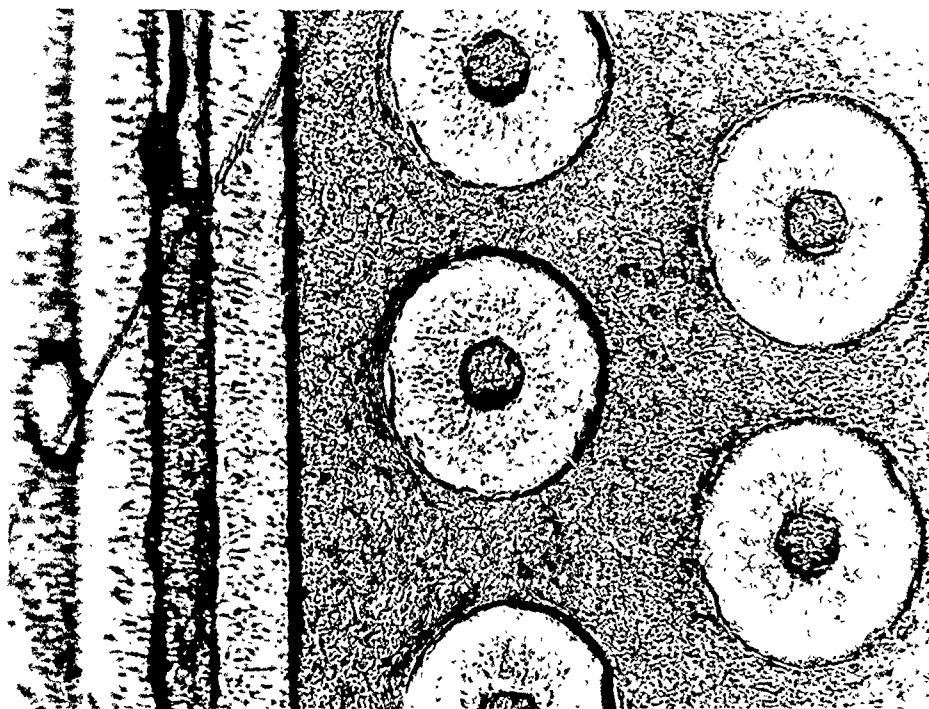
In several instances, transverse matrix crack progression was monitored during the fatigue testing at the precise location where the composite eventually failed. For example, on the 438 MPa high frequency specimen, transverse matrix cracking was observed via replica examination to initiate off the inner 90° fiber-matrix interface at 7500 cycles, Figure 36. Between 7500 and 10000 cycles (Figure 37), this crack propagated transversely across the 2 inner 90° plies to both of the 2 inner 0° plies and began

Figure 36. Matrix Crack Propagating to the Left of the Center 90° Fiber (438 MPa 2.0 CPS at 7500 Cycles)

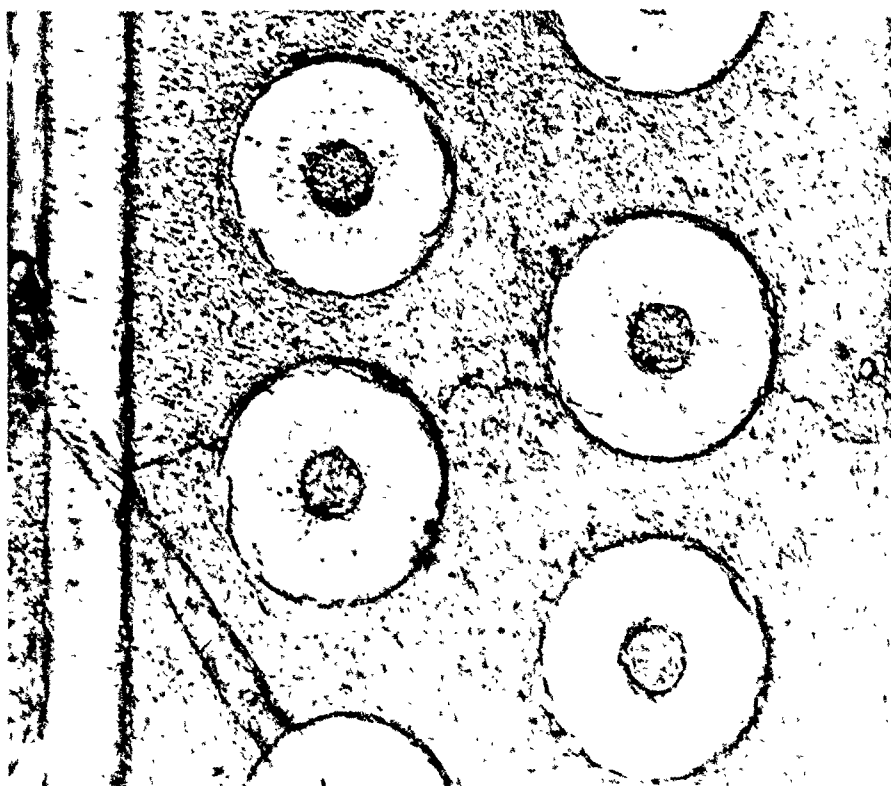
Figure 37. Crack Progressed Across the Inner 90° Fibers to Both Inner 0° Fibers (438 MPa 2.0 CPS at 10,000 Cycles)

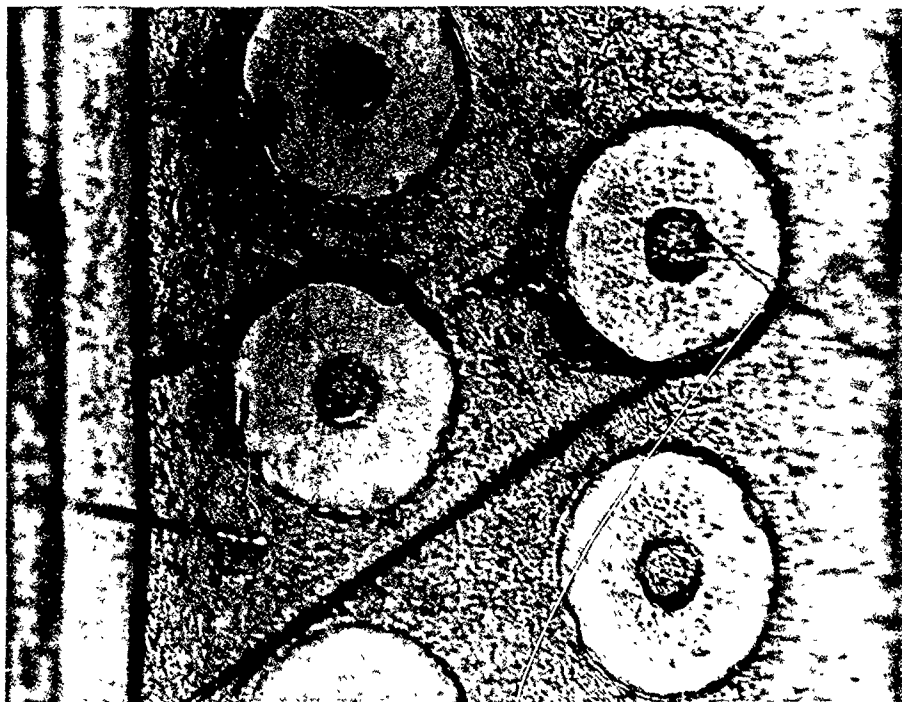
Figure 38. Damaged Fiber-Matrix Interface Zone. 90°  
Fibers Debonding with Matrix (438 MPa 2.0 CPS at 12,500  
Cycles)

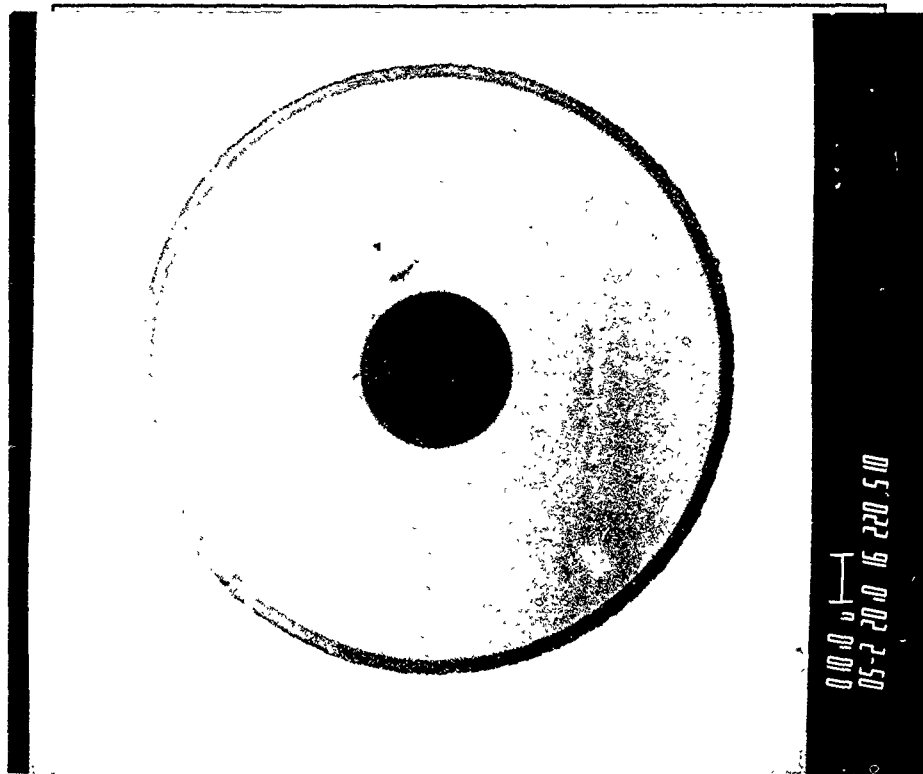
Figure 40. Micrograph of a 90° Fiber with Etched Surface Revealing Reaction Zone (500 MPa 2.0 CPS)

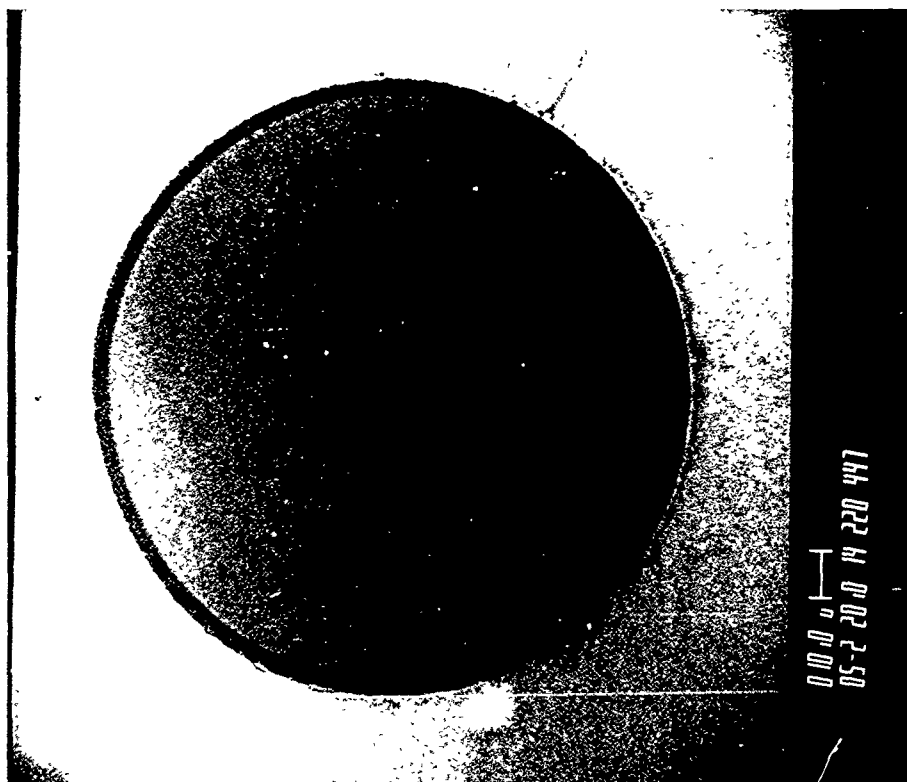
Figure 42. Micrograph of the 0° Fiber Reaction Zone of the Low Frequency 542 MPa Specimen Exposed to Temperature for 3 Hours

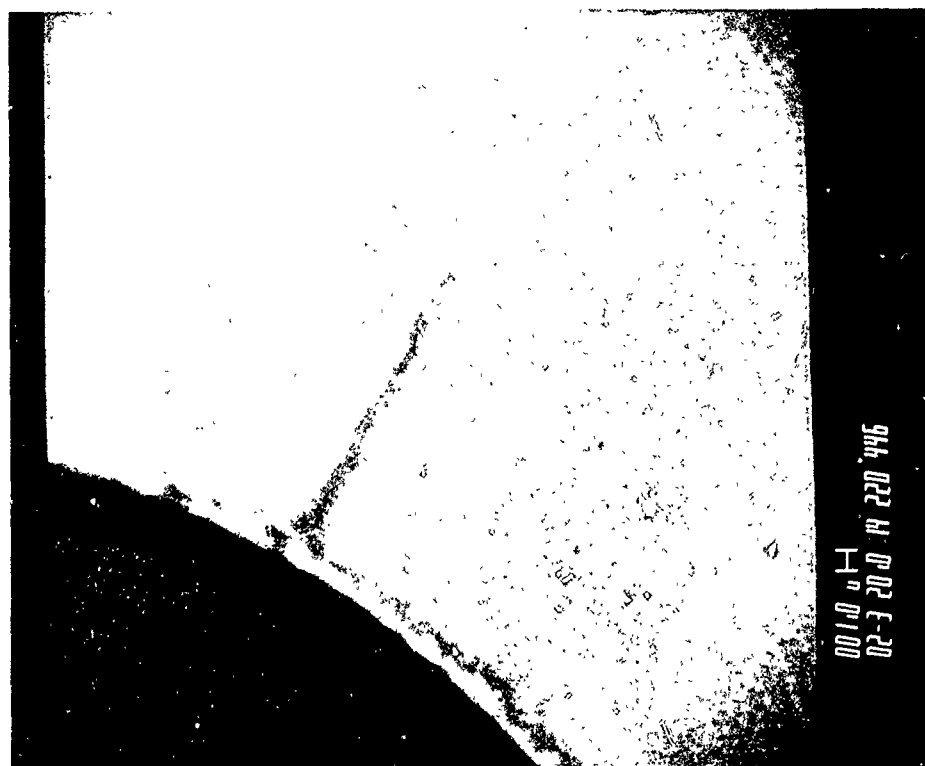
Figure 43. Magnification of Figure 42 (upper right)
