# NATIONAL COMMUNICATIONS SYSTEM

## TECHNICAL INFORMATION BULLETIN 89-11

### 4 ESS™ SWITCH ELECTROMAGNETIC PULSE ASSESSMENT

### VOLUME 2: TASK 3 LABORATORY TESTING OF THE 4 ESS SWITCH

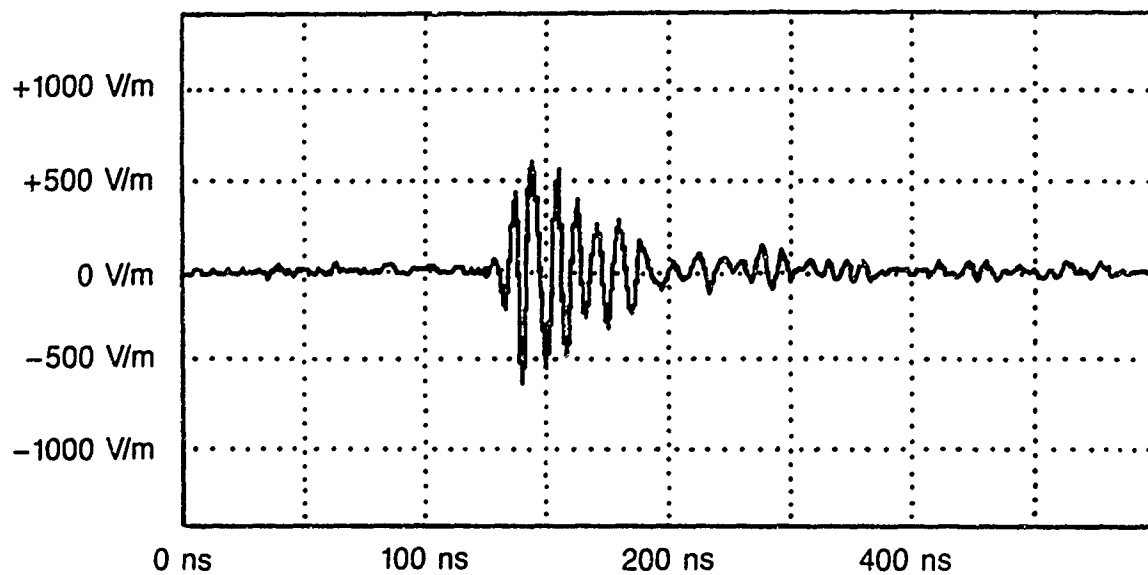
Testing commenced by subjecting individual bays of the switch to the field generated by the small field simulator, with fields of about 500 V/m. (See Figure 2.) The field was localized primarily to one bay but nearby bays received some stress. In this way, a broad picture of the gross susceptibilities of the switch was gained. More precise localization was accomplished using the WEM-jector which induced transients on individual wires connected to the bays with currents from 0.1 amperes to 10's of amperes.

**Figure 2.** Electric field from small field generator, about 0.5m from source.

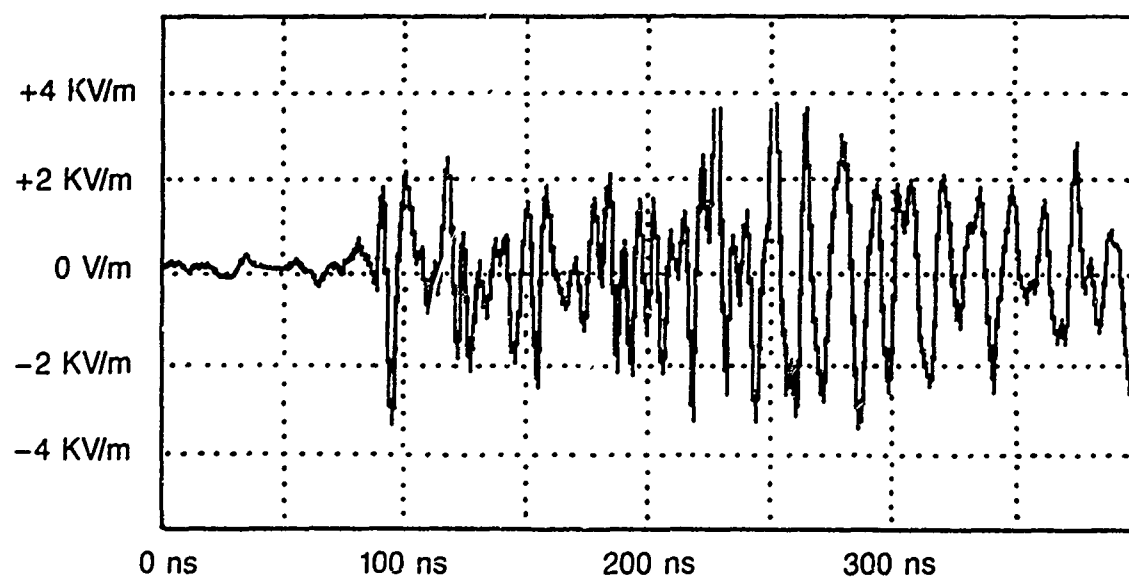
After selectively stimulating separate bays, disruption associated with widespread stimulation of the switch by the high-voltage spark gap was investigated. Fields generated by the spark gap were on the order of 3 kV/m at the backplanes of the switch. (See Figure 3.)

**Figure 3.** Field from spark gap measured at backplane of PPI.

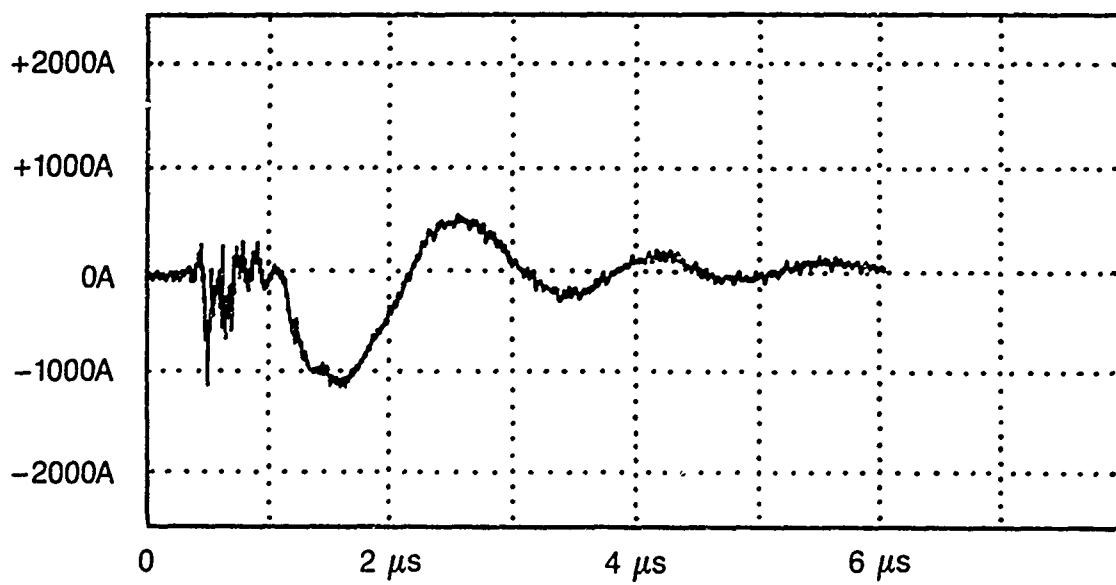
Finally, large cable currents on long cables in the switch were generated by inducing currents on cables in the cable trays. Currents on groups of 24 cables were about 1000 amperes (Figure 4); while on single cables the currents were about 40 amperes (Figure 5).

Figure 4. Current on bundle of 24 cables between PPI and MCC.

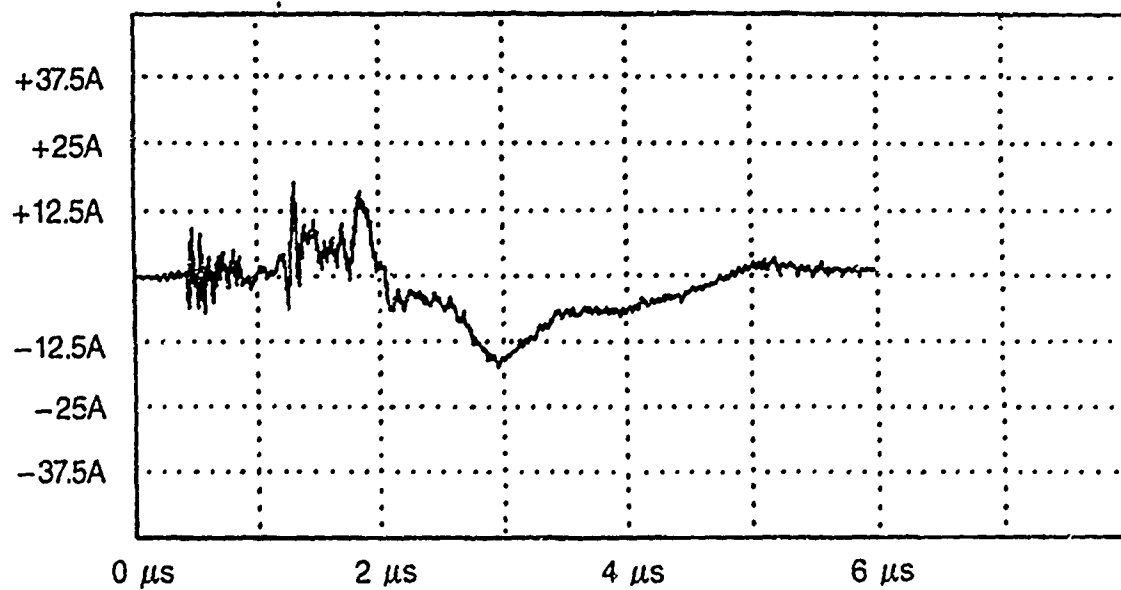
Figure 5. Current on 1 cable between PPI and MCC.

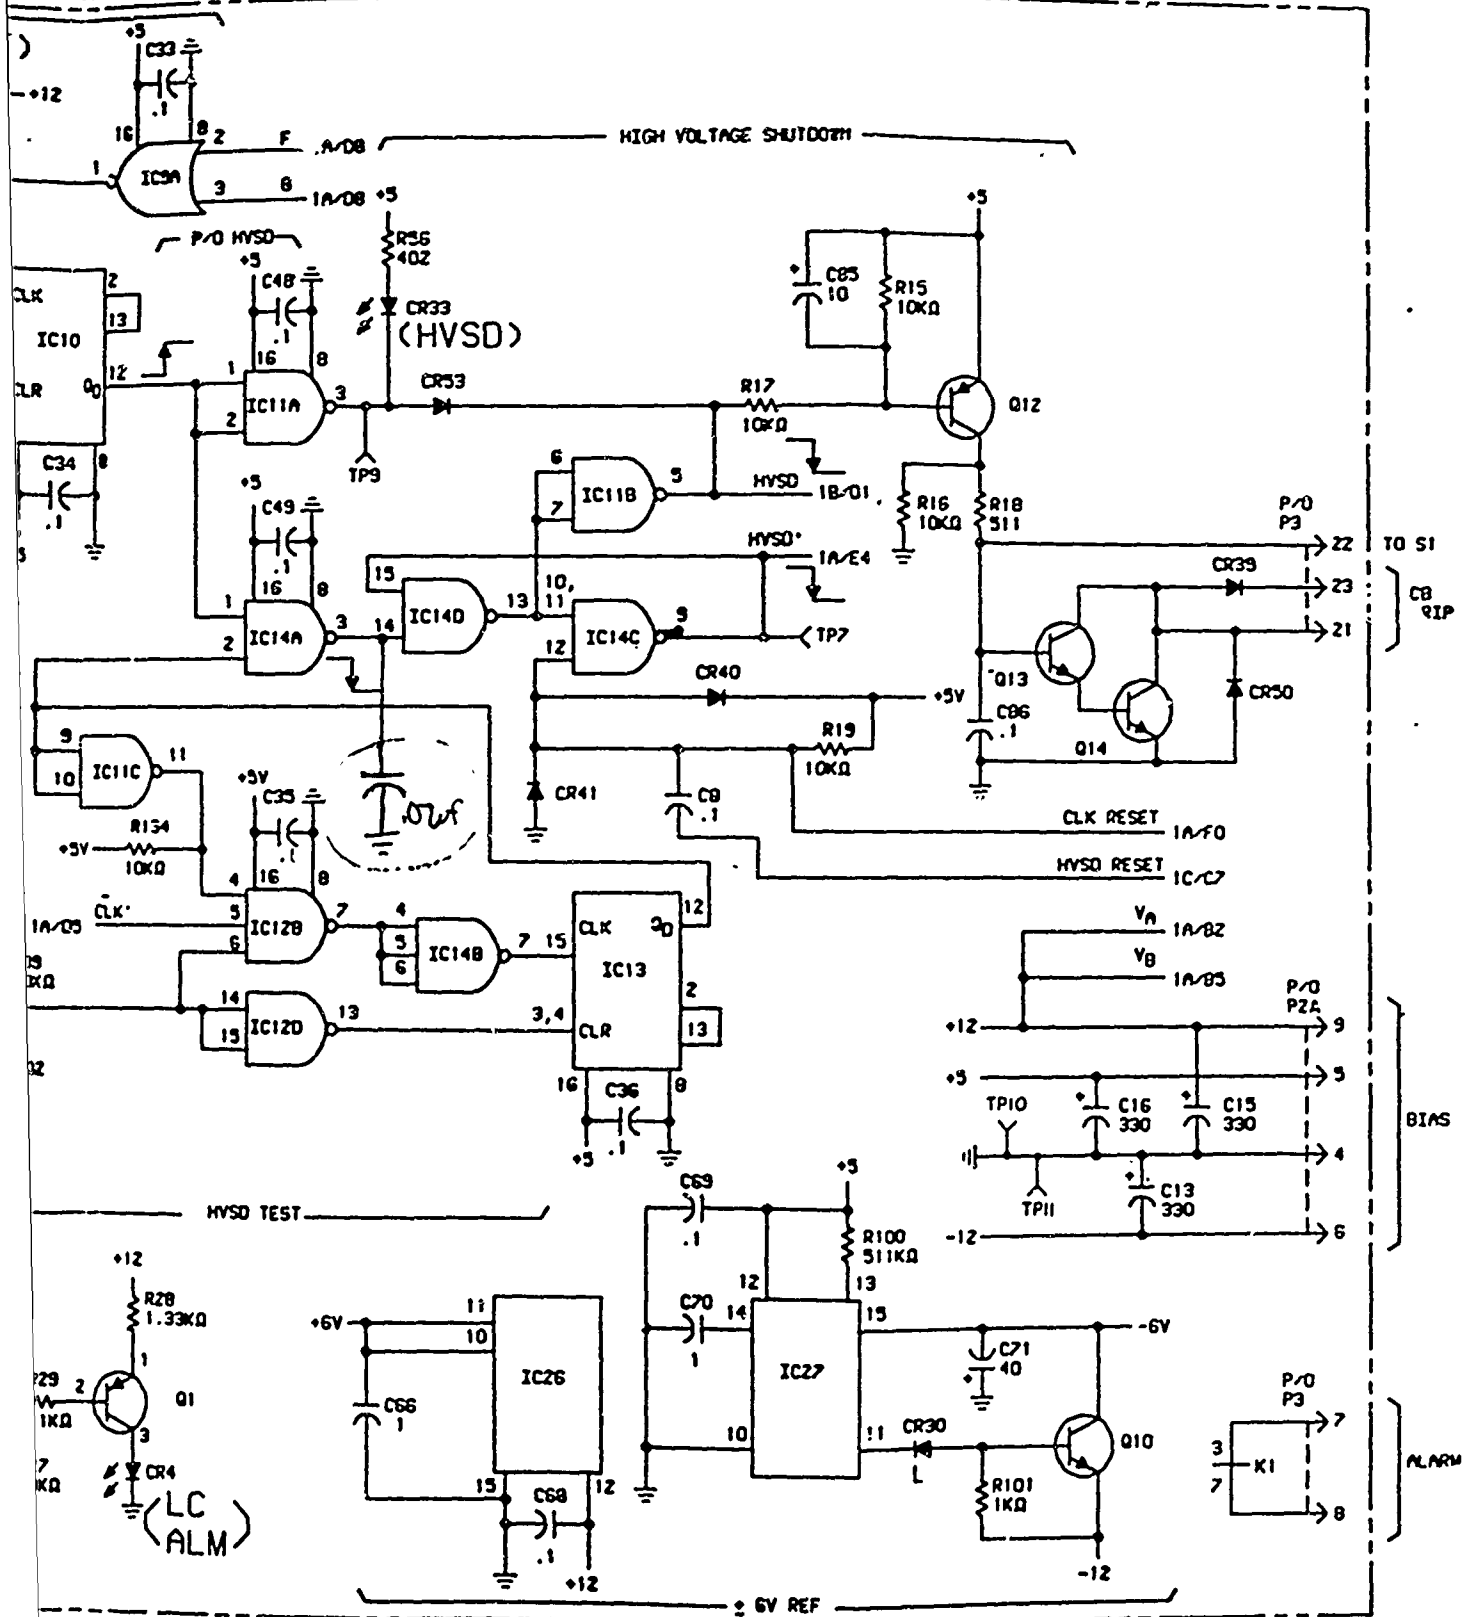
The sensitivities arose from coupling transients into the High-Voltage Shutdown (HVSD) circuitry, either onto voltage sense leads or onto leads carrying a shutdown signal. No hardware damage was found after these shutdowns.

Figure 7. Schematic of circuit pack in 620C and 625C power plants, with modification circled.

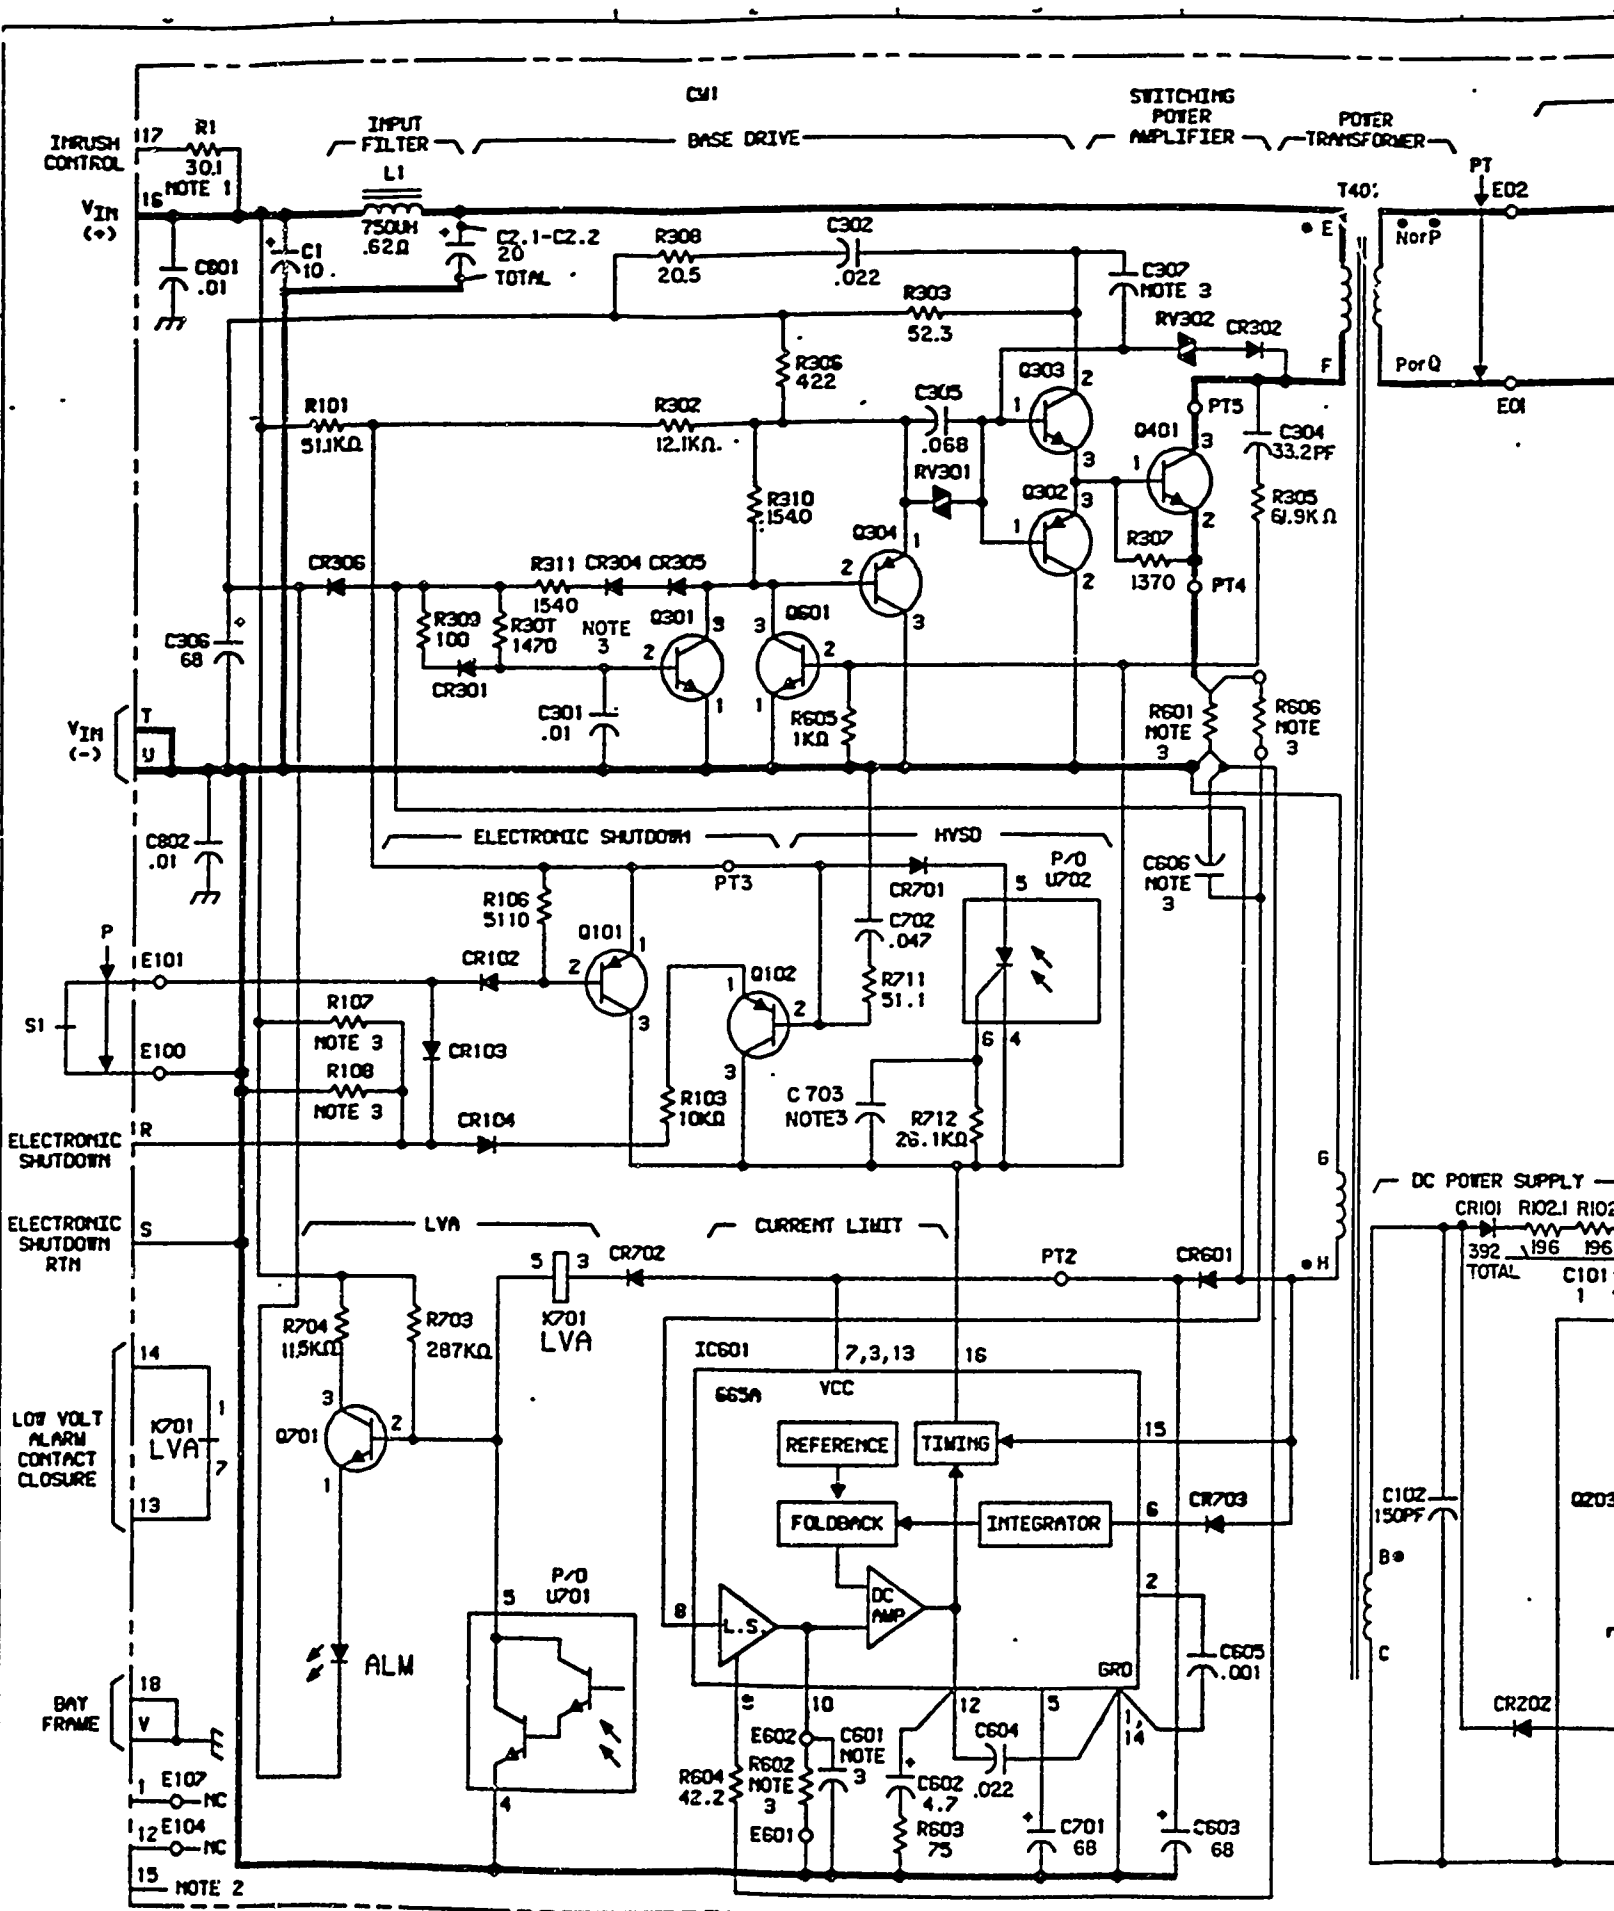
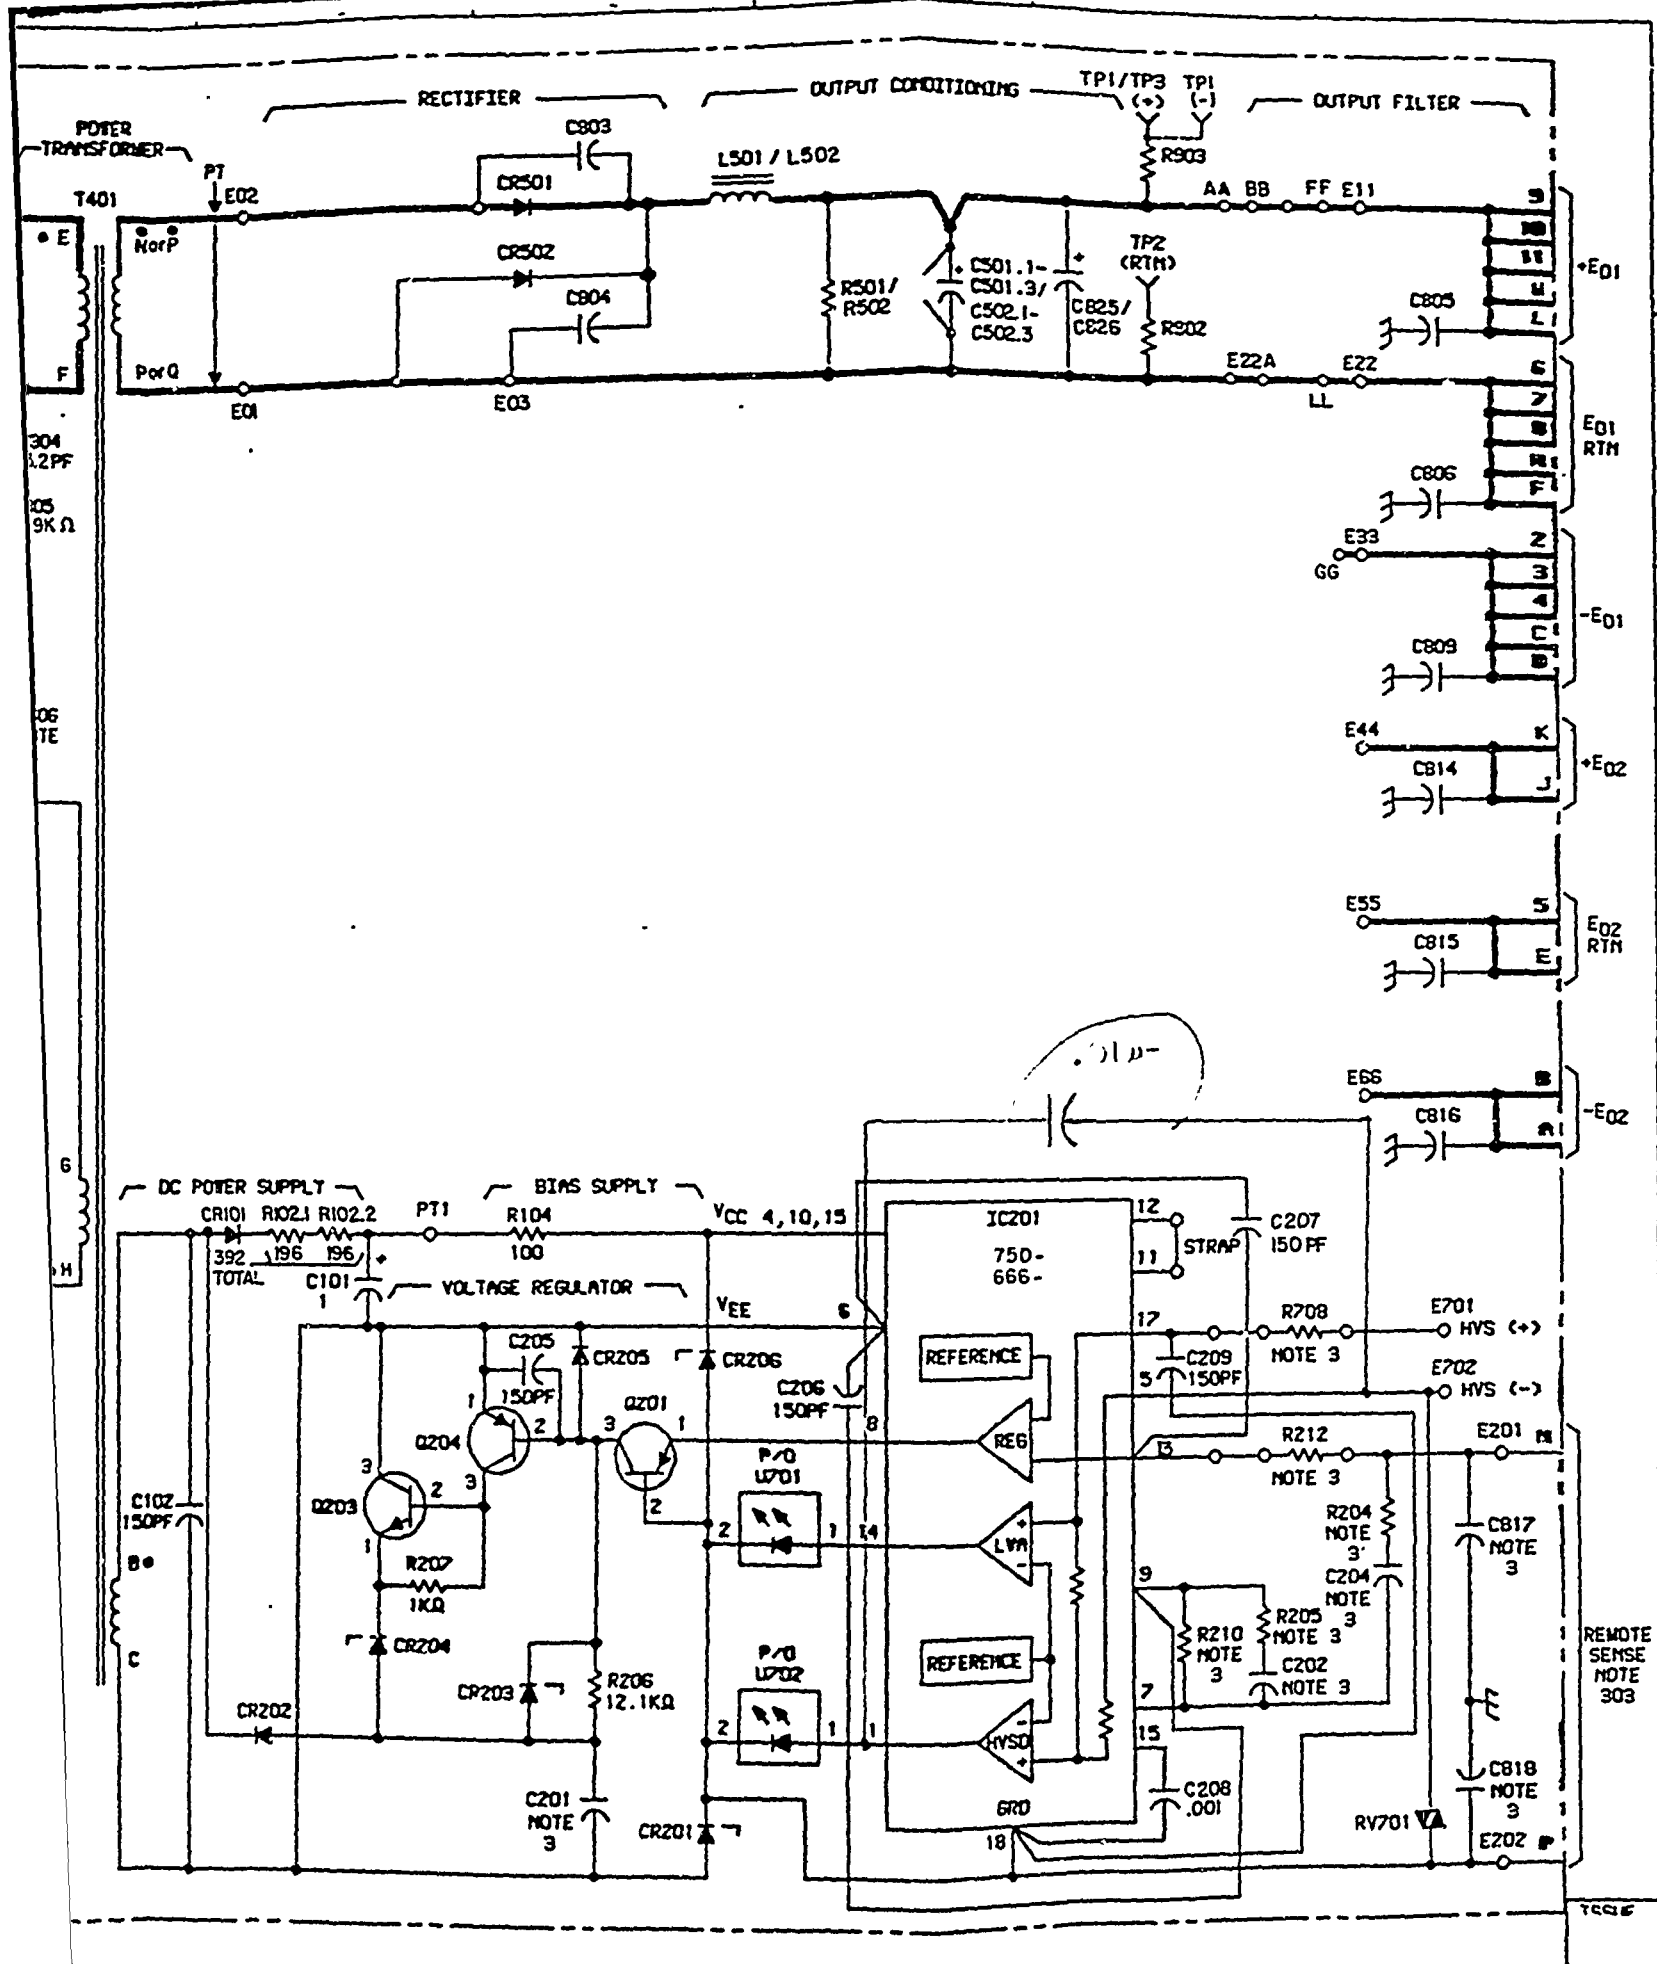
Figure 8. Schematic of 140L1 circuit pack, with modifications circled

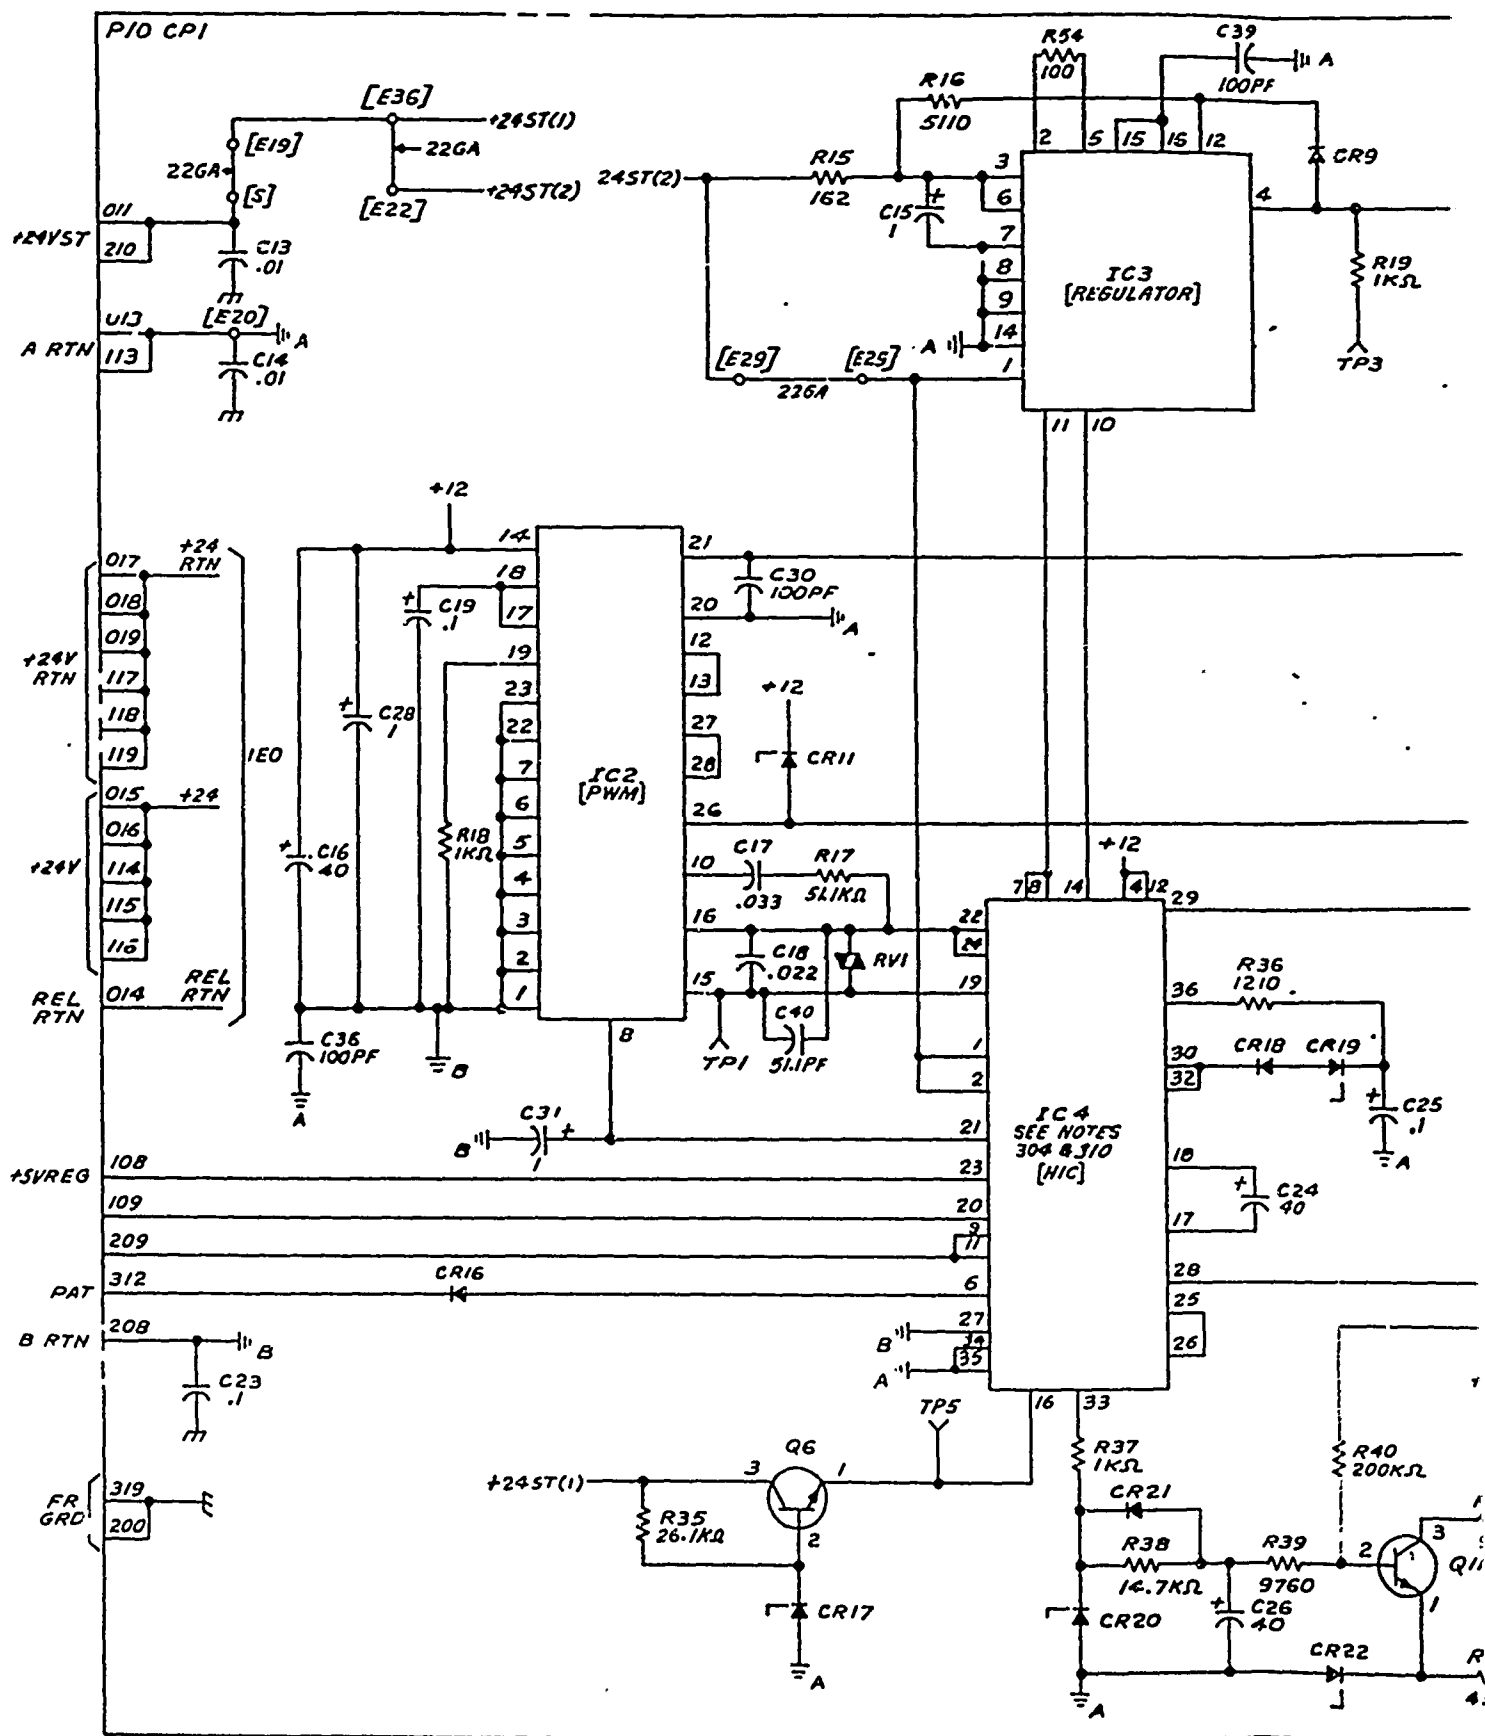
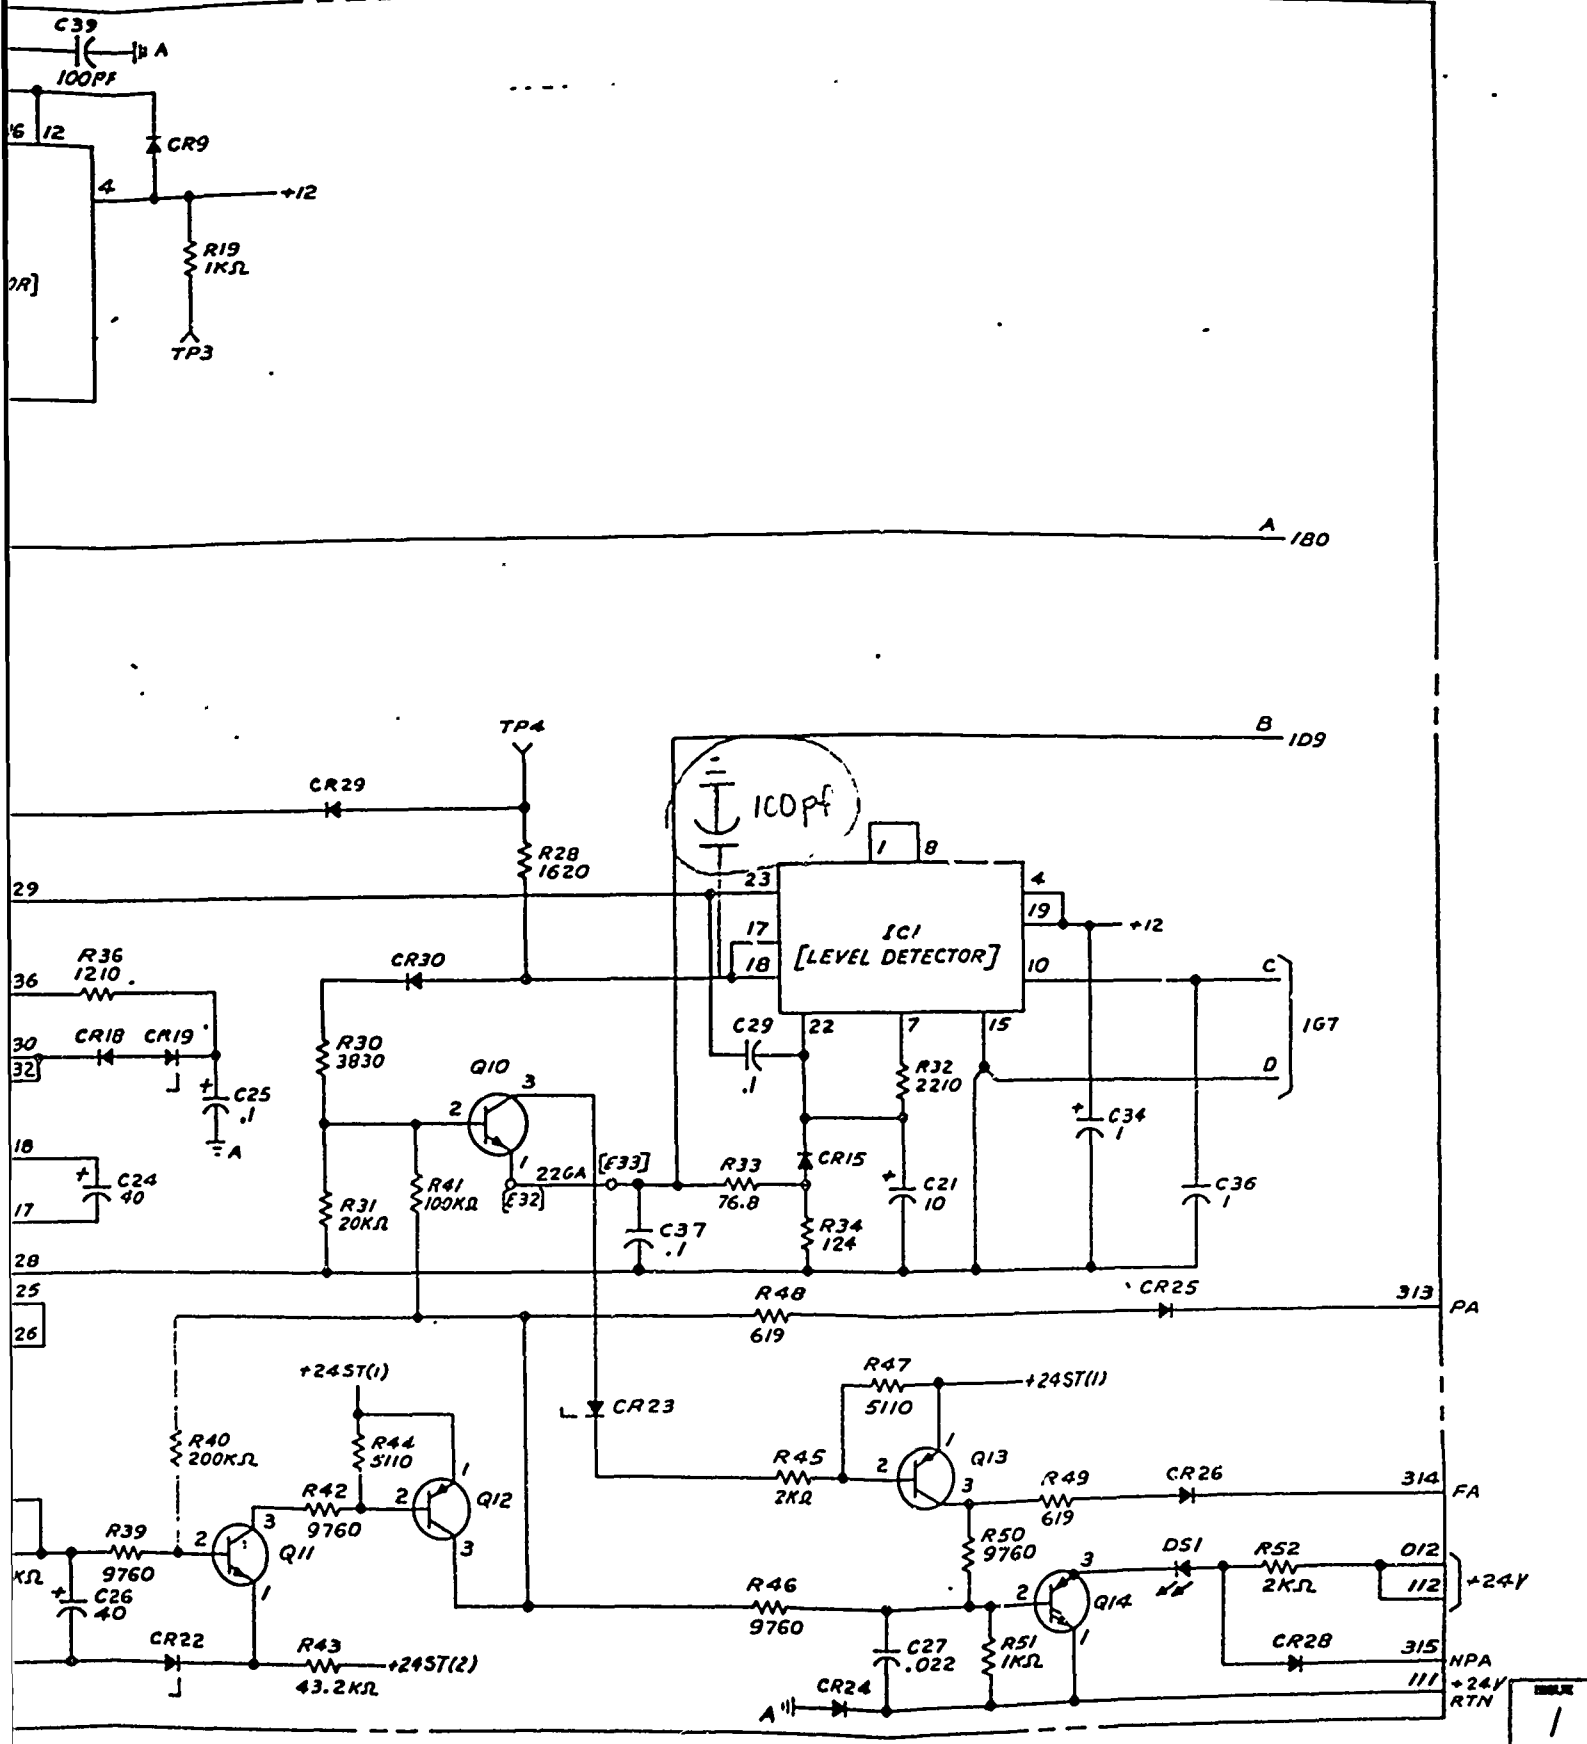
Figure 9. Schematic of circuit pack for 87389-E, -F, -J, -M, -S power converters, with modification circled.

| Circuit Pack | Modification |
|---|---|
| 87389-E, -F, -J, -M, -S | 100 pF from IC1, pins 17 and 18 (shutdown signal) to ground |

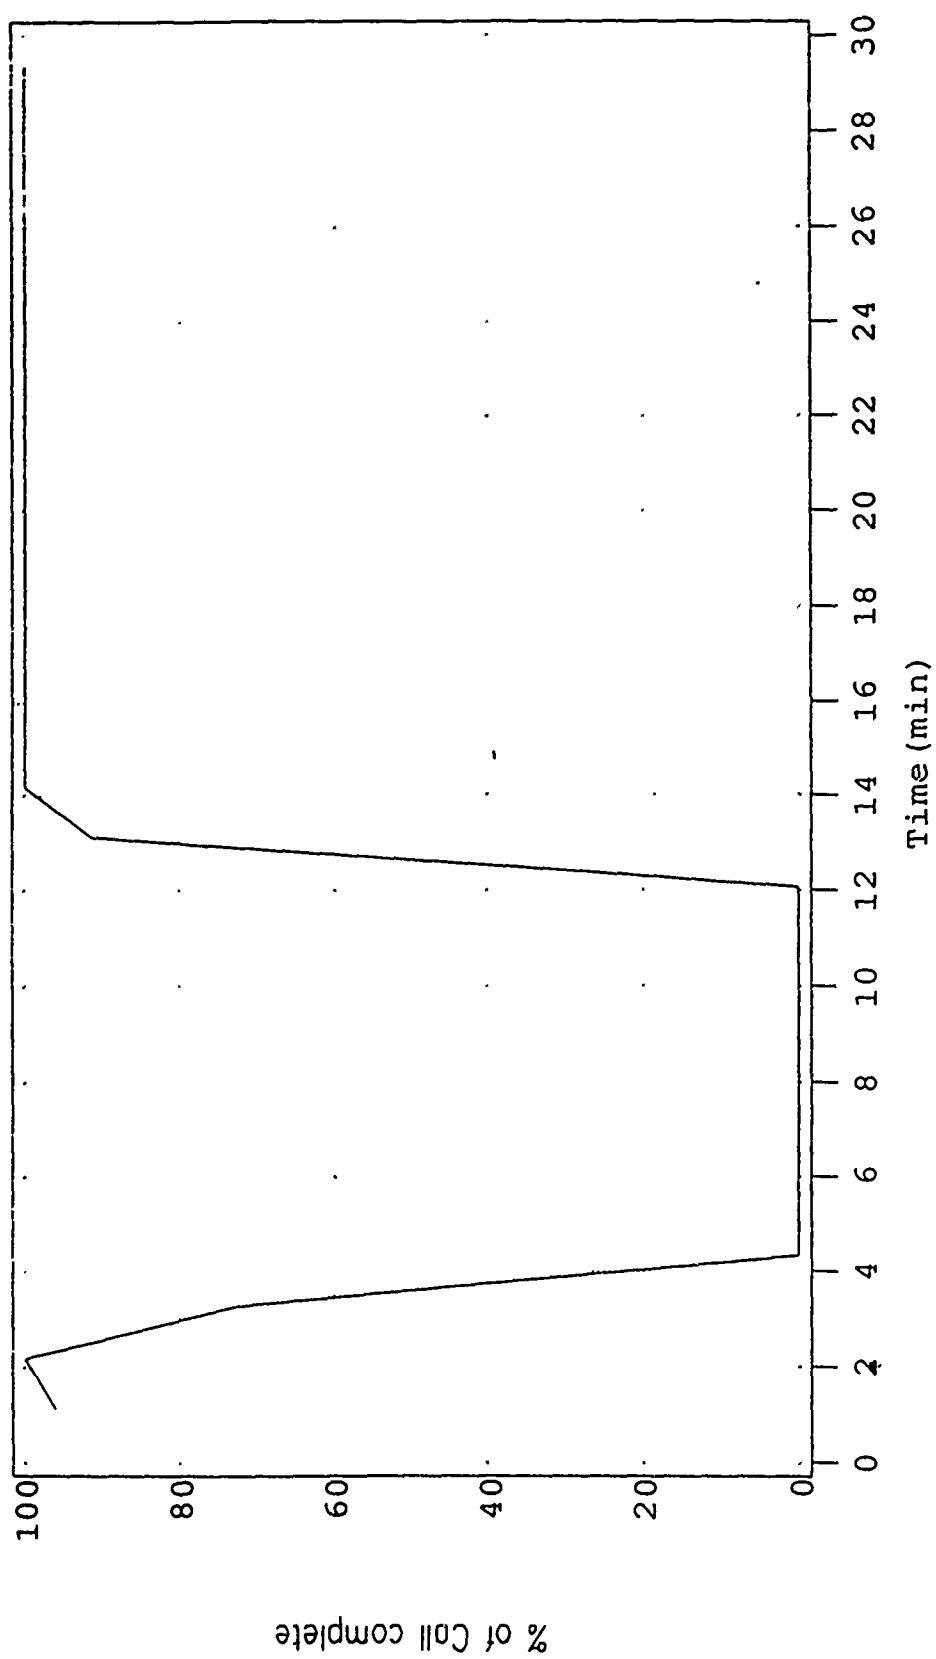
When an interrupt on the switch occurred, call processing was usually interrupted for a few seconds (~ 15) while the 1A Processor determined what actions were required to deal with the interrupt. If no further actions were needed, call processing resumed as normal. However, if the problem was significant enough to get the switch to initiate a phase, a further interruption in call processing would ensue. This interruption lasted for the time needed for the phase (from a few seconds for a phase 1 to about 2 minutes for a phase 3) plus an additional time needed to bring on line peripheral equipment required to process calls. Altogether, call interruptions lasted from 2 to 10 minutes. (See Figure 10.)

Figure 10. Percentage of transient calls completed before and after pulse.

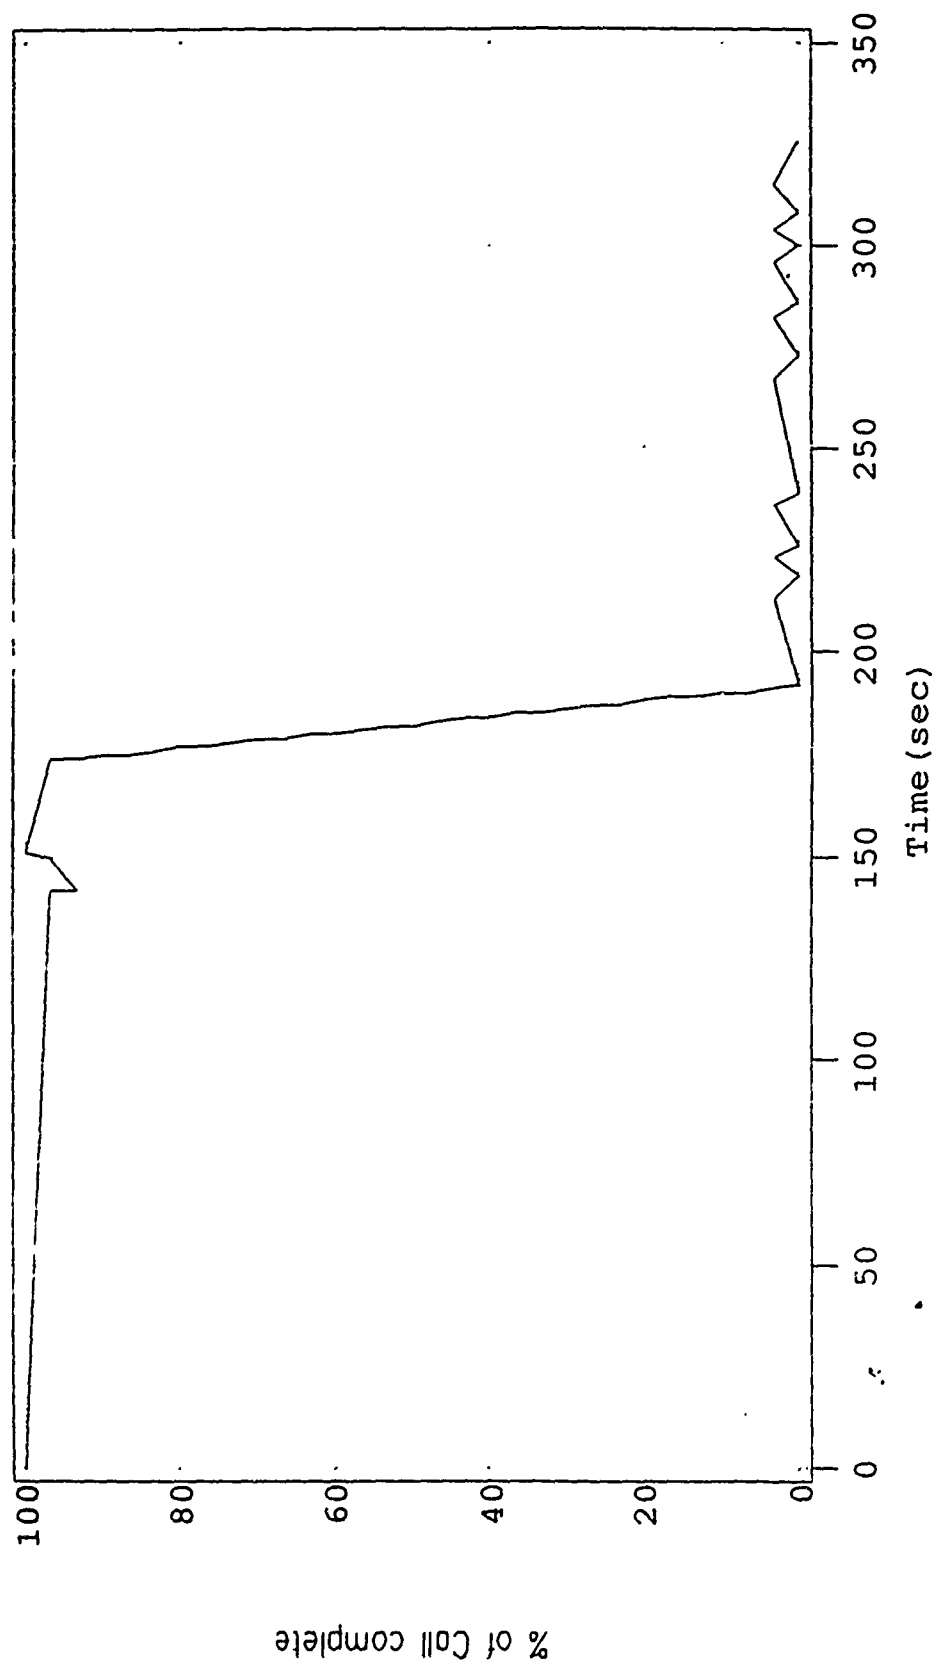
Stable calls were affected only by high-level phases or when the equipment servicing the calls was taken out of service (duplex failures in the DIF or TSI). (See Figure 11.) Otherwise, they usually remained connected. One interesting mode observed was when the processor was incapable of processing new calls, and the stable calls were still connected through the switch. The DIF, TSI, and TMS were intelligent enough to continue the stable call connections. These calls stayed up until the processor regained its sanity. When the processor initialized the DIF, TSI and TMS, they then knocked down the stable calls.

**Figure 11. Percentage of stable calls connected before and after pulse.**
