TECHNICAL REPORT HL-90-19

# A STUDY OF VEGETATION ON REVETMENTS SACRAMENTO RIVER BANK PROTECTION PROJECT

## PHASE 1

### LITERATURE REVIEW AND PILOT STUDY

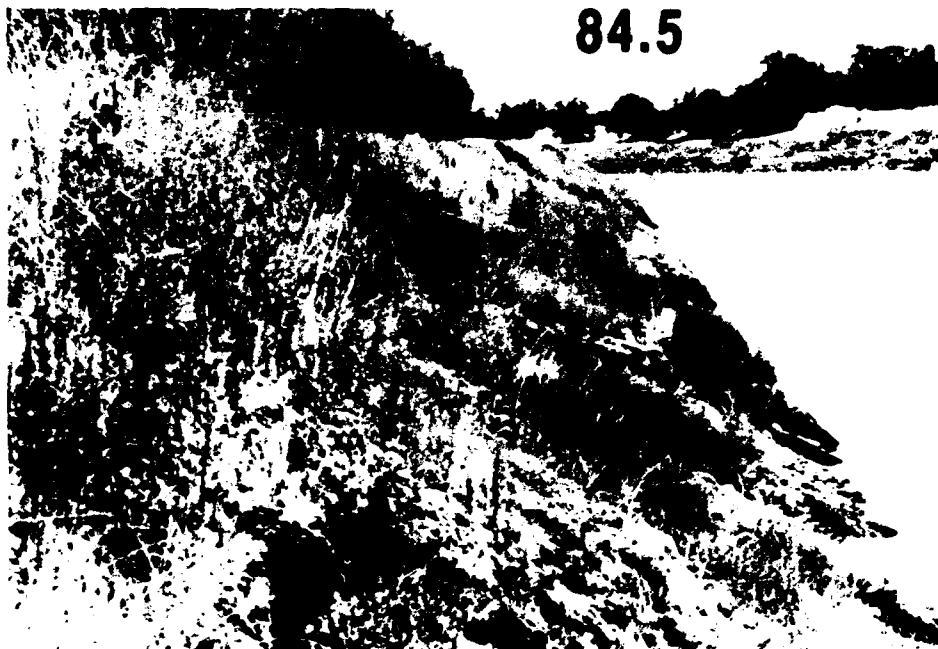
a. RM 84.6 to 85.4L

Figure 20. PL-99 damage sites, pilot study reach (Sheet 1 of 3)

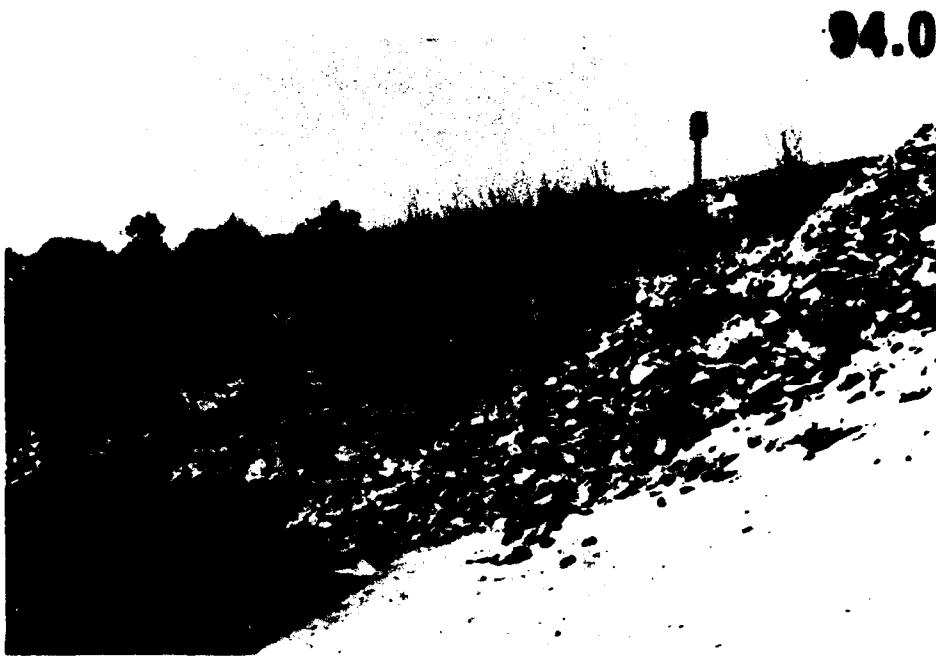
c. RM 94.0L

Figure 20. (Sheet 2 of 3)

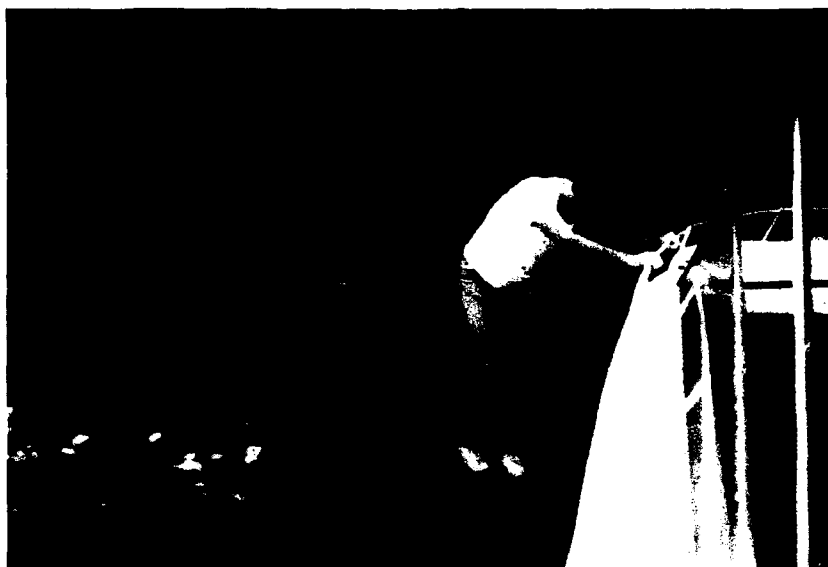
a. RM 108.2R

Figure 21. Typical cobble revetment damage  
observed in pilot study reach
