NASA  
Technical Memorandum 4195

# Evaluation of Composite Components on the Bell 206L and Sikorsky S-76 Helicopters

Donald J. Baker

AUGUST 1990

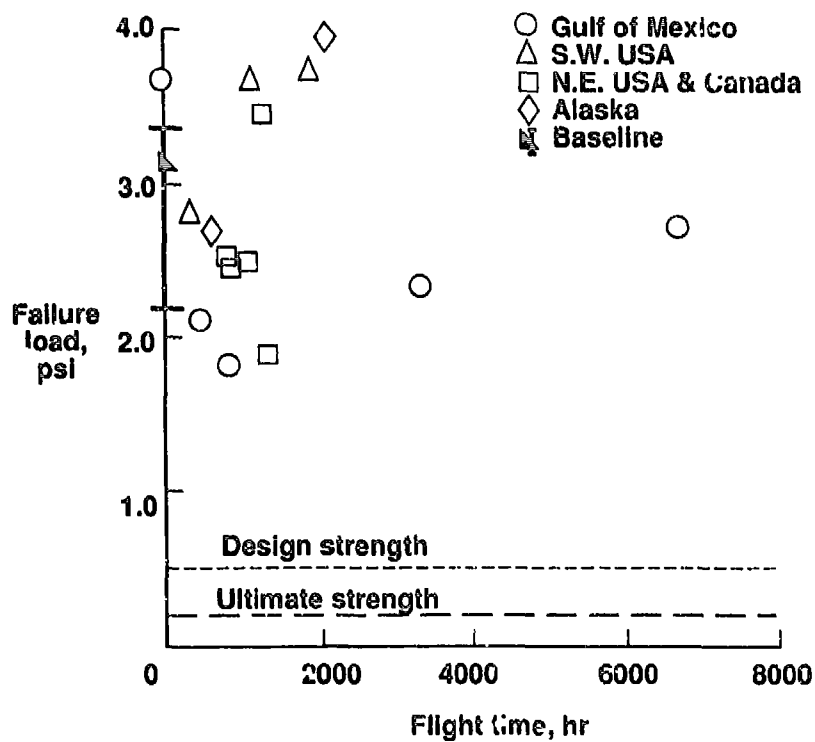
Failure loads (table 3) for 15 forward fairings vary from 1.80 to 3.93 psi, and service times for these components vary from 386 to 6750 hr. Failure loads as a function of flight hours are shown in figure 13. Each open symbol represents the failure load for

a different exposure area. Failure loads vary from 1.80 to 3.93 psi and exceed the design strength of 0.49 psi (ref. 2) by more than a factor of 3. Failure loads for forward fairings tested to determine the baseline strength (ref. 2) varied from 2.2 to 3.4 psi. Failure loads for 8 of the 15 forward fairings tested are between 2.2 and 3.4 psi. The large scatter in the failure load could be the result of variations in the fabrication process. Considerable variation could result from putting down the single ply of Kevlar fabric (style 281) on a compound contoured surface. The lay-up requires cutting and overlapping the fabric at many places to prevent wrinkling on the surface. The stiffness of the forward fairing as a function of the flight hours is shown in figure 14. The stiffness was calculated using measurements for the deflection of the upper surface at a point 14.5 in. from the aft end as the load was applied. The stiffness of all fairings, except one, exceeded the stiffness of the certification fairings. The fairings that have been tested accumulated a total of 23 730 hr of flight time.

Figure 13. Failure load of forward fairings after exposure.

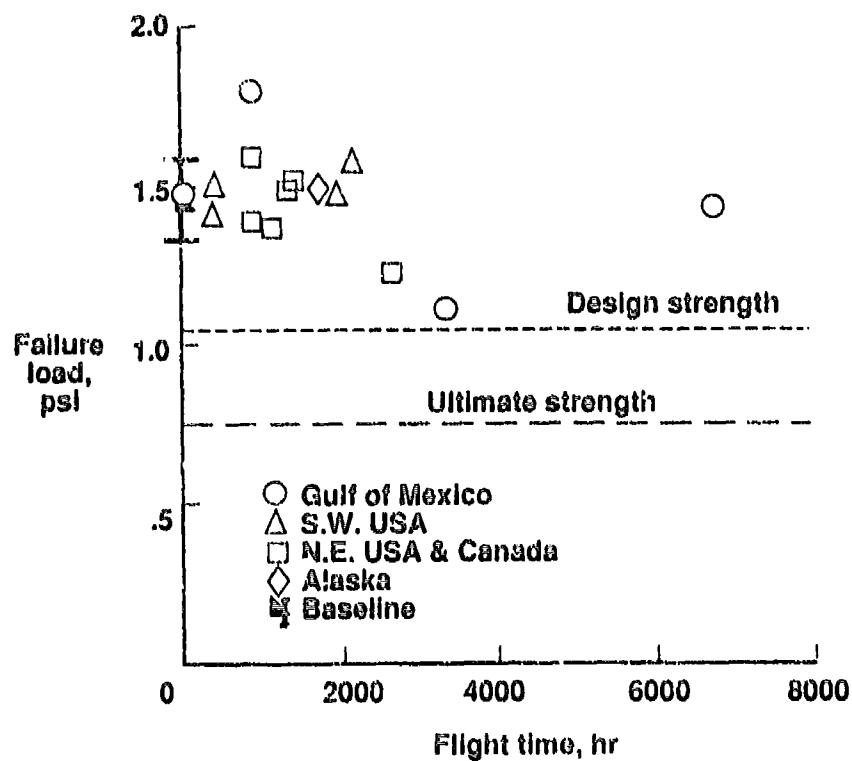
Failure loads (table 4) for 15 vertical fins vary from 1.12 to 1.80 psi, and service times for these fins vary from 385 to 6750 hr. Failure loads as a function of flight hours are shown in figure 15. All fins exceed the design strength of 1.05 psi. Failure loads for 12 of the 15 fins are between 1.35 and 1.57 psi, which is the range of failure loads for the baseline tests (ref. 2). One fin that was struck by lightning is identified in table 4. The fin was damaged at the top with no damage in the structural box. This fin failed at 1.23 psi with no apparent effect from the lightning strike. The environment does not appear to affect the failure load of the vertical fins. The stiffness of the vertical fin as a function of flight time is shown in figure 16. Stiffness was calculated using measurements for the tip deflection as the simulated aerodynamic load was applied. The certification deflection data for the fin are not available. The vertical fins that have been tested have accumulated 26 139 flight hours.

Figure 15. Failure load of vertical fins after exposure.

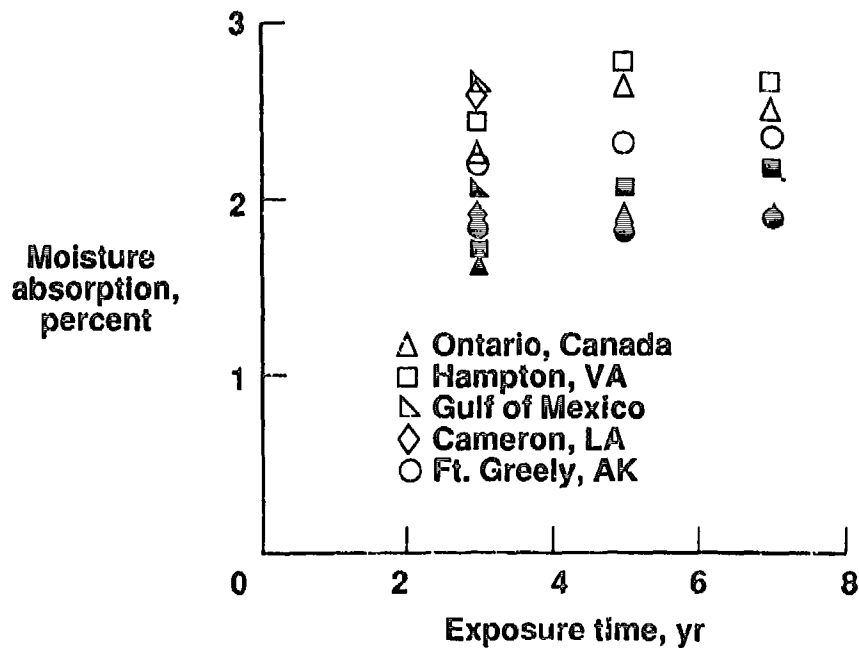
Moisture absorption data for the Kevlar-49/F-185 material are shown in figure 20. This figure indicates that painted specimens absorb more moisture than the unpainted specimens. Actually, the painted specimens absorb up to 0.63 percent (average) more moisture than the unpainted specimens. Moisture absorption data for the Kevlar-49/LRF-277 material are shown in figure 21. The trend in this material

Figure 20. Moisture absorption of Kevlar-49/F-185 composite material. Solid symbols represent unpainted specimens.

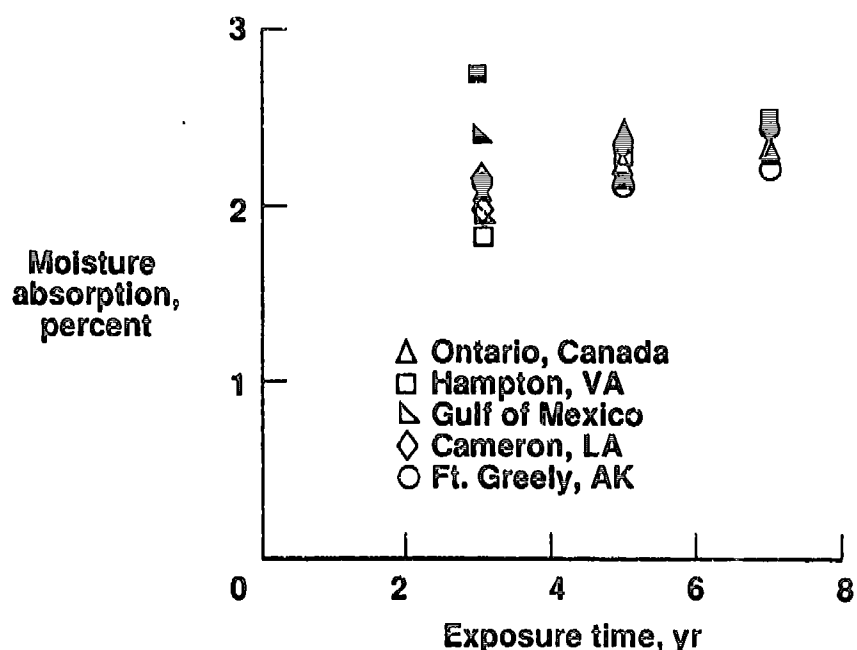
is the opposite from the other two Kevlar materials in this program. For the Kevlar-49/LRF-277 material the unpainted specimens absorb more moisture than the painted specimens. By the seventh year of exposure the unpainted specimens are approaching an equilibrium condition of 2.3 percent moisture absorption.

Figure 21. Moisture absorption of Kevlar-49/LRF-277 composite material. Solid symbols represent unpainted specimens.

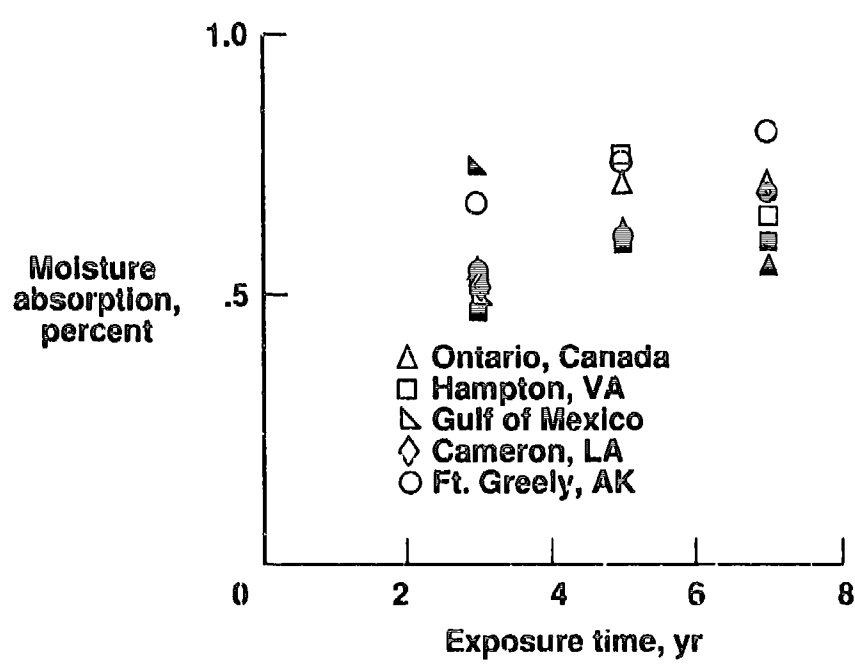
Moisture absorption data for the T-300/E-788 graphite/epoxy material are shown in figure 22. The 0.74-percent absorption for a 3-year exposure at the Gulf of Mexico does appear high. There is no method to determine if this high moisture absorption would continue in the Gulf of Mexico since the rack was destroyed before the removal of specimens after 5 years of exposure. No trend is evident after 3 years of exposure. After 5 and 7 years of exposure the painted specimens absorbed approximately 0.10 percent more moisture than the unpainted specimens, the same trend followed by two of the Kevlar/epoxy systems. Kevlar-49/epoxy materials absorb four to five times more moisture than graphite/epoxy materials because the Kevlar fibers absorb moisture. The average values, for each material, compare well with published values for other Kevlar/epoxy and graphite/epoxy systems (ref. 1).

Figure 22. Moisture absorption of T-300/E-788 graphite/epoxy composite material. Solid symbols represent unpainted specimens.
