INVESTIGATION INTO THE FAILURE CAUSE OF A  
DOUBLE ACTING, LEADING EDGE GROOVE,  
TILTING PAD THRUST BEARING

Brian K. Peterson  
Technology Branch  
Turbine Engine Division

October 1990

AERO PROPULSION AND POWER LABORATORY  
WRIGHT RESEARCH AND DEVELOPMENT CENTER  
AIR FORCE SYSTEMS COMMAND  
WRIGHT-PATTERSON AIR FORCE BASE, OHIO 45433-6563

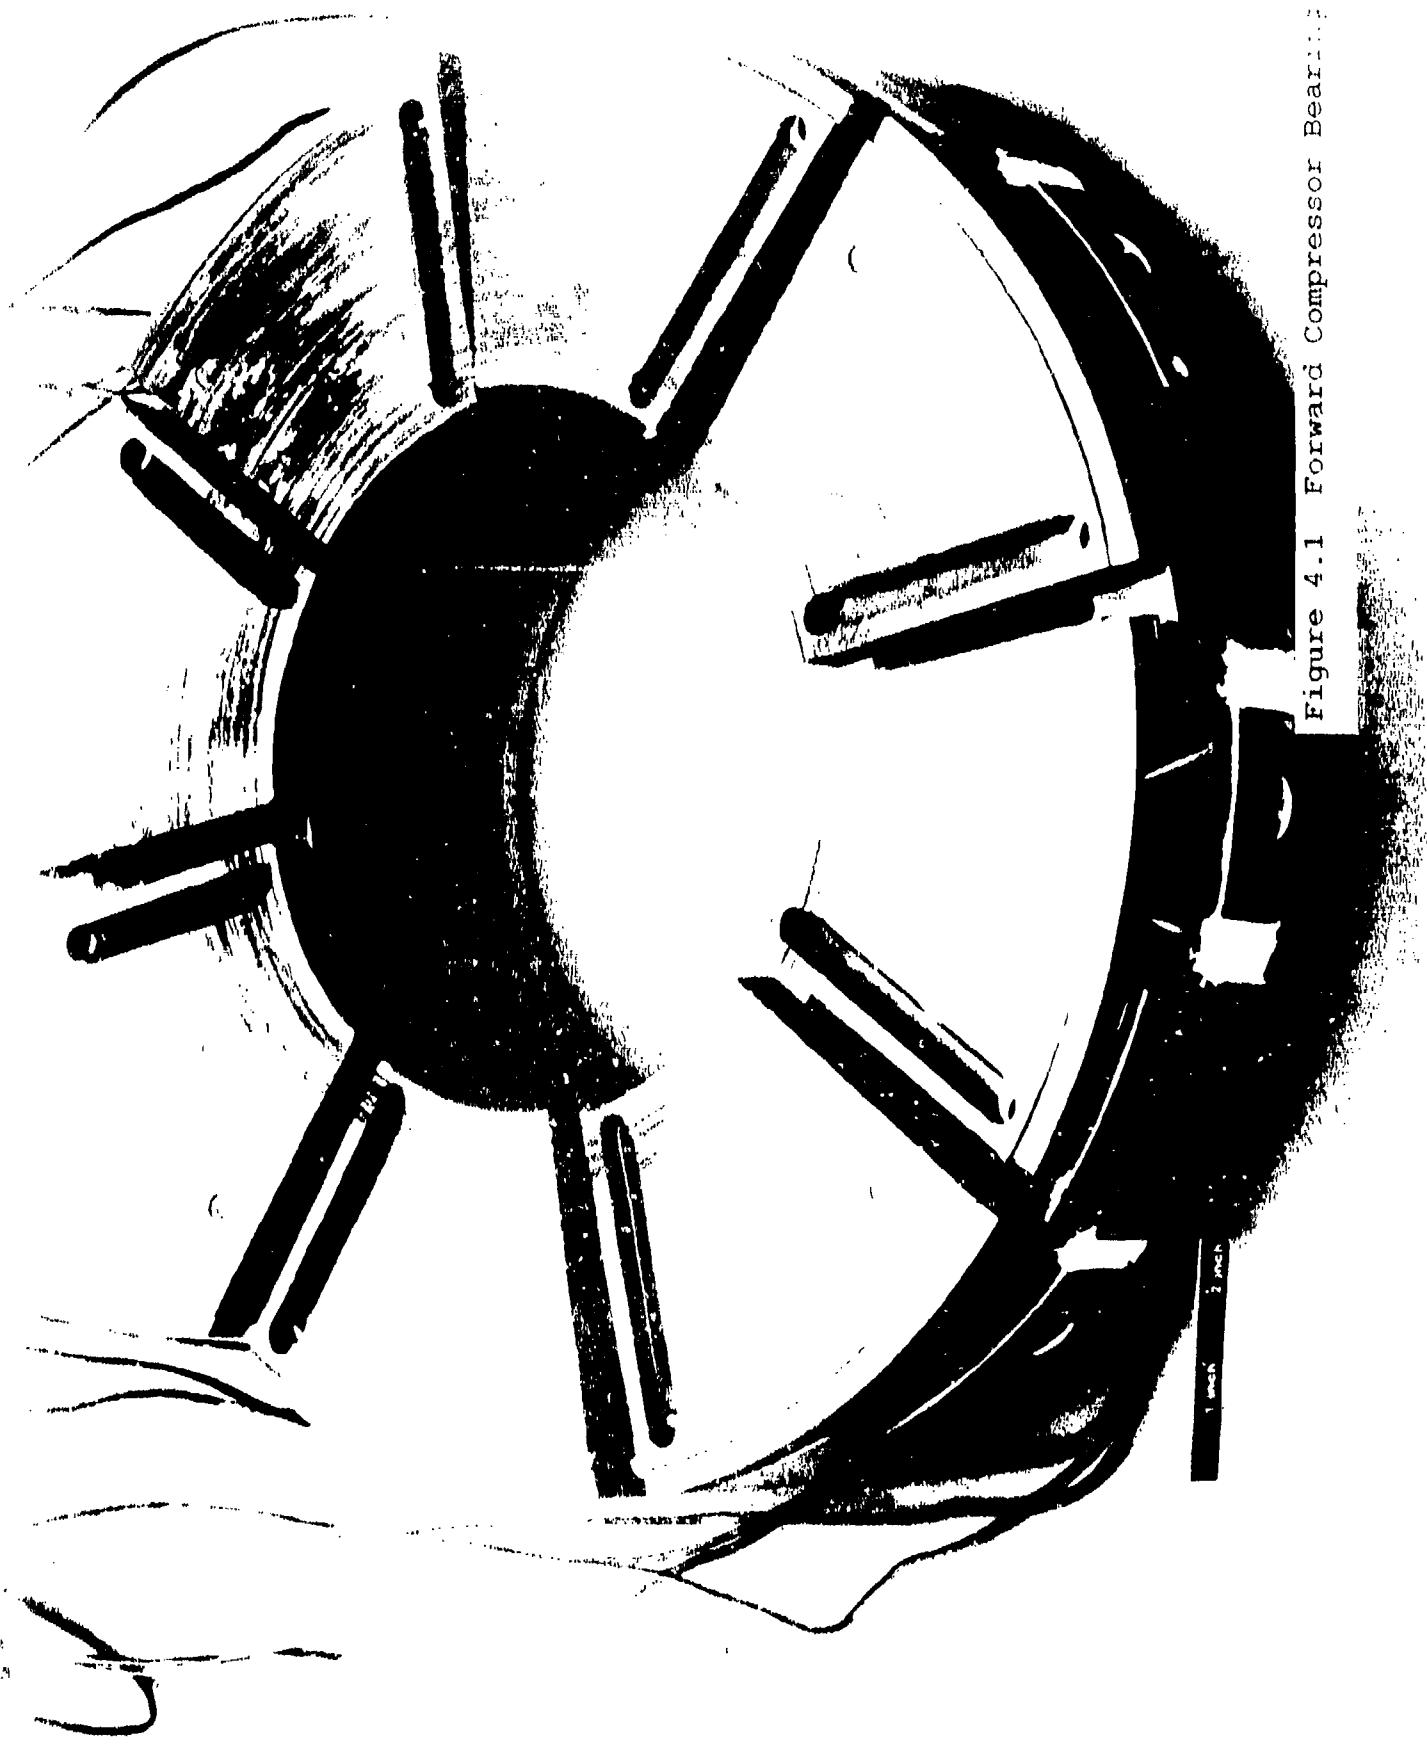
Figure 4.1 Forward Compressor Bearing

As shown in Figure 4.1, damage to the forward bearing pads was extensive, resulting in the complete loss of babbitt material on all bearing pads and destruction of all evidence of the failure cause. More information on the failure cause was available from the rear pads. Evidence of scoring and galling was apparent on the rear pads shown in Figure 4.2. Scoring is evident on the forward and rear sides of the titanium thrust collar as shown in Figures 4.3a and 4.3b, respectively.

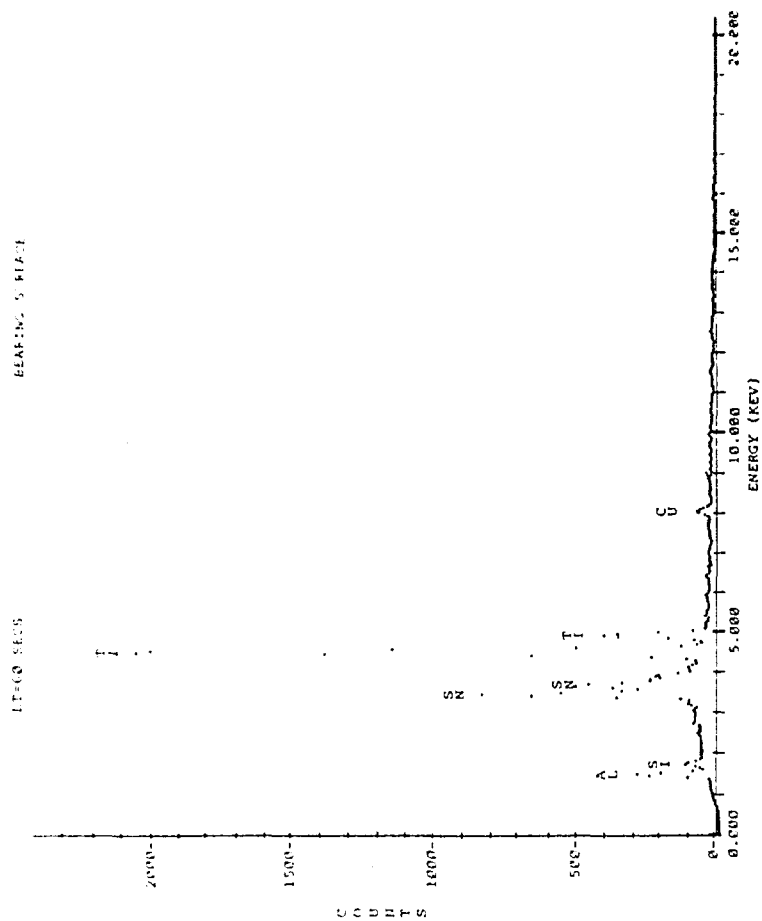
Figure 4.13a Smeared Failure Zone

Figure 4.13 provides a closer look at some areas in Figure 4.12, as well as element identification of the surfaces. Figure 4.13a shows one of the heavily smeared areas. X-ray diffraction results show a large titanium peak, as well as tin, aluminum, silicon, and copper peaks. Figure 4.13b shows one of the flaked areas. Again, a large titanium peak is evident, along with tin, aluminum, silicon, and copper peaks. The bottom, left corner of Figure 4.13b shows a pit created by galling. Figure 4.13c is a photograph of this area. The magnification reading and scale printed on the photo should be disregarded. Titanium is the predominant peak of the element identification.

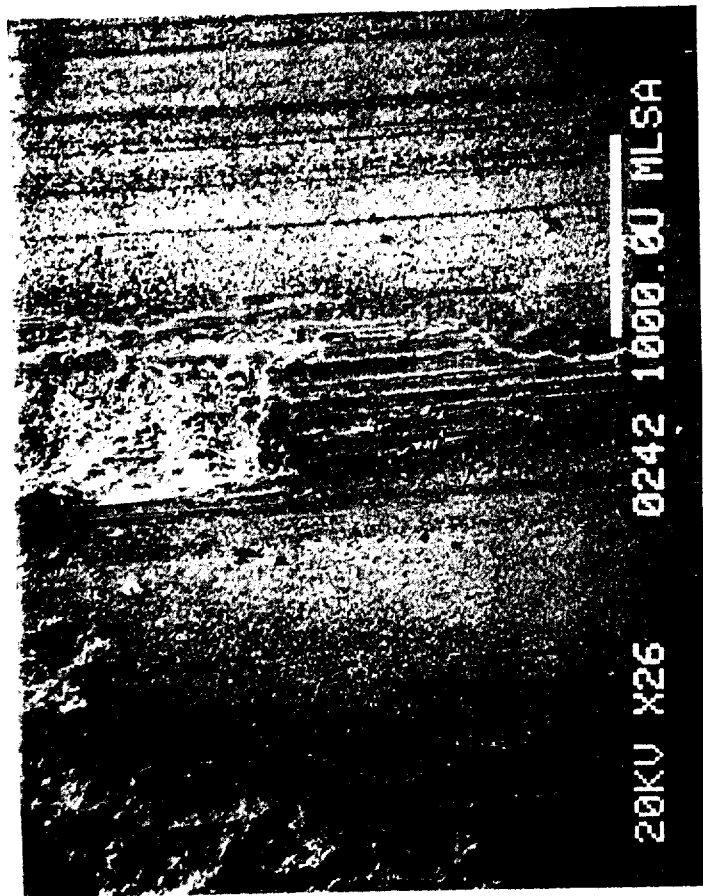
Figure 4.22a Wear Scar Beginning

Figure 4.22 shows the SEM examination of the surface of a wear scar at its beginning and end and the corresponding elemental identification. Figure 4.22a shows the beginning of the wear scar. The direction of collar movement across the surface is upward. At the very bottom of the photograph, at the entrance to the wear scar, is a wear groove approximately 0.015 inches wide. This is indicative of a wear or foreign particle initiating the scar. Two zones are evident on the wear scar; a zone of smeared metal, followed by a zone of galling. Figure 4.22b shows a closeup of the smeared zone. Results of mass spectroscopy of the area are shown adjacent. High titanium and tin peaks are evident. Figure 4.22c shows a closeup of the galled zone. Titanium is more prevalent here than in the smeared zone. Figure 4.22d shows the scar end. There is not an exit groove for a wear particle indicating that the wear or foreign particle did not exit. No wear or foreign particle was found in the scar. The scar end is characterized primarily by galling. Figure 4.22e shows a closeup and the corresponding elemental identification. This area is identical in composition and structure to the galled zone at the scar entrance.

Smearing of the material on the pad is evident in the SEM results from bench tests 1 and 3. The photograph in Figure 4.22a show that the debris created by galling was carried around by the titanium collar rotation back into the scars. This debris was smeared into the scar. This may be the reason for the intermediate frequency found in test segments IV and XI, although there is not enough evidence to prove this. Other possible explanations for this intermediate frequency may lie in the removal and reconstruction of oxidized layers in the titanium, or it may be a result of the galling mechanism.
