MISCELLANEOUS PAPER GL-91-13

# INVESTIGATION OF AIRFIELD RUNWAYS AT JACKSONVILLE NAVAL AIR STATION

June 1991

Final Report

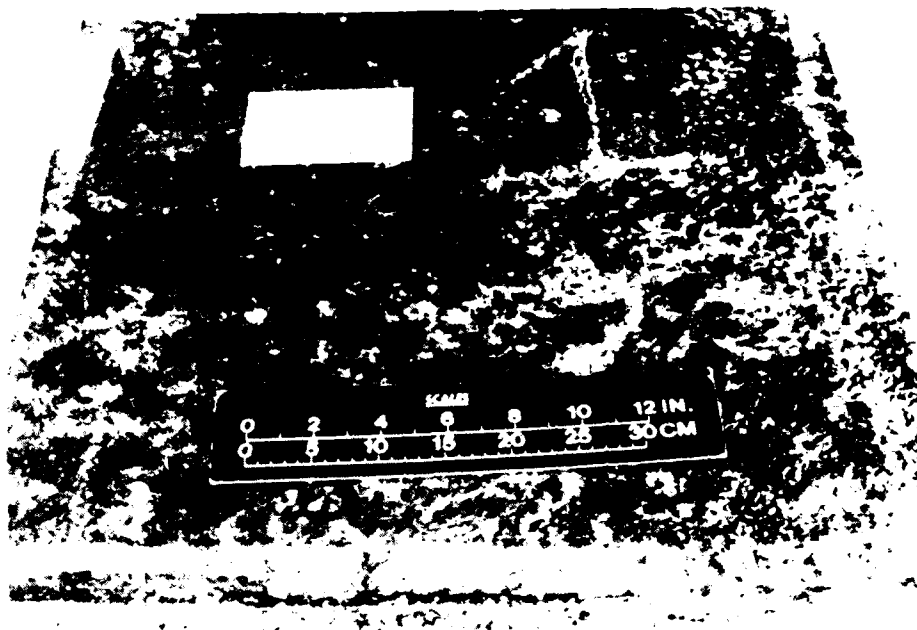
Photo 5. Pavement surface - Slab 1

| <u>Slab</u> | <u>Runway</u> | <u>Station</u> | <u>Centerline<br/>Offset<br/>(ft)</u> | <u>Amount of<br/>Traffic</u> | <u>Visual Pavement<br/>Surface Condition</u> |
|---|---|---|---|---|---|
| 1 | 9/27 | 109+05 | 15L | Heavy<br>Touchdown Zone | Raveled, open-textured<br>excessive rubber<br>buildup |

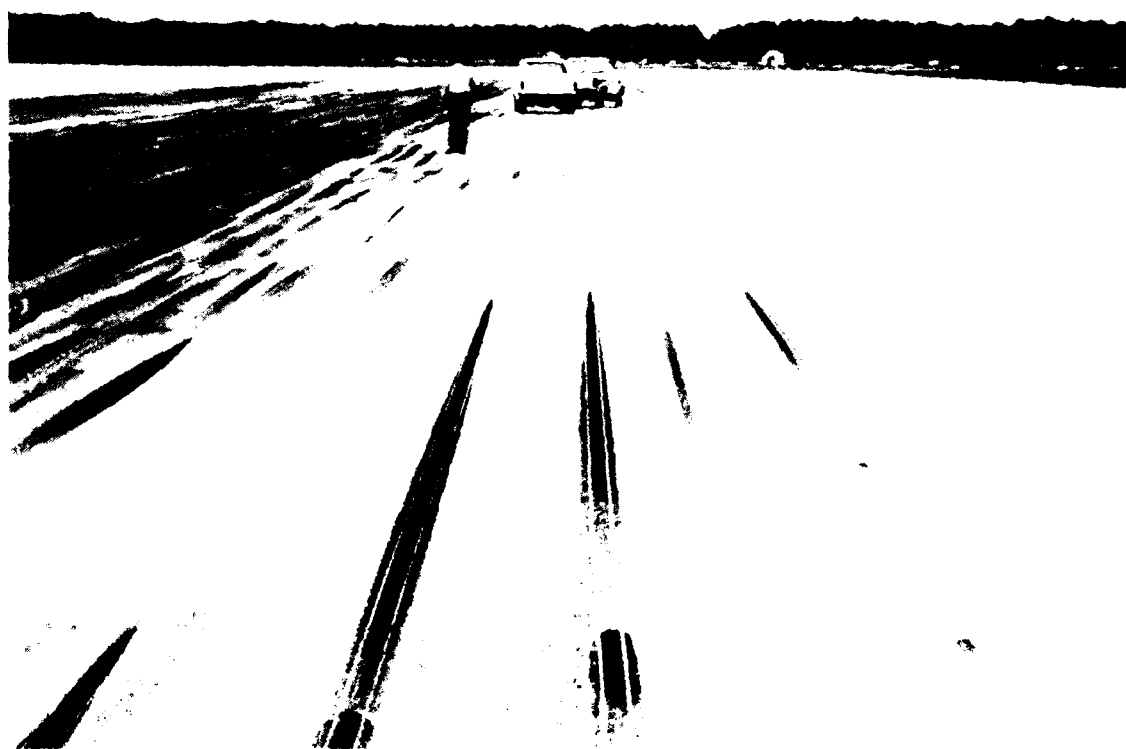
In the previous visual inspection on 6 November, it was observed that an obvious color difference existed between the outside paving lanes and the inside lanes. Slab samples 2 and 5 were taken from the outside lanes. The ductility values indicated that there was a difference in the asphalt cements. The ductility values for slab samples 2 and 5 were 2 to 4 times greater than the other slab samples, indicating that this binder was not as brittle and hard as the asphalt cements of the inside lanes.

Figure 10. Two distinctive colors in asphalt concrete mixture.
