# EXAMINATION OF PROTECTIVE COATINGS UTILIZED ON ARMY DS2 CONTAINERS

VICTOR K. CHAMPAGNE, Jr., MARC S. PEPI,  
CATHERINE M. ZOLLER, and SAUL ISSEROW  
MATERIALS TESTING AND EVALUATION BRANCH

June 1991

US ARMY  
LABORATORY COMMAND  
MATERIALS TECHNOLOGY LABORATORY

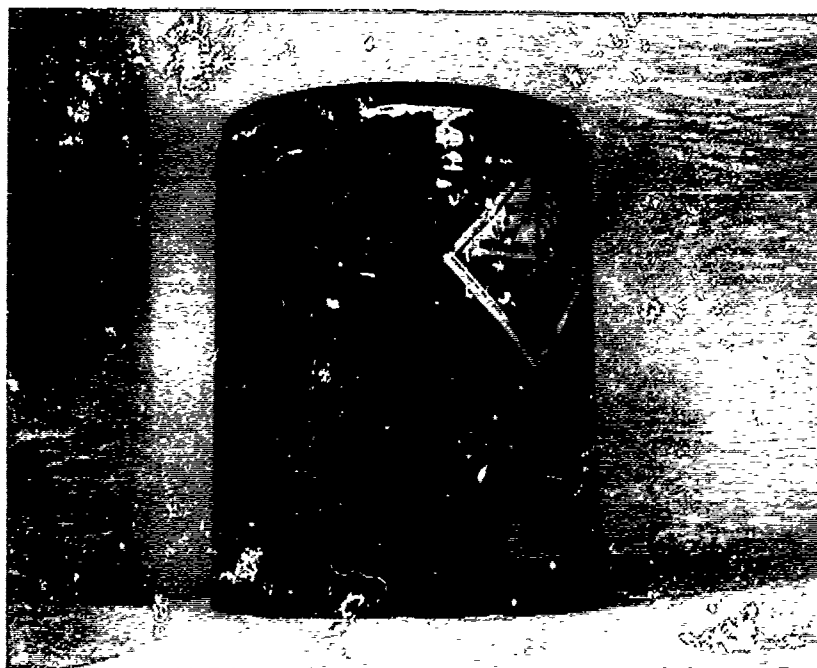
damage, leaving behind a bright white undercoat, as depicted in Figures 2 and 3. In addition, all three macrographs reveal a dull, matte finish on approximately 66% of the surface area of the container. This was most likely the result of weathering and exposure to adverse storage conditions. Figure 4 illustrates an area near the bottom weld chime where the topcoat had also been damaged. To the left of this region, a few isolated blisters and corrosion of the base metal occurred. The only significant evidence of corrosion was observed at welded seams which trapped moisture and allowed crevice corrosion to take place. Figure 5 shows the bottom weld chime which contains an example of crevice corrosion at the welded seam (top of micrograph). The bottom edge of the container had experienced some general corrosion where the external surface coating had been worn away. Figure 6 represents the corrosion observed along the side weld seam which also served as a site for water entrapment.

Figure 2. Prior mechanical damage to five-gallon container revealing bright white undercoat. Reduced 85%

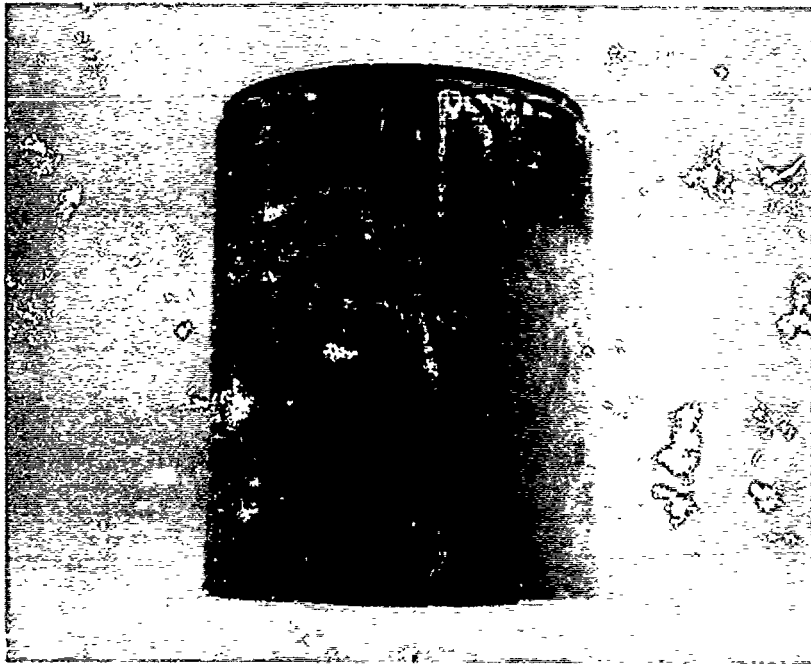
Figure 3. Another view of prior mechanical damage to five-gallon container revealing bright white undercoat. Reduced 85%

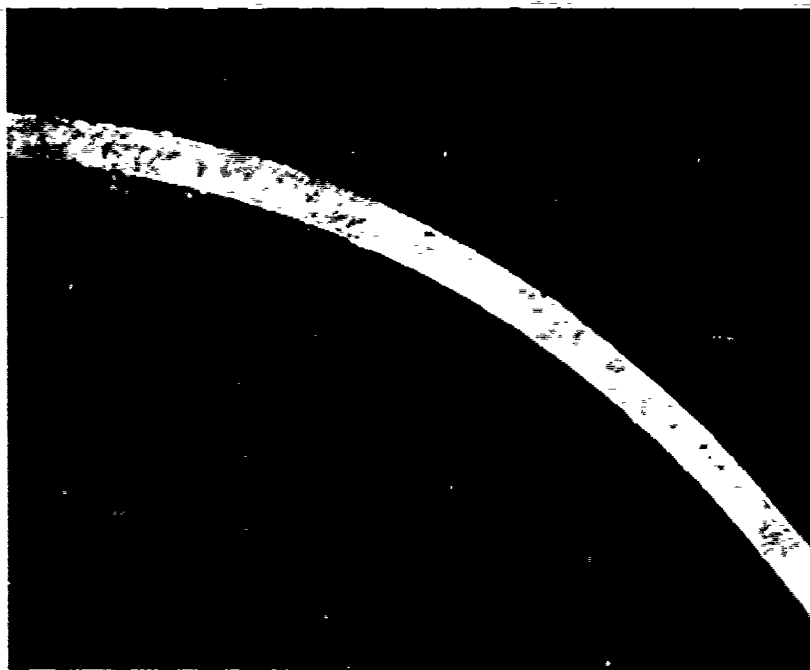
Figure 11. General corrosion at the base of the 14-liter container. Mag. 7.5X

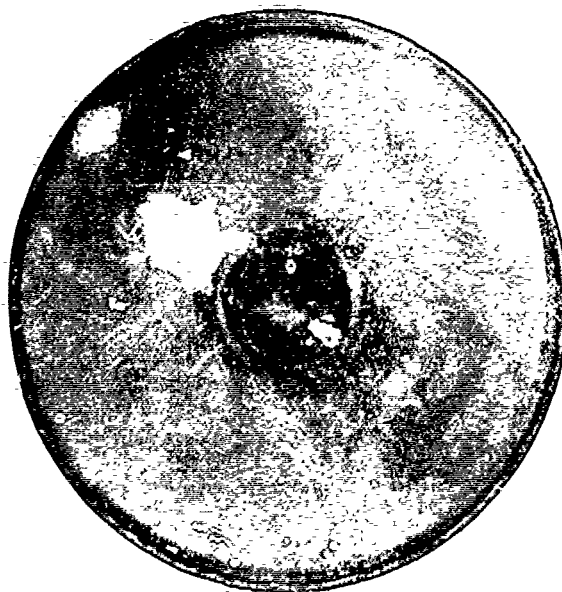
Figure 12 is a macrograph of the 1-1/3-quart container in the as-received condition. This container appeared to be in the worst overall condition showing evidence of blistering, denting, and staining, as well as varying degrees of corrosion. This condition may be attributed to the fact that it was the oldest container under investigation. The top surface, especially near the closure, exhibited extensive general corrosion, as shown in Figure 13. The entire top of the container being recessed allowed water to collect. This cup design provided a haven for corrosion. The side seam consisted of overlapping material which formed a longitudinal gap along the exterior of the container where crevice corrosion was predominant, as shown in Figure 14. Figure 15 contains a graphic example of the extensive blistering which occurred randomly over the exterior surface. Blistering is one of the first signs of the breakdown in the protective nature of a coating. The blisters were local regions where the coating had lost adherence from the substrate and where water accumulated and accelerated deterioration. Extensive corrosion was seen beneath blisters that had been scraped off during examination. In some instances, solder spatter and other surface asperities were observed beneath the paint blisters. Surface debris such as greases, shop dirt, etc. can also lead to poor coating adhesion and cause blistering. Figure 16 shows an example of general corrosion that took place at the bottom crimp-solder where the coating had been damaged when the container rested against a supporting surface.

Figure 13. Extensive general corrosion along the top surface  
of the 1-1/3-quart container. Reduced 20%

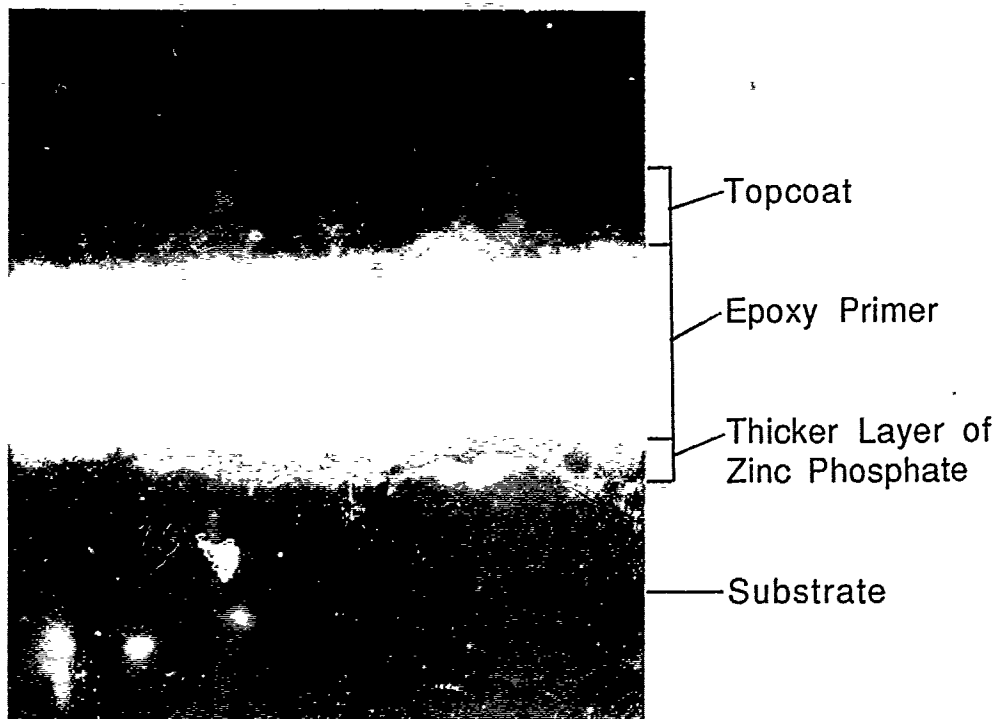
In general, the coatings displayed good adherence and were uniform, except for the phosphate layer which appeared to be quite discontinuous. Figure 20 further illustrates this point as it shows a thick phosphate layer, in contrast to Figure 19 which revealed only trace

amounts of this coating. Figure 20 represents an area sectioned from the side weld where the topcoat was nonuniform and thinner than the specification permitted. Figure 21 shows a cross section of the top weld which did not contain a topcoat layer. As previously described, within the Visual Inspection section of this report, areas of the topcoat had been damaged contributing to the nonuniformity of the topcoat. Regions where the closure contacted the top of the container were especially susceptible to this type of damage.

Figure 20. Representative cross section of the coating system of the five-gallon container taken from the side weld area, showing a thicker zinc phosphate coating. Mag. 500X

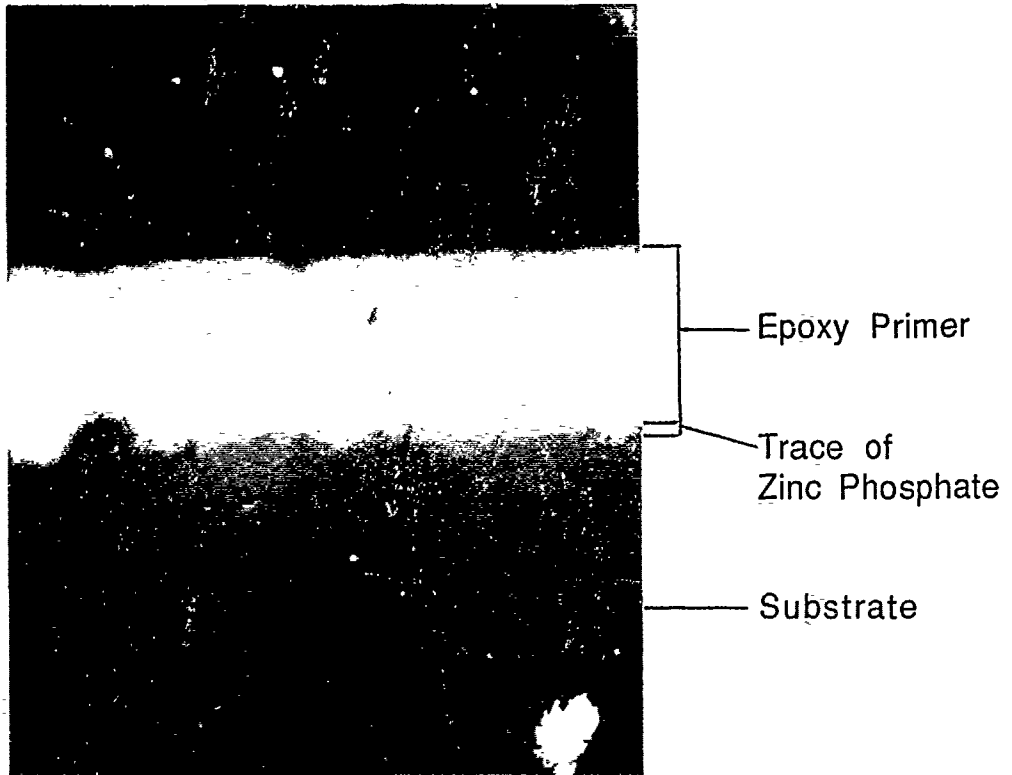
Figure 21. Cross section of the top weld of the five-gallon container indicating the nonexistence of a topcoat layer. Mag. 500X

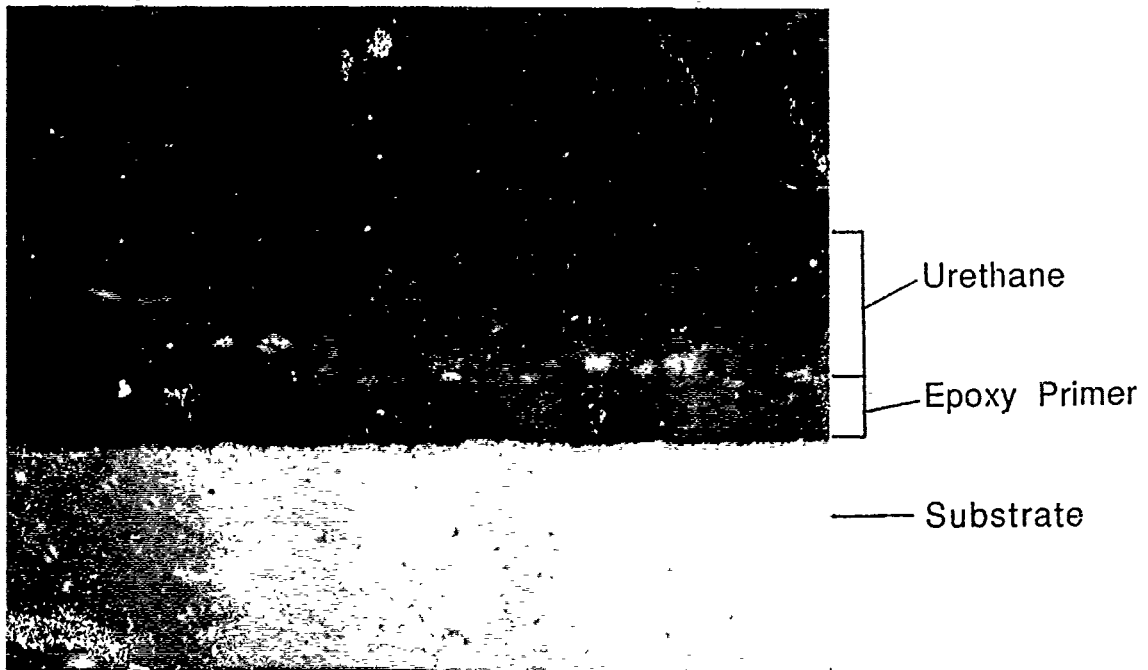
In Figure 25 the epoxy primer is approximately 0.6 mils in thickness while the topcoat averages about 1.8 mils which conformed to the lower range of the specified requirements. This trend was observed throughout most of the specimens examined. The urethane coating was also nonuniform at the top and bottom of the container and the epoxy primer was very discontinuous in these same areas, as Figure 26 reveals. The epoxy primer appeared spotty beneath the green topcoat instead of as a continuous layer. The photograph clearly shows the green urethane coating in intimate contact with the wash primer on the substrate and the absence of a red epoxy primer coating on most of the specimen.

Figure 25. Representative cross section of the coating system of the 14-liter container taken from side B. Mag. 500X

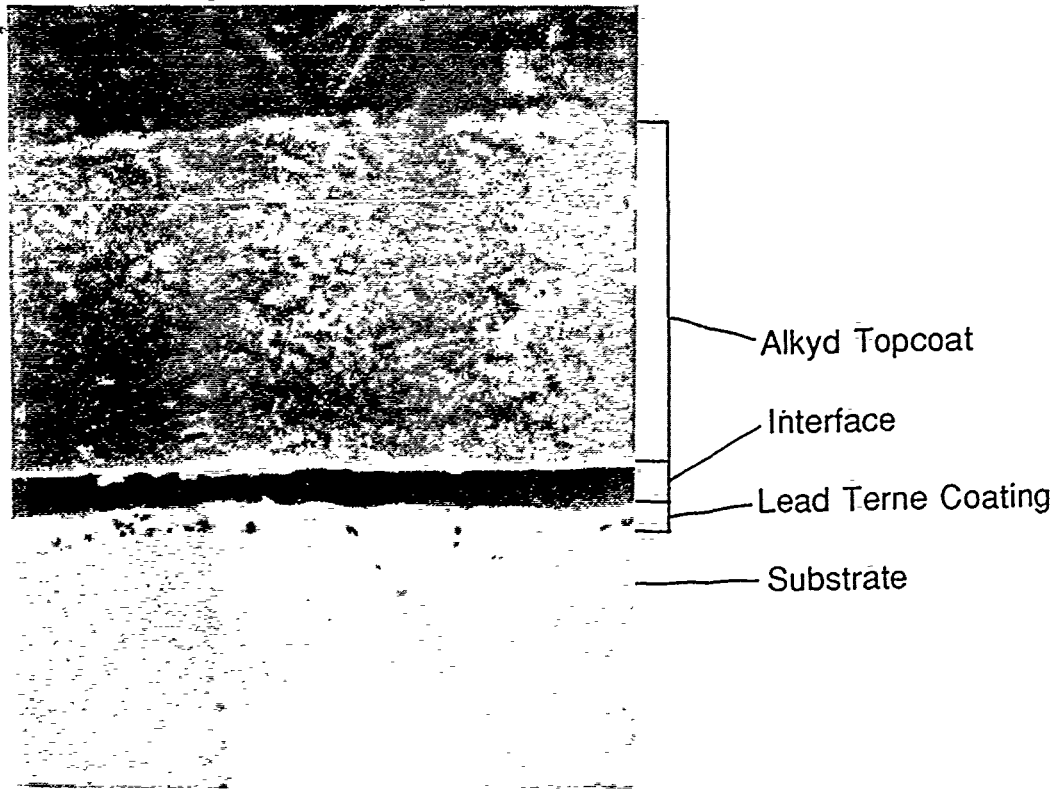
Figure 44 is an SEM micrograph of the exterior coatings located on the top weld of the 1-1/3-quart container. The black region separating the alkyd coating from the terne coating is an interface where there is no adhesion. The photograph identifies the terne coating and the alkyd topcoat. Figure 45 shows the interior terne coating observed on the top weld cross section. Both interior and exterior terne coatings were uniform and displayed good adhesion to the steel substrate. Figures 46 and 47 reveal the resulting spectrum obtained from the exterior and interior terne coating, respectively. The only major peaks detected consisted of lead and tin which are the primary elemental constituents of the coating. Figure 48 is the resulting spectrum of the alkyd coating present on the 1-1/3-quart container. Figure 49 represents the infrared spectrum of the same coating which indicates that the coating was an alkyd.

Figure 44. SEM micrograph of exterior coatings present on the 1-1/3 container. Mag. 750X
