Supplement to a Report to  
Congressional Requesters

August 1991

# U.S.S. IOWA EXPLOSION

## Sandia National Laboratories' Final Technical Report

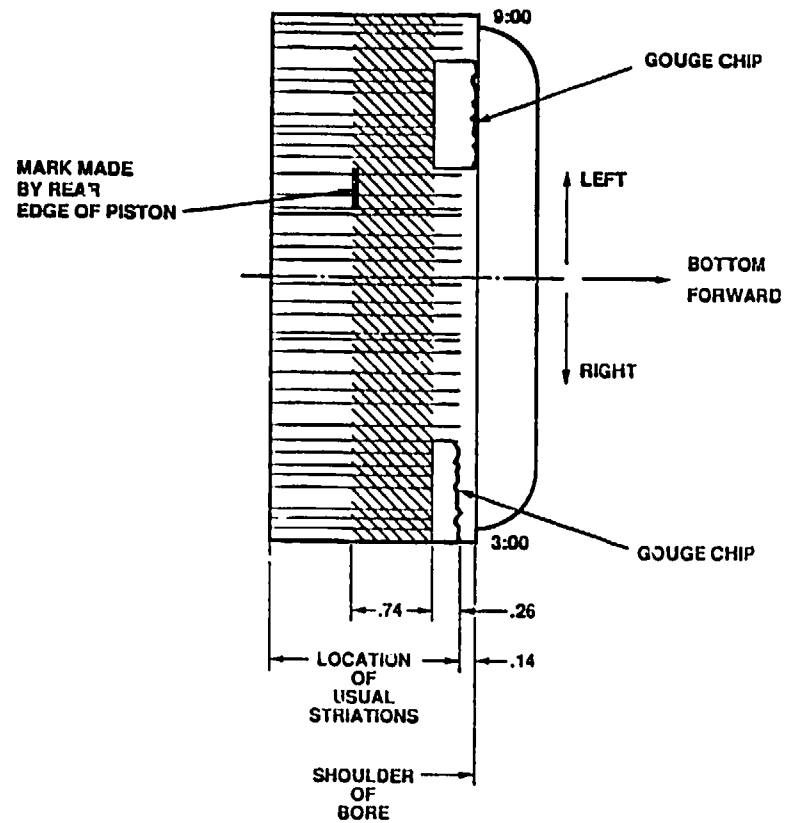
Examination of the front of the rammerhead shows that the right side of the buffer had received considerable damage caused by the impact with the bulkhead. On this side, the marks clearly show that the upper right side of the rammerhead impacted the small buffer located on the bulkhead. It is reasonable to associate the formation of the chip on the right with the impact of the rammerhead into the bulkhead, and the chip on the left with the initial blast force.

Figure 22. Developed surface of lower half of rammerhead bore.

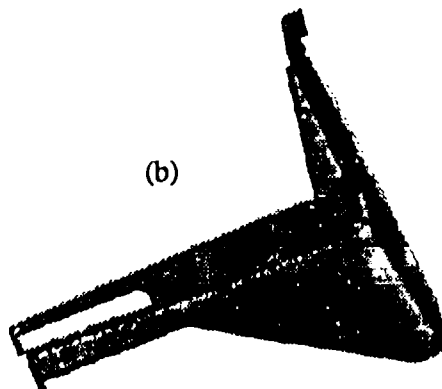
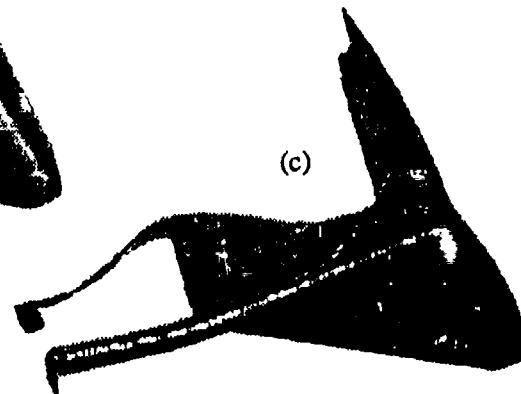
Figure 24. Photograph of:  
(a) deformed rammerman's seat  
(b) scale model of "as-designed" seat and  
(c) scale model of "as-built and bent" seat

The top aft edge of the "as-built" seat also differs from the "as-designed" in that about one-half of the inboard side of the mounting flange had to be removed to clear piping mounted on the bulkhead. Figure 25 shows the location on the rear gun bulkhead where the seat mounting flange was secured by two 1/2 in. bolts. Directly outboard of the seat is a sheet metal mounting clip that secures two pipes in the corner of the gun room. Since this clip is undamaged, it can be concluded that the seat motion could not be directly outward since this would have crushed the clip and pipes. The rammerman foot rest also constrains the motion of the seat in the forward direction. The aft face of this foot rest on the USS IOWA was located 25 in. forward of the rear bulkhead. This permits about 5 1/4 in. of forward motion before the forward leg (which according to Figure 24a is virtually unbent) of the seat strikes the foot rest.
