USACERL Technical Report E-91/08  
July 1991

# **Evaluation of Central Heating Plant at Rickenbacker Air National Guard Base**

by  
Martin J. Savoie  
John Gostich  
J.W. Chappell  
John Richards

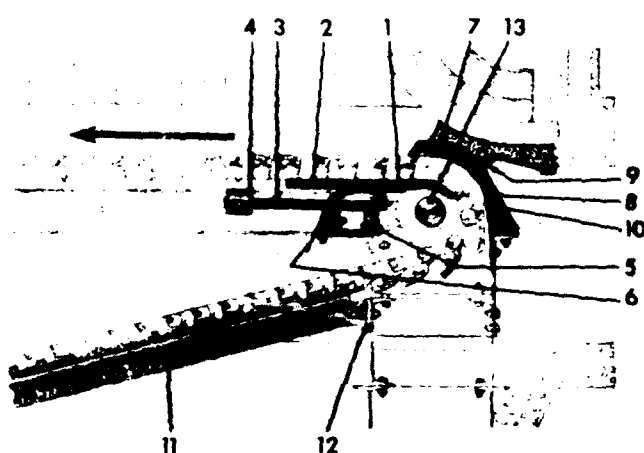
Figure 7. Detroit stoker rear grate seal and deflector tuyeres.

A typical repair item for all four boilers was the rear grate seals. On boiler No. 8, a Detroit Stoker, these are called the rear grate seal tuyeres (Figure 7). On boilers Nos. 4, 6, and 7, Riley Stokers, they are called rear grate refractory-filled air seals (Figure 8). These seals prevent air leakage at the rear of the grate surface and, in conjunction with the front and side seals, maintain minimum excess air in the furnace.

| Boiler No. 8 - Detroit Spreader Stoker | <ul style="list-style-type: none"> <li>** Replace eight rear grate seal tuyeres</li> <li>** Replace all feeder blades on Feeders Nos. 1 and 2 (left to right facing boiler front)</li> <li>** Replace all feeder plates and spilling plates</li> </ul> |

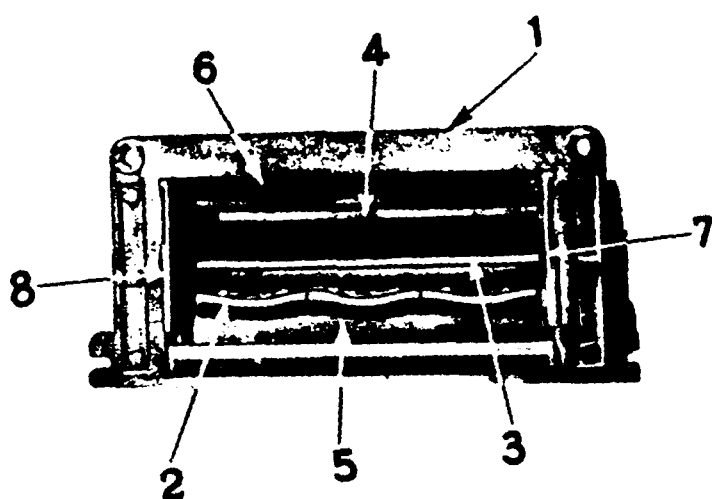
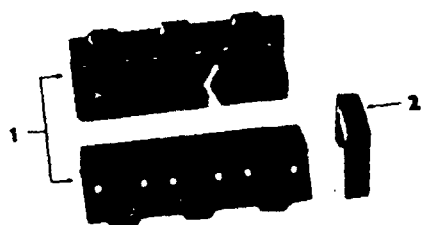
Figure 9. Detroit stoker feeder assembly.

The feeder plates and blades (Figure 9) need to be replaced on boiler No. 8. Boiler No. 4 needed the most repairs, requiring repair to the skid shoes, drive shaft and idler shaft bearings, drive shaft sprockets (Figure 10), feeder arms (Figure 11) and deflector tuyeres (Figure 7). Table 3 summarizes the recommended repairs for each of the stokers.
