**MONITORING COMPLETED COASTAL PROJECTS PROGRAM**

MISCELLANEOUS PAPER CERC-91-5

**SPUD POINT MARINA BREAKWATER, BODEGA BAY  
SONOMA COUNTY, CALIFORNIA**

Final Report

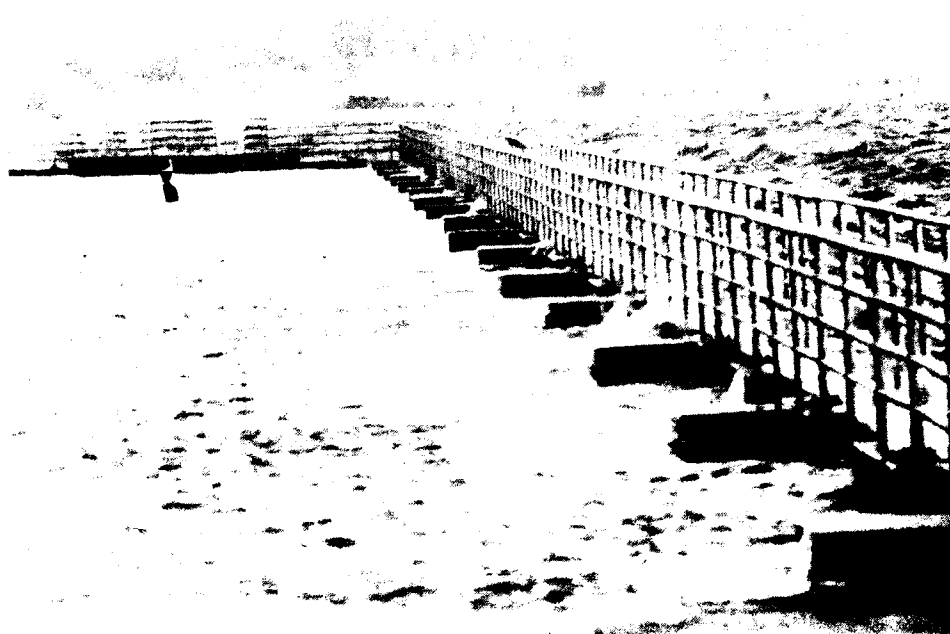
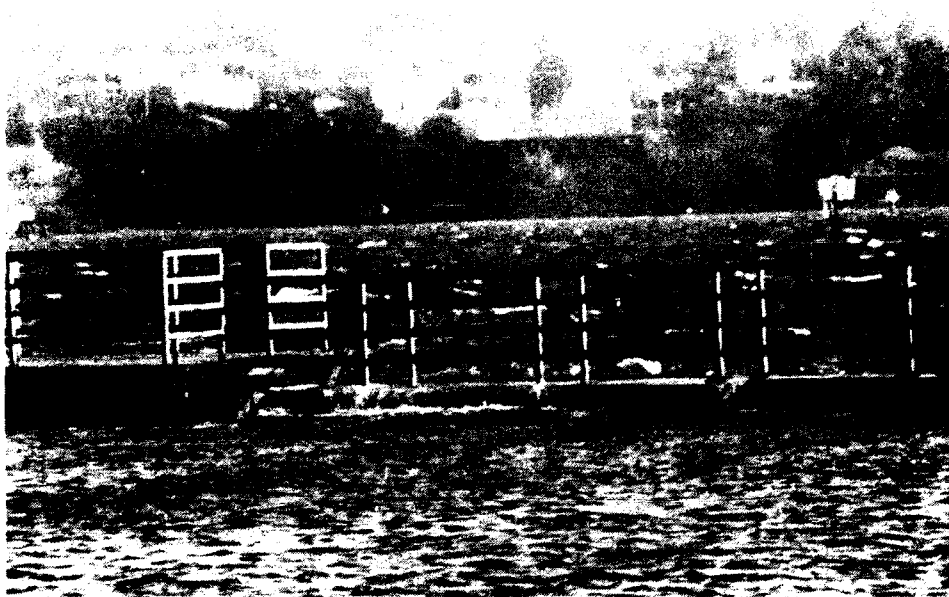
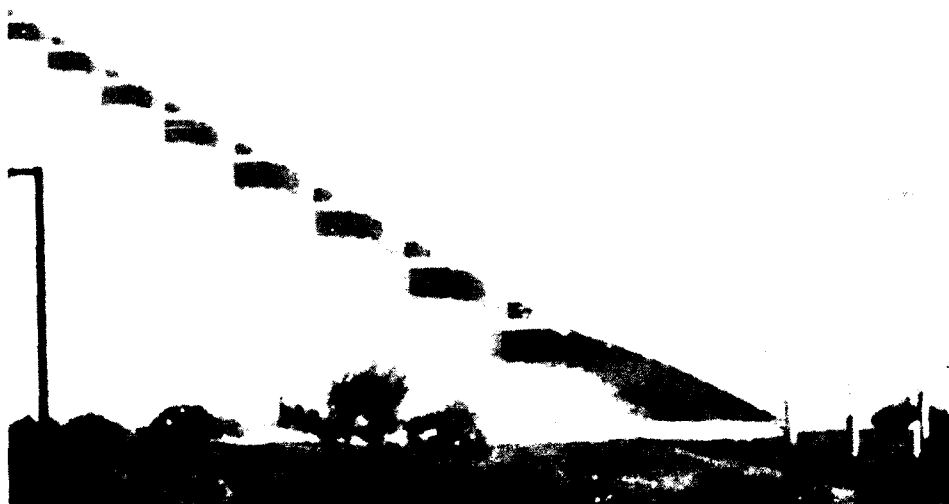
Figure 19. Breakwater in storm conditions at high tide (Sheet 1 of 3)

wake large enough to penetrate the breakwater and cause rolling of the docked boats. Figure 19 (a - f) is convincing evidence of the breakwater's wind wave attenuation performance under severe conditions. Even with overtopping, the water inside the marina remained calm.
