# Naval Research Laboratory

NRL Memorandum Report 6861

## High Pressure Turbine Blade Life Extension

August 28, 1991

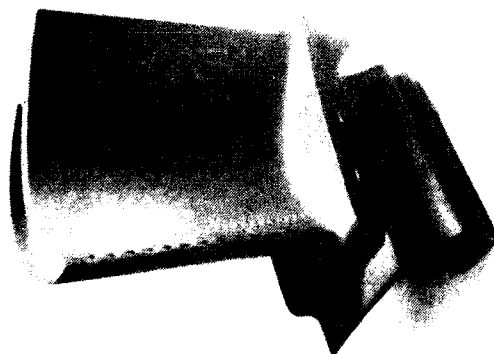
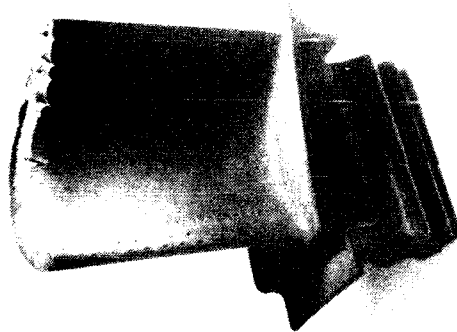
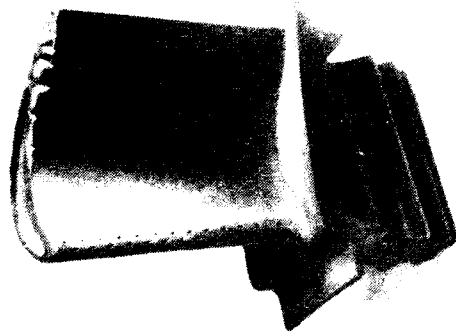
DS-R80H HPT blades, both new and those removed from F404 engines after 14,030 EFTC (low EFTC) and 27,449 EFTC (high EFTC), were received from the NADEP NORIS for evaluation in this study. All blades received a CODEP coating and the precipitation heat treatment as shown in Table 1. Additional blades in all three conditions were received from NADEP NORIS, via Chromalloy Division Oklahoma, following removal of the CODEP coating. Figure 1 illustrates the appearance of the HPT blades without the CODEP coating. The severe erosion of tip region of both the low and high EFTC blades is readily apparent in Figure 1.

The blade tip erosion visible in Figure 1 and the microstructural examination of the engine run blades suggested that a blade tip repair procedure could be considered to extend the blade life since the structure of all blades below the tip regions exhibited no apparent degradation from F404 engine operation. Chromalloy Division Oklahoma suggested the use of MERL 72, a cobalt-base alloy, as a possible tip repair material on the basis of previous blade tip repair experience. Subsequently, Chromalloy Division Oklahoma produced trial blade tip weld repairs using MERL 72 on both low and high EFTC blades for NRL evaluation.

Figure 1. HPT blades in the new and engine-run conditions.

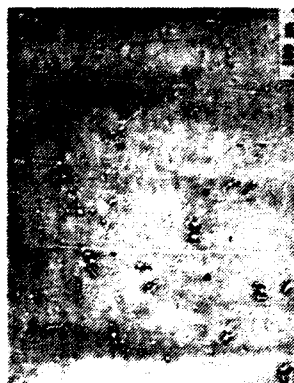
The microstructure of the engine run and new blades is illustrated in Figure 4. This figure compares the microstructure of the blades at two locations along the blade axis. In the mid region of the blades, approximately the mid-point of the length of the blade, the microstructure of all three blades is seen to be similar.

**Figure 4.** Optical micrographs of new and engine run (not HIP) DS-R80H blades at two locations along the blade axis.

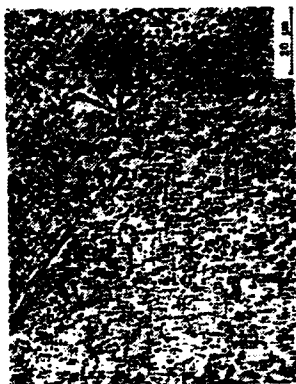
Figure 7. Optical micrographs of the tip region of HPT blades in new, low hours and high hours engine run conditions for the HIP processed and non-HIP processed conditions.

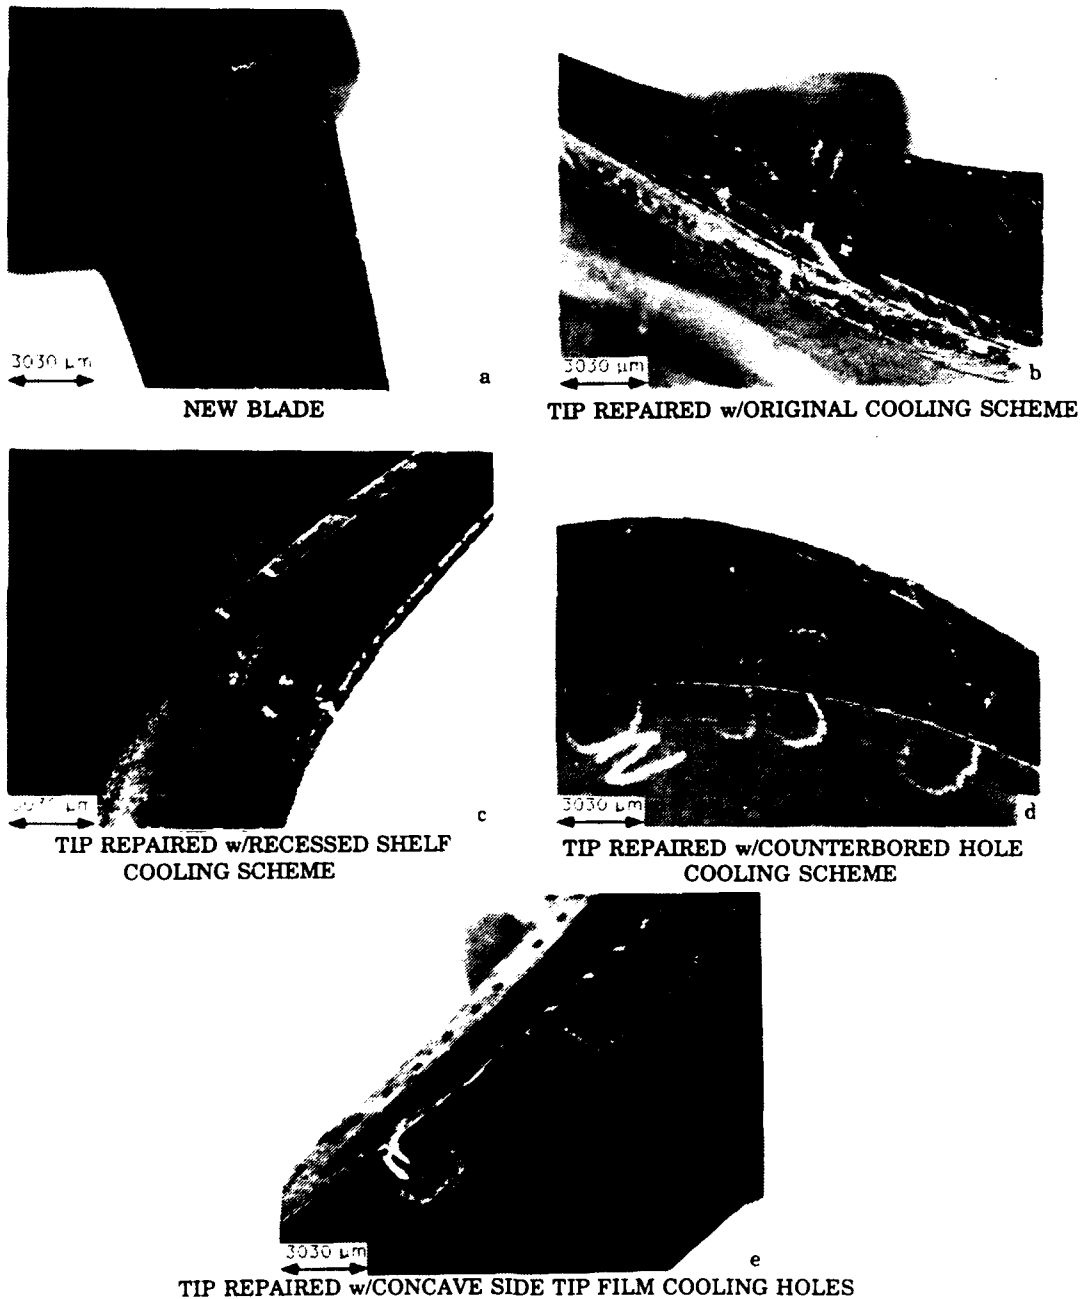
The blade tip regions of the HPT blades which were ASMET engine tested are illustrated in Figure 14. Note the physical condition, especially the trailing edge tip of each blade, which

shows the erosion and/or cracking produced by the ASMET engine test exposure. In particular, note the severe erosion of the blade which was new prior to the engine test and the general lack of erosion of the tip repaired blade with a similar cooling hole configuration.

Figure 14. Trailing edge tip regions of ASMET engine tested, MERL 72 tip repaired, DS-R80H HPT blades.

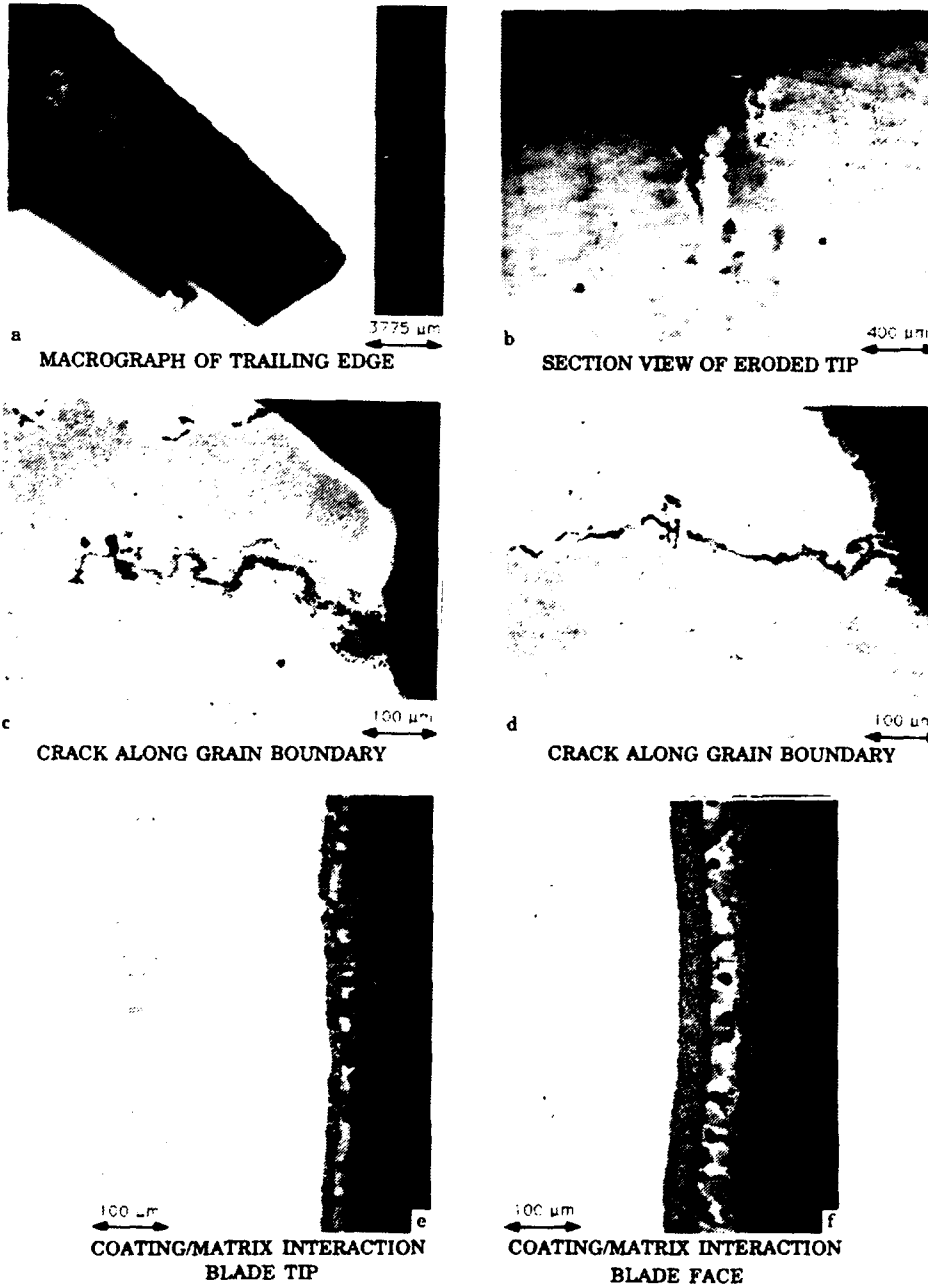
Figure 15 shows the microstructure of a new HPT blade after ASMET engine testing. The severe trailing edge tip erosion is shown in Figures 15(a) and (b). Figures 15(c) and (d) show the development of cracking along grain boundaries. The coating/matrix interaction is shown for both the blade tip and the blade face in Figures 15(e) and (f).

Figure 15. DS-R80H HPT blade, ASMET engine tested, new before test.

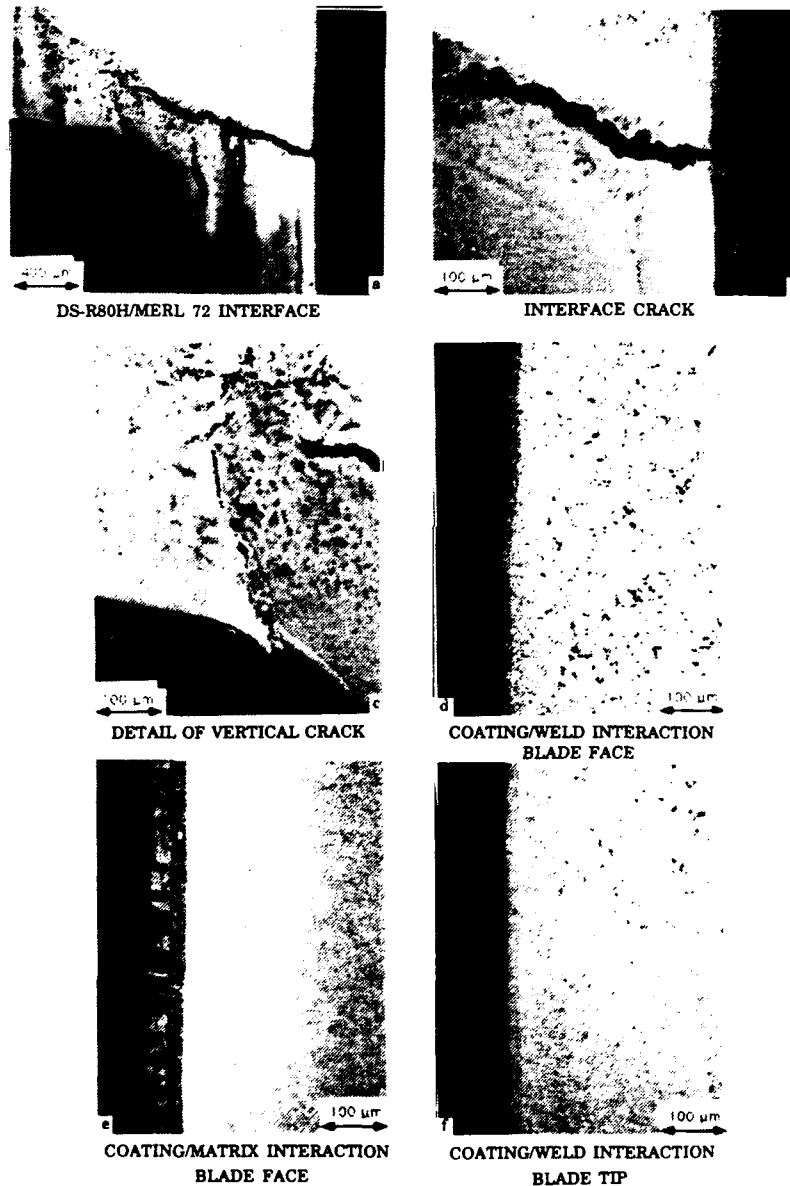
The microstructure of an engine run HPT blade (total EFTC unknown) which was MERL 72 weld tip repaired by Chromalloy Division Oklahoma, configured with the original cooling hole scheme and ASMET engine tested is shown in Figure 16. Figures 16(a) and (b) illustrate a crack which developed at the blade surface which followed the DS-R80H/MERL 72 interface. Figure 16(c) shows the crack tip region and the oxide formed along the entire crack path. Figures 16(d), (e) and (f) illustrate the microstructure of the coating/weld and coating/matrix interactions at various locations on the HPT blade.

Figure 16. DS-R80H HPT Blade, ASMET engine tested, MERL 72 tip repaired by Chromalloy to original tip cooling scheme before engine test.

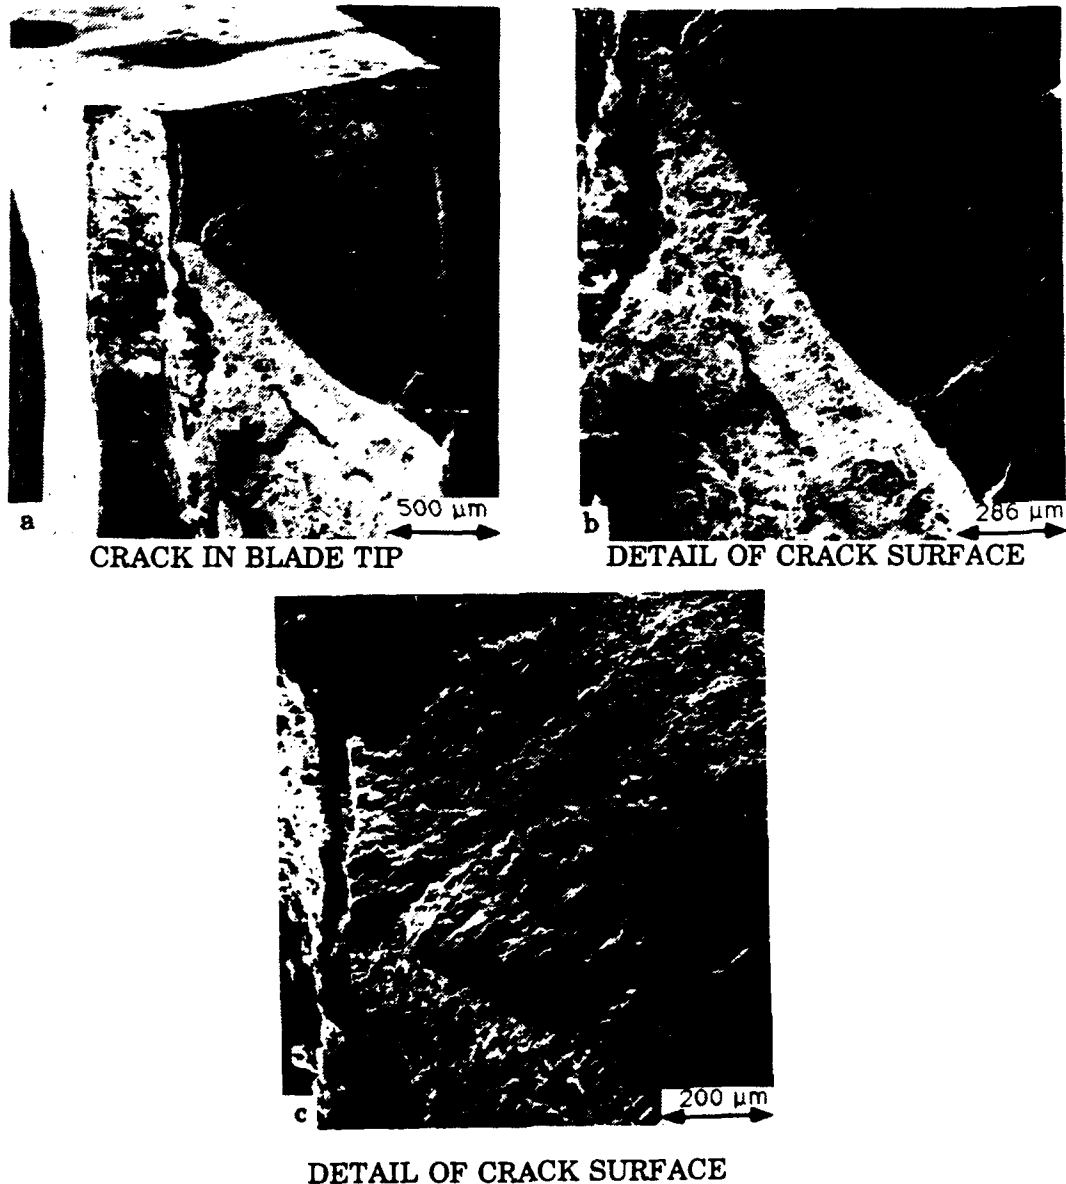
A portion of an ASMET engine tested blade which contained a crack in the repaired blade tip was fractured at liquid nitrogen temperatures to separate the crack and to reveal the details of the crack surfaces. The fractographs in Figure 17 relate to a tip repaired to the original tip cooling scheme. The darker, oxidized crack surfaces were generated by processes during the ASMET engine run and the lighter surfaces were formed when the crack was fractured open. Cracking appears to have initiated at the cooling hole, Figure 17(c), and outside blade surfaces. The crack eventually assumed a growth direction perpendicular to the crack front shown in Figures 17(a) and 17(b).

Figure 17. Fractographs of tip cracks formed during the ASMET engine test of a repaired blade with the original tip cooling scheme before test.

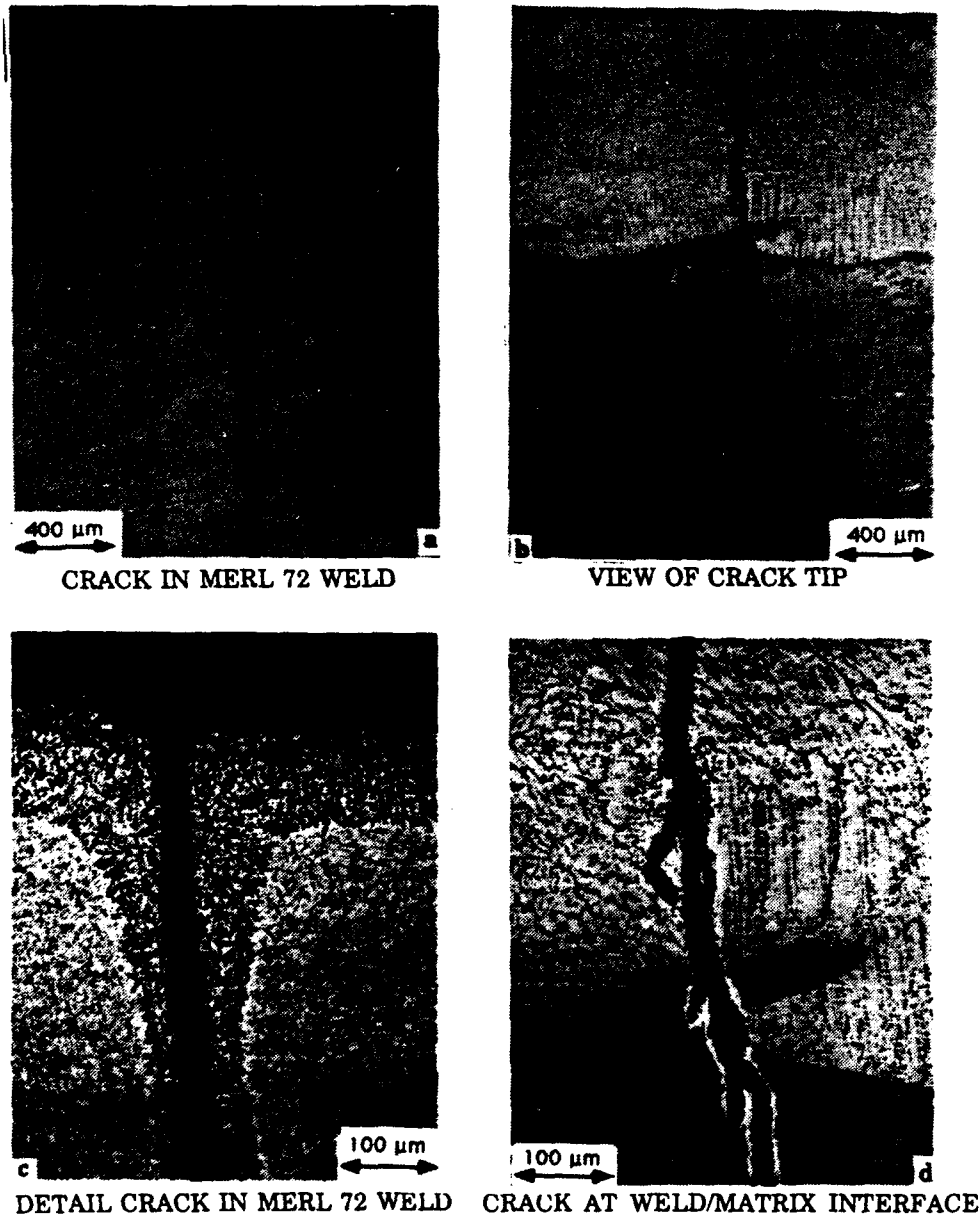
The microstructure of an engine run HPT blade (total EFTC unknown) which was MERL 72 weld tip repaired by Chromalloy Division Oklahoma, configured with a recessed shelf tip cooling scheme and ASMET engine tested is shown in Figure 18. Figure 18(a) illustrates a crack observed in the MERL 72 weld in the vicinity of a cooling hole. Figure 18(b) shows the crack tip region at the DS-R80H/MERL 72 interface. These regions are shown in greater detail in Figures 18(c) and (d). Note the reaction zone formed within the weld along the crack surface and at the top surface of the blade tip, Figure 18(c). Of the four tip configurations examined microstructurally, only the recessed shelf tip cooling hole configuration exhibited this behavior. No differences in microstructure, weld alloy chemistry or coating integrity could be determined which would explain the formation of the reaction zone observed for this blade.

**Figure 18. DS-R80H HPT blade, ASMET engine tested, MERL 72 tip repaired by Chromalloy with recessed shelf tip cooling scheme before engine test.**

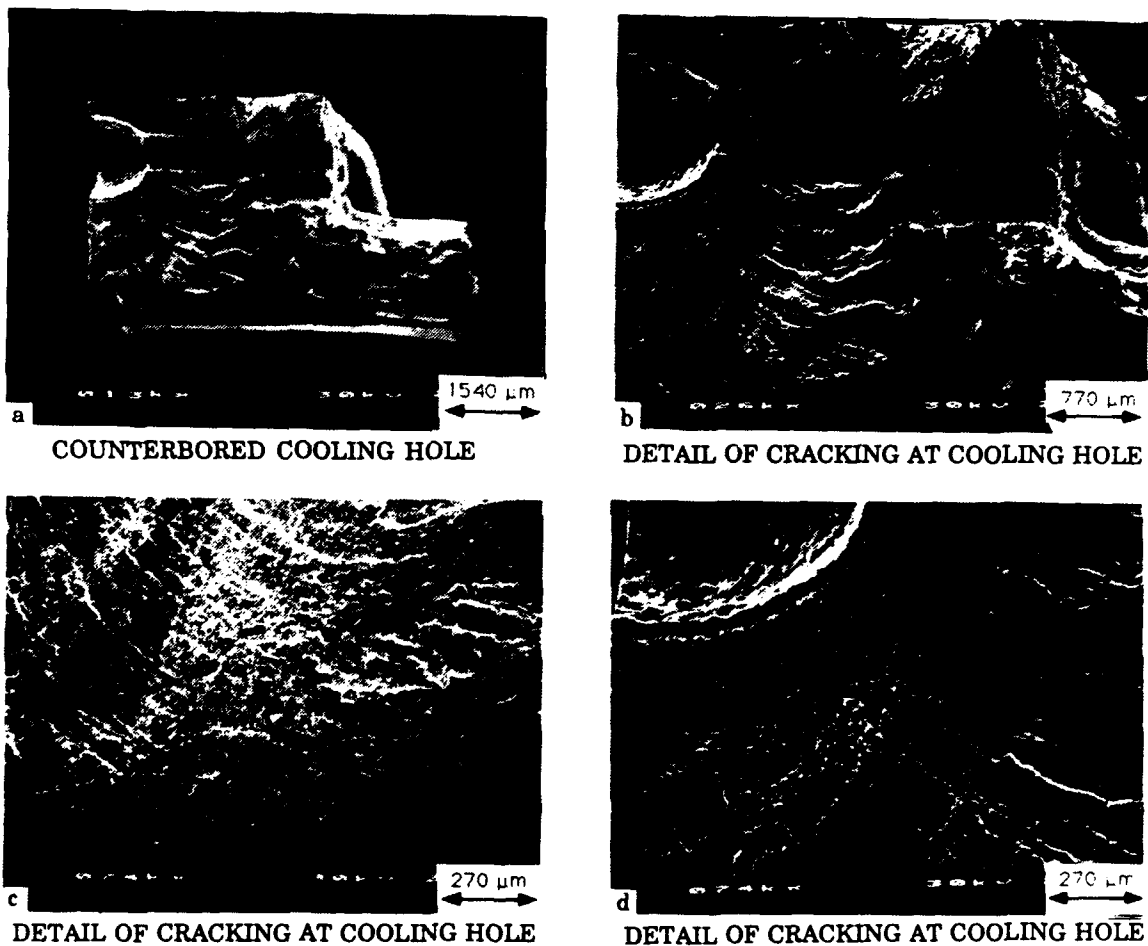
The microstructure of an engine run HPT blade (total EFTC unknown) which was MERL 72 tip repaired by Chromalloy Division Oklahoma, configured with counterbored tip cooling holes and ASMET engine tested is shown in Figure 19. Figure 19(a) illustrates the overall view of a counterbored cooling hole showing a crack which originated at the tip surface/hole interface. Figures 19(b), (c) and (d) illustrate the details of cracking in this region.

Figure 19. Fractographs of a crack in a DS-R80H HPT blade, ASMET engine tested, MERL 72 tip repaired by Chromalloy with counterbored tip cooling holes before engine test.

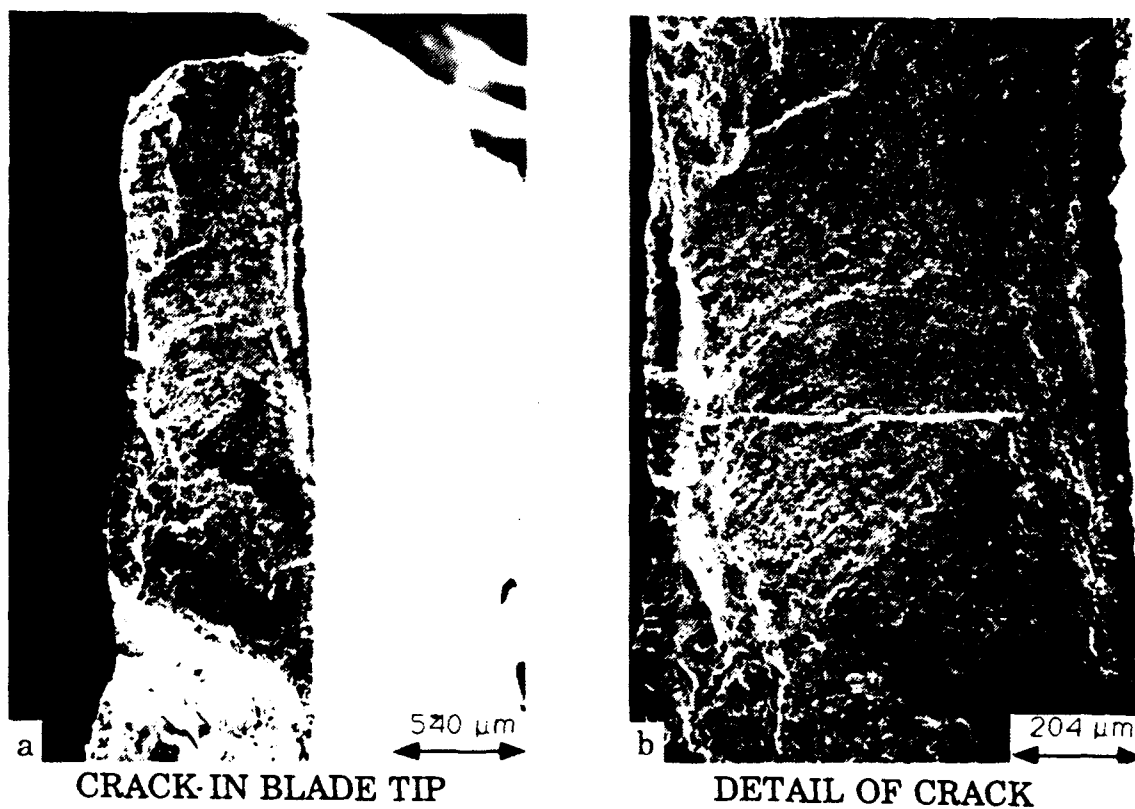
Figure 21. Fractographs of a crack in a DS-R80H HPT blade, ASMET engine tested, MERL 72 tip repaired by Chromalloy with concave side tip film cooling holes before engine test.

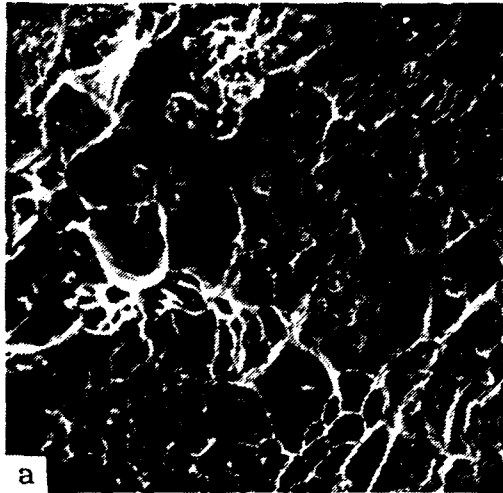
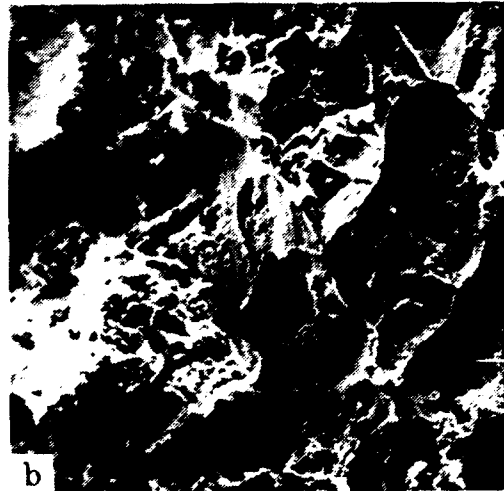
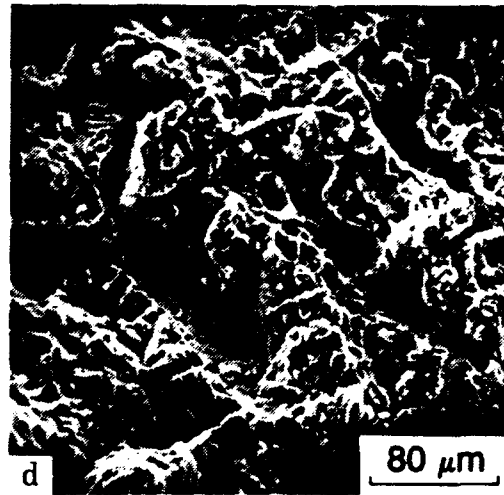
Scanning electron microscopy (SEM) was used to examine the rupture surfaces of the creep/rupture specimens tested in this investigation. SEM micrographs from a specimen tested at 871°C (1600°F), Figures 26(a) and (c), show that both the HIP processed and non-HIP processed specimens failed in a ductile manner by microvoid coalescence. However, for the specimens tested at 982°C (1800°F), the SEM micrographs indicate evidence of surface cracking which linked up to reduce the creep life of the HIP and, to a lesser extent, the not-HIP processed specimens, Figures 26(b) and (d).

Figure 26. Scanning electron micrographs of the DS-R80H creep-rupture specimens tested at 871 and 982°C.
