MTL TR 91-25

# FAILURE ANALYSIS OF THE APACHE MIXER PIVOT SUPPORT

U.S. ARMY MATERIALS TECHNOLOGY LABORATORY  
MATERIALS TESTING AND EVALUATION BRANCH

July 1991

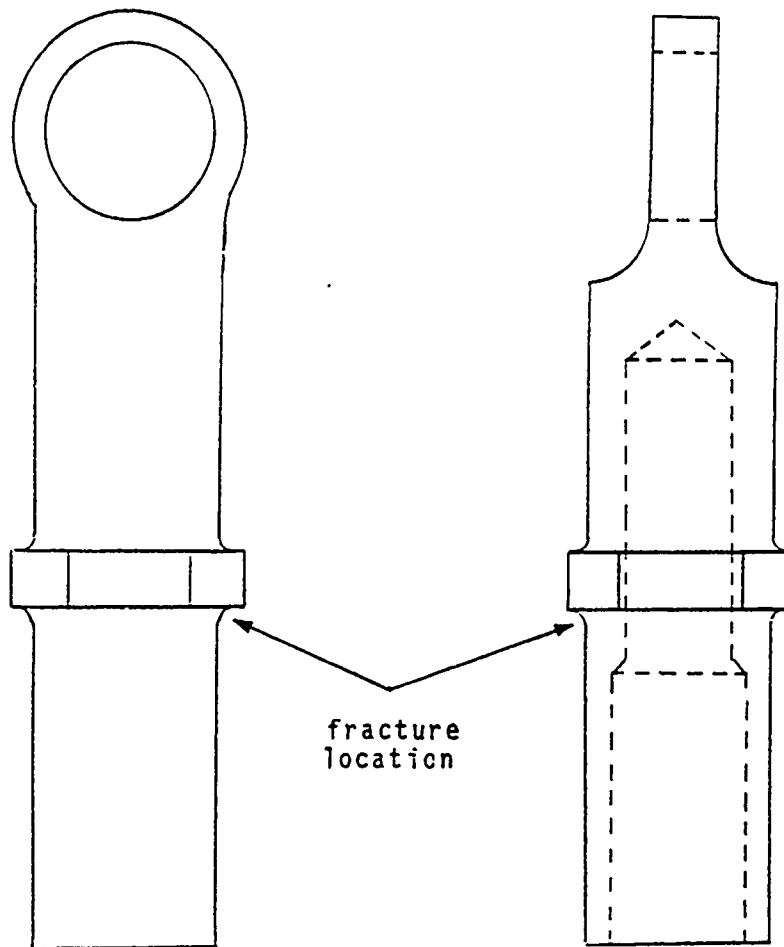
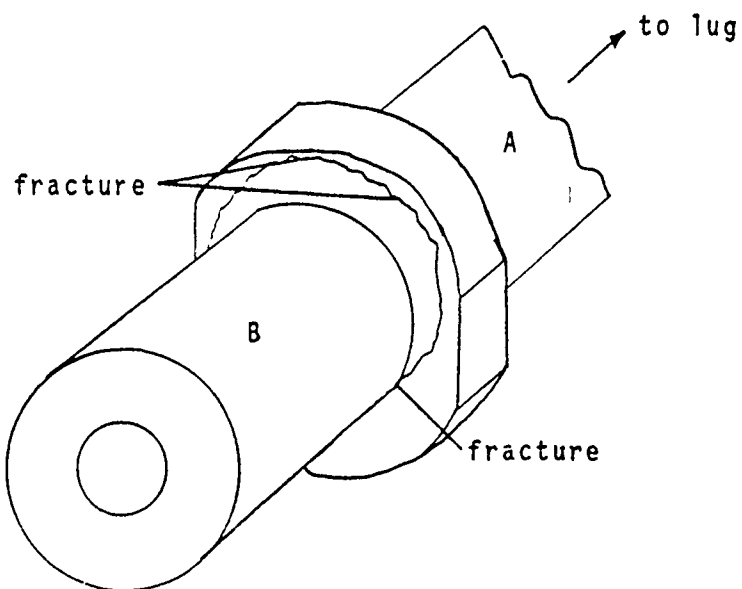
Figure 2 is a schematic of the mixer pivot support, showing the location of the failure. The failure site had been previously analyzed for stress concentrations by McDonnell-Douglas and was not identified as the most critical area. Other regions on the part were calculated as having higher stress concentrations ( $K_t$  values). Figure 3 shows the broken component in the as-received condition. Figure 4 was photographed after rotating the mixer pivot support 180°. The upper half (Part A) of the component which contained the bearing was in relatively good condition, as compared to the lower half (Part B). The surface coating of Part A was intact and the serial numbers and manufacturing identification data were easily distinguishable. There were no obvious signs of corrosion or mechanical damage to Part A. In contrast, however, Part B showed significant wear on surfaces that contacted the bushing. These regions are characterized by dark stains (designated by the arrows) in the macrograph. The cadmium coating appeared to have been almost entirely worn away during service and severe corrosion pitting had occurred in these areas.

Figure 2. Schematic of mixer pivot support showing location of fracture.

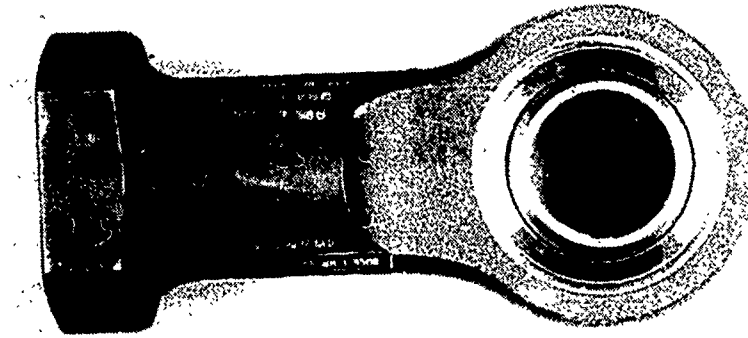
Figure 3. Shows the mixer support in the as-received condition.

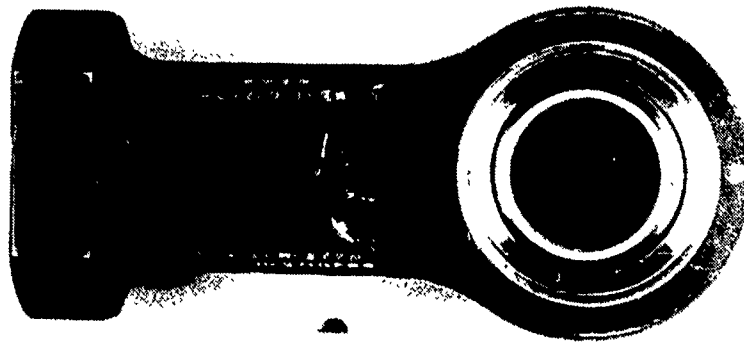
Figure 4. Shows the part in the as-received condition rotated 180° from Figure 3.

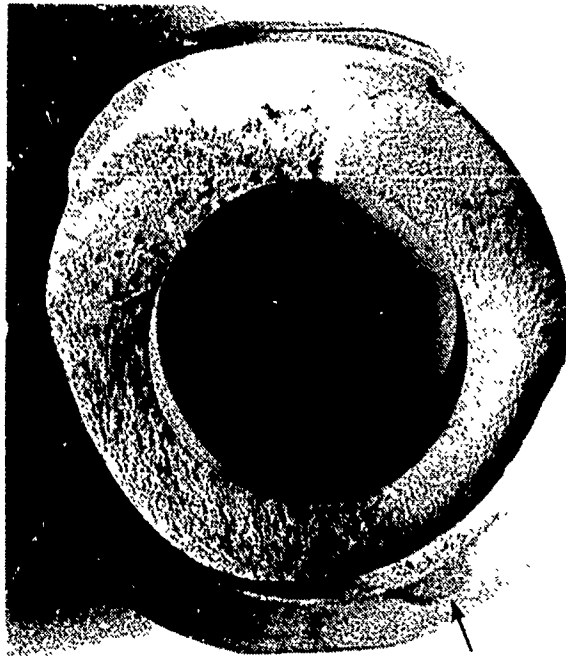
Figure 8A is a fractograph of Part A which was taken by exposing the fracture surface under a series of various light sources which were directed onto the macroscopic features at very acute angles. Normally, such a photograph consists of a single exposure but due to the

complexity and geometry of the fracture, four separate exposures were taken and subsequently blended together with light to obtain the contrast needed to reveal the important features of the fracture surface. Figure 8B is a schematic of fracture Face A which identifies the crack initiation site and traces the fracture path. The fracture plane intersected the radius at the crack origin. The radial lines and chevron patterns indicated that the fracture proceeded from the bottom right of the photograph (as designated by the arrow) up along both sides of the central hole. Where the two fractures meet at the top, a ridge is visible. This suggested that the fracture, indeed originated at the bottom radius, as illustrated.

Figure 8A. Optical fractograph of Face A  
(arrow identifies crack origin).

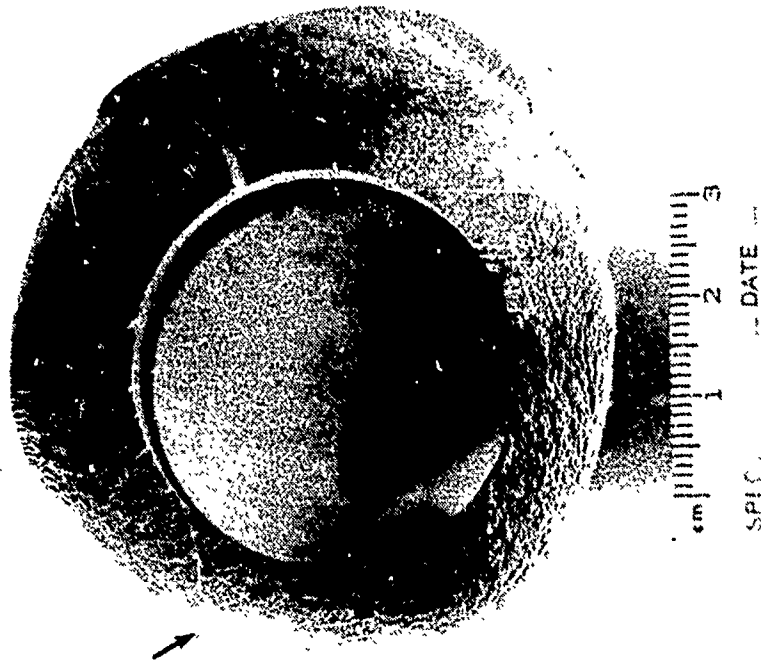
Figure 9A is a fractograph of Part B which also reveals the crack origin and direction of propagation. The fracture face was badly smeared in many areas, as indicated by the bright spots on the photograph. This may have been caused by improper handling of the fractured component prior to examination, possibly the result of forcing both halves of the fracture faces together. Damage may have also occurred when the component was removed from the aircraft or after it had failed. In all cases the surface smearing is attributable to a post-fracture incident. An important feature of the fracture, located at the very top of the photograph, is a shear lip region where final fracture had occurred. Both Faces A and B contained surfaces that were very flat-faced in appearance, displaying no signs of plasticity, which is often associated with a brittle fracture. The shear lip zone, however, showed evidence of ductility. The existence of a shear lip zone served to further substantiate the location identified as the crack origin, since final fracture would tend to occur in an area opposite the initiation site on this component.

Figure 9A. Optical fractograph of Face B  
(arrow identifies crack origin).

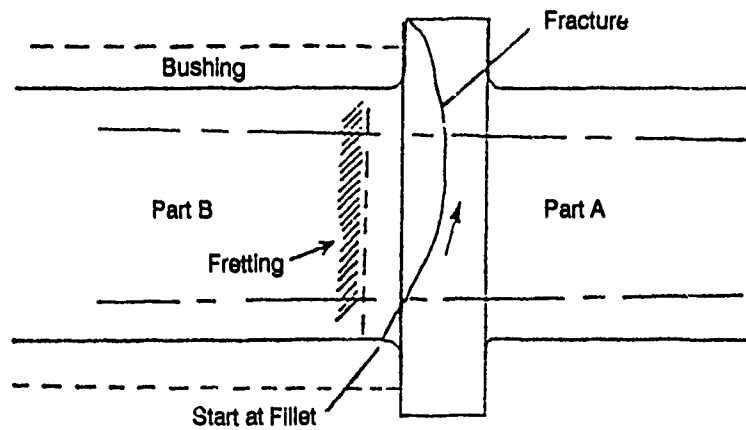
Figure 12 is a schematic which defines the area of fretting and its location relative to the fracture plane. It is important to note that the region of severe fretting was located just below the fracture plane and crack origin. Figure 13 is a macrograph of the crack initiation site located on fracture Face A. Again extensive corrosion pitting had occurred in this region. Figure 14 shows the corrosive attack at higher magnification. The entire area had experienced severe attack.

Figure 12. Schematic showing location of fracture and fretting.

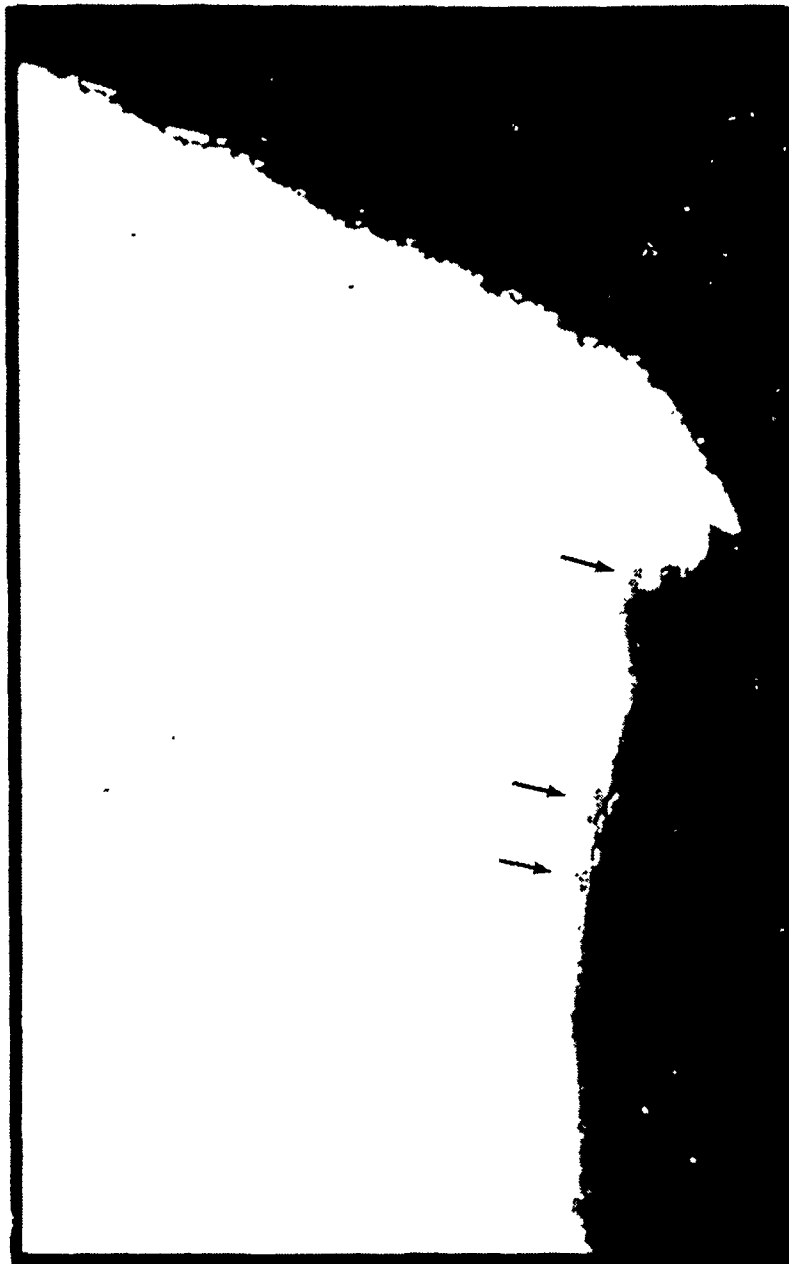
Figures 16 and 17 are representative micrographs of the fine martensitic structure observed on all of the specimens examined. The microstructure was consistent with the heat treatment performed on the component. There was no evidence of unusual material defects or large inclusions. Figure 18 shows the cross section of the crack origin in the as-polished condition. The arrows in the photograph point out corrosion on the radius. Figure 19 reveals the same area in the etched condition. The only notable feature was banding which extends vertically in the micrograph and appears as alternating light and dark bands. Since the component was machined from bar stock, the banding was the result of rolling during primary processing. The banding runs lengthwise to the mixer pivot support. Figure 20 represents the corrosion pits viewed in the top section of Figures 18 and 19. Note the cracks which originated from the bottom of these pits. The cracks extend parallel to the fracture plane. Figure 21 shows the same view as in Figure 20 but in the etched condition. The microstructure appeared uniform across the fracture plane and along the radius, with no signs of decarburization. The fold of metal located at the top of the micrograph surrounded by a dotted line on one side, represents an area that had been mechanically damaged after the fracture occurred and is of no significance to the cause of failure. Figure 22 shows the series of cracks identified by the arrow in Figure 21, at higher magnification. The cracks appear to extend in an intergranular fashion.

Figure 18. Cross section of crack origin taken through fracture Face B, in the as-polished condition. Mag. 50X.

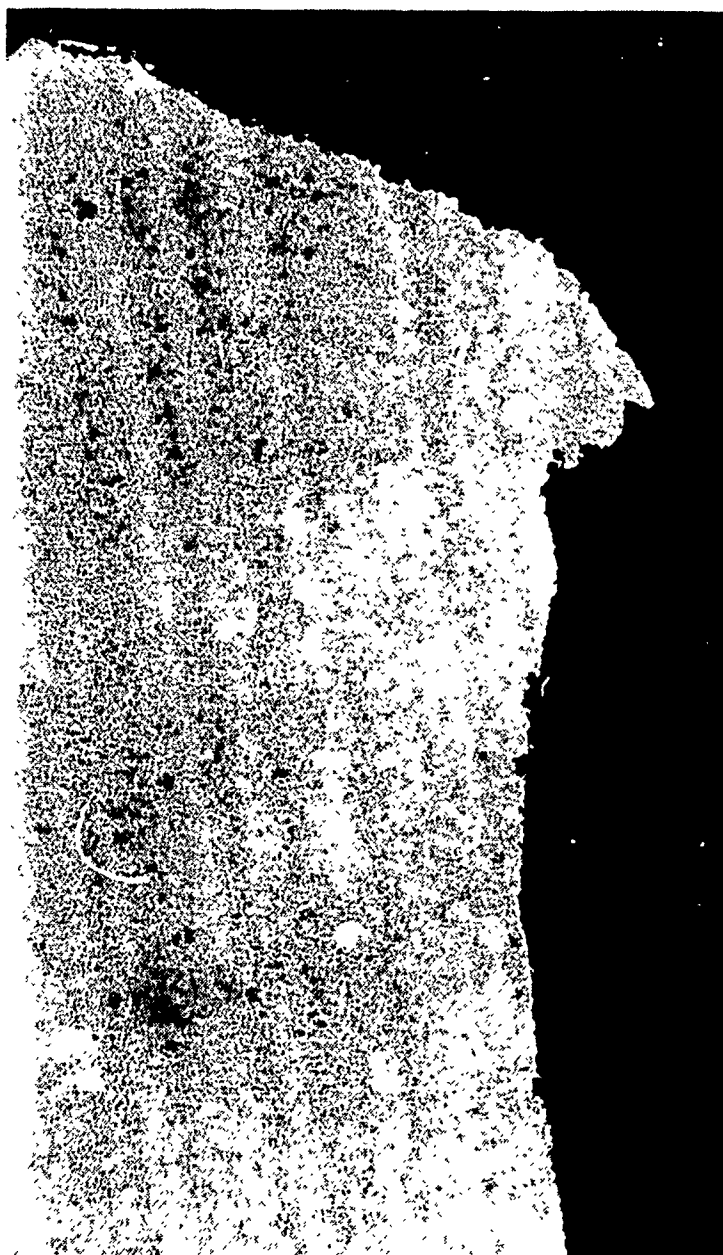
Figure 19. Cross section of crack origin taken through fracture Face B, in the etched condition. Mag. 50X.

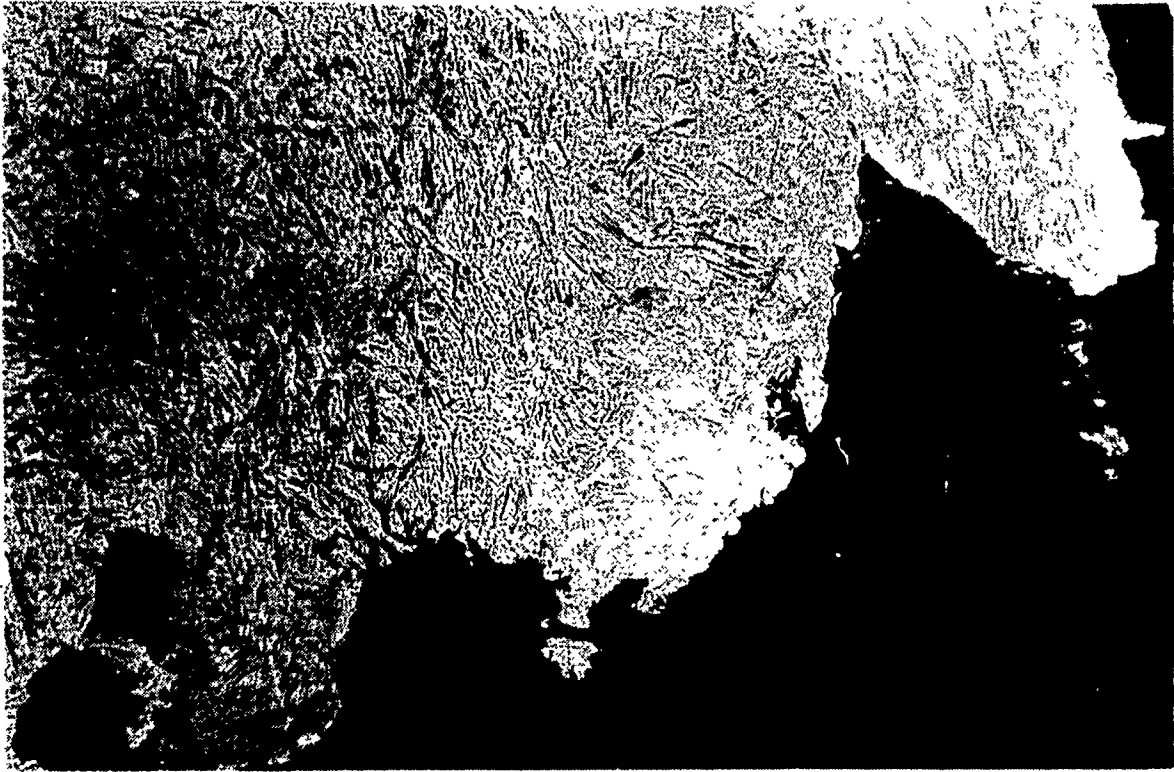
Figure 21. Same area as shown in Figure 20 after etching. Mag. 1500X.

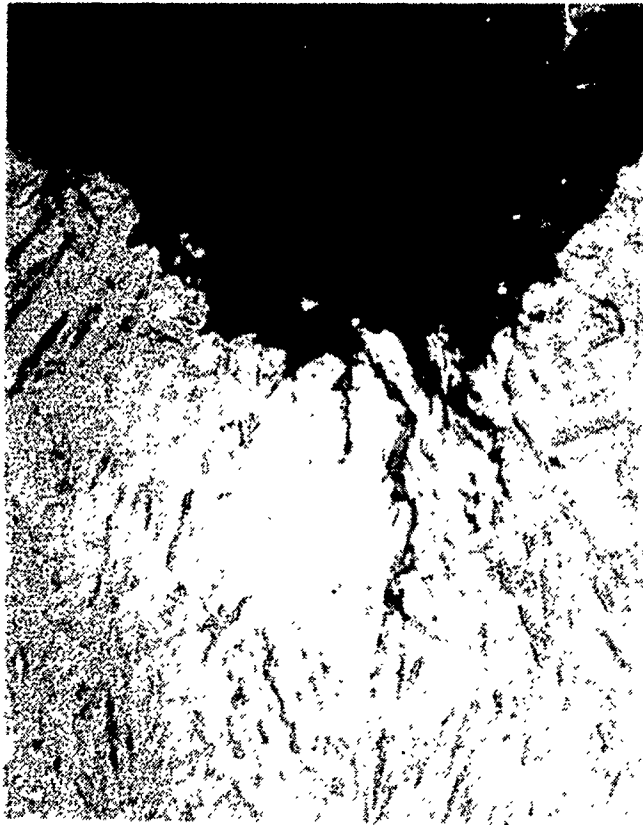
Figure 22. Enlarged view of a crack at the bottom of a pit. Mag. 1500X.

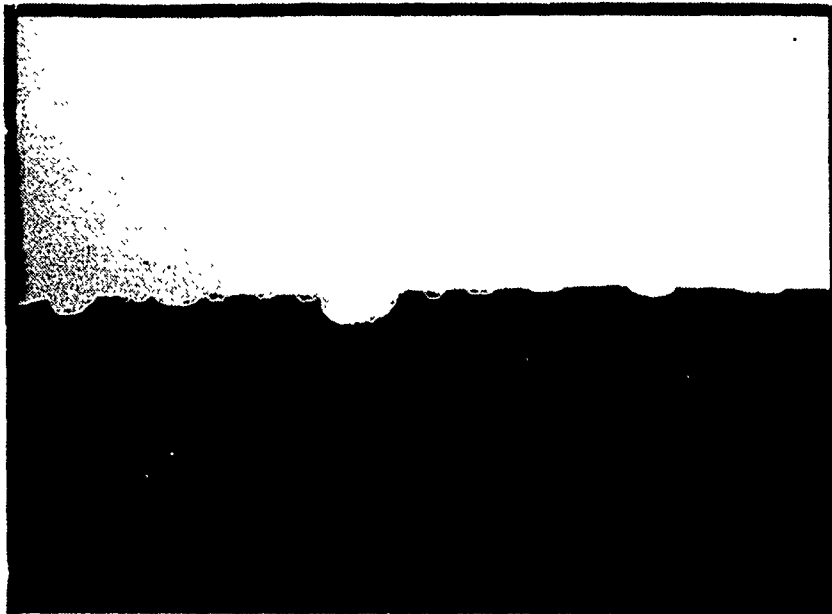
Figure 23 shows the pitted metallographic specimen in the as-polished condition. The large pit located in the center of the photograph has been magnified in Figure 24. The pit depth was approximately 18 mils. Figure 25 shows the same pit after the specimen was etched in a 1% Nital solution. Note the banding which extends horizontally across the photograph.

Figure 23. Shows pitted cross section, refer to Figure 15A for location. Mag. 10X.

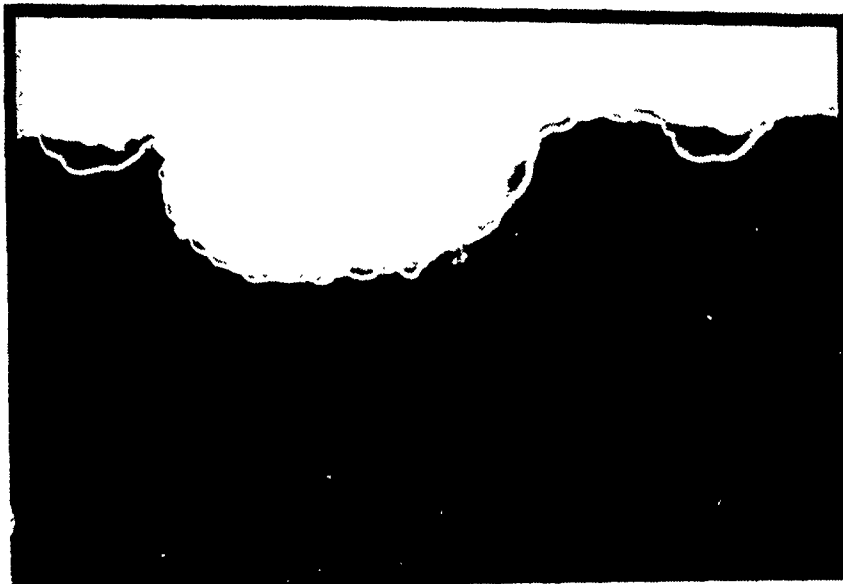
Deposits of sand, corrosion, and salts were found within the pits examined. The depths of some of the pits were as much as 18 mils. Metallographic examination of a cross section taken through the crack origin revealed cracks in the bottom of some pits. These cracks ran parallel to the fracture plane.

Figure 24. Shows large pit as seen in center of Figure 23. (Pit depth ~ 18 mils). Mag. 50X.

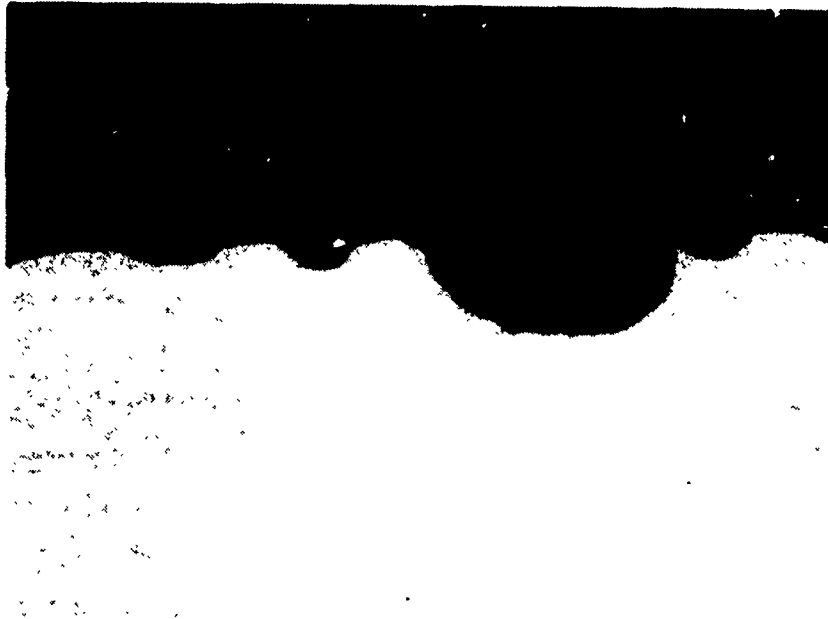
Figure 25. Shows pitted cross section after etching.  
Note evidence of banding. Mag. 25X.

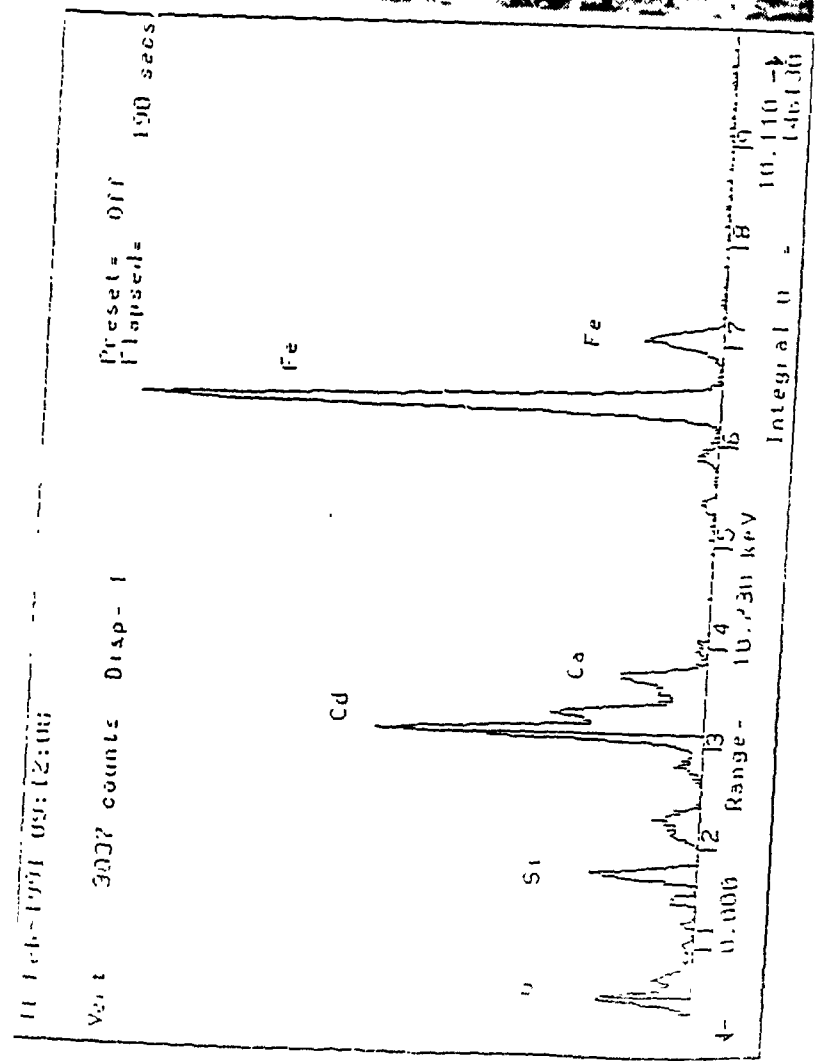
Figure 35. EDS spectra revealing chemical constituents within a pit.

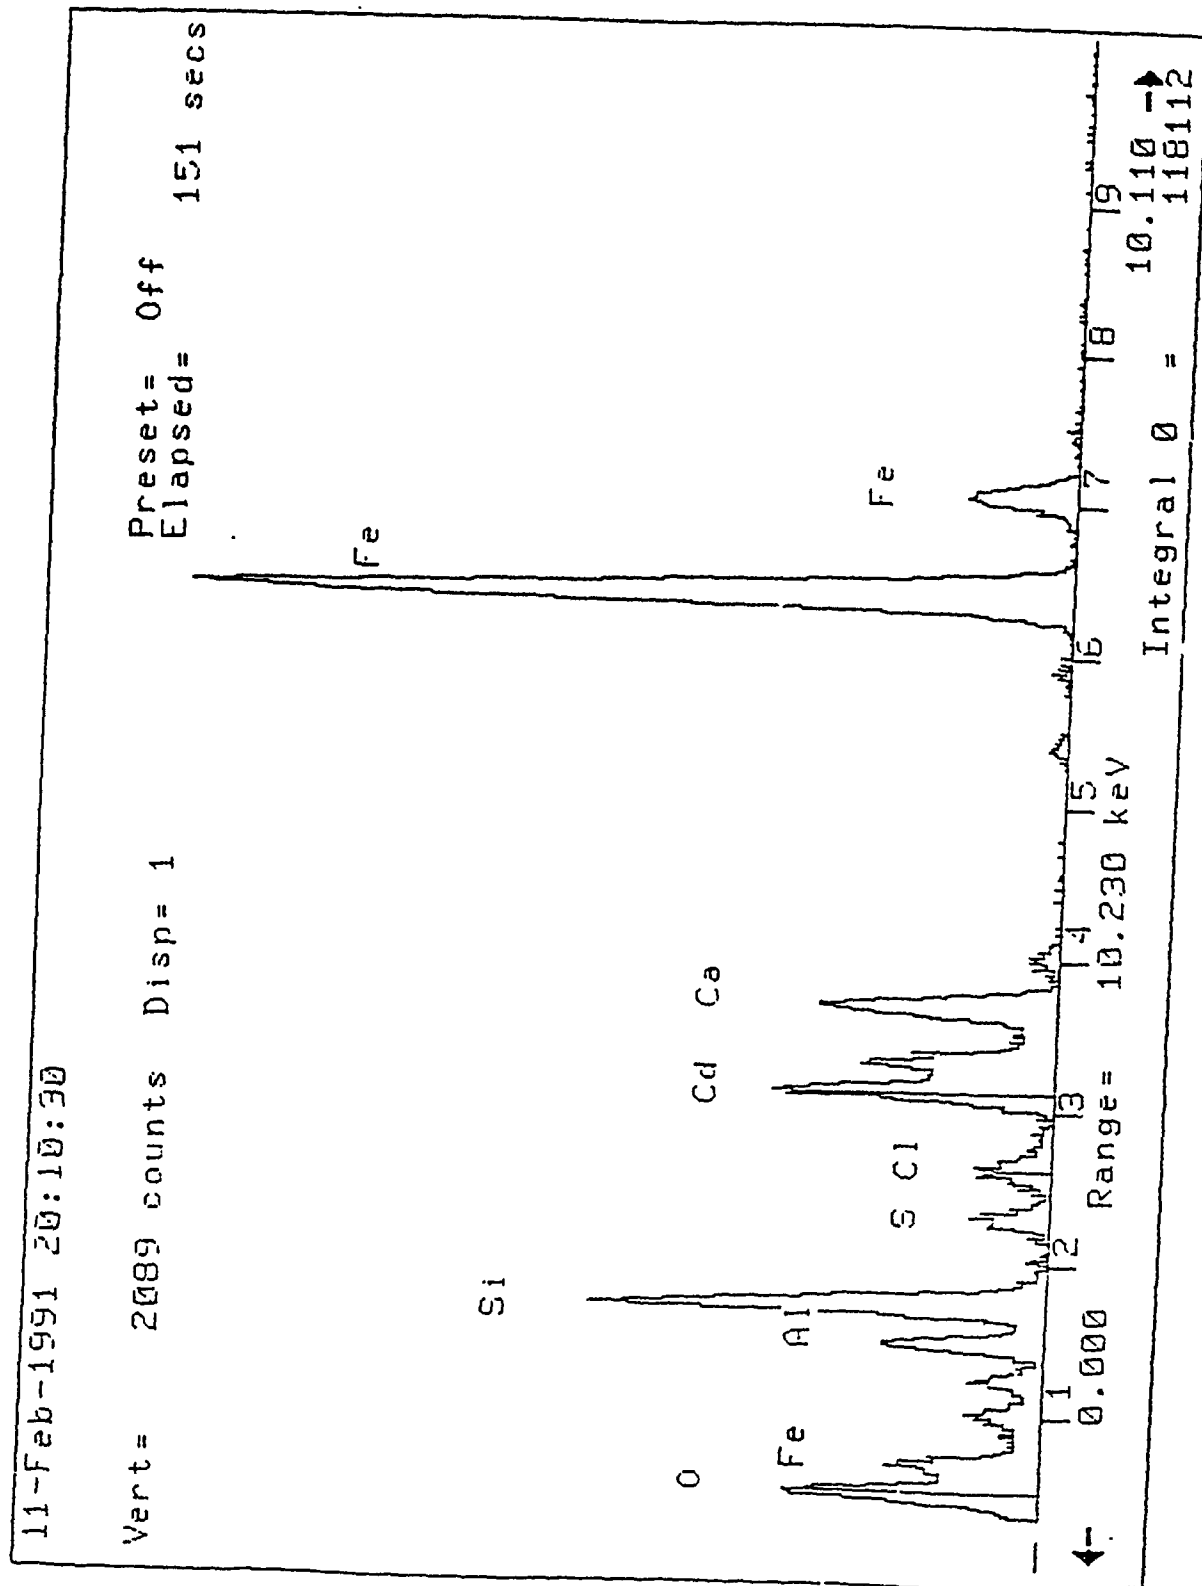
Figure 36 contains an SEM fractograph showing a sand particle (as denoted by the arrow) and the corresponding EDS analysis which consisted of silicon and oxygen with a trace of iron (from the base material). Figures 37 and 38 contain the EDS spectra obtained from the inside regions of other pits adjacent to the fracture. The most significant finding was the existence of chlorine which might be associated with salt water intrusion.

Figure 37. EDS spectra from within a pit adjacent to fracture.

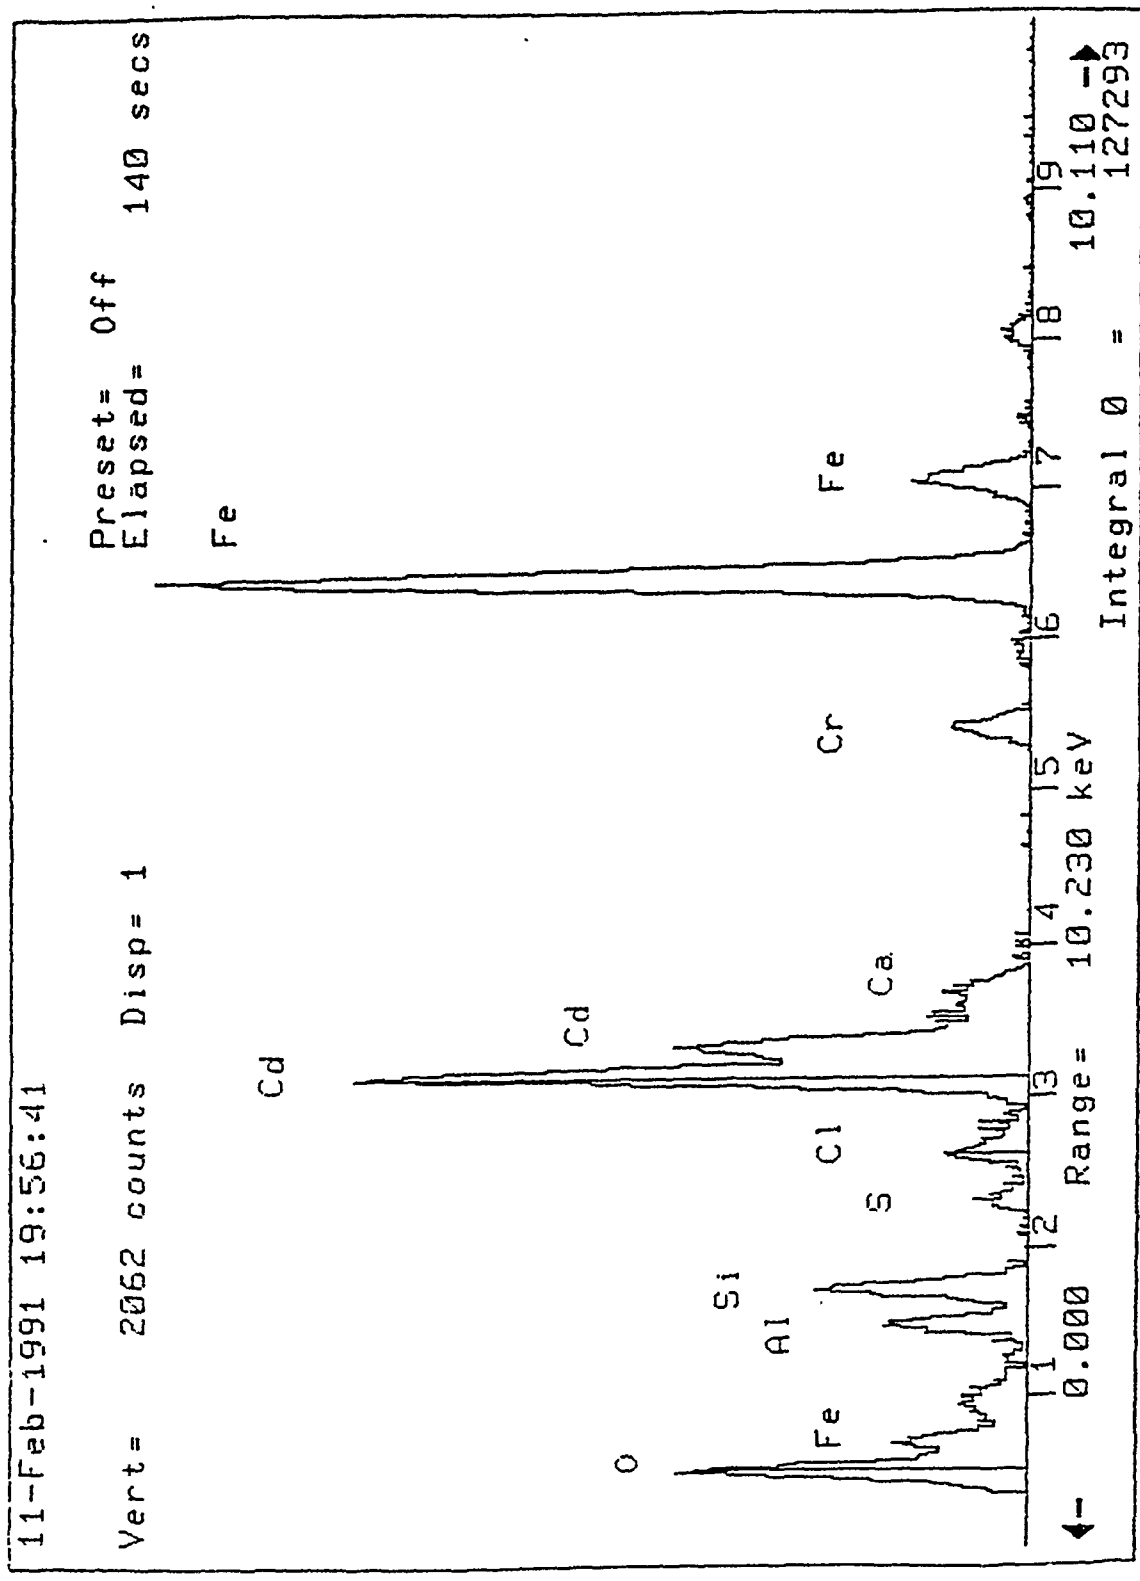
Figure 38. EDS spectra from within a pit adjacent to fracture.
