CR 91.012

**Contract Report**

September 1991

**SOIL BIOENGINEERING  
MAJOR GULLY WASHOUT REPAIR,  
SILVERHILL AIRFIELD,  
BALDWIN COUNTY, ALABAMA**

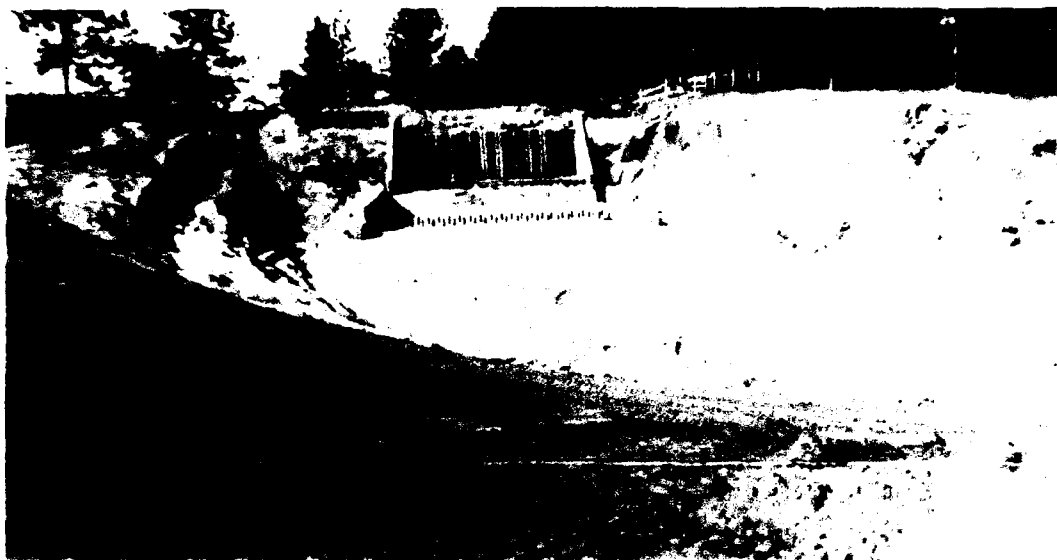
Photo 2. The existing drop structure area during the early stages of construction

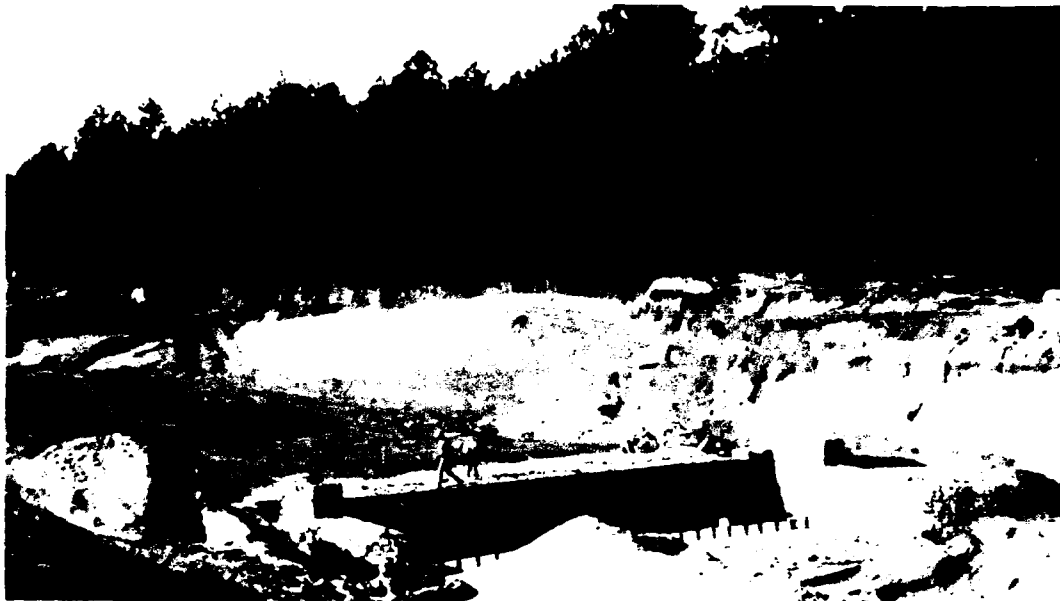
Photo 9. The left bank, "upstream" and alongside the second installed drop structure, during construction.

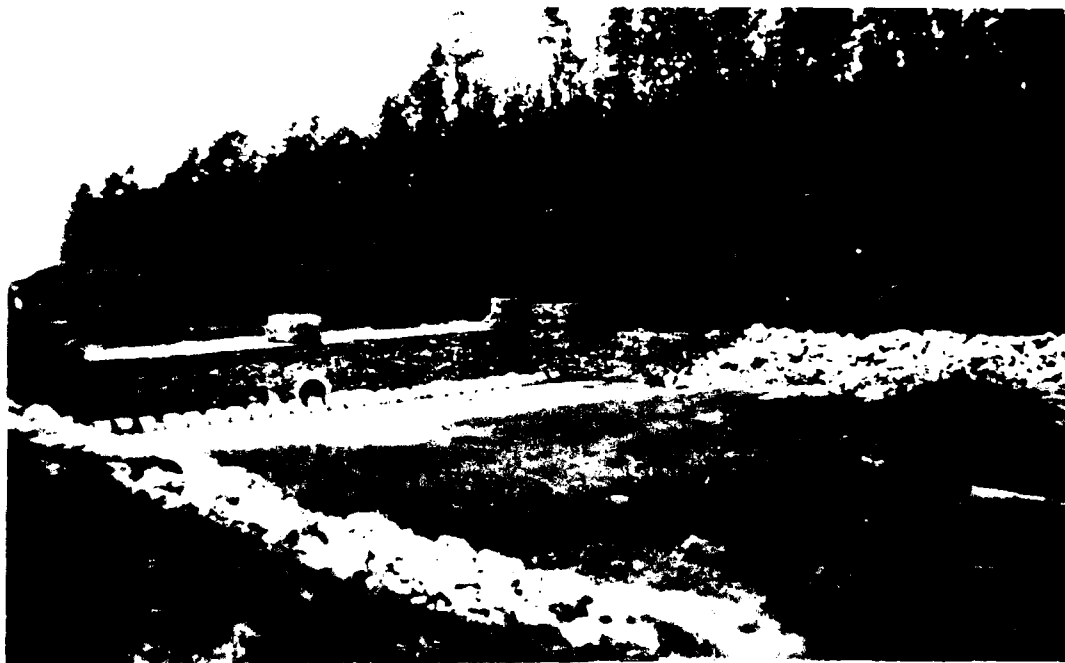
Photo 10. The left bank, "upstream" and alongside the second installed drop structure, three (3) months after installation of the brushlayers.

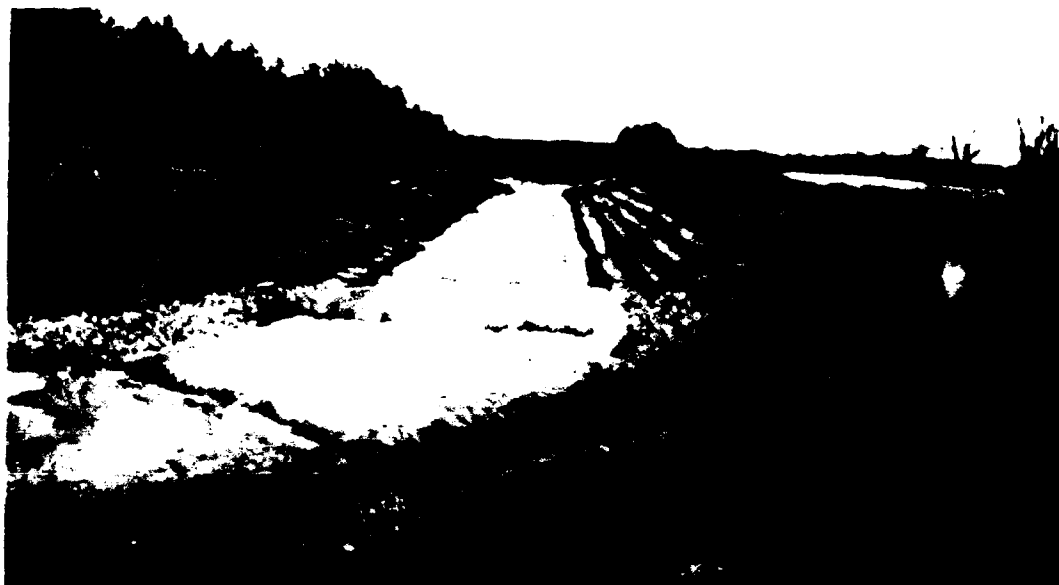
Photo 13. View "downstream" after the soil bioengineering brushlayer and live siltation systems had been installed.
