**McGLELLAN AIR FORCE BASE**

# OPERABLE UNIT B PRELIMINARY ASSESSMENT SUMMARY REPORT

## VOLUME III: APPENDICES C, D & E

INSTALLATION RESTORATION PROGRAM (IRP)  
STAGE 3

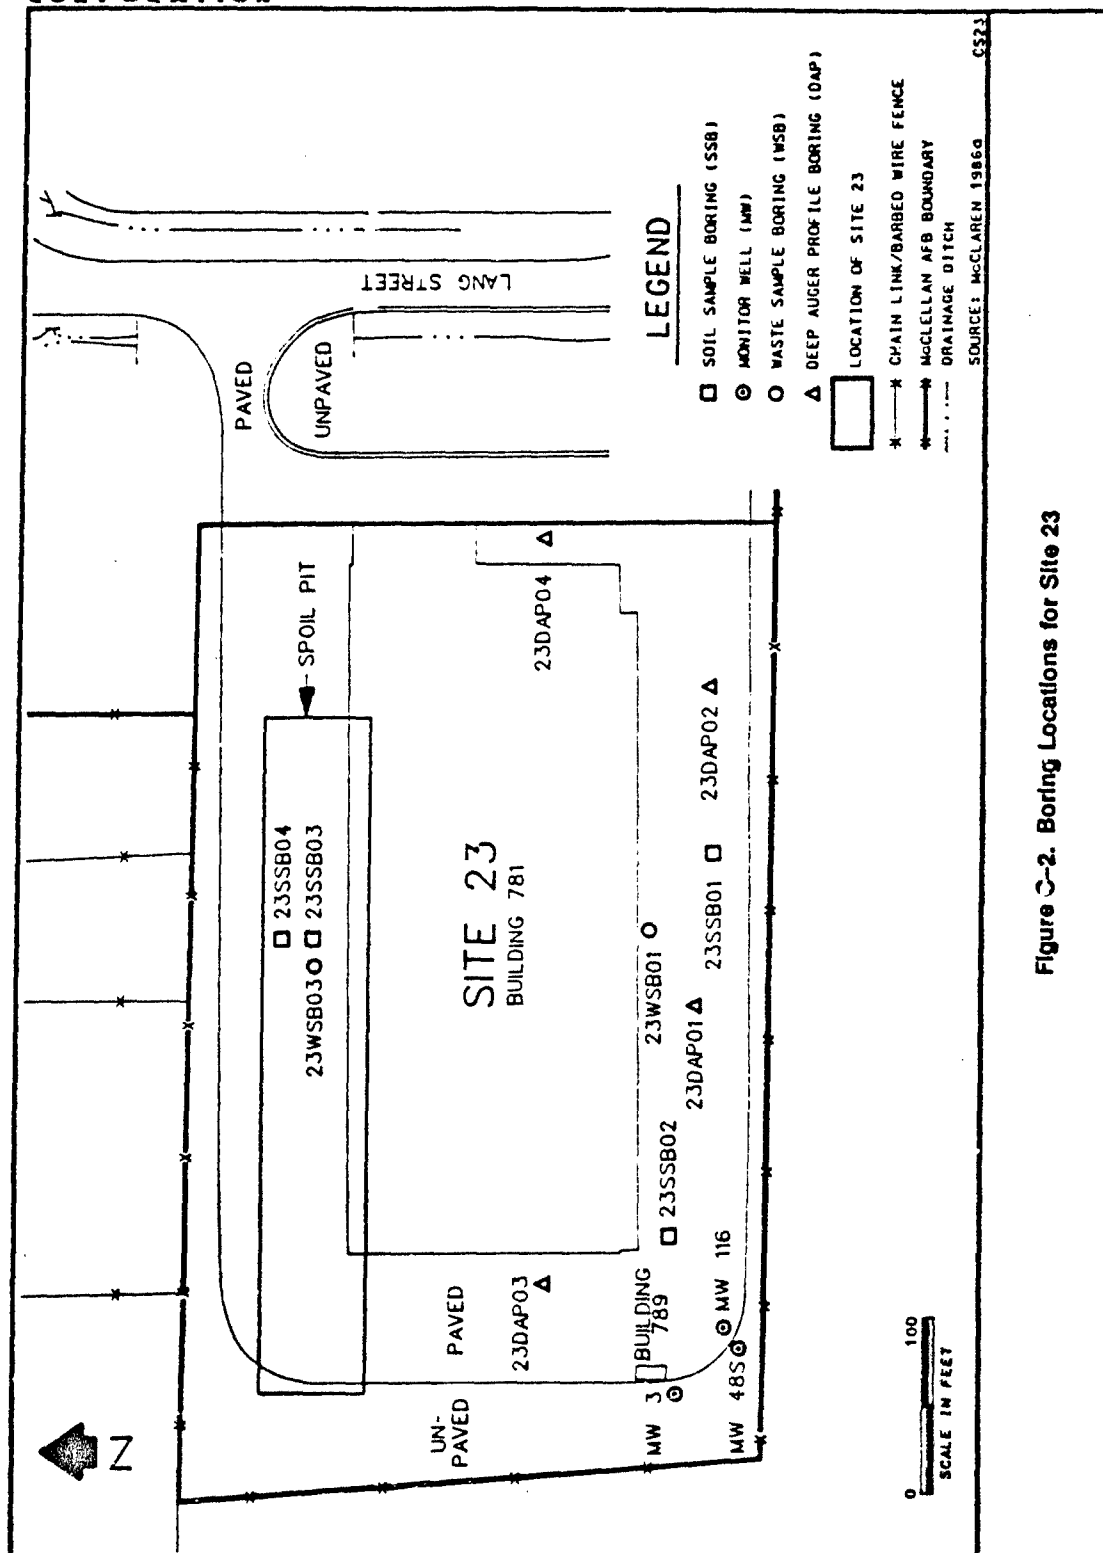
**Figure C-2. Boring Locations for Site 23**

Odors, discolored soil, or buried debris were noted in 7 of the 10 borings. The odors were described as "slight solvent/sewage" odors. Debris and discolored soil was found to 24 feet BGS.

Inspect the water lines in the vicinity of Site 23 to determine if they are leaking. If leaks are found, they should be repaired to reduce further transport of contaminants in the soil. Collect and analyze additional soil samples to further characterize the extent of contamination.

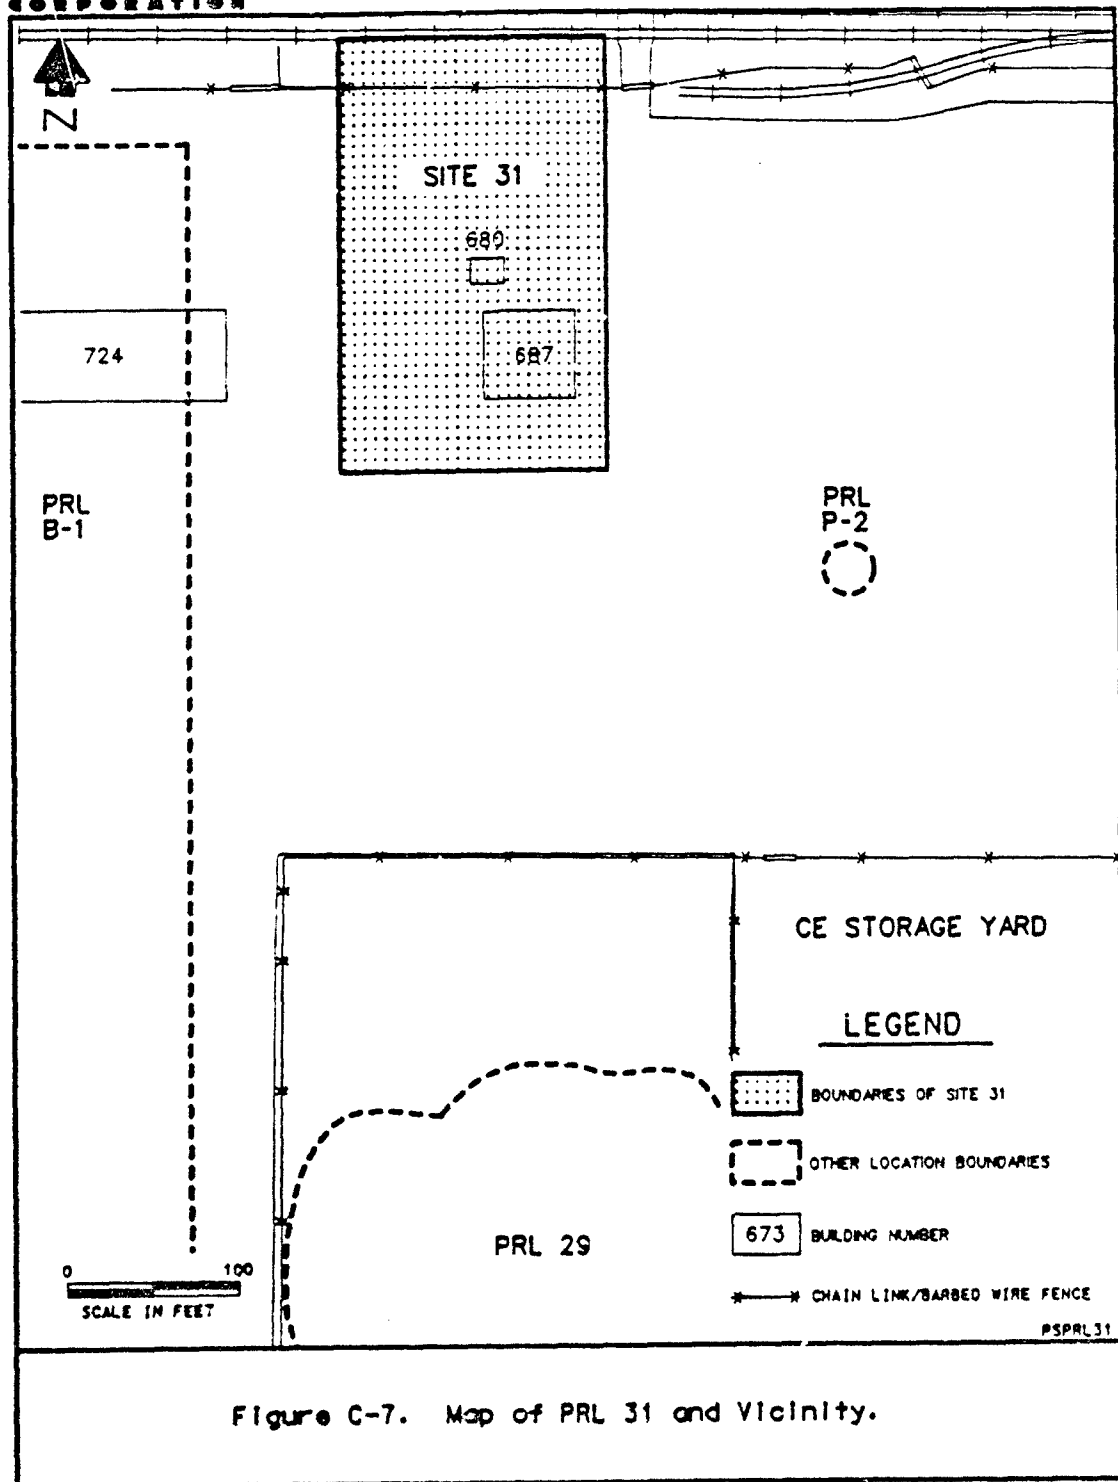
Figure C-7. Map of PRL 31 and Vicinity.

Discolored soil was noted at 2 to 3 feet BGS in Borings 31WSB02, 31WSB15, and 31SAP18.  
Odors were noted in Borings 31SAP17 and 31SAP18 at 2 to 3 feet BGS.
