# Technical Report

DEVELOPMENT OF A COMPUTERIZED DATA BASE TO MONITOR  
WHEELED VEHICLE CORROSION

OCTOBER 1989

Alfonso L. Baldi  
Edwin A. Crombie  
David P. Dillard  
Alloy Surfaces Company  
100 Locke Road  
Wilmington, Delaware 19809

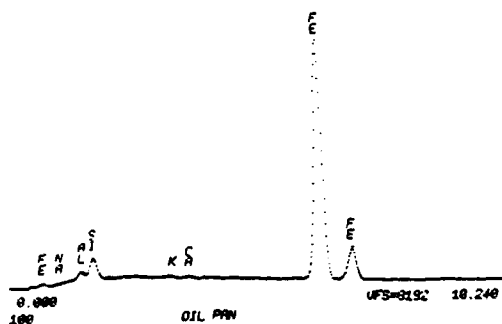
Figure 5.8-2. TRC Failed Component Case History

Inspection of two year old field vehicles demonstrated early signs of paint chips, spalling and areas of general corrosion attack. Continued inspection and maintenance of oil pan external surfaces will extend life. This part may fail premature of TRC projections.

Section Adjacent to Penetration Showing Corrosion of Exterior Surface

Penetration in Oil Pan

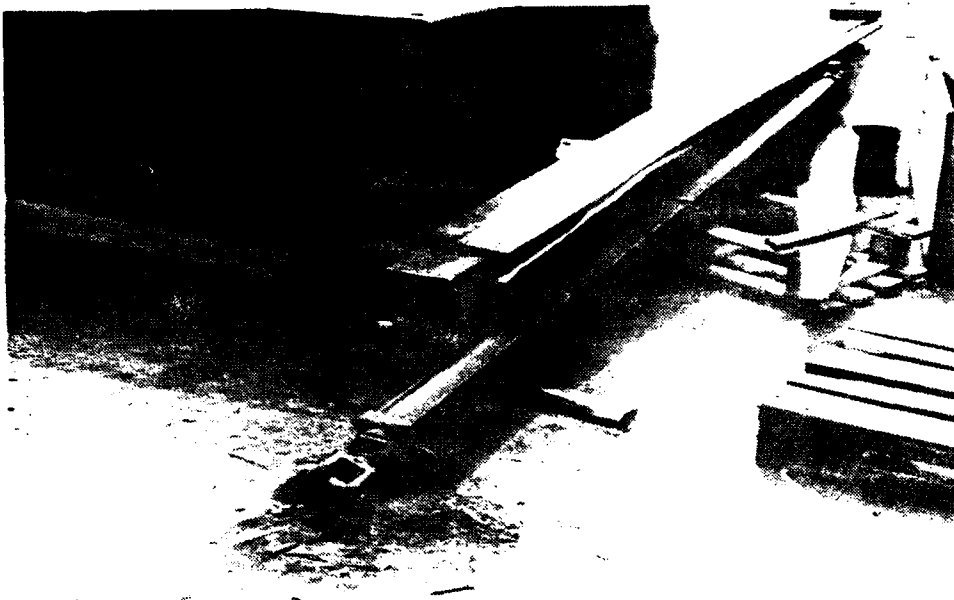
Figure 5.9-4. Damage to Containers and Corrosion of Exposed Components

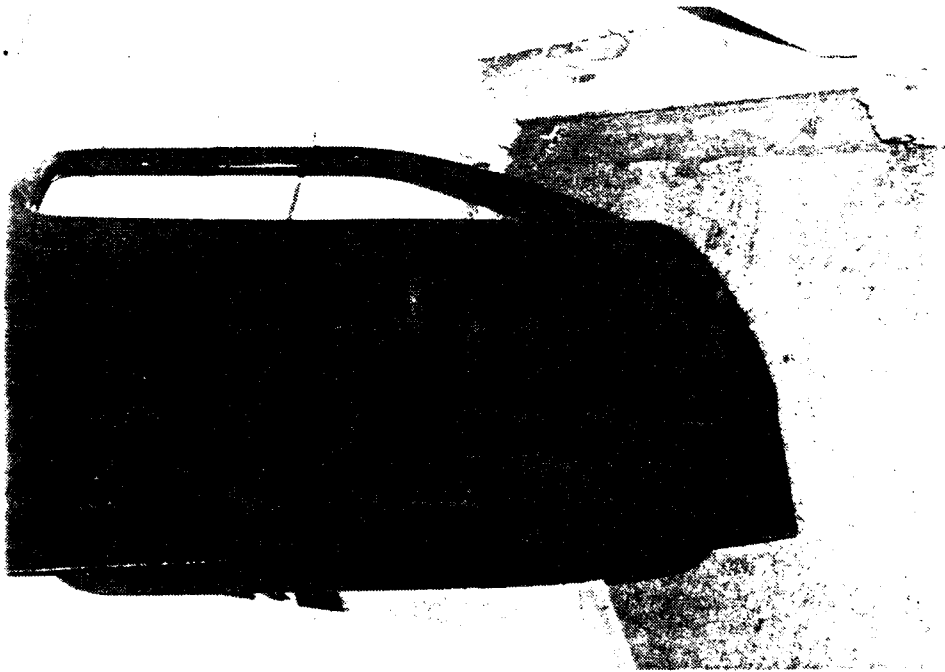
The parts which have been removed from the package are then stored by stacking them on large racks and shelves without intermediate packing material, resulting in metal-to-metal contact. Such storage results in abrasion or spalling of protective coatings, such as paint or film lubricants, exposing underlying base metal to general atmospheric erosion. Examples of corrosion problems associated with indoor storage of large parts that have been removed from O.E.M. packaging are shown in Figures: 5.9-8 and 5.9-9.

Figure 5.9-8. Indoor Storage of Large Components
