# Construction Foundation Report

## Mud Mountain Dam Seepage Control Cutoff Wall

White River, Washington

August 1991

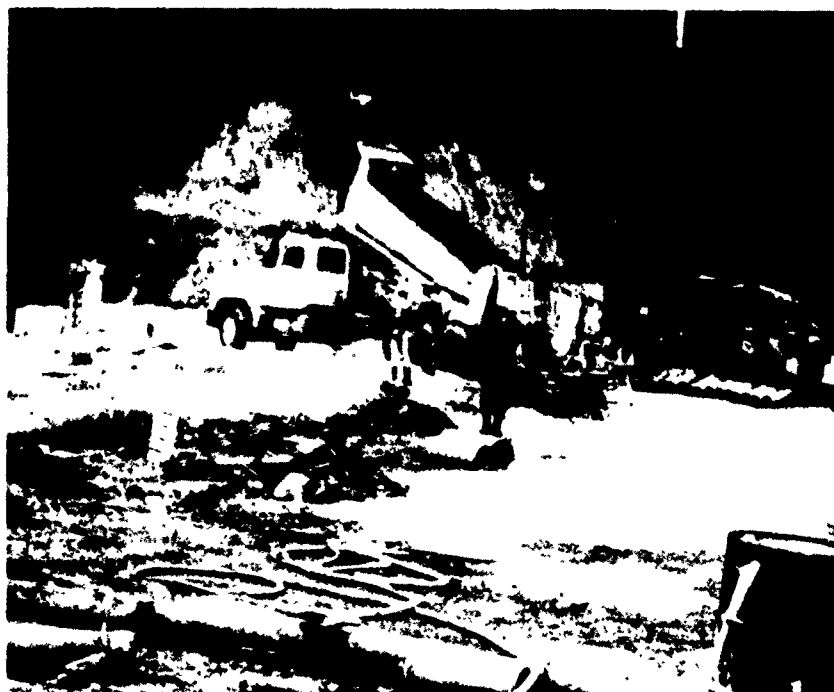
Emergency measures for uncontrolled slurry loss being implemented. Contractor is dumping wasted sand/silt mix from desander back into panel to help seal cracks.
