NAVAL BIODYNAMICS LABORATORY  
NBDL-91R003

## HUMAN FACTORS ASSESSMENT OF USCG 47-FT MOTOR LIFEBOAT

Technical Report

October 1991

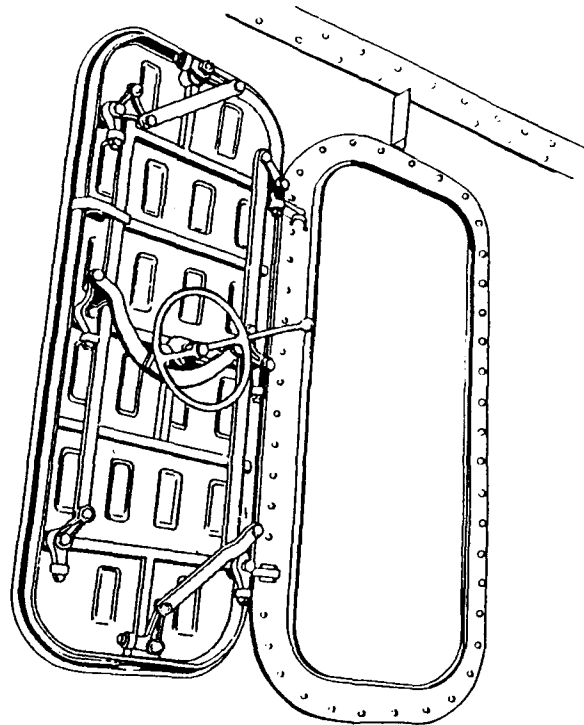
- The door impedes the movement of the port OB chair.
  - The bolts of the door are exposed and present a hazard to the crew passing through the door. Crewmembers have reported minor injuries due to these bolts.

Figure I.3. Watertight door with control wheel, extended handle, and dogs.

- Approach:**
- The door should be designed with a self-locking mechanism to secure the door in an open position. This mechanism is recommended for all doors.

- Grab handles should be placed over the doors and on both sides of the door.
  - Additional positive control of the door can be gained by installing a handhold/grip on both sides. Currently, crewmembers are required to open the door and hold it open (with the dog handle) while climbing up the ladder.

- Recess, cap, or remove threads from the end of the bolts to eliminate the workspace hazard.

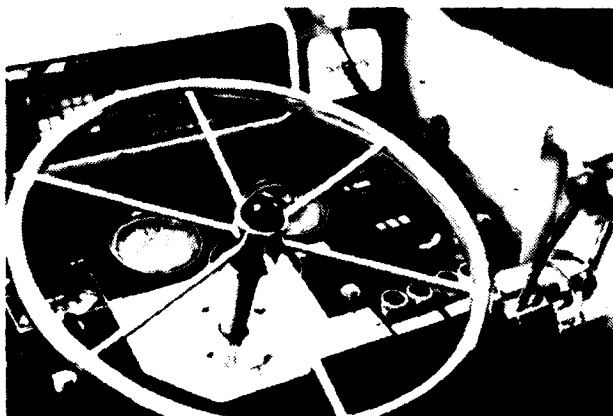
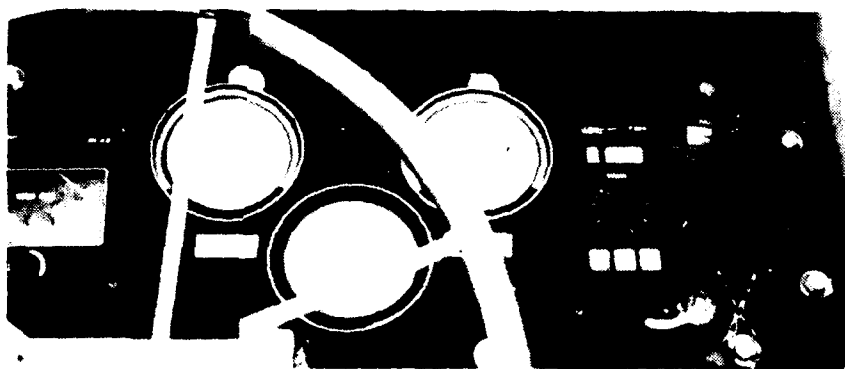
addition, the fathometer, digital compass, and autopilot control are obstructed by hand microphone coiled cords (see Figures II.2a and II.2b). HFE guidelines recommend not placing one control or display behind another, which requires operators to reach around or shift equipment to see the display or manipulate the control.

- The autopilot control and fathometer displays accumulate internal moisture and compromise the view of the operator.
- The navigation light switch panel is located on the radar plotter screen enclosure.
- The wet compass is not located on the centerline.

Figure II.2a. Current starboard steering station on open bridge.

Figure II.2b. Current starboard steering station open bridge/dials.

- Display units should be completely water and shockproof and should be filled with dry nitrogen to prevent fogging and internal corrosion.
- Relocate the wet compass to the centerline.

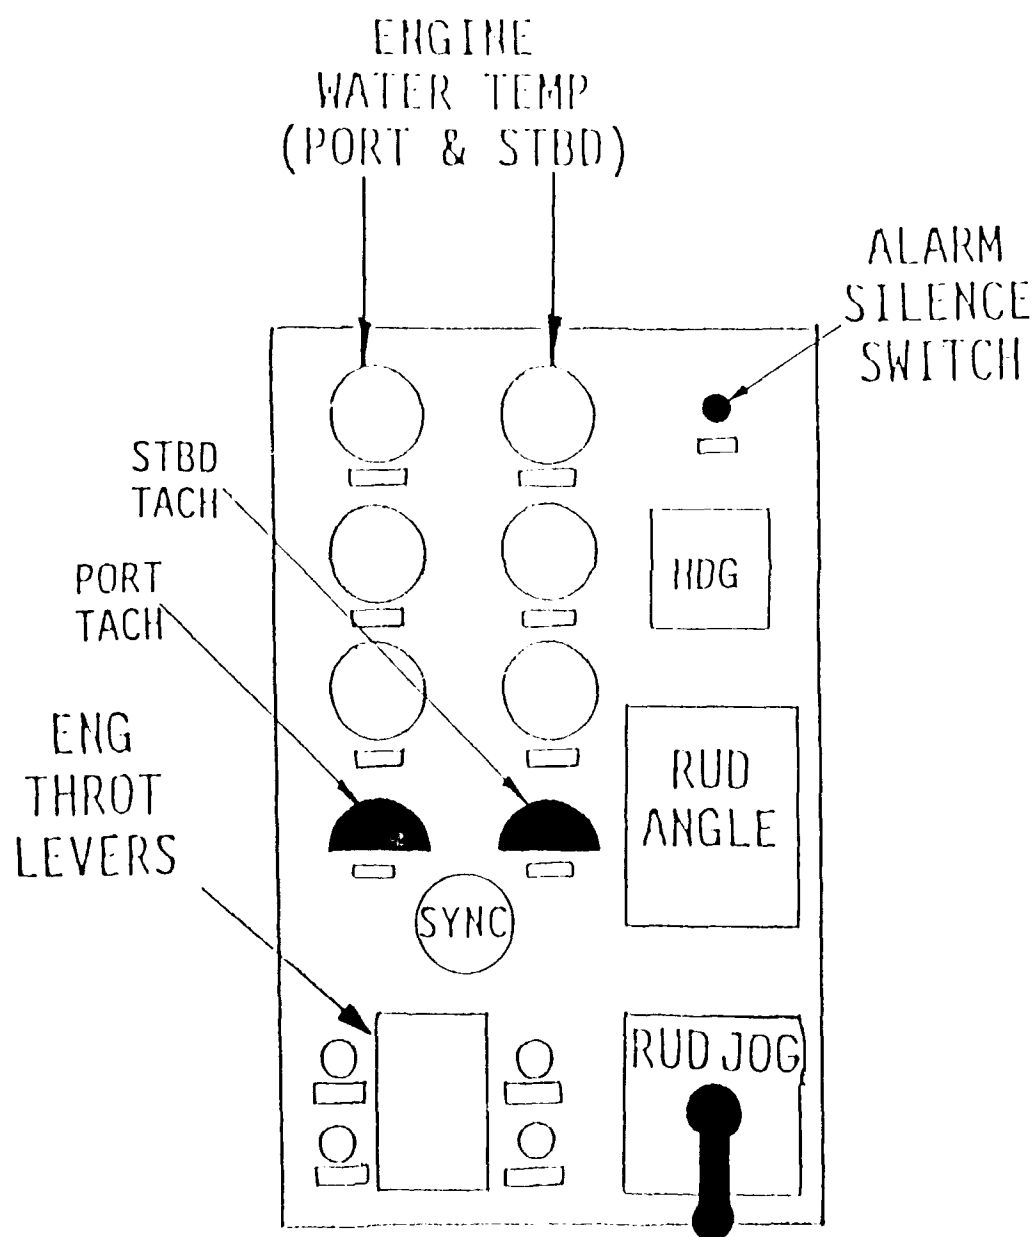
Figure II.5. Proposed port steering station on open bridge.

- The proposed console layout is recommended to avoid scattering controls and displays on the console without regard to functional associations (see Figure II.5).

- For example, the throttle control in its proposed position is on the same side as the engine indicators and the tachometers. Obviously, the throttle control is related to the indicators and the tachometers. Related functions should be arranged together so that their association is readily apparent to the operator. It is recommended that when a panel display is affected by a particular control, the display and control should be located near each other.

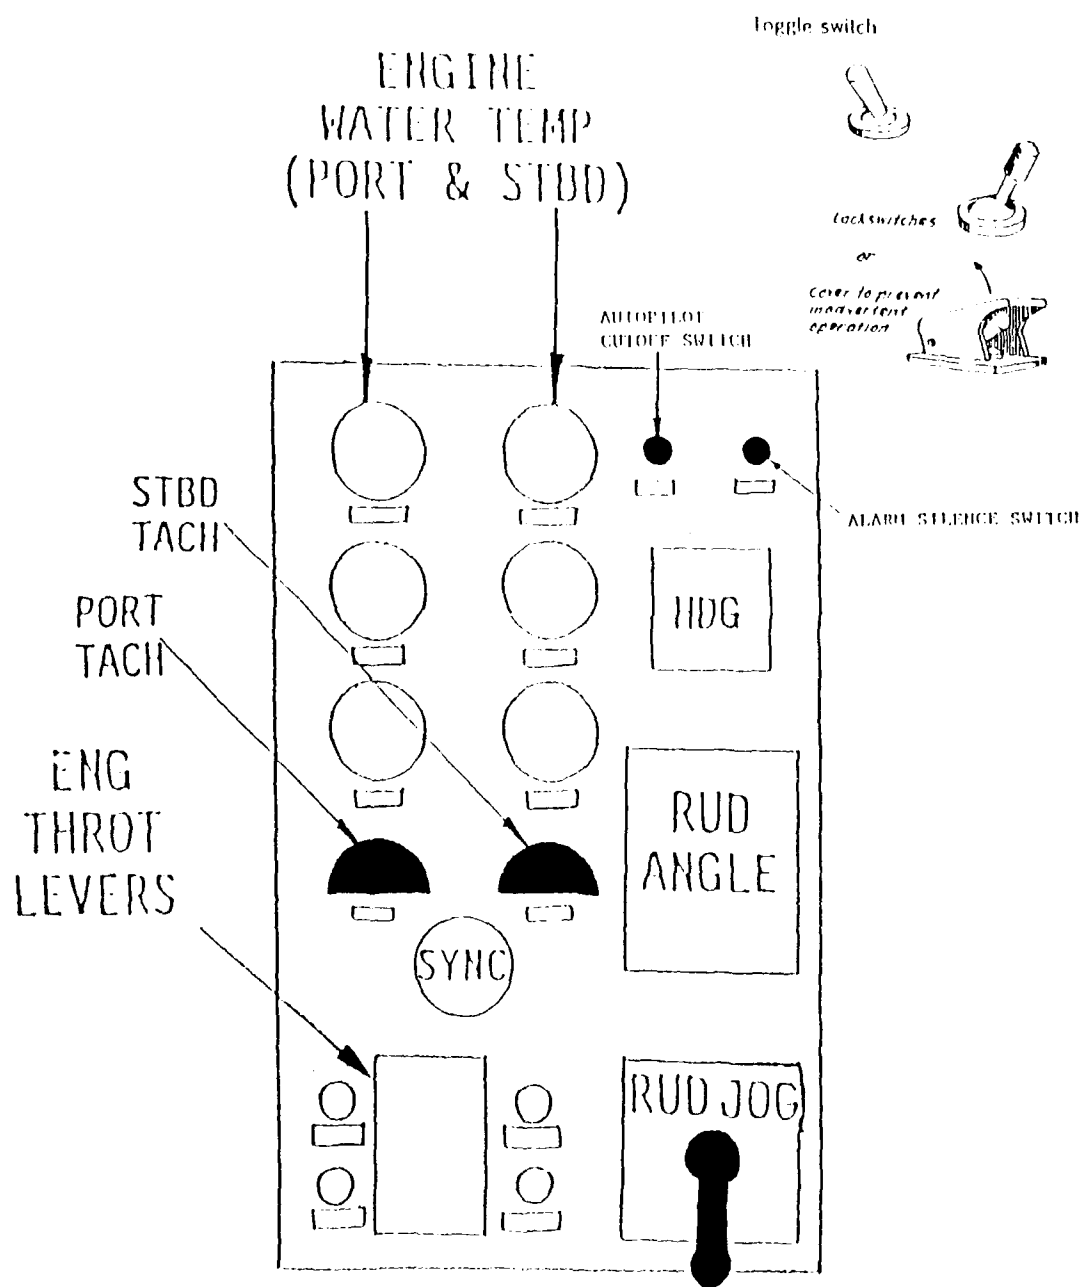
**Figure II.6.** Proposed autopilot cutoff switch on open bridge.

- Place an autopilot cutoff switch above the heading indicator on the port steering station console. A standard two-position toggle switch with a locking mechanism or protective cover to prevent inadvertent activation is recommended (see Figure II.6). The same type of mechanism is recommended for the alarm silence switch. The recommended minimum distance between the two toggle switches

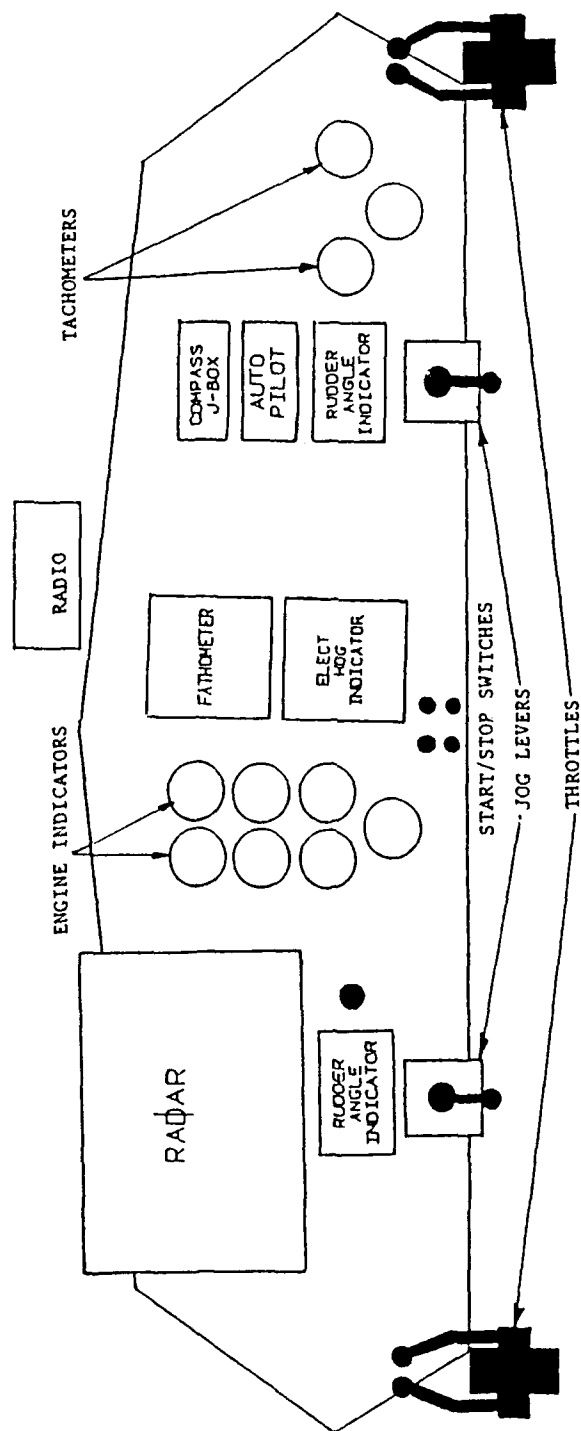
Figure II.16. Proposed enclosed bridge with two sets of jog levers and throttles.

- Figure II.16 illustrates a layout that utilizes two sets of jog levers and throttles, increasing the ability to maneuver the boat from the enclosed bridge. In this configuration the primary steering station is located starboard and the navigation station is located port.

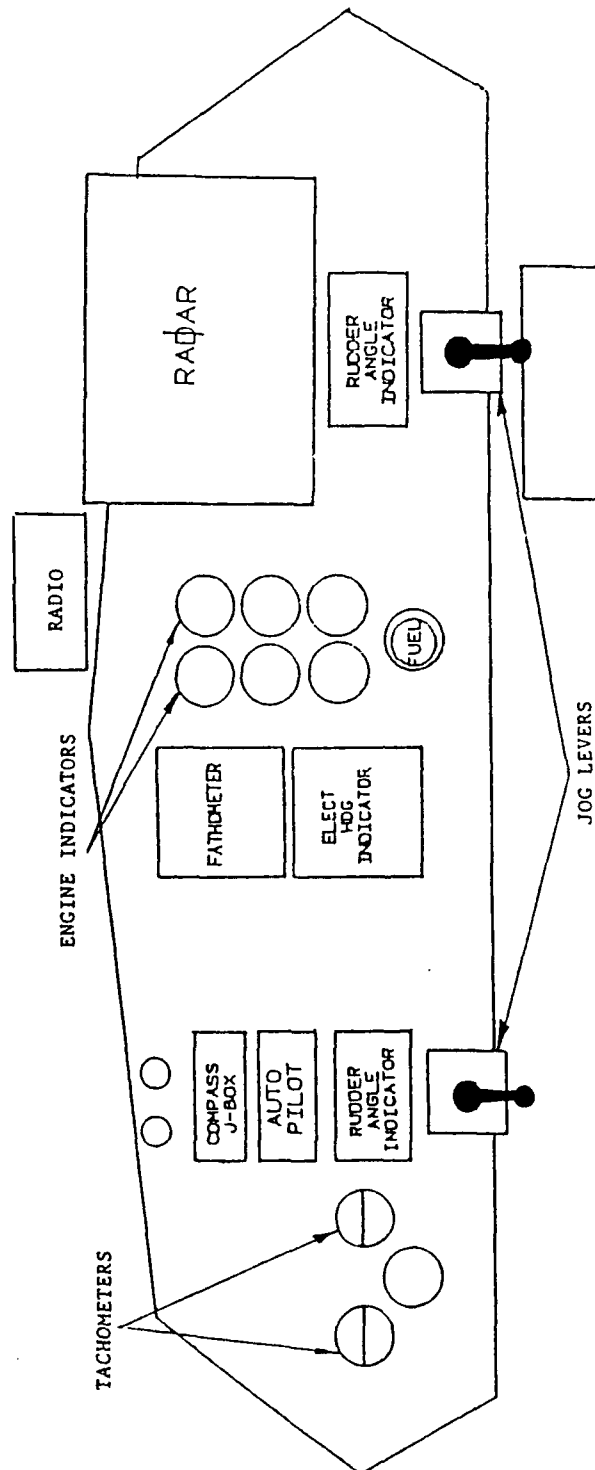
Figure II.17. Proposed enclosed bridge layout.

- Relocate the enclosed bridge jog levers from the operator chairs to the dashboard/console in the horizontal position (see Figure II.17). Operators are usually in a standing position when conducting mooring and other critical maneuvers. Moreover, the relocation of the levers will allow the operators to operate the lever controls comfortably (in both sitting and standing positions). This design incorporates the proposed centerline throttle position. The jog
