| 4. TITLE AND SUBTITLE<br><br>Human Factors Assessment of USCG | | | | 5. FUNDING NUMBERS<br><br>69X0243 | |
| 7. PERFORMING ORGANIZATION NAME(S) AND ADDRESS(ES)<br><br>Naval Biodynamics Laboratory<br>P. O. Box 29407<br>New Orleans, LA 70189-0407 | | | | 8. PERFORMING ORGANIZATION<br>REPORT NUMBER<br><br>NBDL-91R003 | |

This report documents the ergonomic and safety deficiencies noted 14-16 November 1990 during an on-site familiarization and inspection of the prototype USCG 47-ft motor lifeboat (MLB). The following human factors problem areas are addressed: steps, platforms, and railings (including ladders); doors, hatches, and passageways; controls; instruments and displays; workspace; and habitability considerations (including chairs).

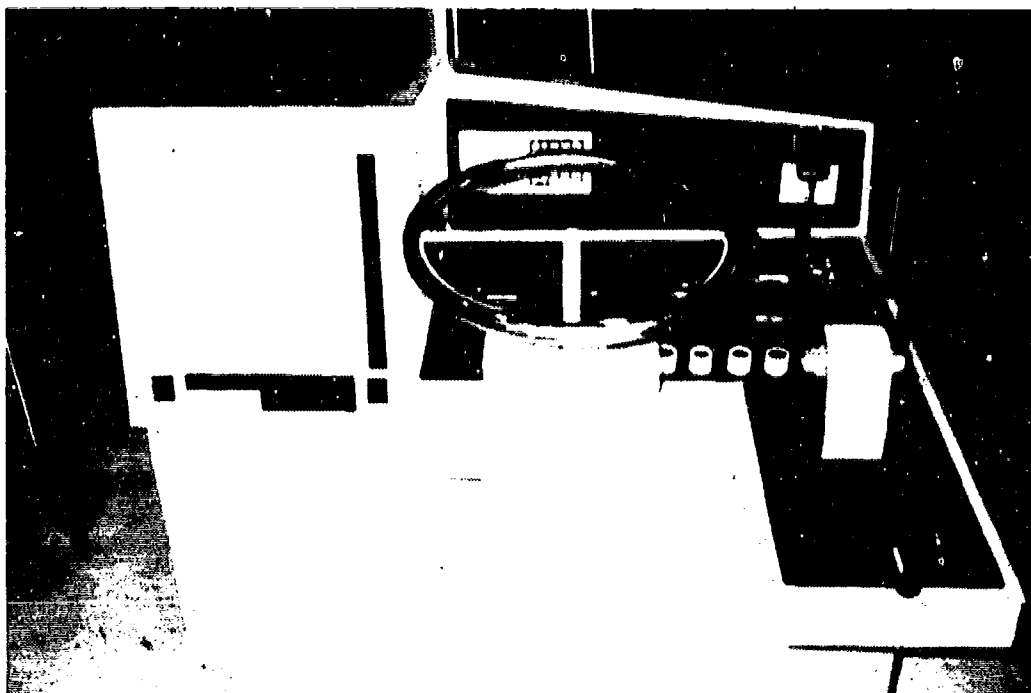
Figure II.1a. Current starboard steering station on open bridge.

- All controls and displays viewed and controlled by the operator are not clearly visible from the normal operating position (seated). In

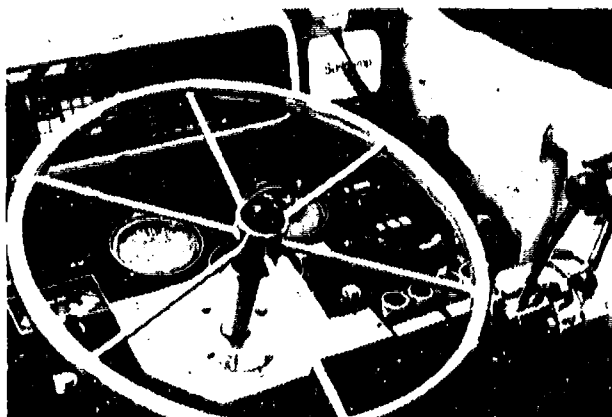
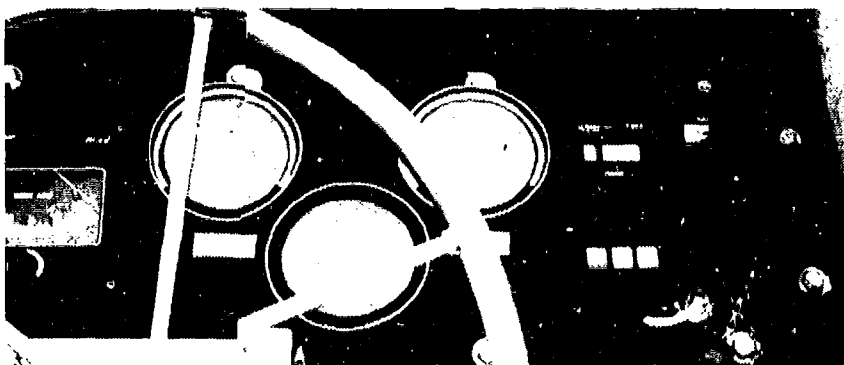
addition, the fathometer, digital compass, and autopilot control are obstructed by hand microphone coiled cords (see Figures II.2a and II.2b). HFE guidelines recommend not placing one control or display behind another, which requires operators to reach around or shift equipment to see the display or manipulate the control.

- The autopilot control and fathometer displays accumulate internal moisture and compromise the view of the operator.
- The navigation light switch panel is located on the radar plotter screen enclosure.
- The wet compass is not located on the centerline.

- Display units should be completely water and shockproof and should be filled with dry nitrogen to prevent fogging and internal corrosion.
- Relocate the wet compass to the centerline.
