TECHNICAL REPORT ARCCB-TR-92004

## 155-MM M284 GUN TUBE FAILURE

SANDRA O. ROY  
JOHN ATCHINSON

FEBRUARY 1992

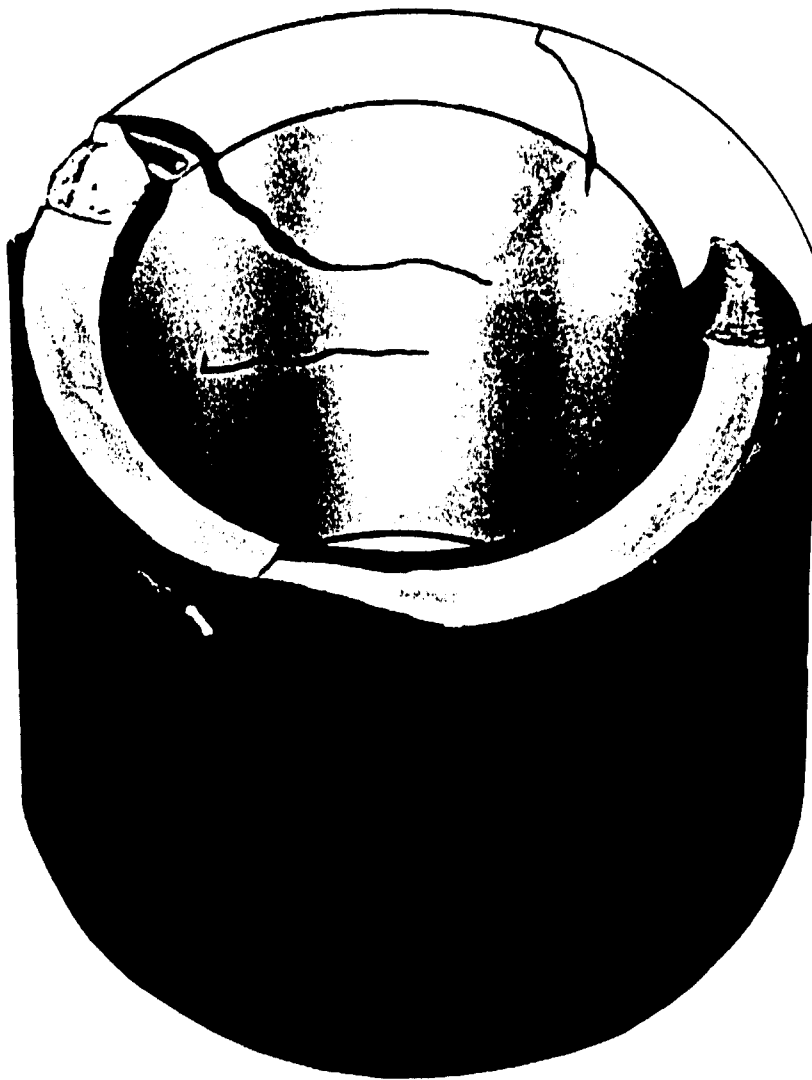
Upon receiving the failed gun tube forging, a thorough visual examination was conducted. Two segments of the failed tube were received from the Manufacturing Division: a segment approximately 15 inches long (closer to the breech end labeled M1) and a section approximately 11 inches long labeled M2 depicted in Figures 3 and 4, respectively. The failed region is located roughly 62 inches from the muzzle end.

Figure 4. Segment of gun tube with fracture located near muzzle end (M2).

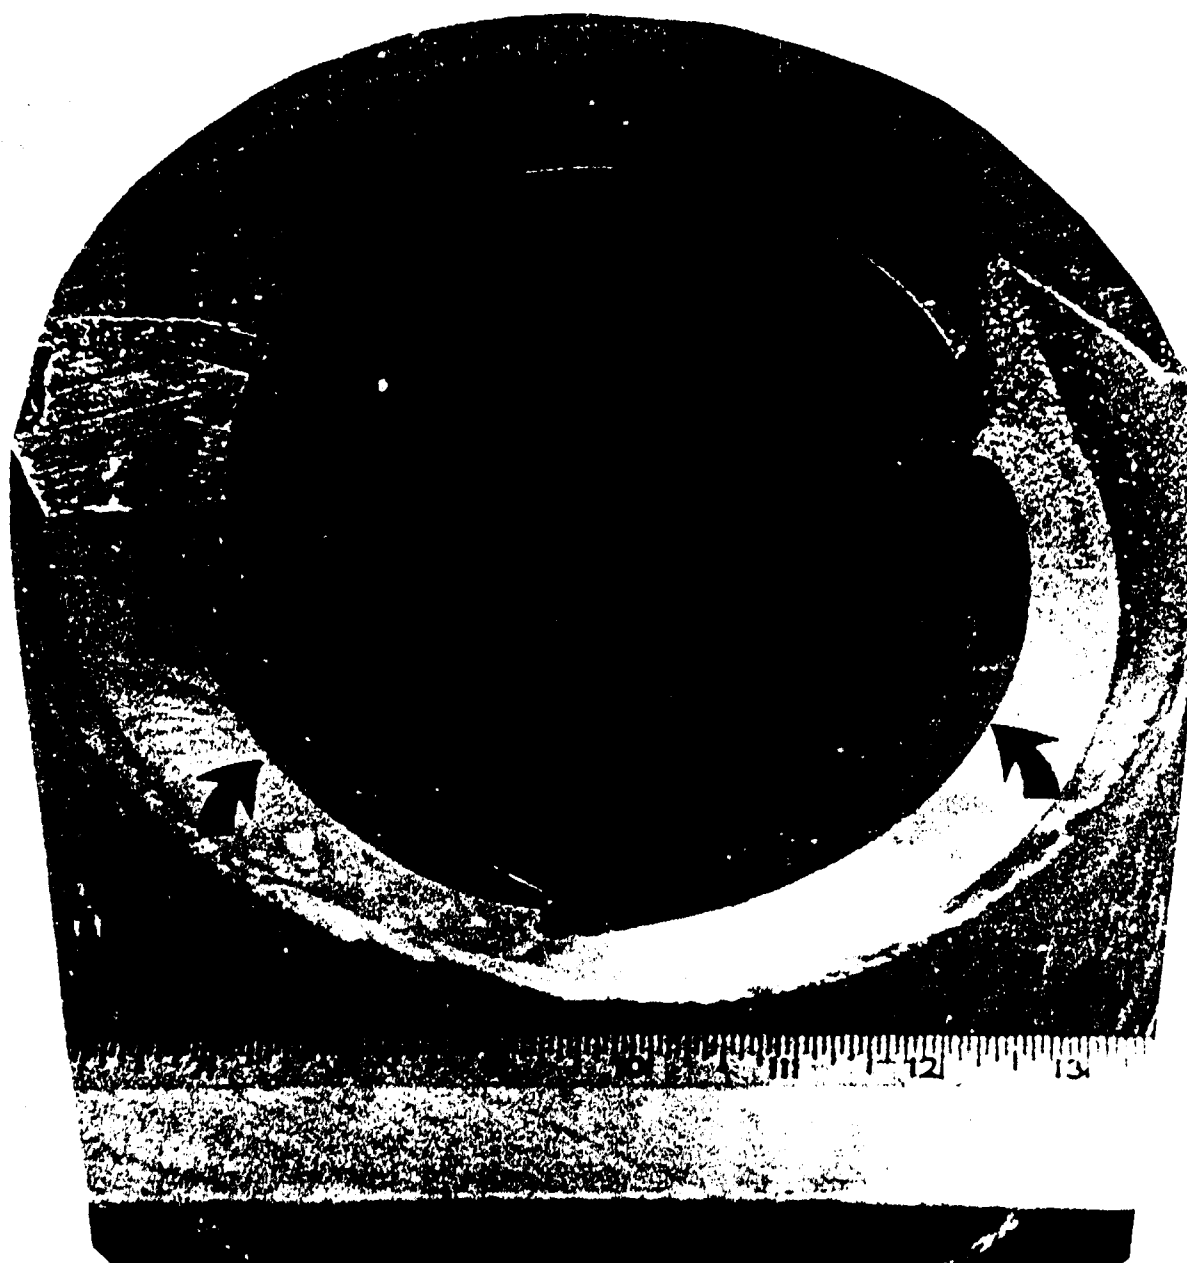
Examination of the fracture surface, seen in Figures 5 and 6, revealed a dark gray region extending from the bore surface into the tube wall. This region is relatively smooth and is a result of quench cracking during the hardening cycle of the heat treatment. The dark gray appearance is due to subsequent oxidation during tempering. The depth of this dark region is about  $\frac{3}{8}$  inch. The circumferential crack (fracture surface) veered off into a longitudinal crack (Figure 7) with the same depth of oxidation, indicating it existed prior to heat treatment (tempering). Small cracks running skewed from the longitudinal axis were observed on the bore surface in this general vicinity.

Figure 5. Dark gray ring on half of the fracture surface (end closer to the breech) (indicated by arrows).

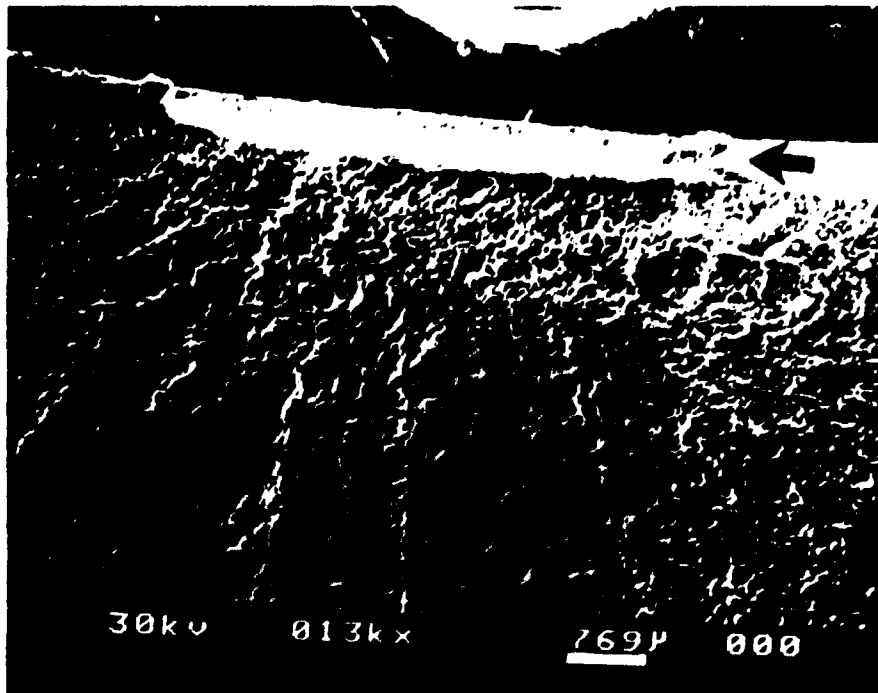
Examination by scanning electron microscopy (SEM) of a fracture initiation site, shown in Figure 11, revealed macroscopic crack indications propagating into the oxidized layer of the fracture surface. These indications were crack-type in nature and of substantial depth, as illustrated in Figures 12a and 12b. The orientation and flow pattern of these indications are identical to those observed during magnetic particle inspection.

Figure 11. SEM of fracture origin  
(indicated by arrows).

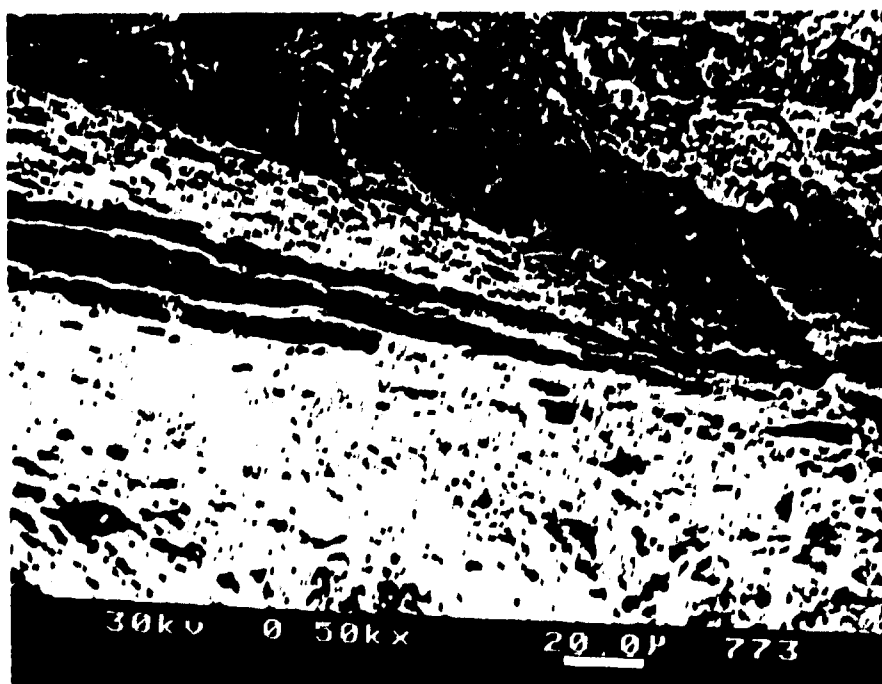
SEM was also conducted on the fracture surface of the tensile bars. The fracture surface disclosed nonmetallic inclusions determined to be manganese sulfides (MnS) by energy dispersive x-ray analysis (EDXA). Figure 13 illustrates the morphology and distribution on the fracture surface. The fracture mode was of a ductile mechanism.

Figure 13. EDXA illustrating MnS inclusion (500X).
