DOT/FAA/RD-91/1

**Composite Profiles of  
Helicopter Mishaps at  
Heliports and Airports**

January 1992

Final Report

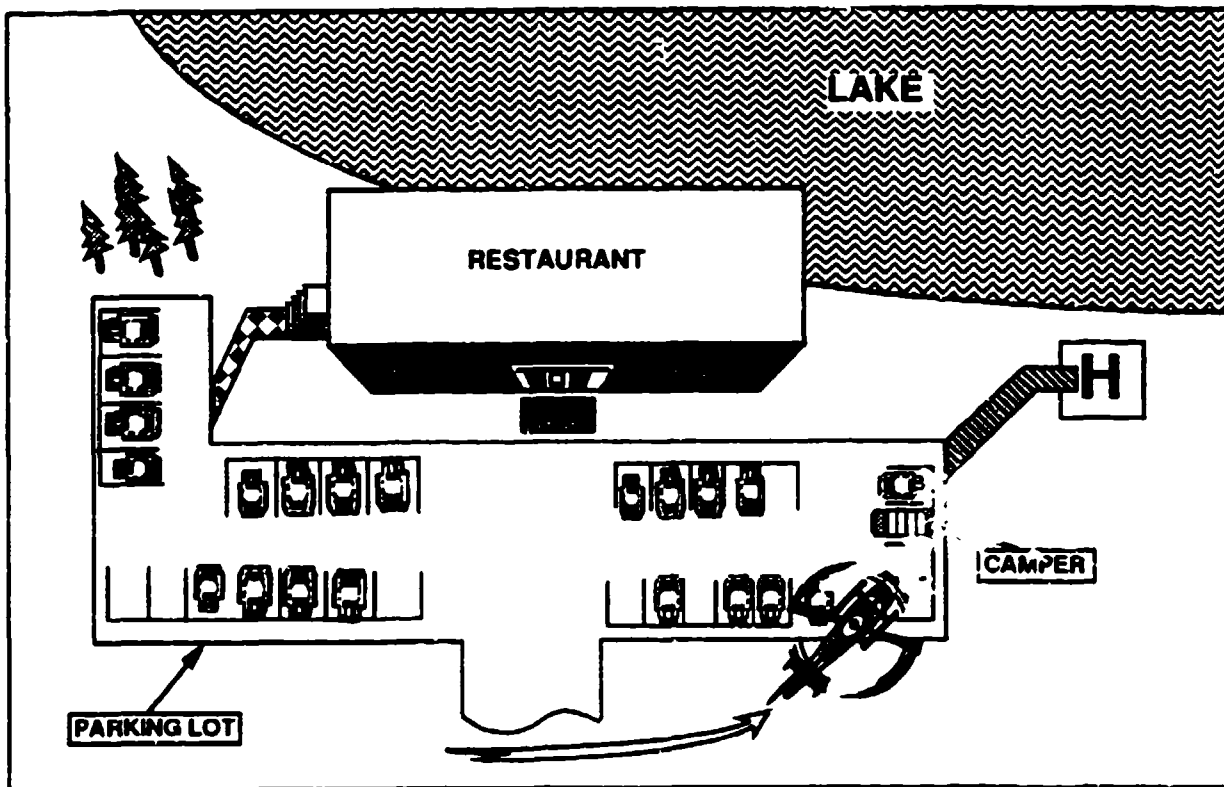
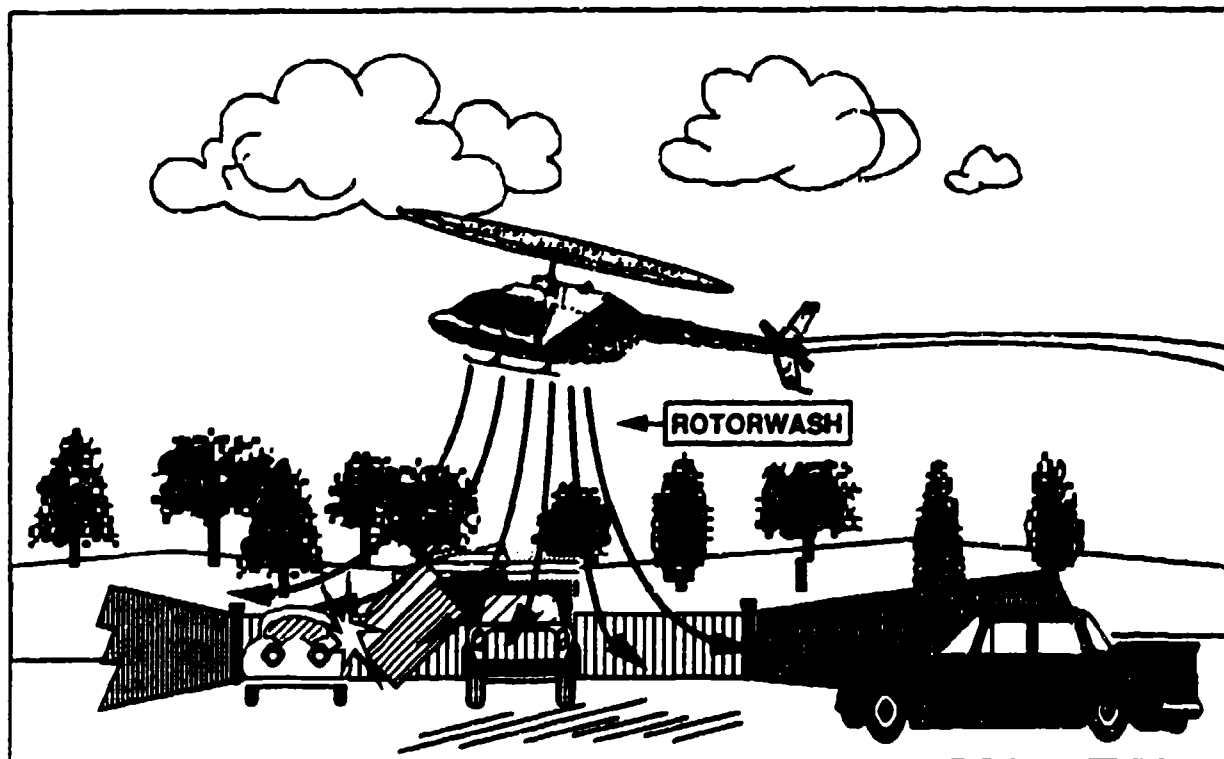
FIGURE 4 ROTORWASH DAMAGE

Clear Groundspace - Rotorwash has been the cause of personnel injury and property damage in a number of mishaps. It is important to control the groundspace under the approach/departure path to at least the recommended distance of 280 feet from the edge of the primary surface (reference 3). In addition, as was shown in the mishap presented above, the approach/departure path that a pilot will choose cannot be guaranteed. Therefore, the facility operator may wish to ensure that, where possible, groundspaces under other potential approach/departure paths have limited access because of the possibility of mishaps due to rotorwash.

Approach/Departure Paths - Pilots should attempt to adhere to the recommended approach/departure path whenever conditions allow for such procedures. At times, it may seem easy to put aside established procedures when there appears to be plenty of clear space surrounding a heliport. When the wind is not a significant factor, a pilot may choose to approach a heliport from a direction other than that prescribed by the heliport markings. However, judicious approach/departure paths are designed based on several factors, not just prevailing wind. Helicopter performance, safety, noise, obstacles, and objects underlying the approach/departure paths must be considered. Whenever possible, avoid flying over people, vehicles, and structures, particularly during takeoffs and landings. Figure 5 depicts the proper approach.

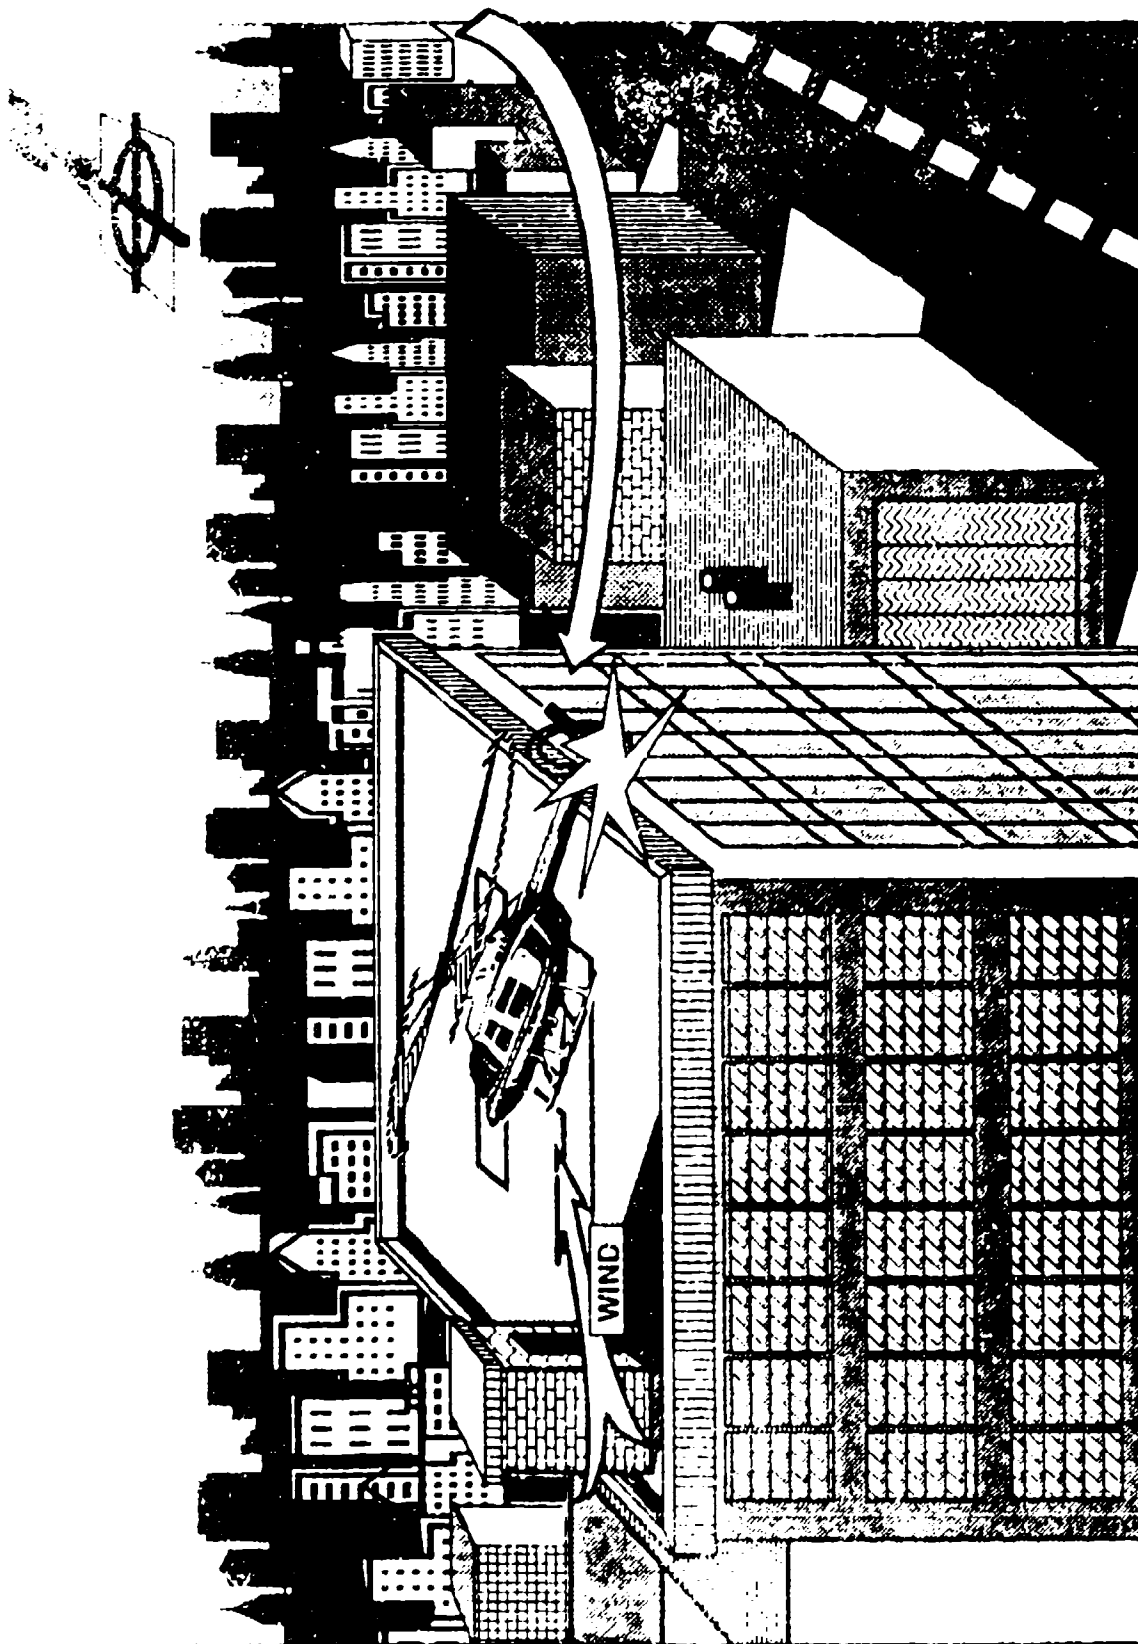
FIGURE 26 OBSTACLE STRIKE - PARAPET

In this mishap, the pilot did not have a VASI-type guidance system to assist him in executing an approach at the proper angle. Visual guidance

Environmental Considerations - It is sometimes impossible to avoid conditions that may affect the method employed by a pilot to operate to or from a facility. Early morning and evening ground fog, mountainous terrain bordering the facility, man-made obstacles, unusual wind conditions, and sun angle can all affect safety. If possible, pilots should routinely be reminded of these circumstances where they exist, possibly via radio. If direct communications are not available, safety bulletins, posters, and other "awareness" efforts would be helpful.
