WL-TR-91-4032  
DOT/FAA/CT-91/23  
VOL II, Part 3

COMPOSITE FAILURE ANALYSIS HANDBOOK  
VOLUME II - TECHNICAL HANDBOOK  
PART 3 - CASE HISTORIES

R.J. Kar  
Northrop Corporation  
One Northrop Avenue  
Hawthorne, California 90250-3277

February 1992

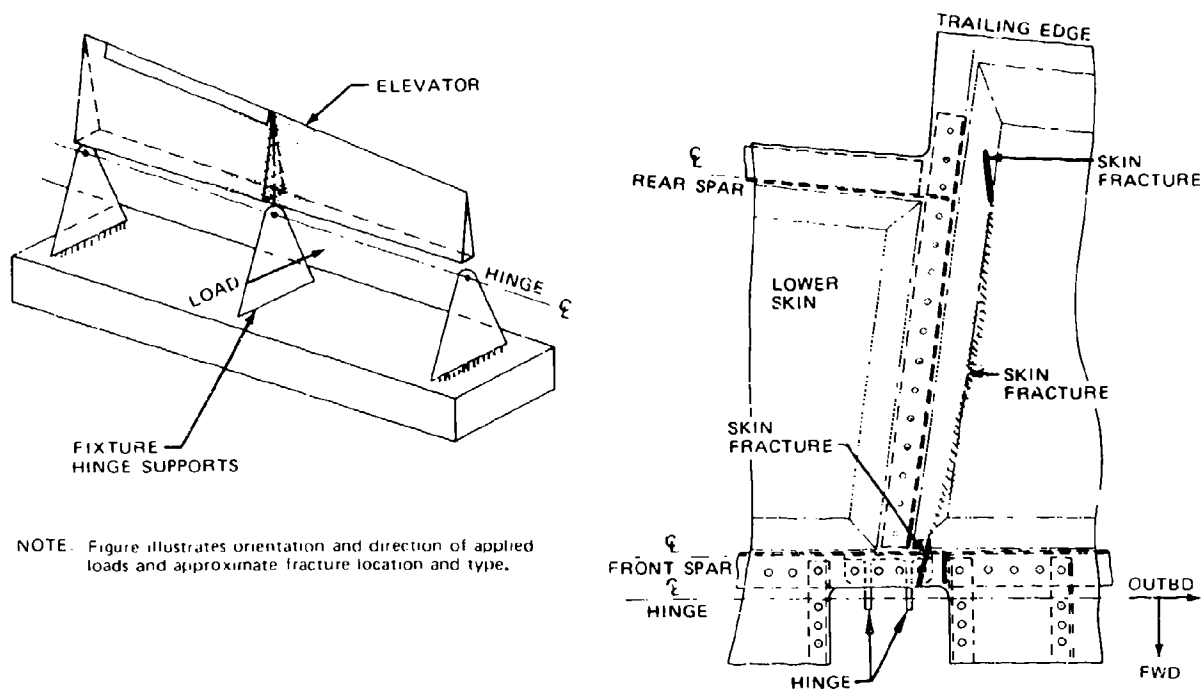
Figure 2-1. 737-300 Elevator Static Test Evaluation

Figure 2-1 illustrates a portion of a graphite/epoxy tapered box structure which fractured during test. This graphite/epoxy box consisted of two honeycomb skin panels fastened to a spanwise spar with intermediate chordwise ribs. A review of the test history revealed that premature fracture occurred during hingeline deflection of the front spar.

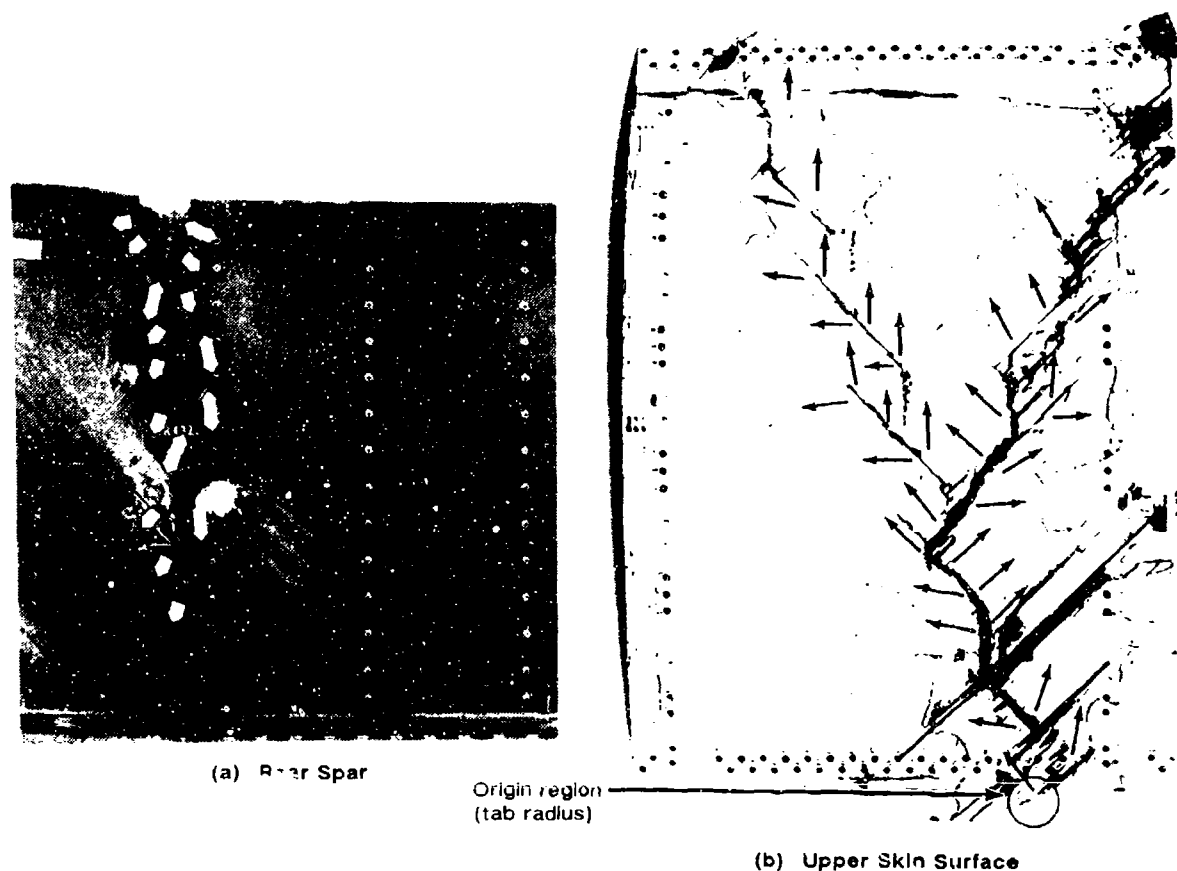
*Figure 2-8. JVX Wing Test Box Crack Mapping Results*

Using the outline of the delamination generated by NDE, the fractures were abrasively sectioned open to minimize artifacts. Detailed crack mapping of the delamination surfaces was performed by optical microscopy, with documentation of the fracture morphologies obtained by the SEM. Areas of delamination were found to be principally Mode I tension dominated, with localized Mode II shear regions. The overall crack growth directions, as well as the fracture origin regions for the upper skin surface and the rear spar are shown in Figure 2-8. These analyses revealed cracking of the upper skin initiated by compression buckling fracture mode at the trailing edge tab radius with resultant fracture propagating toward the leading edge. Similarly, the rear spar fracture originated in a region adjacent to the upper skin surface. Crack mapping in this region was very inconsistent, with a nearly random variation in the microscopic river marks and hackle orientation. No anomalous conditions such as porosity, resin starvation, or chemical contamination were identified in the origin regions.

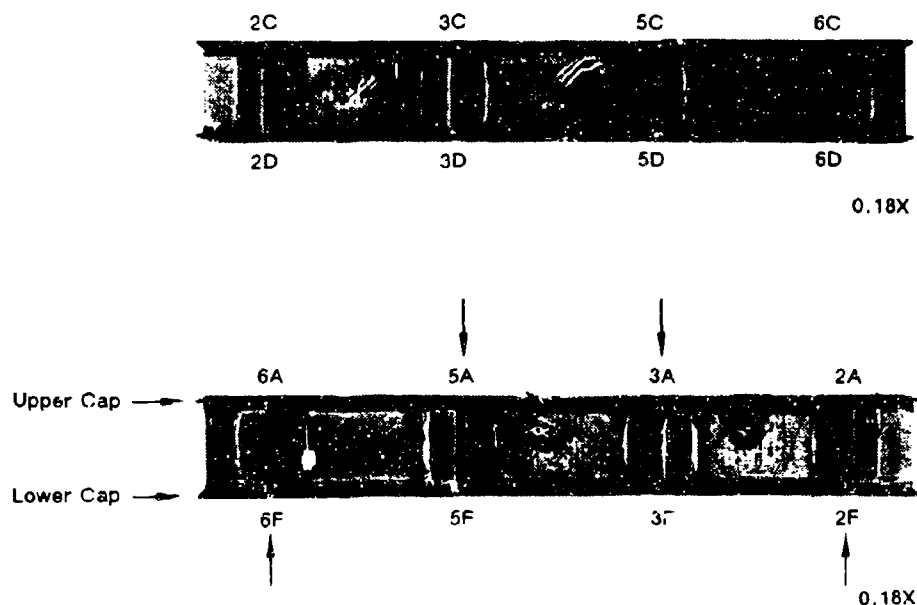
Figure 2-18. CFRP I-Beam in the As-Received Condition

Figure 2-18 shows the I-beam in its as-received condition. This component was fabricated by the personnel at the Air Force Wright Patterson Aeronautical Laboratories (AFWAL). Information regarding the component's layup, material composition, resin content, and cure temperature was provided by AFWAL. The component was tested in a four point bend test. The I-beam consisted of a tape laminate with vertical web and two horizontal caps, similar to stringers used to stiffen skins on aircraft wing construction. Small vertical stiffeners were secondarily bonded at several locations along the length to provide support of the cap flanges during loading. Efforts were aimed at determining the cause of failure with the quickest and lowest cost methods available. As a result, examinations such as fractography were performed without an SEM, relying on macroscopic and optical means of identifying the sequence and origin of fracture.

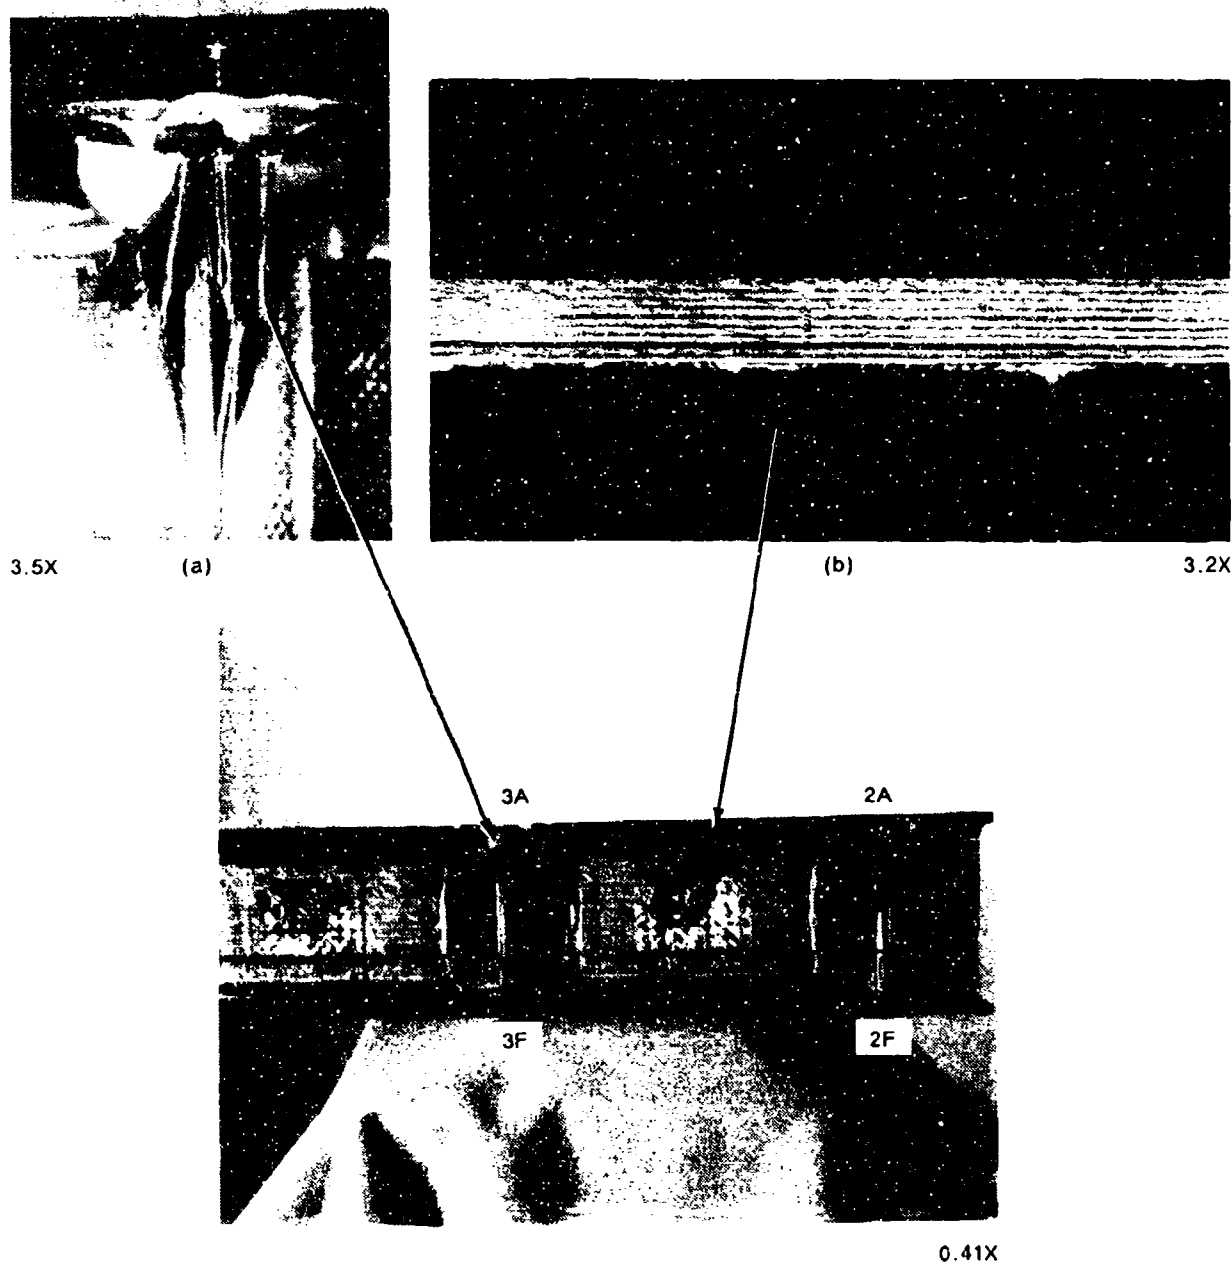
Figure 2-19. Regions of (a) Compression Buckling and (b) Delamination in the Upper Cap Section of the I-Beam

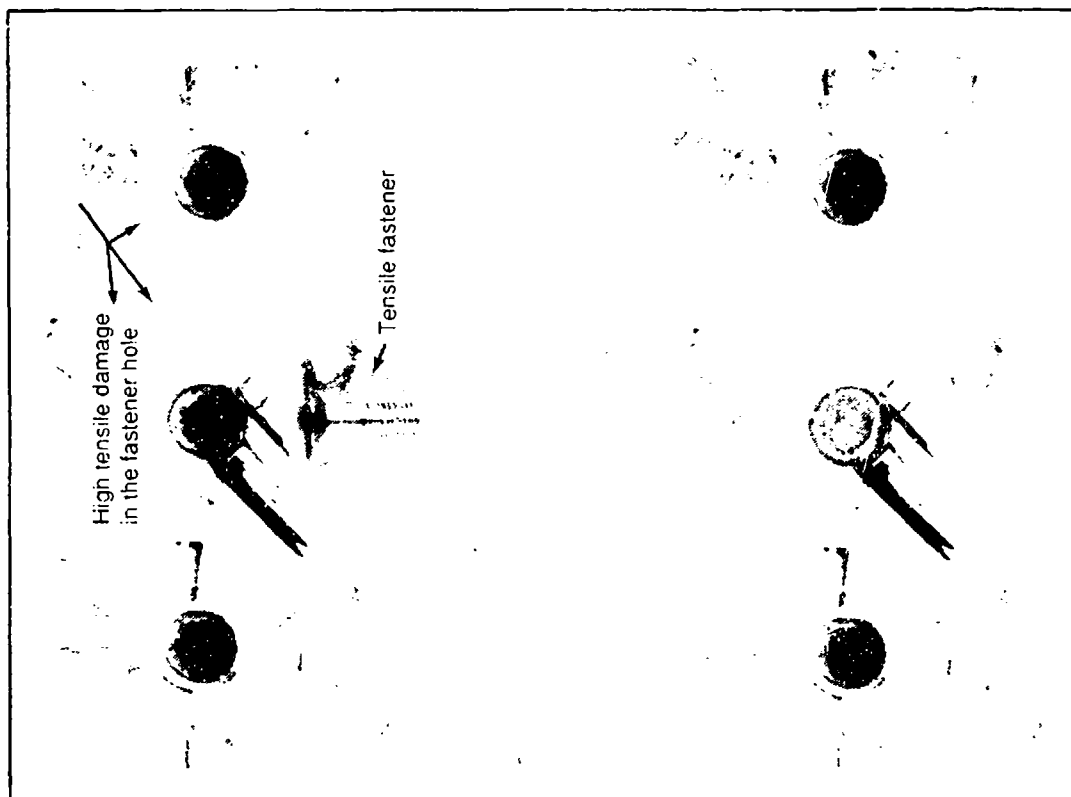
a. Tensile fastener (fits loosely in fastener hole) 0.9X

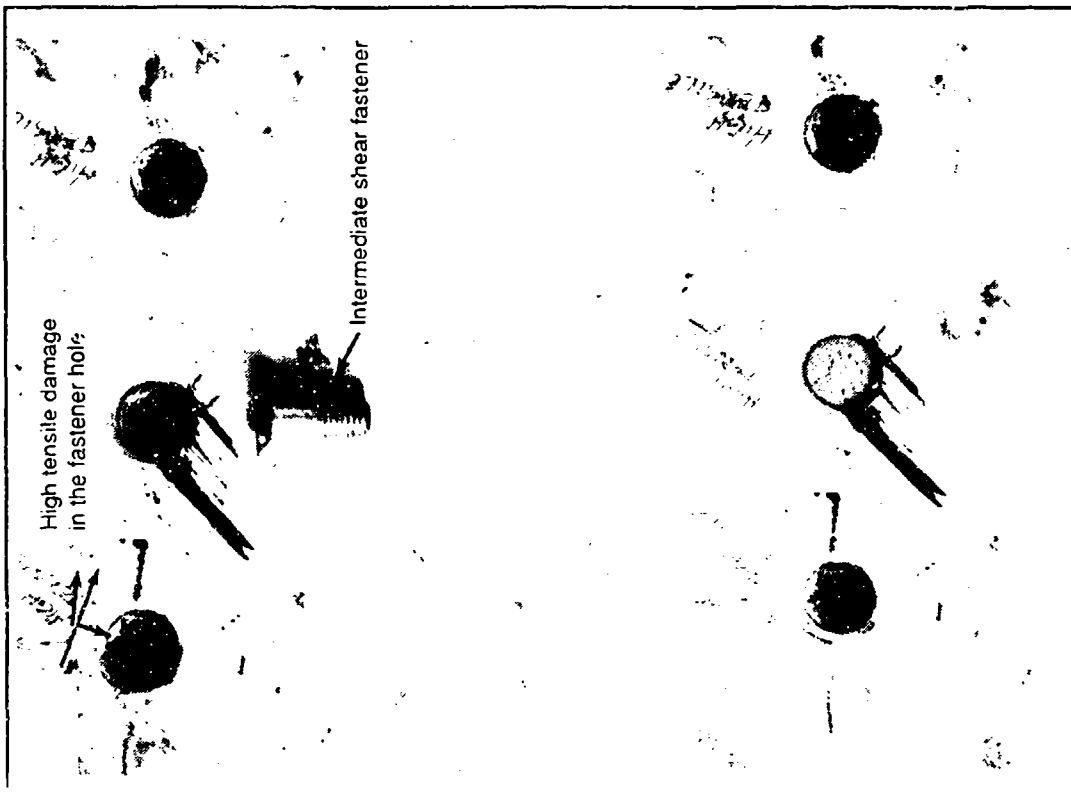
b. Shear (intermediate) fastener (fits snugly in fastener hole) 0.9X

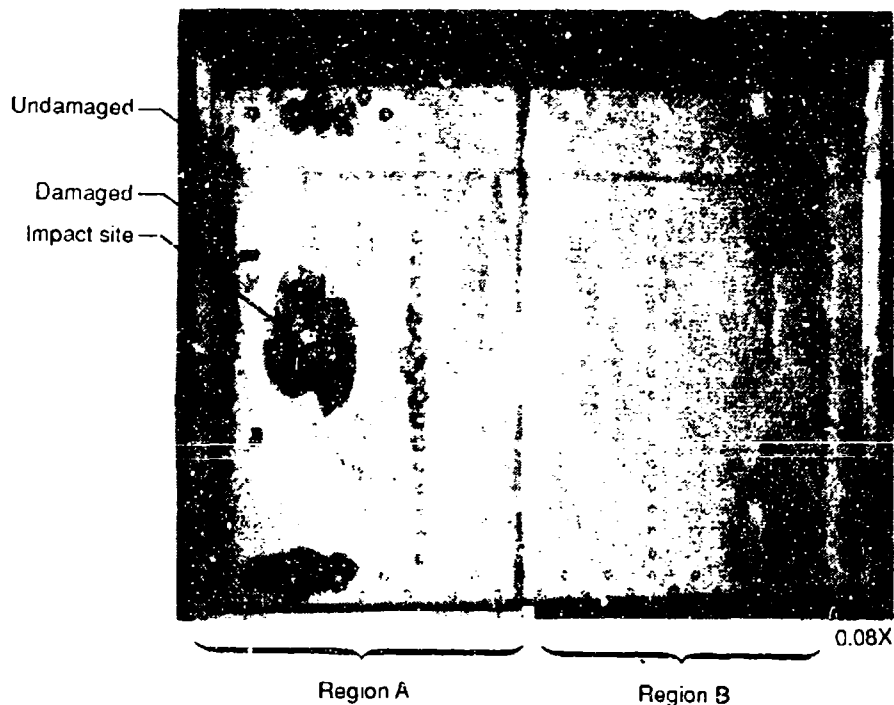
Figure 2-31. Through Transmission Ultrasonic (TTU) Scan of Component

To determine the extent of the damage, through-transmission ultrasonic inspection (C-scan) was performed. The dark-shaded regions in the vicinity of the fastener holes and at the apparent impact site indicate the damaged region. These regions are shaded due to higher attenuation from the anomalous regions. Most of the damage occurred on one half of the panel, Region A, as shown in Figure 2-31.

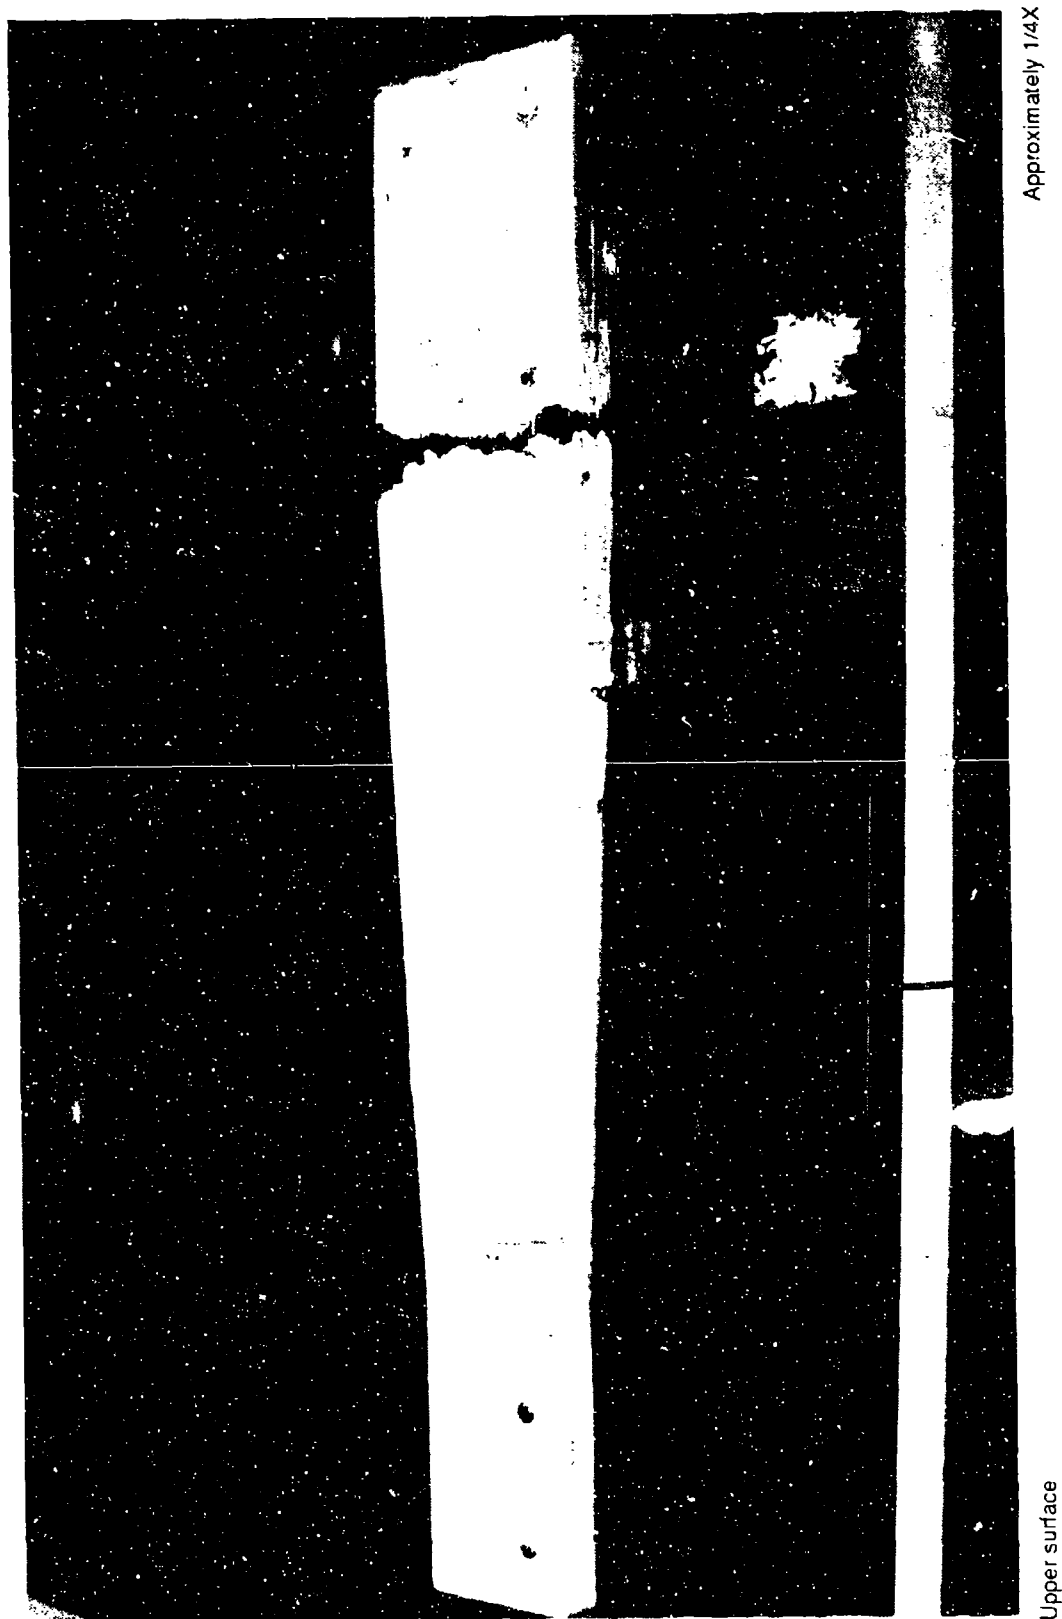
Figure 2-38. Macro photograph of the Upper Surface of the Landing Strut As-Received

Nondestructive evaluation was not performed on this component because the damage was considered to be readily apparent upon visual inspection.

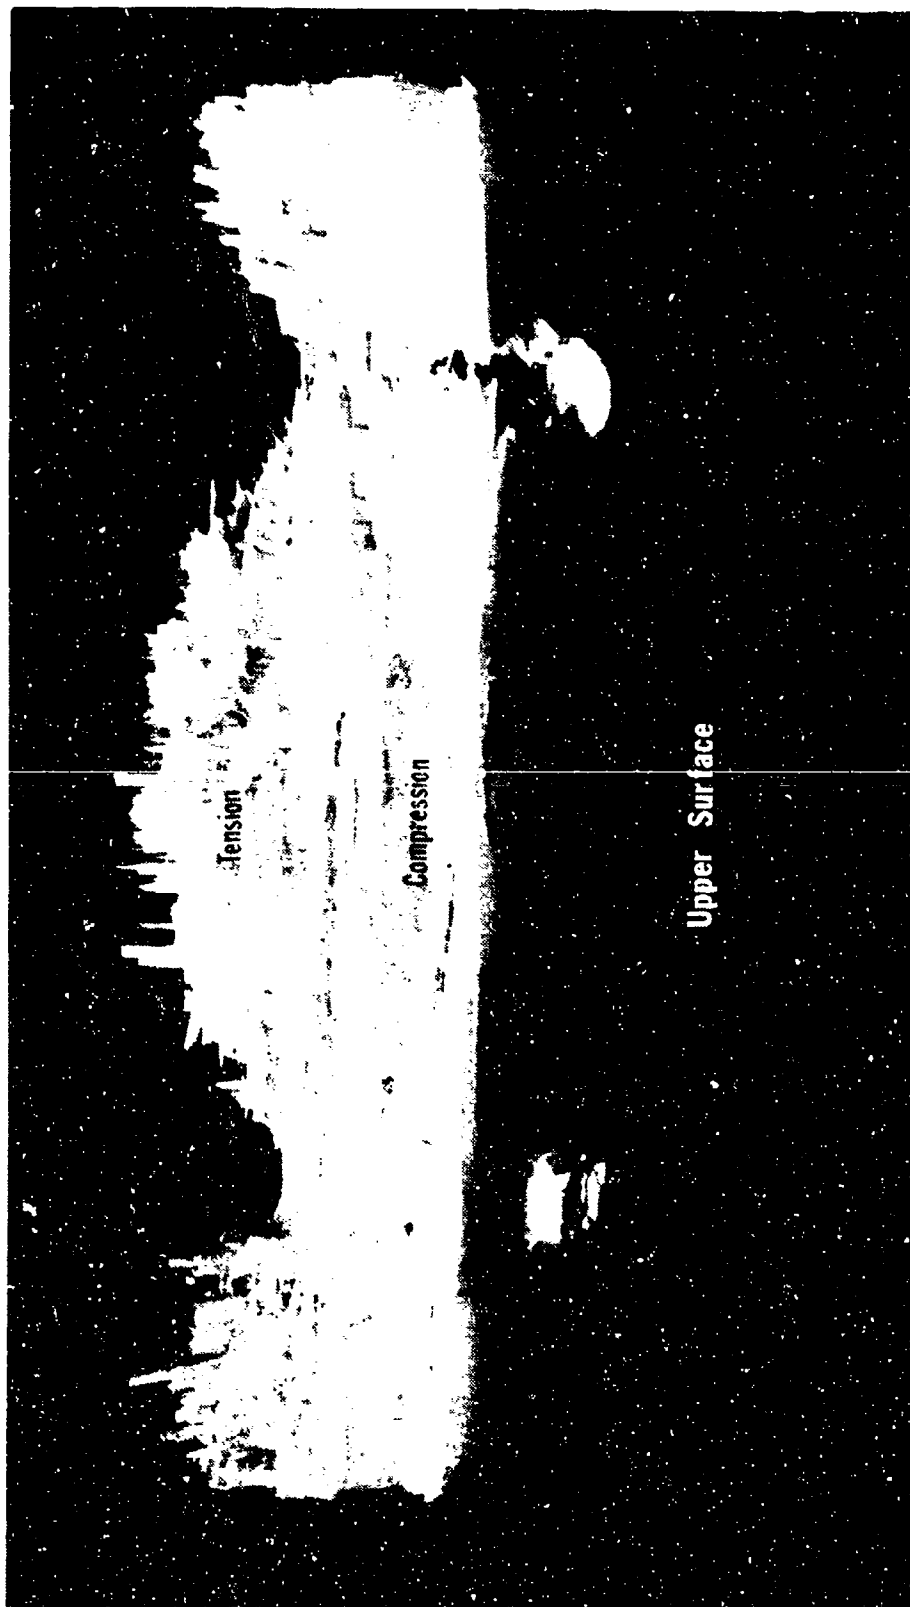
**Figure 2-39. Macro photograph of the Translaminar Fracture Surface on the Small (Fixed Piece) of the Strut**  
 Note: Tension fracture is multiphase and shows individual fibers or bundles; compression fracture is planar.

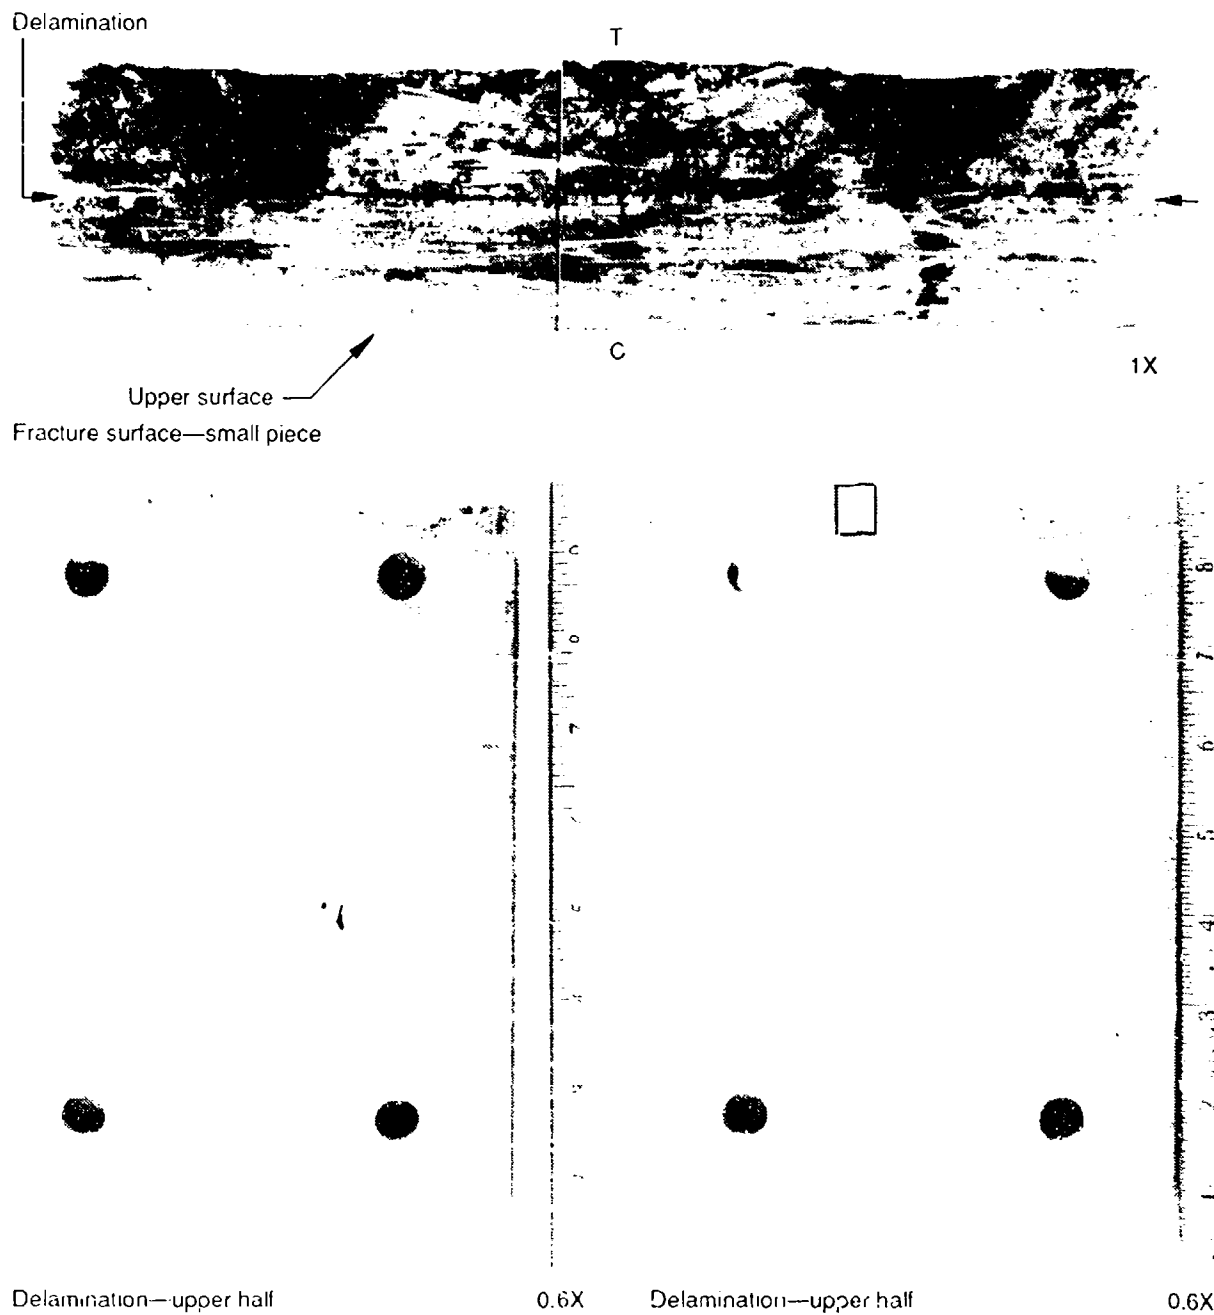
Figure 2-40. Macrophotographs of the Top of the Small Piece Fracture Surface Showing Delamination, Upper Surface, Tension Fracture (T) and Compression Fracture (C)

The lower macrophotographs show the mating delamination surfaces after laboratory separation of the delamination. The area shown by the small box is magnified in Figure 2-46.

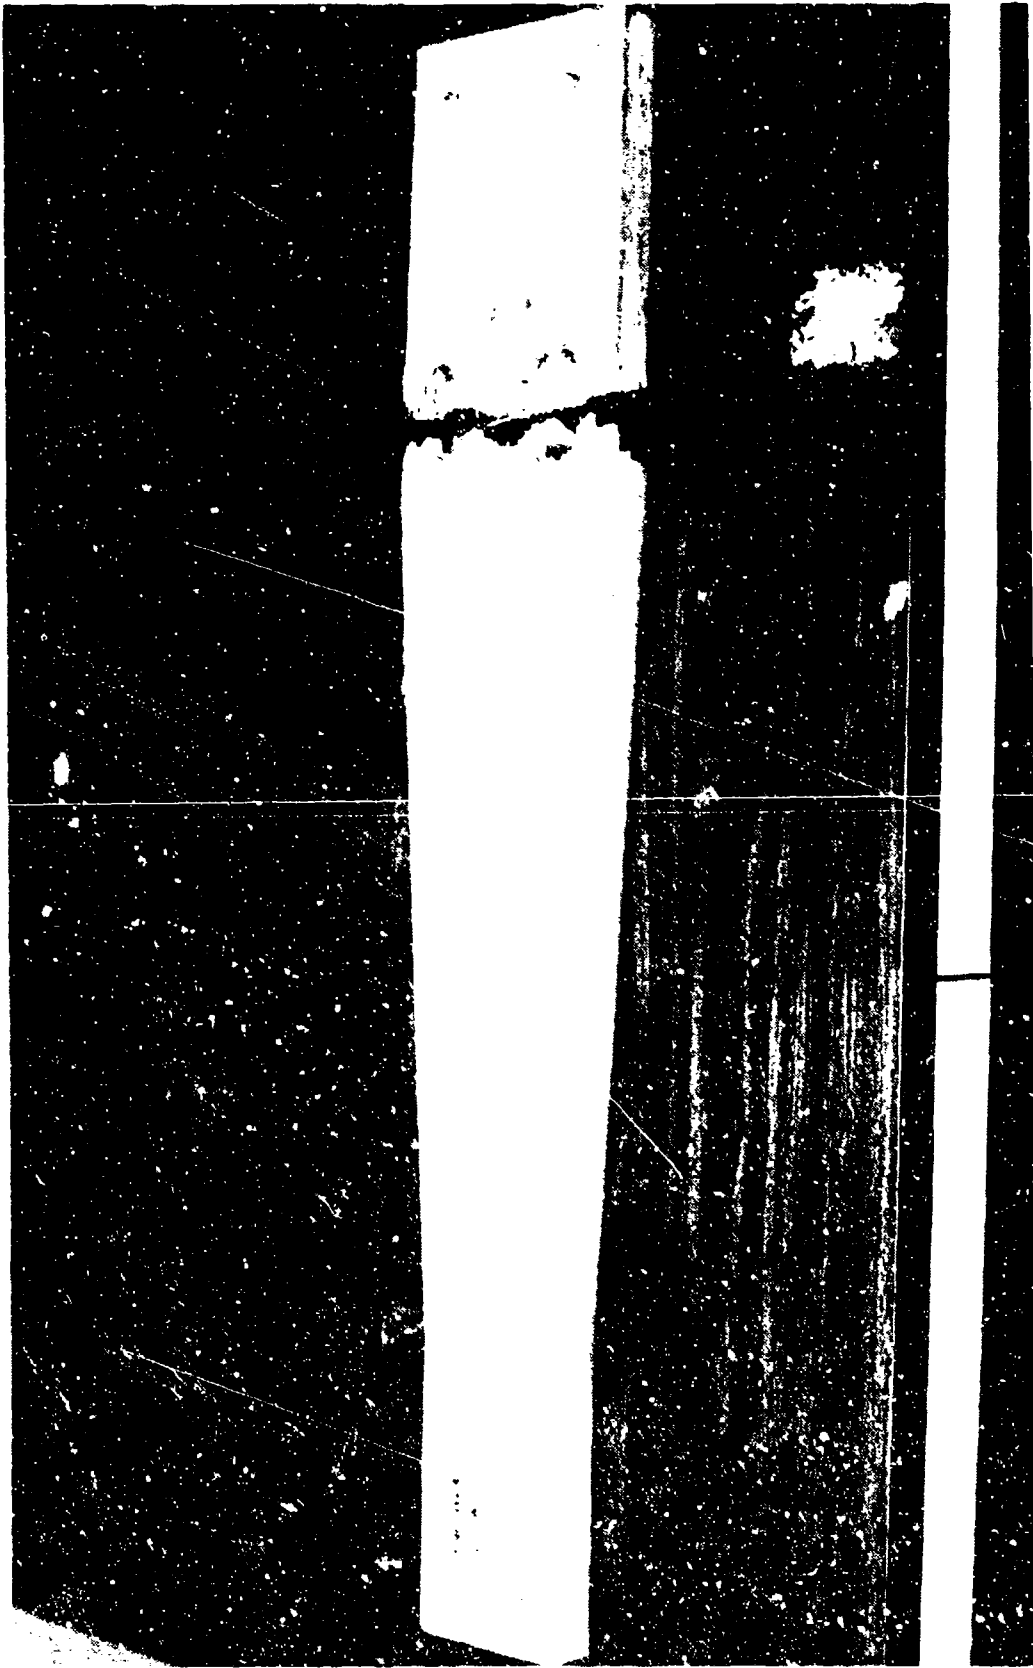
Lower surface

Note: The trans laminar fracture occurred at the bolt holes on the surface.

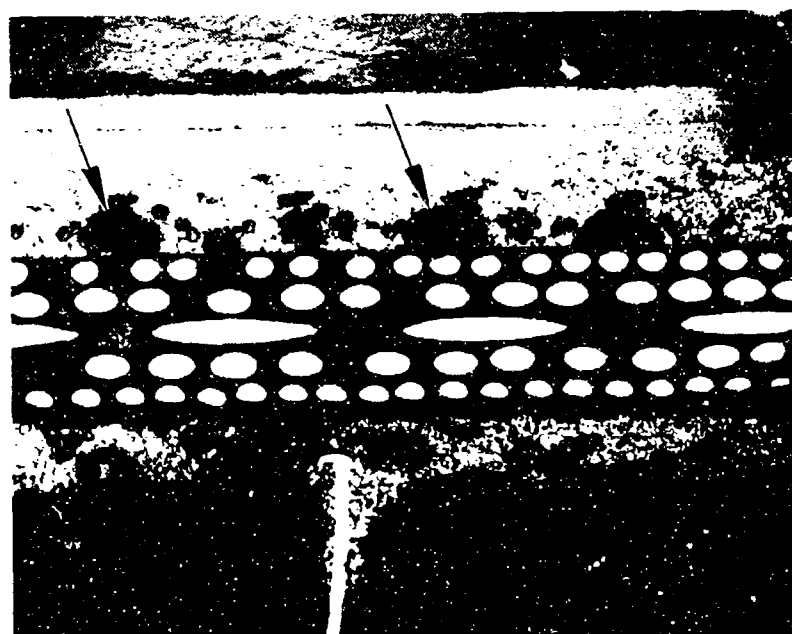
*Figure 2-59. Photograph of Cross-Section Taken Through Rudder Skin*  
 Note Porosity in Skin at Arrows

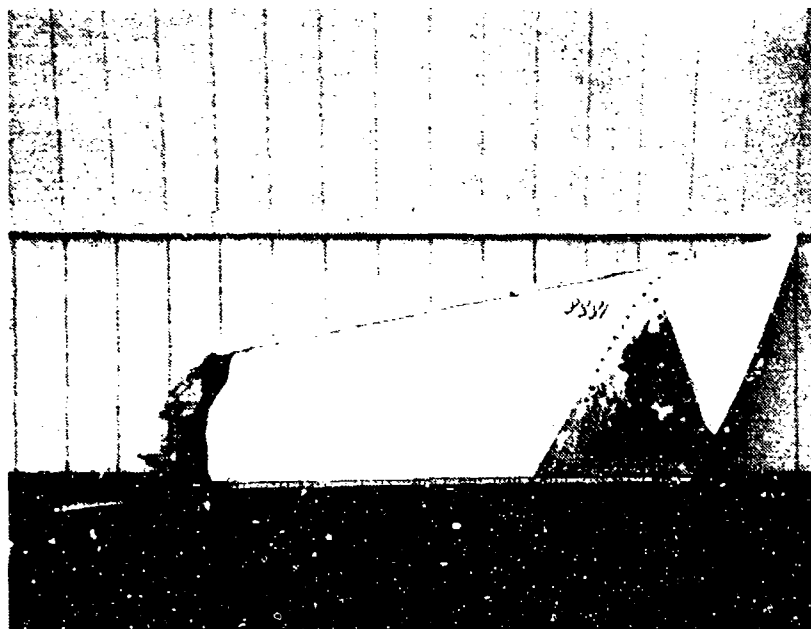
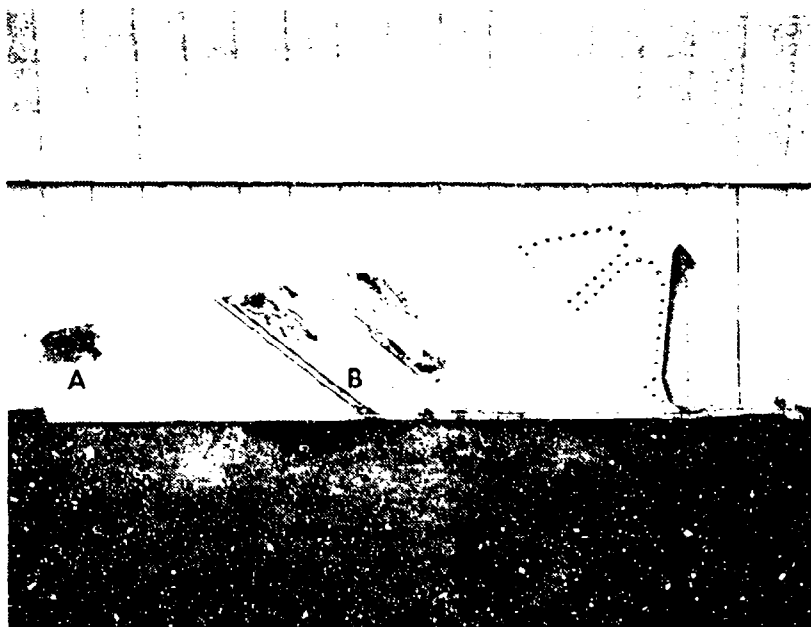
Figure 2-61. As-Received Photographs of Horizontal Stabilizers  
 (a) Outboard Tip Missing on Stabilizer #1, P/N 7630168A890054-2003  
 (b) Skin Damage on Stabilizer #2, P/N 7630168A210053-1015  
 Note damaged zones A and B

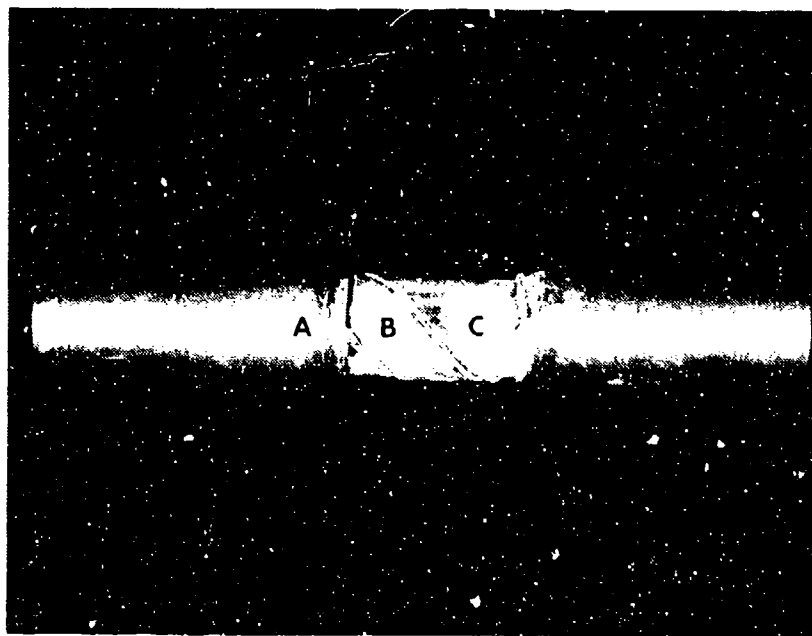
*Figure 2-71. Photograph of Cylindrical Specimen After Sectioning to Expose Internal Damage*

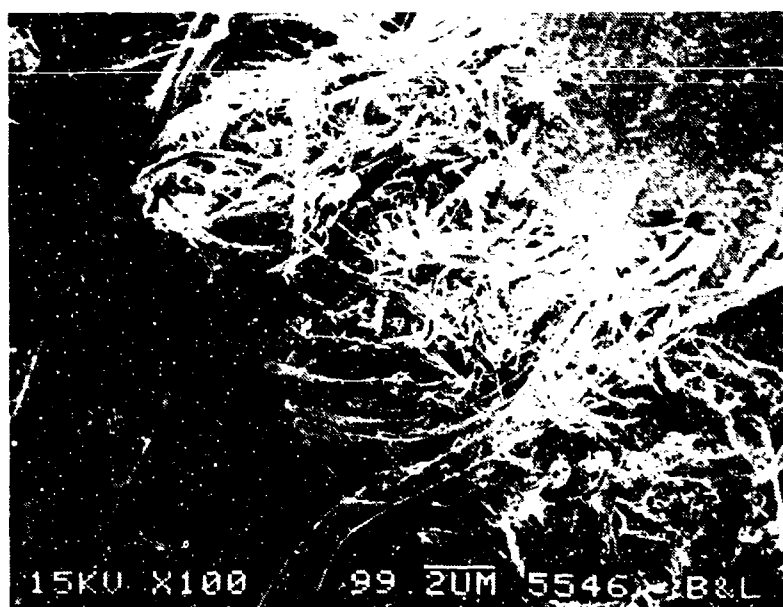
Figure 2-73. SEM Photographs of Damage on Outer Surface of Cylinder  
 (a) Low Magnification Showing Displacement of Fiber Bundles, Splits and Defibrillation of Fiber Ends  
 (b) High Magnification Photograph Showing Fibril Clusters

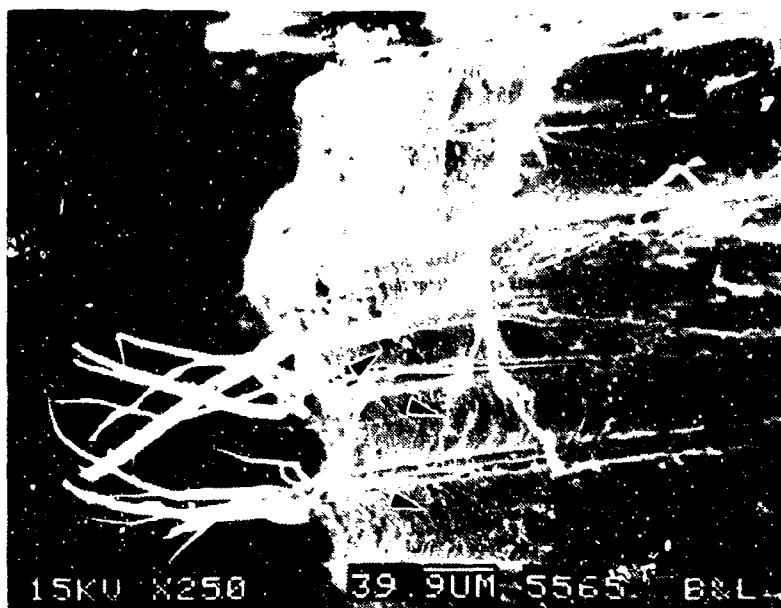
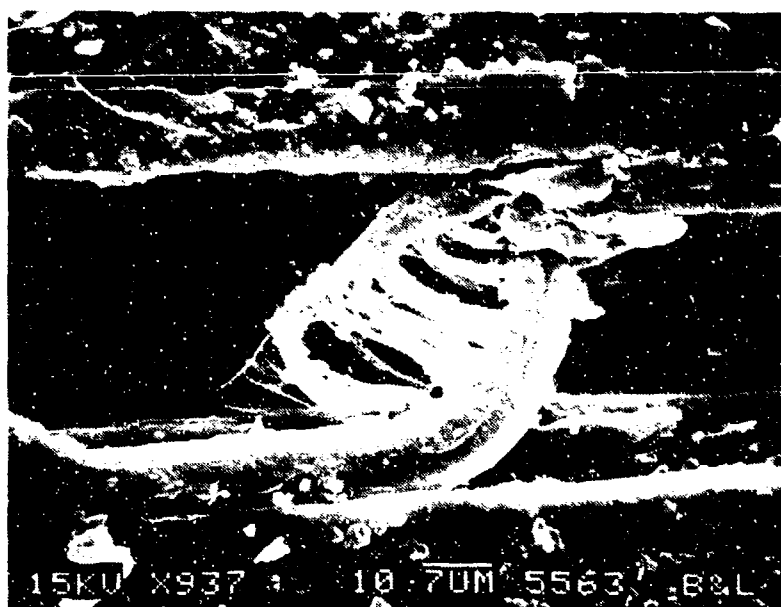
Figure 2-74. SEM Photographs of Outer Surface Damage With Clusters of Fibrils Removed  
 (a) Hackles (Arrows) in Resin  
 (b) Localized Bending of Fibers

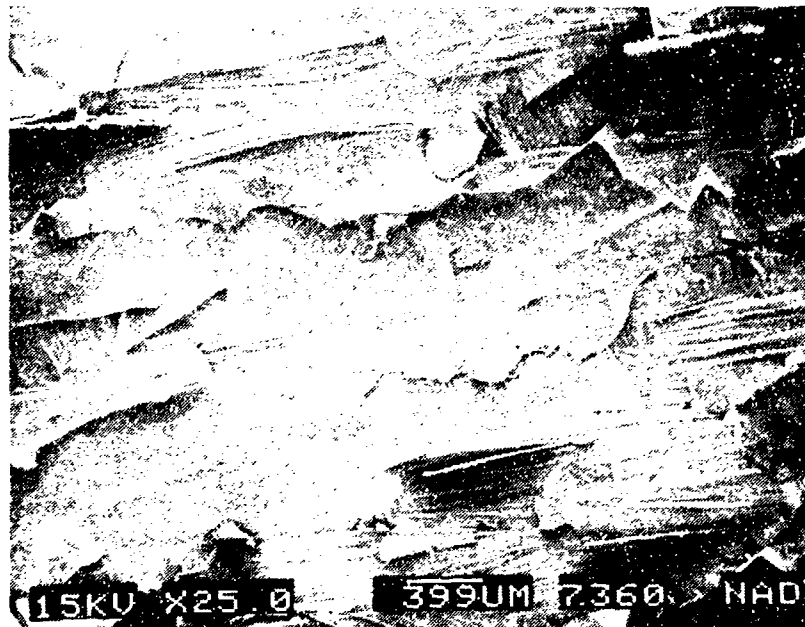
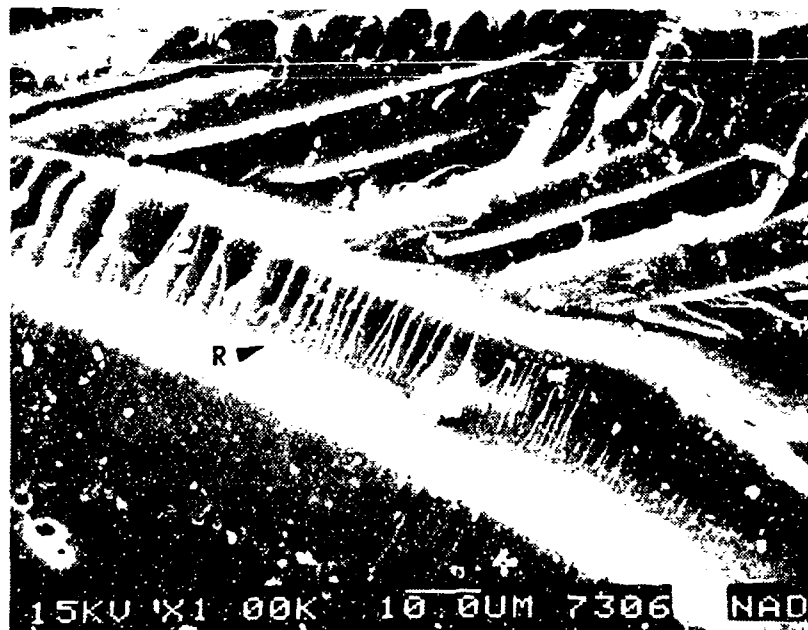
Figure 2-78. SEM Photographs in Region A of Delamination of Bottom Surface of Compound Plate  
 (a) Mixed Cohesive-Adhesive Failure  
 (b) Holes and Voids in Resin  
 Note river patterns (arrow)

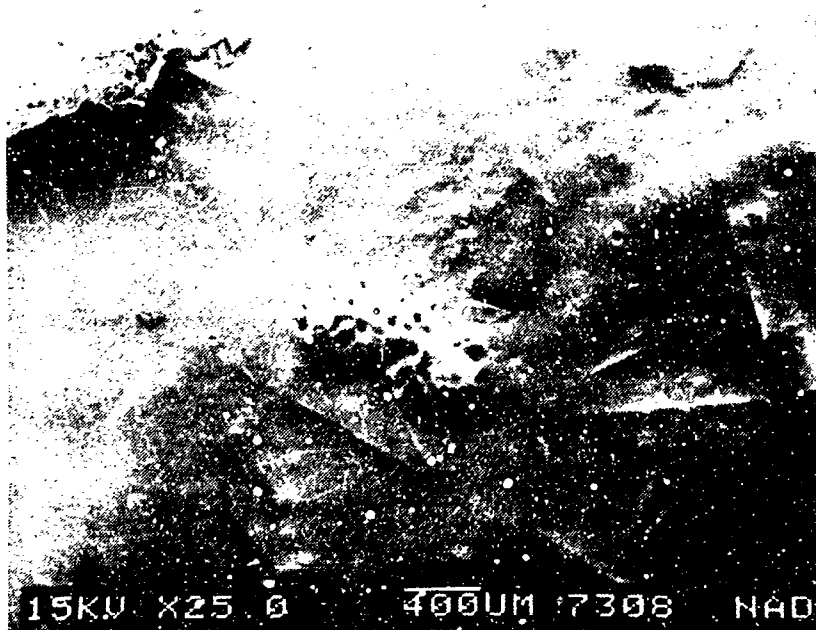
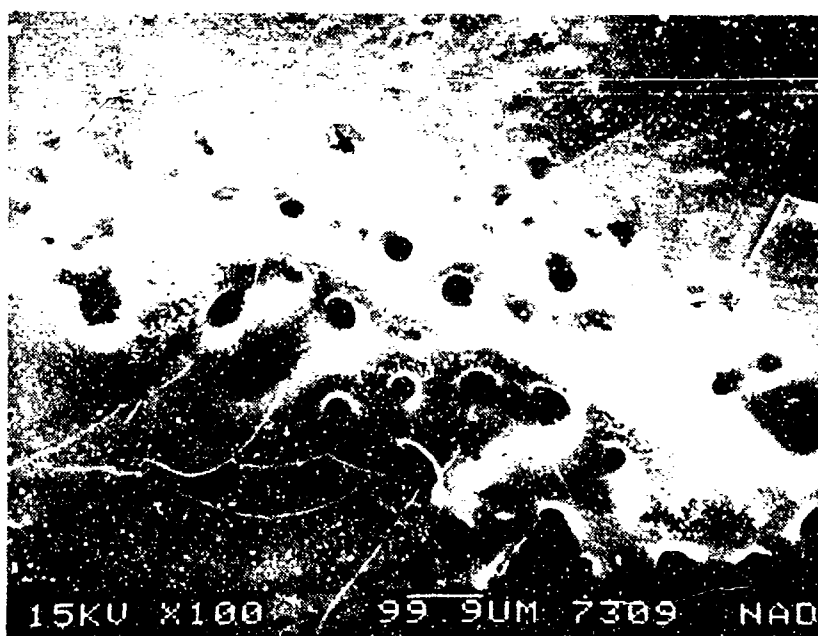
*Figure 2-79. SEM Photographs in Region B of Delamination of Bottom Surface of Compound Plate  
(a), (b) Low and High Magnifications Showing Melted Surface Associated With Porosity and Cracks*

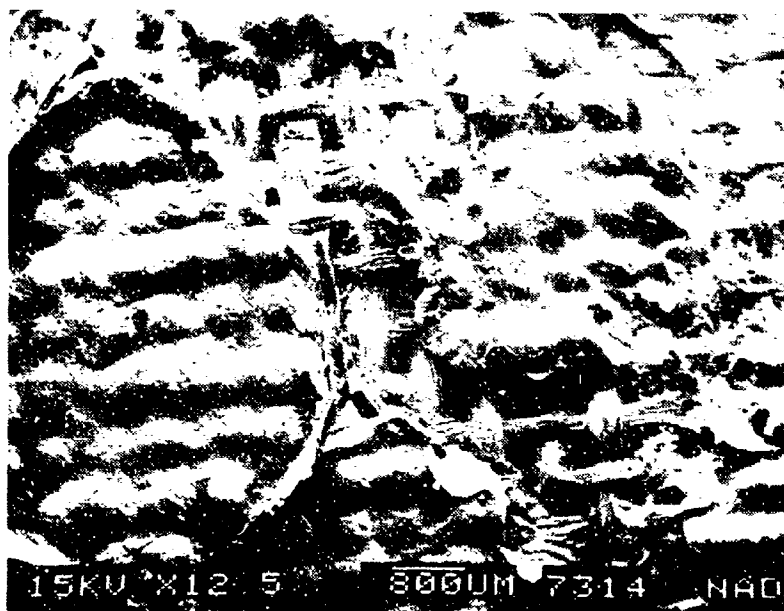
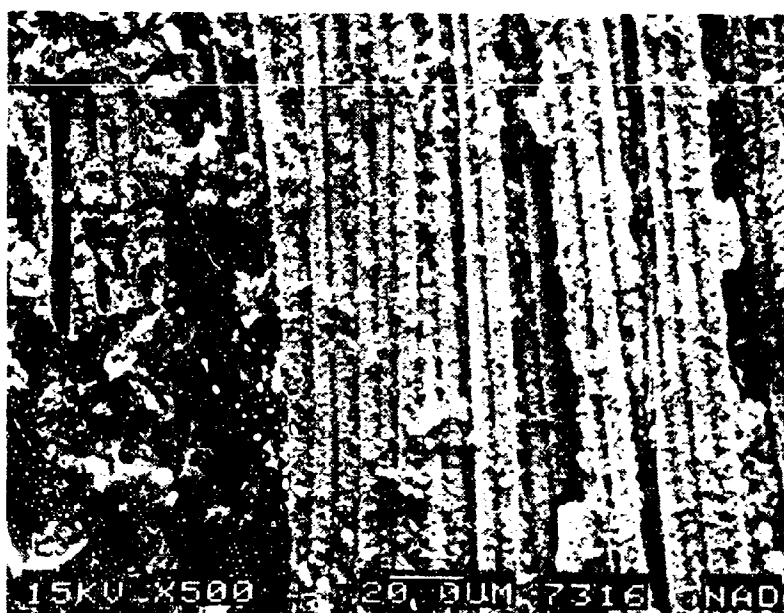
Figure 2-80. SEM Photographs in Region C (Honeycomb Region) of Delamination of Bottom Surface of Compound Plate  
 (a) Adhesive Failure of Honeycomb  
 (b) Heat Damage to Adherend

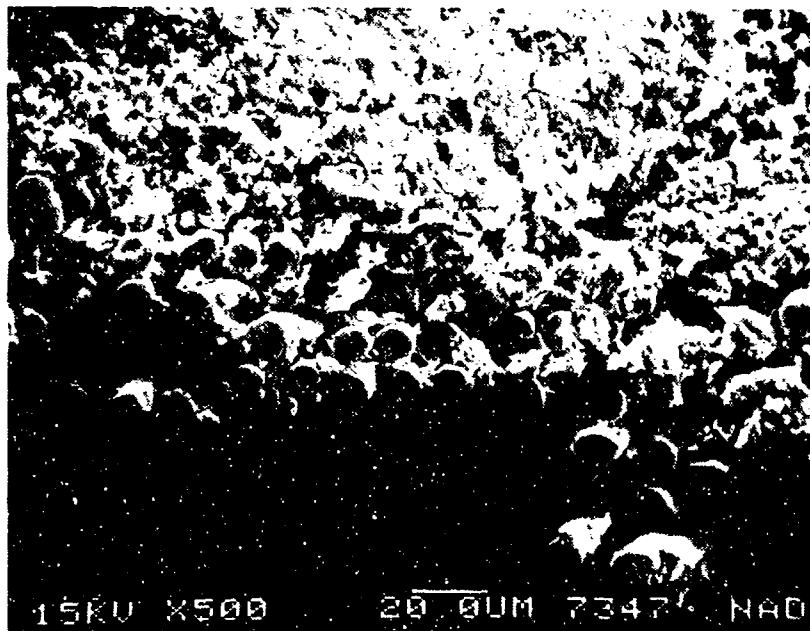
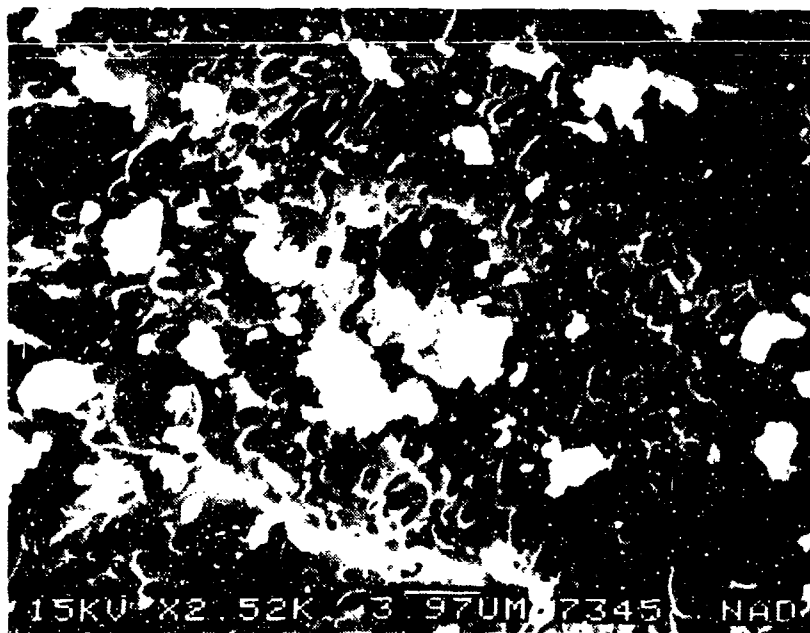
Figure 2-81. SEM Photographs of Bolt Hole Cross-Section in Bottom Surface of Compound Plate (Region D)  
 (a) Compression Fracture of Fiber Ends  
 (b) Porosity and Debris in Resin

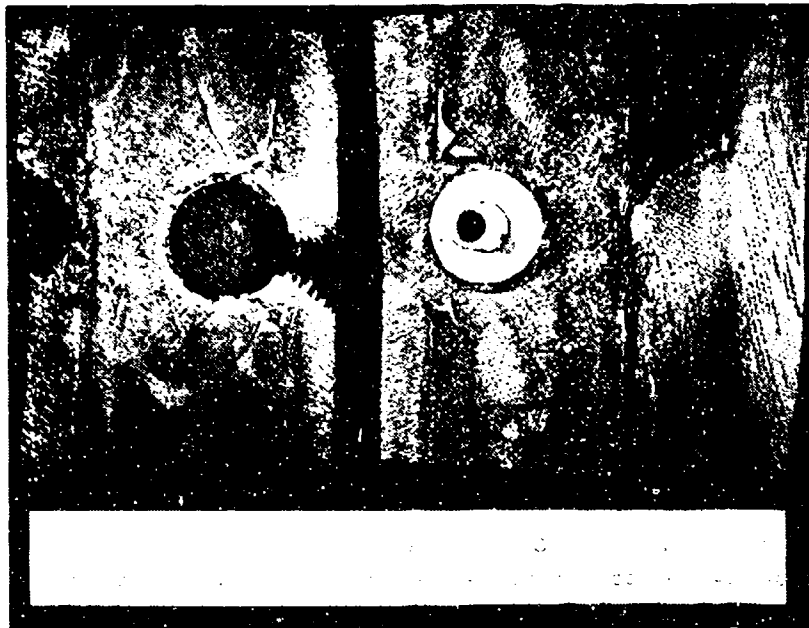
The top surface of the compound plate was also examined. The section was extremely brittle and delaminated upon gentle handling with a tweezer (Figure 2-82). Evaluation of the fragment, which appeared to be ceramic in nature, revealed evidence of overheating as suggested by the bent contour (Figure 2-83a) and voids observed during SEM examination (Figure 2-83b).

*Figure 2-82. Delamination in Top Surface of Compound Plate (Mating Halves)*
