## NONDESTRUCTIVE EVALUATION OF A GRAPHITE ALUMINUM COMPOSITE SPACE RADIATOR PANEL

BY NEIL M. FELDMAN AND JOHN V. FOLTZ

RESEARCH AND TECHNOLOGY DEPARTMENT

DECEMBER 1991

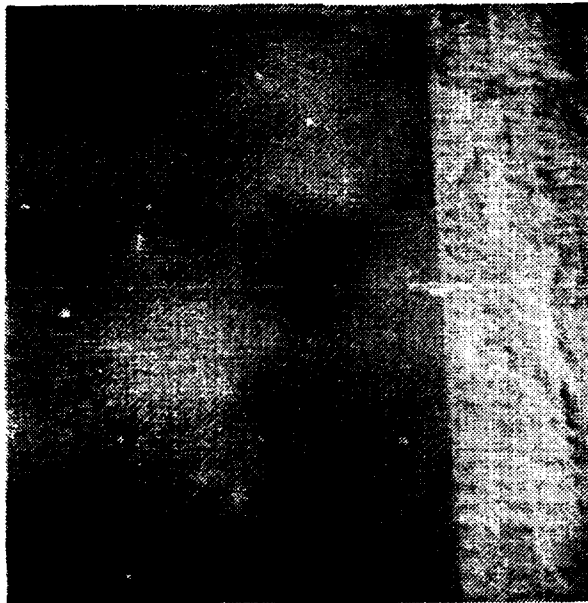
Each of the pinhole size dots corresponds to a pore or shallow microdimple in the aluminum. The pores were not crack-like and there were no radial crack-like indications around any of the bolt holes. The larger pores indications were approximately .02 inch in diameter, whereas most of the pore indications were approximately .005 inch in diameter (see Figure 11).

FIGURE 11. DYE PENETRANT POROSITY PATTERN

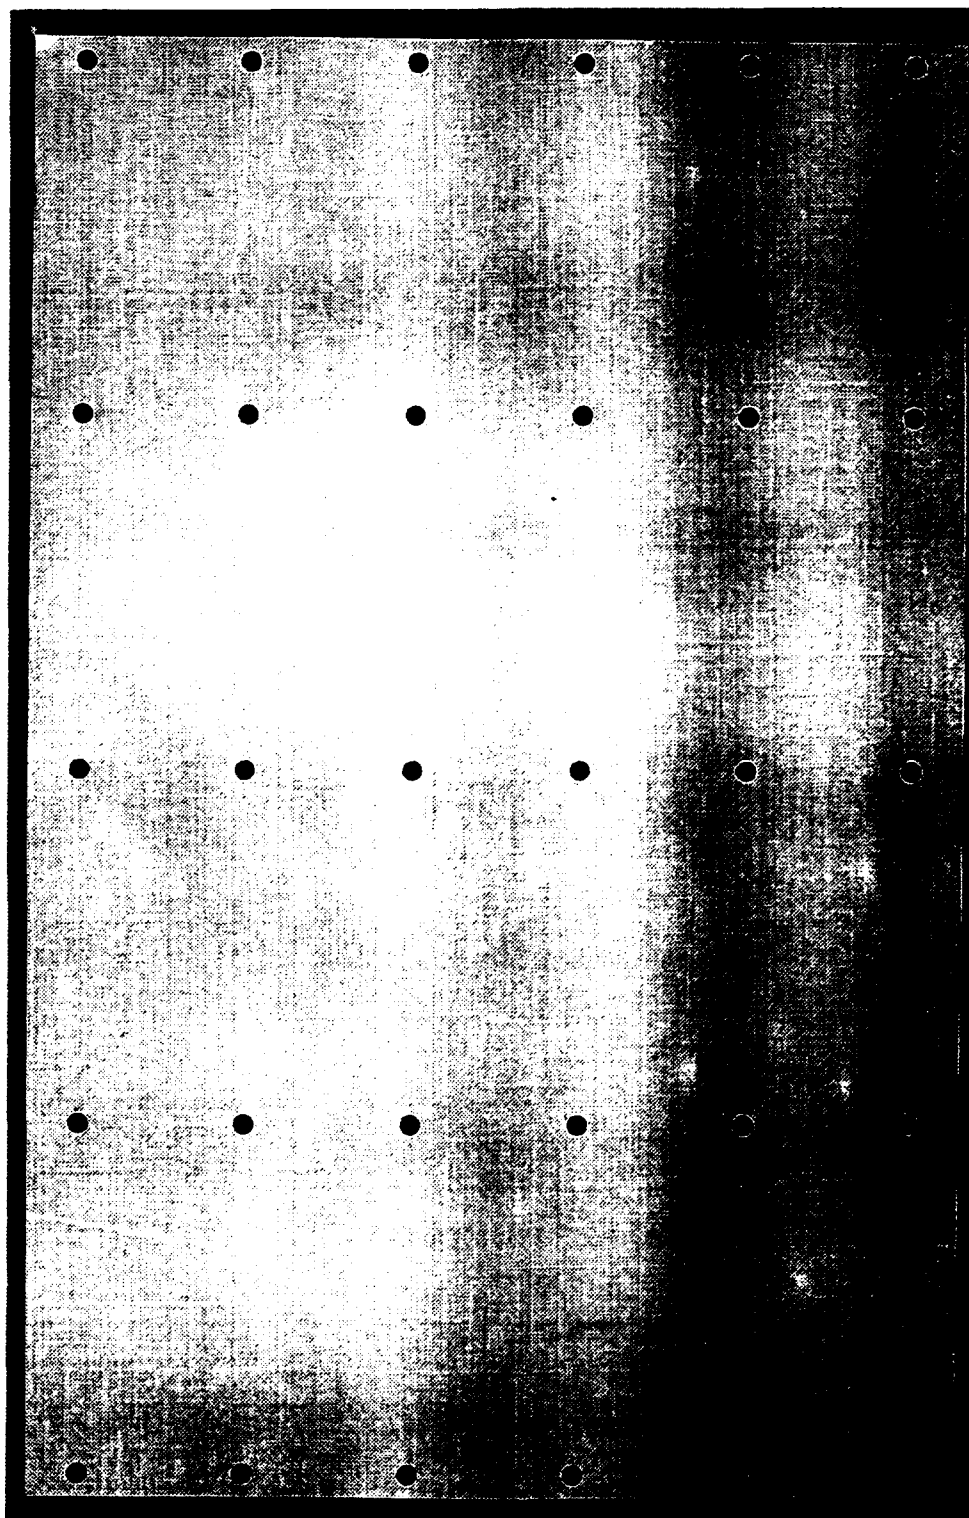
Figure 14. White dots are exhibited all over the panel which can be attributed to two phenomena. The first would be that the nickel-plating process produced a very rough surface leaving small bead-type bumps on the surface of the panel. The other case for the white areas on the film is that the microdimples or pores were nickel-plated over, giving a very thin layer of nickel over the pore. The pores are filled with nickel, and since nickel has significantly higher absorption than aluminum and graphite, the nickel indications on the radiograph can be seen easily. Around the machined holes are prominent white bands which are attributed to a layer of pure nickel on the inside diameter of the drill holes (Figure 14). The nickel bands on the radiograph are an excellent method of checking the uniformity of the thickness of the nickel-plating process.

FIGURE 14. RADIOGRAPH OF COMPOSITE AFTER NICKEL PLATING

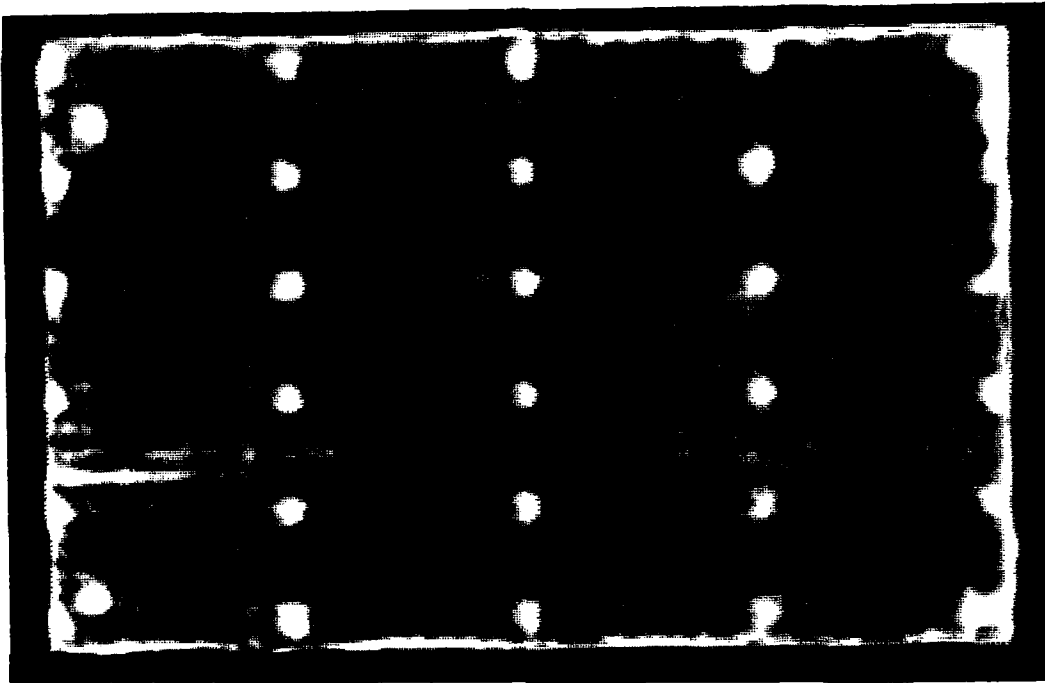
FIGURE 21. GREY SCALE C-SCAN OF PANEL AFTER HOLES WERE MACHINED

FIGURE 22. COLOR SCALE C-SCAN OF PANEL AFTER HOLES WERE MACHINED

from the ultrasound data and visual inspection. This area is where the entire signal is attenuated approximately 19 dB. In Figures 21 and 22, the holes can be seen in the C-scan after the panel has been machined. The holes are white because of the RTV adhesive attenuating the ultrasound signal. The panel for Figures 21 through 25 is rotated 180° around the 0° axis changing the orientation of the C-scans, but leaving the ultrasound parameters unchanged. This change in orientation occurred because the reference number on the panel was cleaned during the machining process, and Ni plated over. In Figure 22 the delaminations in the left region of the panel appeared to be reduced in severity in the C-scan. But, the delamination in the left side of the panel is unchanged in its signal attenuation. The center and right region of the panel is more homogenous in signal strength, areas of anomalies seem to have lessened in severity. The reasons for this phenomenon will be represented in the discussion. From the C-scan the panel appears to be in good structural shape.

The composite panel's soundness appeared to improve in the subsequent C-scans after the holes were machined. A hypothesis is that this phenomena is attributed to the panel's physical layup properties during fabrication. When the composite is fabricated a residual stress is created by the aluminum shrinking and the graphite fiber tending to remain in its original form during the cool down process. The graphite fibers are under compression while the aluminum is under tension. When the holes are machined there is a relaxation of the membrane stresses in both materials created by the free surface around the holes and decreasing with distance from the free surface. If there is a delamination within the composite the delamination could lead to a bending moment between layers. When some of the compression is released by the drill holes the relaxation allows the delamination to close.

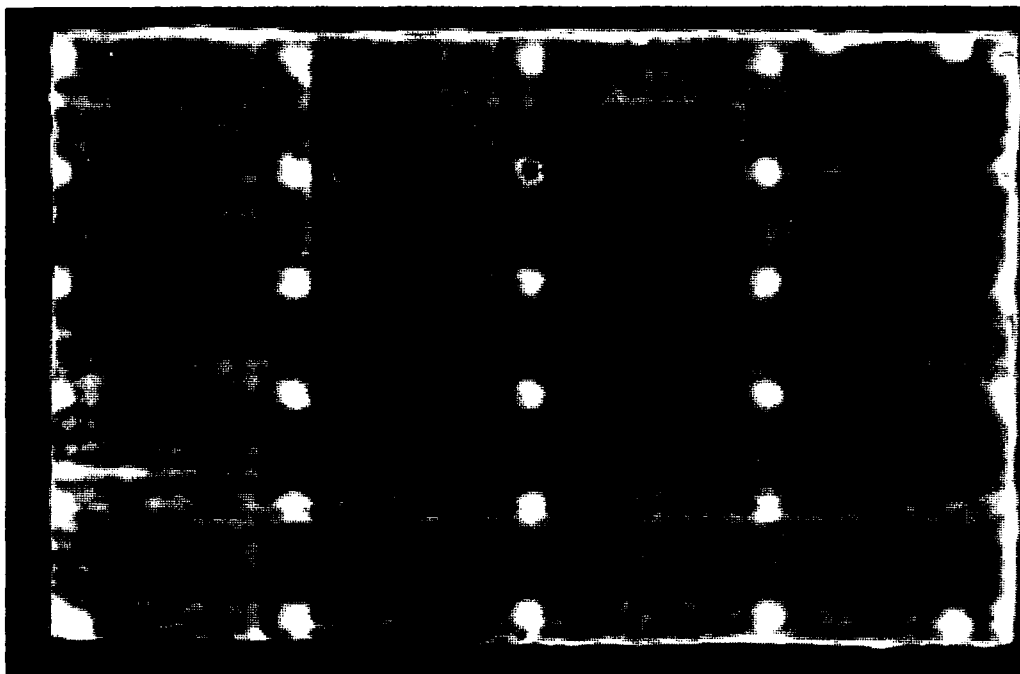
FIGURE 23. GREY SCALE C-SCAN OF PANEL AFTER NICKEL PLATING

FIGURE 24. COLOR SCALE C-SCAN OF PANEL AFTER NICKEL PLATING

The C-scans in Figures 23 and 24 were conducted after the panel went through the process of being nickel plated. The panel appeared to be unchanged from the nickel-plating process.
