**THREE CASE HISTORIES OF CRACKING PROBLEMS  
ASSOCIATED WITH  
STEEL BRIDGE FLOOR BEAMS**

A Report on a Research Project  
Sponsored by the  
STATE OF ILLINOIS  
DEPARTMENT OF TRANSPORTATION and the  
U. S. DEPARTMENT OF TRANSPORTATION  
Federal Highway Administration

DEPARTMENT OF CIVIL ENGINEERING  
UNIVERSITY OF ILLINOIS AT  
URBANA-CHAMPAIGN  
URBANA, ILLINOIS  
JUNE 1992

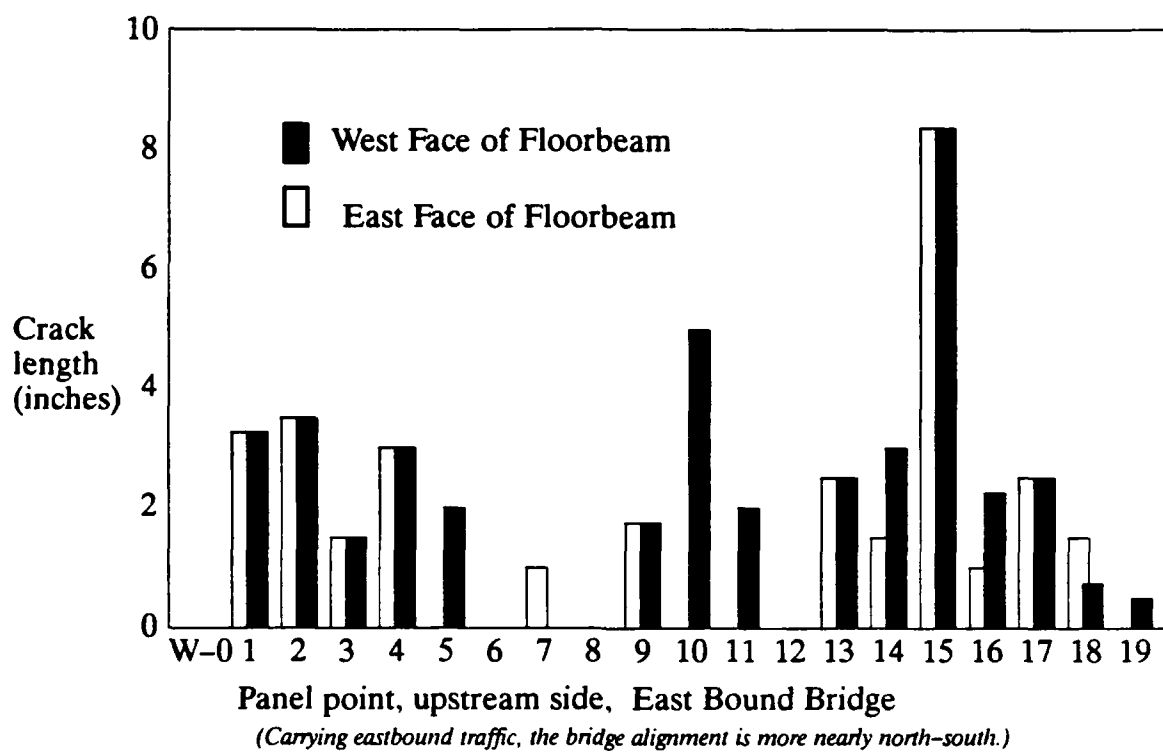
Fig. 3.4a Crack Measurements at Floorbeam Ends, Various Panel Points

The occurrence of the cracks in the floor beam ends at the top flange-to-web region at various panel points along the span is illustrated in Fig. 3.4a and 3.4b for half of the span carrying eastbound I-474 traffic. Fig. 3.4a refers to the upstream end of the floor beam and 3.4b to the downstream end. Note that the alignment of the bridge is more nearly north-south as it crosses the Illinois River at this location. These data come from the detailed tabulation [11] of inspection results for 1985 and 1986.

The most common crack lengths are on the order of 2 to 3 in., but with instances of locations where cracks of 6 to 8 in. are present.
