AEROSPACE REPORT NO.  
TR-0089(4935-08)-1

## An Investigation of the Effect of Low Velocity Impacts on P75/934 Graphite/Epoxy Composites

J. N. SCHURR, M. T. QUINN, and G. F. HAWKINS  
Materials Sciences Laboratory  
Laboratory Operations

1 April 1991

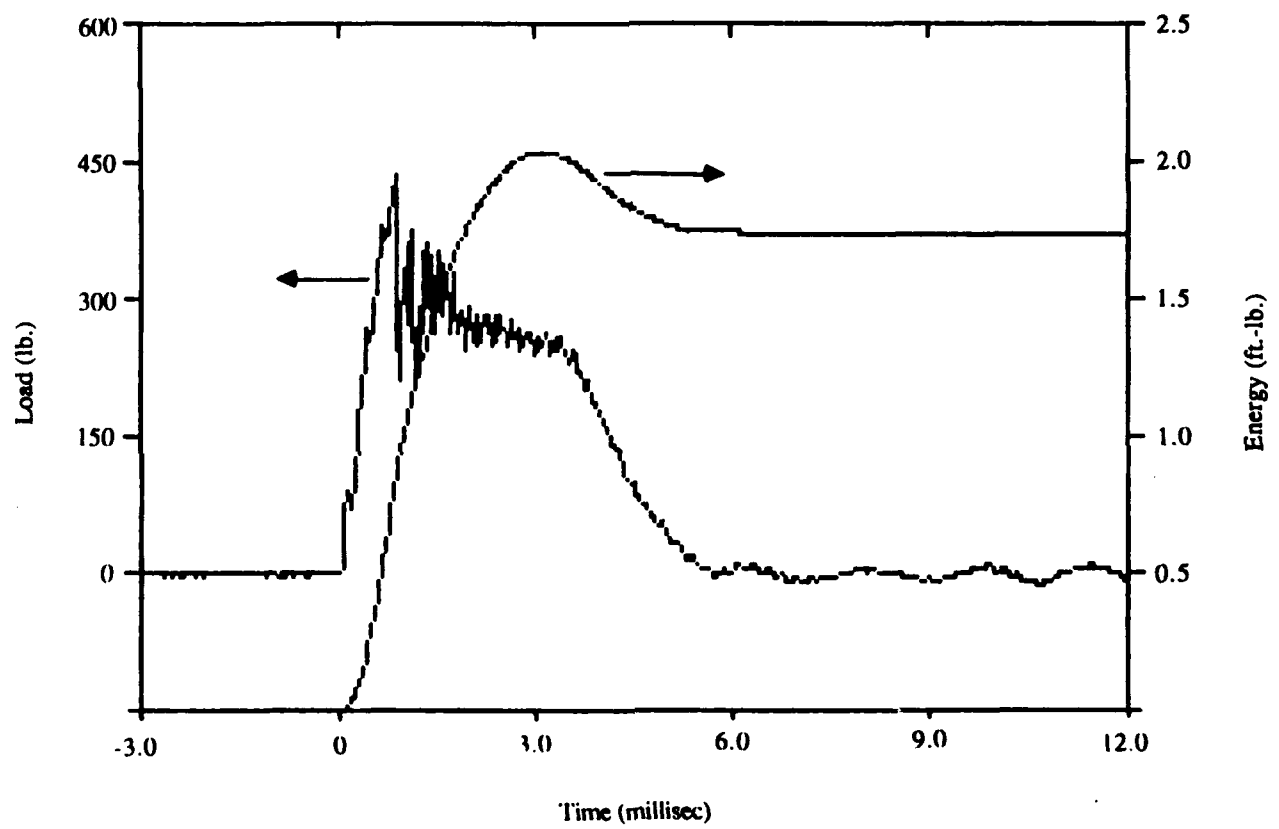
The measured load and calculated absorbed energy vs time plot for NDT-4.11 is shown in Fig. 9. When the impactor first hits the specimen, the load rises linearly as the specimen undergoes elastic deformation. Then there may be yield behavior with increased damage to the impacted plate. The load continues to rise to a maximum, at which point the load drops suddenly, indicating brittle failure.

Fig. 9. Plot of Load and Energy vs Time for NDT-4.11

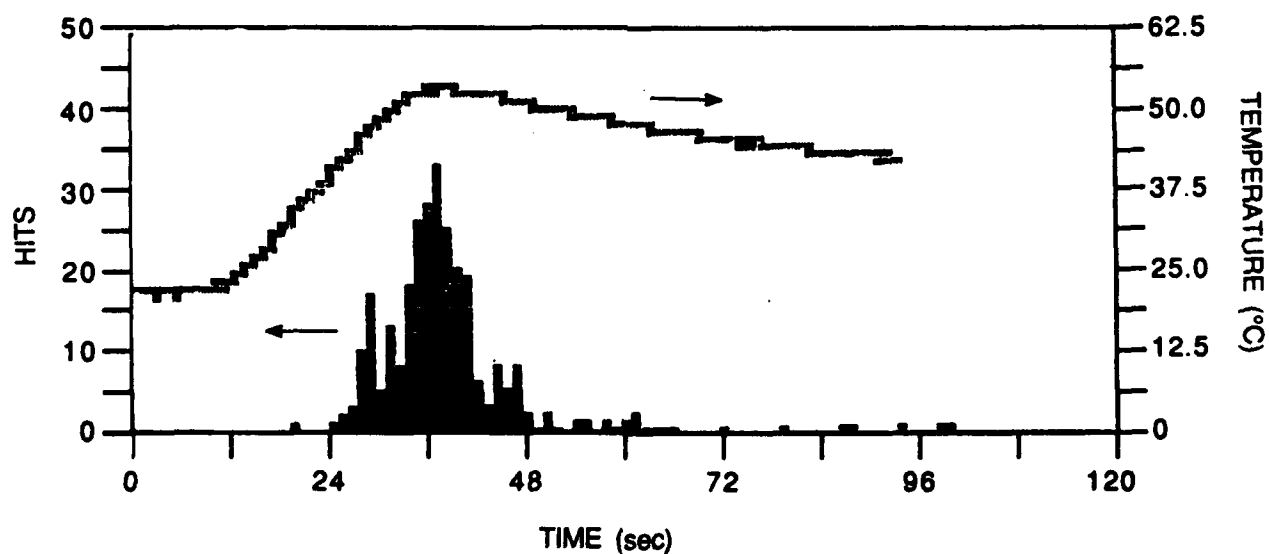
The first run was made on an undamaged specimen cut from NDT-4. The results are graphed in Fig. 18. As expected, no notable AE was detected from the undamaged specimen. When a damaged specimen was tested, AE increased with increased temperature. In their work with carbon-carbon composites, G. F Hawkins et al. attributed the increase in AE signal to the increase in thermal strain caused by the larger thermal gradient (Ref. 16). The results from NDT-4.11 are shown in Fig. 19. The AE data from the four specimens tested indicate an inverse relationship between number of events and impact energy. Also, the amplitude of each event increased with increasing impact energy.

Fig. 19. Acoustic Emission from Specimen NDT-4.11. Total number of hits: 1005. Impact energy of 24.0 in.-lb.
