DOT/FAA/RD-92/8

Performance of Insulated Pavements at Newton Field, Jackman, Maine

Maureen A. Kestler
Richard L. Berg

May 1992

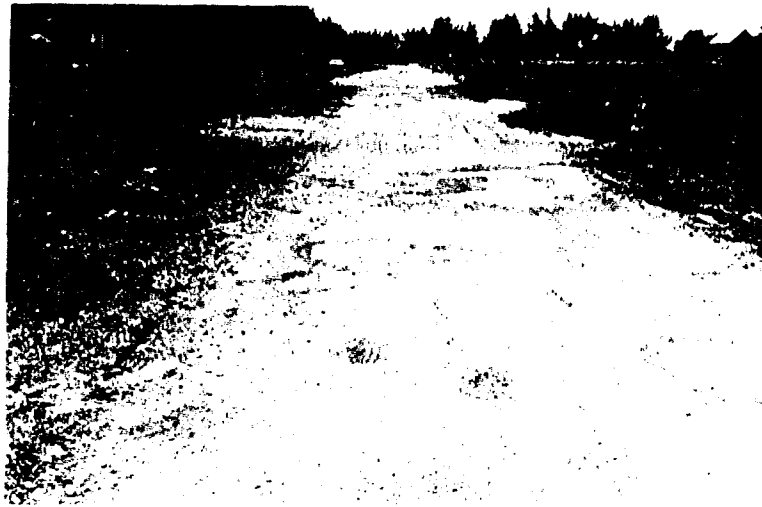
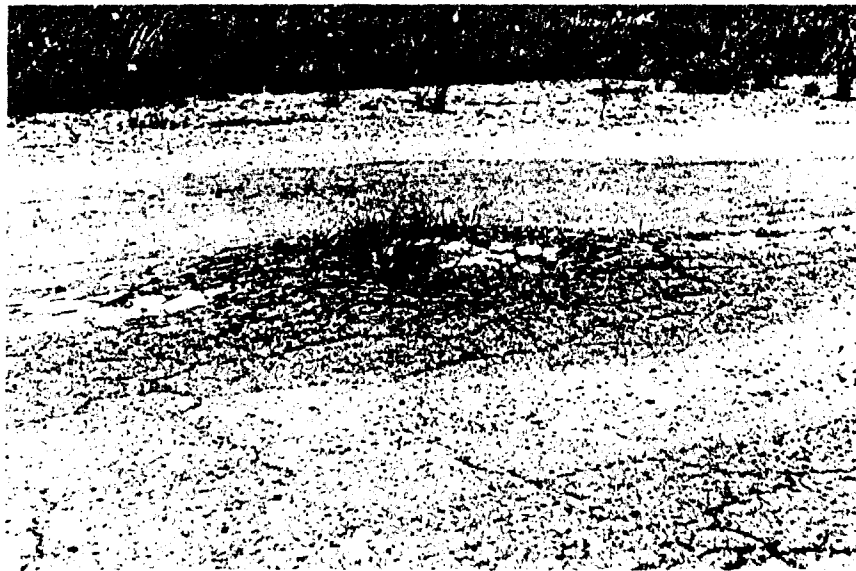
Figure 2. The Newton Field runway before 1986.

The runway at Newton Field was reconstructed in 1986. The old runway was in extremely poor condition, as is shown in Figure 2. The longitudinal and transverse pavement surface was highly irregular and was disintegrating as a result of moisture entering the large number of cracks. Although located in the same vicinity as the old runway, the new 2900- × 60-ft runway is longer, wider, and at a slightly different orientation than the old runway.

a. Looking northwest.

b. Boulder heave.

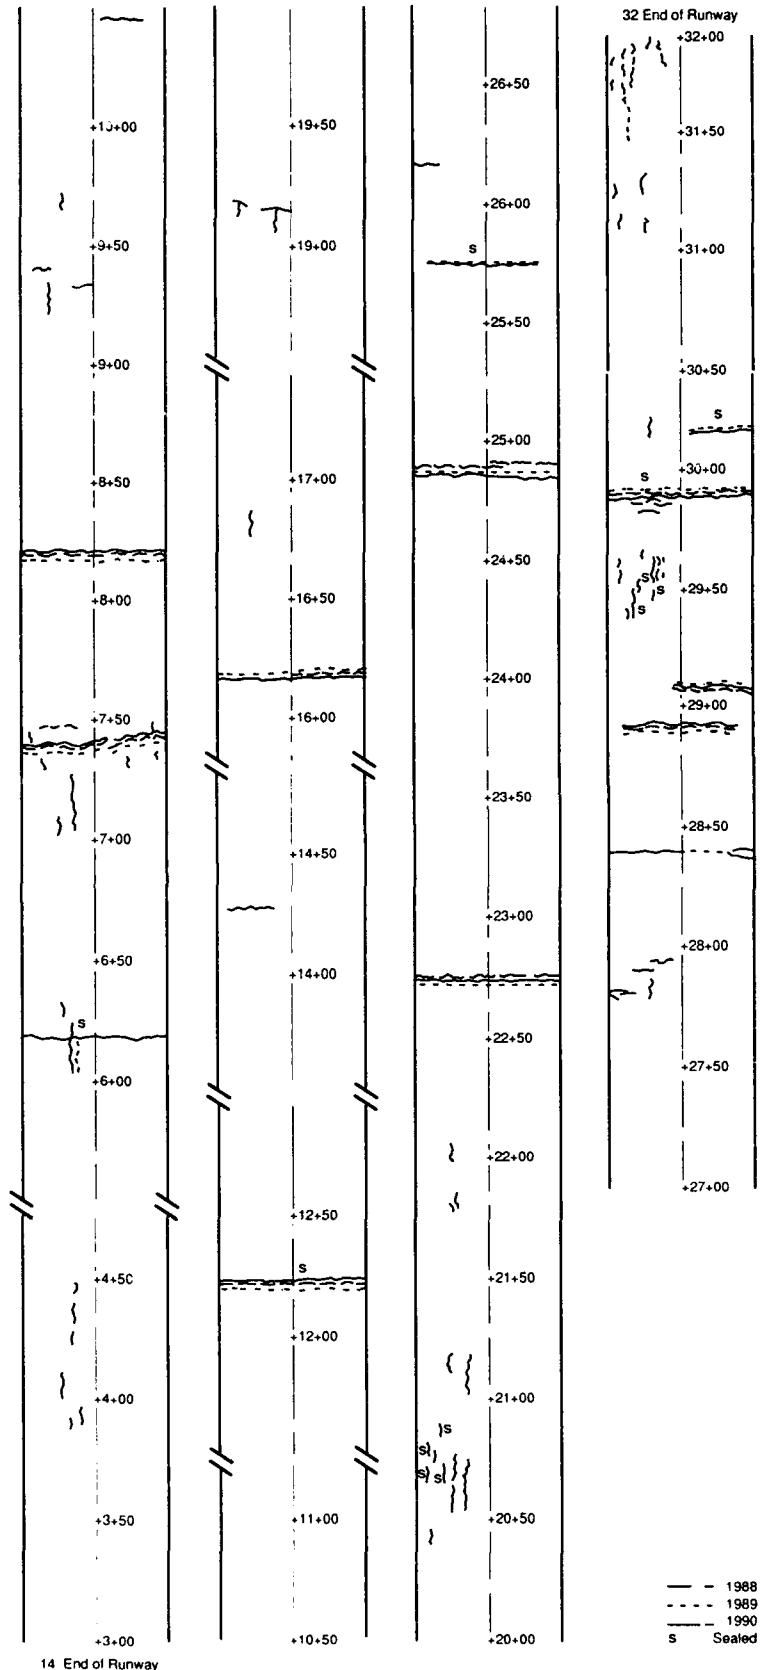
Figure 9. Newton Field pavement crack map.

The asphalt concrete was placed in two lifts. The first was placed immediately following construction in 1986, and the second was placed in 1987. Two major transverse cracks developed in the first lift during the first year: one at station 8+00, and the second at station 30+00. Each of the two cracks reflected through the final layer.

The progression of crack development following placement of the final 1 1/4-in. asphalt concrete lift in 1987 is shown in Figure 9. Although the cracks had been sealed in September 1989 with a rubberized crack sealer and polyfiber, nearly all cracks have since reopened. In all instances, the failure occurred due to a loss of adhesion between the asphalt pavement and the sealing agent. The crack shown in Figure 10a was unsuccessfully sealed with silicone shortly before being resealed with the rubberized crack sealer.

Generally, the cracks have manifested themselves in two varieties: small longitudinal cracks typically occurring in localized groups, and individual long, wide, transverse cracks. Elev-

en transverse cracks extend across, or nearly across, the entire runway, and two transverse cracks extend across the taxiway. Crack density is particularly high at the southeast (32) end of the runway; elsewhere, cracks are fairly evenly distributed.

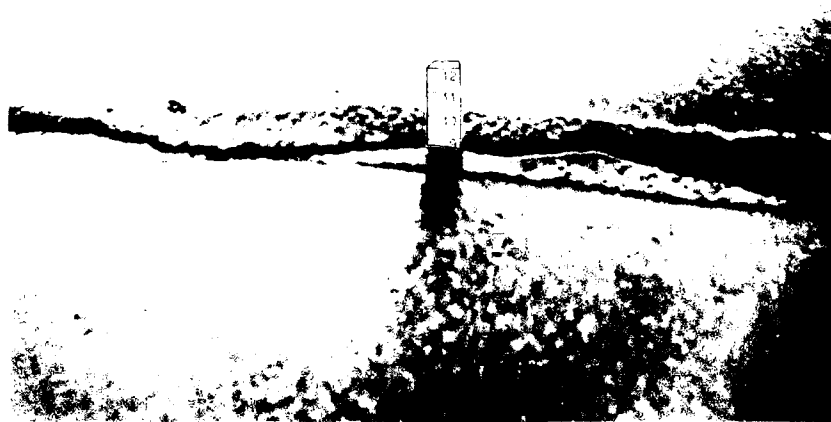
b. Crack at station 16+15.

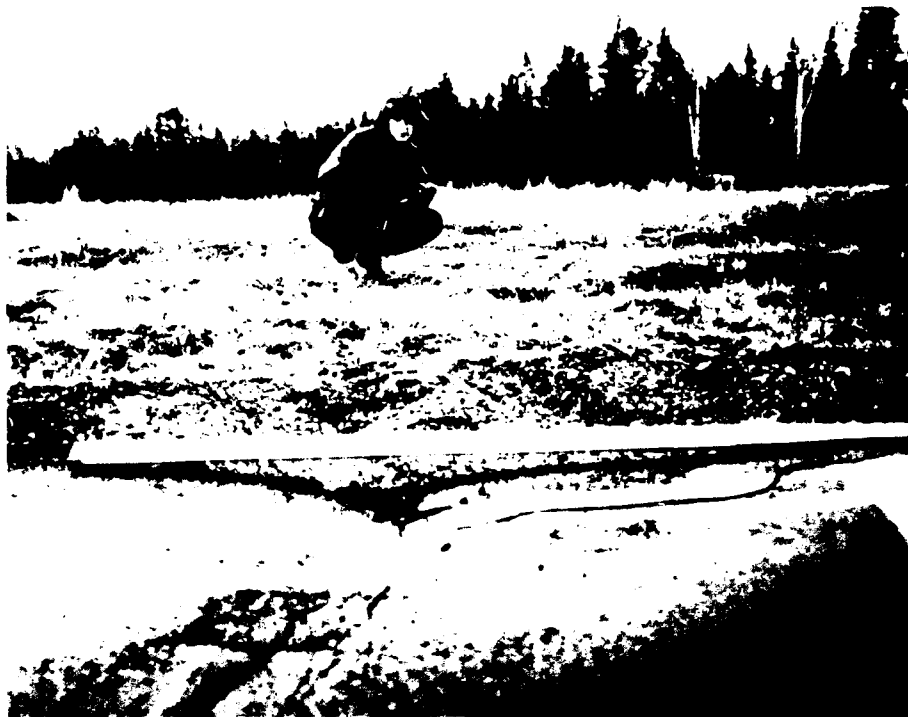
c. Settlement of pavement at station 29+95
Figure 10 (cont'd).

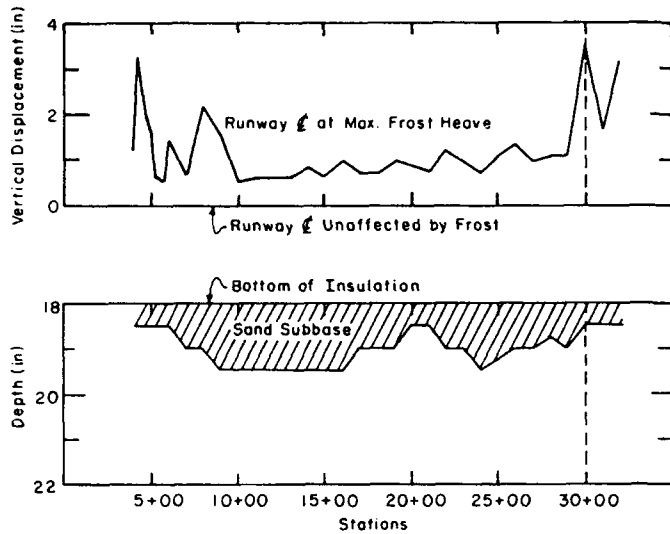
Figure 11. Profile of frost-heaved centerline and corresponding depth of sand subbase, March 1990.

32+00, approximately 3 in. Figure 11 shows both the March 1990 centerline profile and the depth of sand subbase along the length of the runway. The areas that experienced appreciable frost heave generally correspond to the two ends of the runway that were excavated to a lesser depth. In addition, both ends of the runway were particularly spongy during construction.

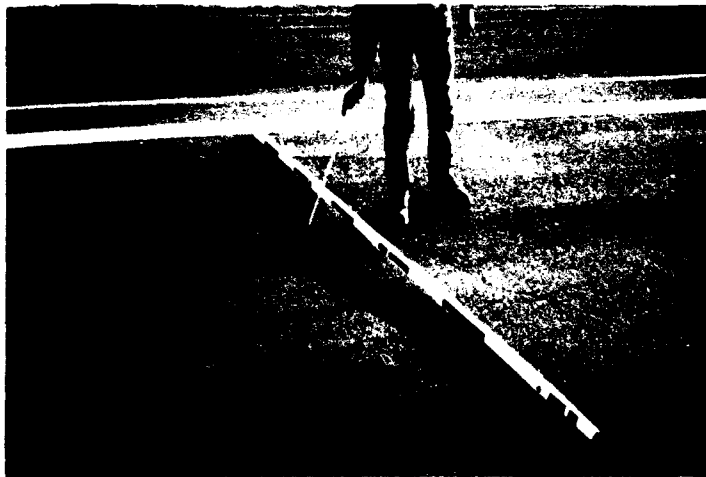
Figure 12. Differential frost heave near station 8+00. The "valley" is about 6 in. below the "ridges."

Localized differential heave was exhibited each spring in the vicinity of station 8+00 and between stations 29+00 and 32+00. Figure 12 depicts the irregular pavement surface near station 8+00 in early April 1988; in this area the differential movement was about 6 in. A variety of methods have been employed to investigate the causes of the localized differential frost heaving; the methods and observations are discussed later in this report.

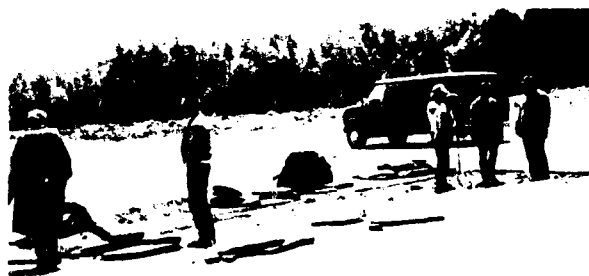
ized settlement (Fig. 16). Figure 17 shows the overlapping and damaged insulation that was removed and replaced. The damaged insulation at this particular location had been attributed by the consulting/design firm to settlement of the backfill above the 10-in. PVC sewer line that crosses the runway at a depth of approximately 8 to 9 ft beneath finished grade. It is probable, however, that similar insulation damage or separation of adjacent panels caused the temperature anomaly at station 4+50. Similar problems also are probably responsible for the substantial differential frost heave at both ends of the runway. These areas were undoubtedly more unstable during construction than areas with a thicker layer of granular material beneath the insulation. Since the subgrade possessed very low strength during construction, movement of the insulation panels due to construction traffic probably caused the individual boards to move, resulting in gaps in some locations and overlap in others.

Figure 16. 1987 removal of pavement at station 30+00.

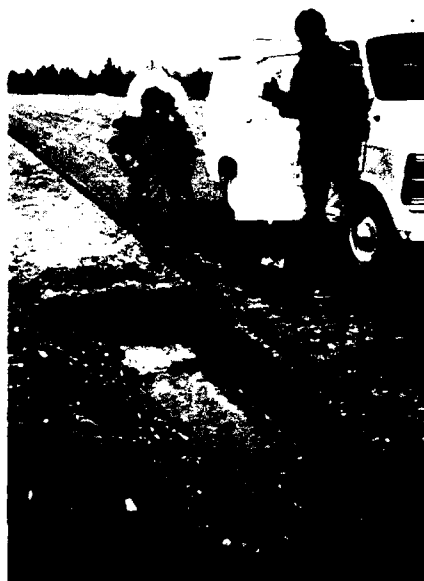
Figure 18. Station 7+75, south edge of Newton Field runway.

In April 1988, a 2- × 5-ft trench was hand-excavated immediately adjacent to the north edge of the runway at station 4+25. The insulation proved to be intact, with only a 1/4-in. gap between panels. A similar 2- × 8-ft trench at station 7+75 on the south edge of the runway again yielded intact insulation; however, a 2 1/2-in. gap was observed between insulation panels (Fig. 18). A third trench was started at station 4+75 on the south edge of the runway, but was abandoned when insulation was not encountered at the excavated depth of 18 in.

a. Trench excavation

b. Gap between insulation panels

1. Field investigations confirm that gaps in excess of 2 in. have developed between the buried insulation panels in the shoulder area immediately adjacent to the asphalt pavement, indicating that similar discontinuities have probably developed beneath the asphalt pavement itself. Further studies are recommended to assess the thermal effects of panel spacing on both the thermal regime and frost heaving of insulated pavements.
