# Inspection of Fabricated Fuselage Panels Using Electronic Shearography

July 1992

DOT/FAA/CT-TN92/26

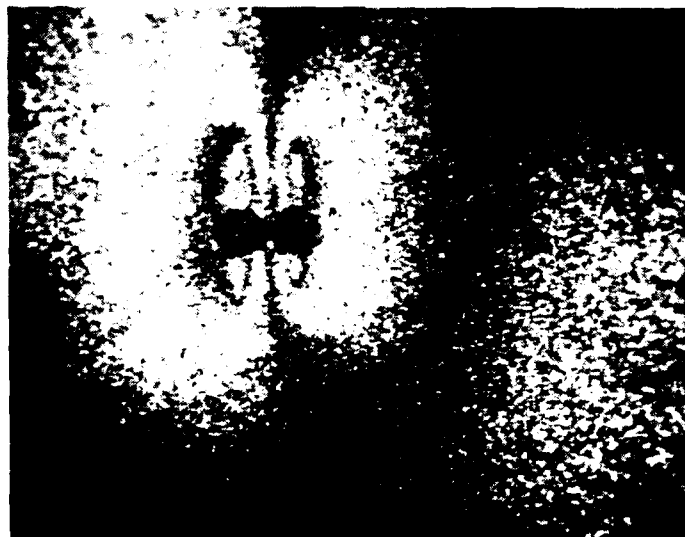
The fourth test series was designed to test the capability of shearography to detect small cracks around rivets. These tests were preceded by lab work on panels with some small fatigue sharpened cracks which are shown in figures 28 and 29. These results, using both thermal and tensional loading, showed the strain concentrations of 0.375-inch long cracks. Initial lab tests indicated that the camera would have to be moved closer than during previous tests in order to resolve these smaller strain concentrations.

FIGURE 29. X-VECTOR SHEAROGRAPH SHOWING STRAIN CONCENTRATIONS AROUND 0.375-INCH CRACKS.
