MTL TR 92-26

# **LAV ARMOR PLATE STUDY**

**US ARMY  
LABORATORY COMMAND  
MATERIALS TECHNOLOGY LABORATORY**

This study was undertaken to determine the cause of cracking in high hard armor steel plates used in the manufacture of light armored vehicles (LAVs) and to make recommendations to alleviate the problem. Cracks in several components from fielded vehicles were analyzed. In many cases the cracking was found to be caused by improper edge preparation in cutting the steel which resulted in environmentally-assisted cracking. Cracks were also observed starting from welds which were attributed to a number of possible causes: stress-corrosion cracking, hydrogen-assisted cold cracking, and cracking due to extremely harsh vehicle use. Base metal mechanical properties, including hardness, tensile strength, and Charpy V-notch impact energy were measured from room temperature to  $-40^{\circ}\text{F}$  ( $-40^{\circ}\text{C}$ ). Ballistic properties were measured and the propensity of the steel to crack under ballistic impact conditions was also evaluated. Additionally, the study involved a review of MIL-A-46100 and the new Canadian Material Specification, CMS-18.

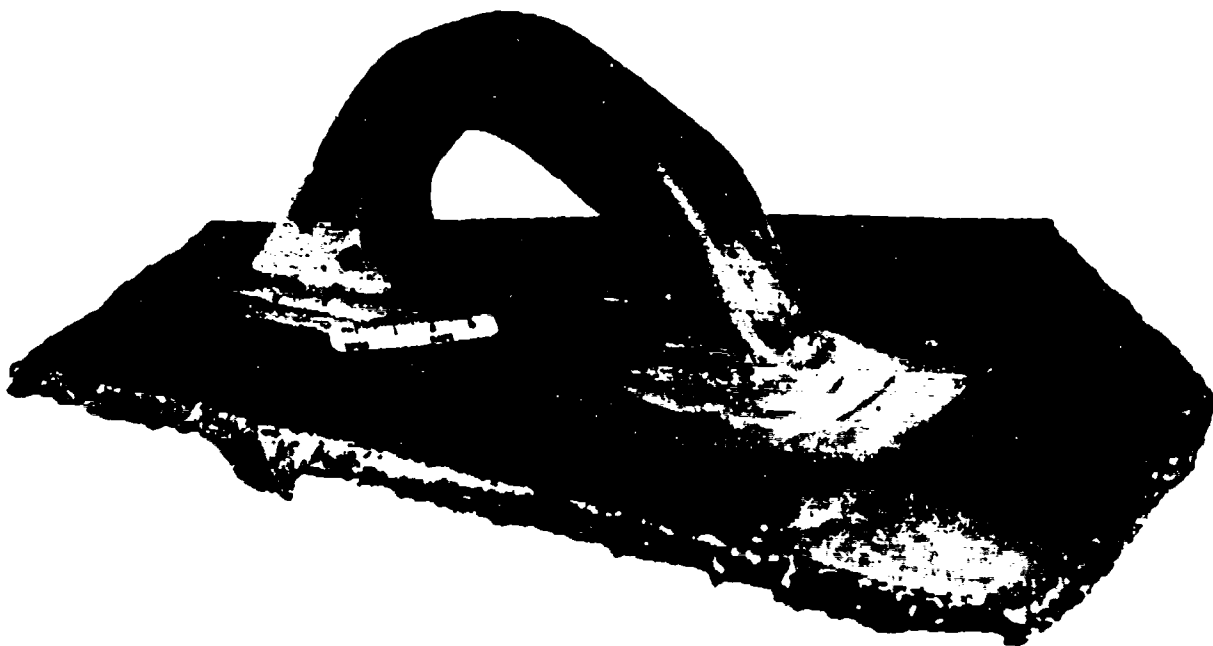
The eyes, about 1" x 1-1/4" in cross section, are welded to the vehicle side panels (7.31 mm thickness). A view of one of the eyes is shown in Figure 1a, and a cross section of the weld in Figure 1b. The three-pass weld can clearly be seen; it consists of an initial root pass followed by a second pass along the high hard armor plate, and finally a third pass against the eye.

Figure 1. (a) Lift-eye, and (b) Weld cross section of DDGM test specimen no. 2.

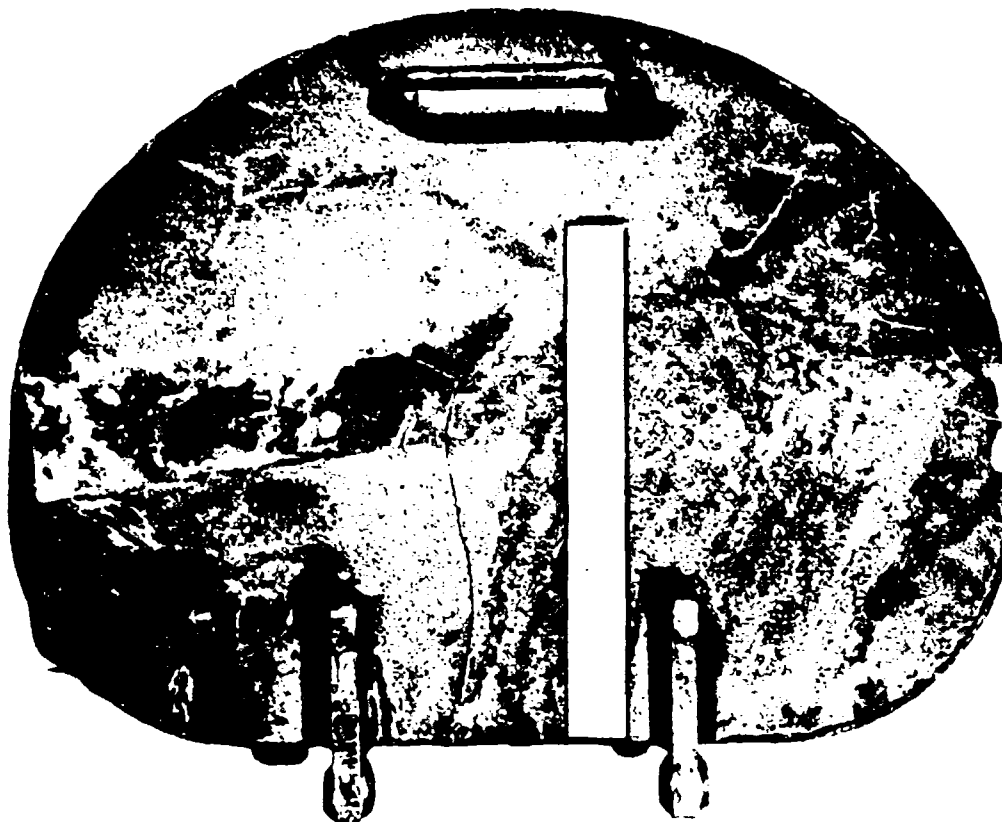
A cracked turret hatch cover from a vehicle Model Number 25MC,DDGM S/N LAV 612, USMC S/N 521765 was received for evaluation. A copy of the field service report of the crack in this hatch is given in Figure 6. The crack length when the hatch was replaced on 15 July 1987 was 8 inches.<sup>4</sup> The crack has since grown to over 12 inches and may be seen starting at the weld at the rim and travelling into the center (see Figure 7a). During cut-out of the crack origin region, binding of the saw occurred and it was evident that considerable residual stress was being relieved. A macrograph of the rim weld and micrograph of the structure of the weld region are shown in Figures 7b and 7c, respectively. Again, there is a layer of martensite next to the weld metal. Typical microhardness traverses across a weld region are shown in Figure 8. This sample was taken from the weld between the right upper front quarter panel and the main front glacis from the LAV that was dropped at Camp LeJeune (now at MTL). As this is a two-pass weld, two traverses were performed: the first just below the front surface (first pass), and the second just below the back surface (second pass). Moving from the weld metal to the base plate, the wide variation in hardness is readily apparent. The weld nugget is quite soft; then, after the fusion zone, there is a layer of very hard fresh (as-quenched) martensite in the base metal heat-affected zone (HAZ) that resulted from re-austenization during welding. The base metal HAZ hardness then drops into the region that did not see a high enough temperature excursion to be re-austenitized and so instead became heavily tempered. Following that, the steel is progressively less tempered during the welding operation and the hardness rises asymptotically to that of the (unwelded) base plate.

The cracking observed initiating from free-cut plate edges was often very similar to that observed in previous studies.<sup>5,6</sup> It was concluded that much of the cracking occurring in LAVs from free-cut plate edges may be attributed to environmentally-assisted cracking. For this mechanism to operate, the following conditions are necessary:

Figure 7 (a) Cracked turret hatch cover, (b) Macrograph of edge of cracked hatch cover, and (c) Optical micrograph of HAZ

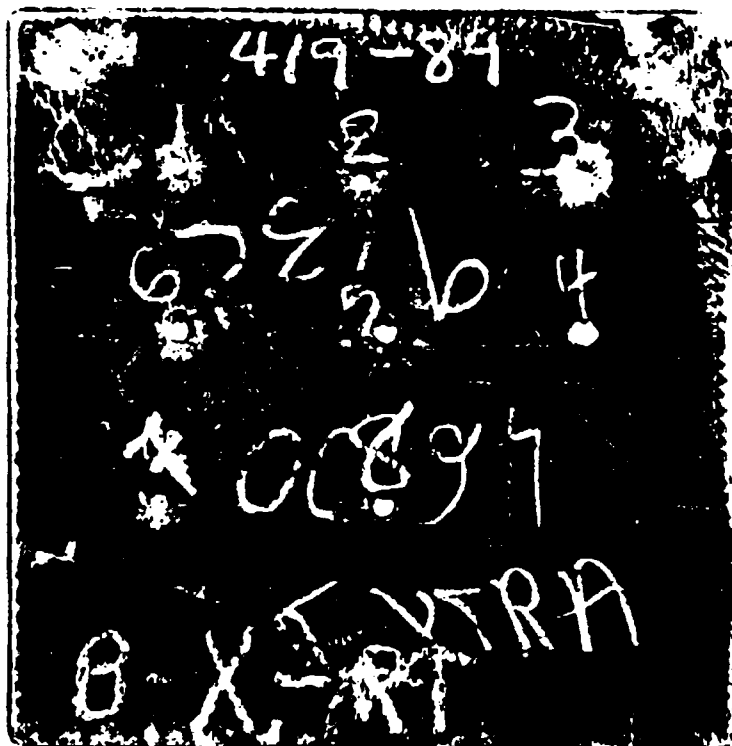
The  $V_{50}$  values are close to the velocities obtained from the handbook,<sup>7</sup> with some values slightly above and some slightly below the nominal. A typical tested plate is shown in Figure 10. The penetration mode is by plugging for those projectiles with velocities exceeding  $V_{50}$ . The ballistic limit increases slightly at colder temperatures. No cracking was observed and all  $V_{50}$  values are well above the muzzle velocity of an AK47 or similar rifle, i.e., 2380 ft/s. The  $V_{50}$  of the 7.31-mm XH plate was higher than that for the regular hardness plate of the same thickness. This is not surprising since many past studies have shown that ballistic penetration resistance of steel correlates most closely with hardness.<sup>8</sup> The 7.62-mm ball threat would not penetrate the 9.71-mm thick plate at the velocities attainable and, thus, no valid  $V_{50}$  could be determined.

Figure 10. Photograph of 7.31-mm XH plate after ballistic testing against 7.62-mm M1943 ball at 0° Obliquity at room temperature, showing partial and full penetrations by plugging.

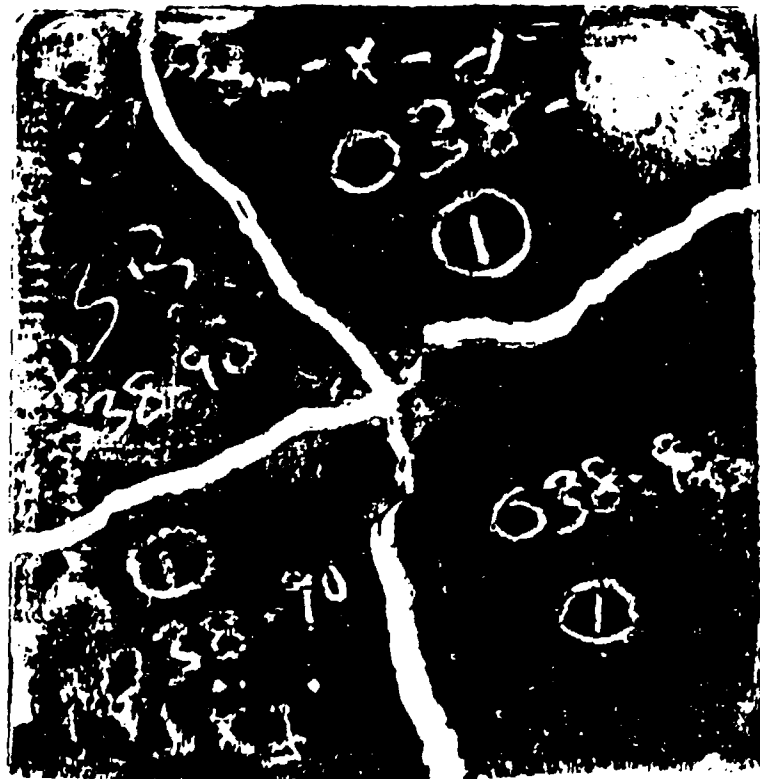
While  $V_{50}$  values were obtained, the primary purpose was to obtain a measure of cracking/shattering resistance. Shattering is defined where the plate is broken into two or more pieces, while cracked plates exhibit cracks emanating from or adjacent to the projectile impact point. Both of the plates with a hardness of 48 HRC, i.e., 6.31 mm and 9.71 mm, did not exhibit any cracking tendency when tested at either room temperature or -40°F. However, both the 7.31-mm plates (the so-called normal and XH materials with 50 HRC and 51 HRC, respectively) cracked under the 20-mm proof round impact at both room temperature (72°F) and at -40°F. Examples of cracked and shattered plates are shown in Figures 11a and 11b, respectively. Thus, in this case, ballistic behavior at room temperature is indicative of behavior at subzero temperatures, i.e., no drastic change occurs and, hence, room temperature testing can be used to indicate any cracking tendency. However, this may not be generally true for other armor plate, other thicknesses, other obliquities, or other projectiles.

Figure 11. Photograph of 7.31-mm plate after ballistic testing against 20-mm proof round at 0° Obliquity, showing plate cracking and plate shattering.

The ballistic study has shown that steel with higher hardness (and carbon content) is more prone to cracking. The Charpy V-notch impact toughness is also improved at lower hardnesses. Thus, this study has confirmed experience at DDGM that higher hardness (i.e., higher carbon steel) should be avoided. It is recommended that the Canadian Material Specification, CMS-18, be employed for future purchases of high hard armor steel for the LAV. The lower carbon content and restricted hardness range specified in CMS-18 is a step in the right direction, although it is likely that further modifications will occur in the future as experience is gained. Because of this tighter specification, initial cost of the steel will be higher, but lifetime vehicle costs should be lower.
