**ENVIRONMENTAL TEST  
SONY DIR-1000, ID-1 DIGITAL TAPE RECORDER  
(VIBRATION, TEMPERATURE AND HUMIDITY)**

John Morgan and Paul Beer  
Mission and Avionics Technology Department (Code 5053)  
NAVAL AIR WARFARE CENTER — AIRCRAFT DIVISION  
Warminster, PA 18974-5000

**13 MARCH 1992**

**FINAL REPORT**  
**Period Covering 20 January 1992 to 24 January 1992**

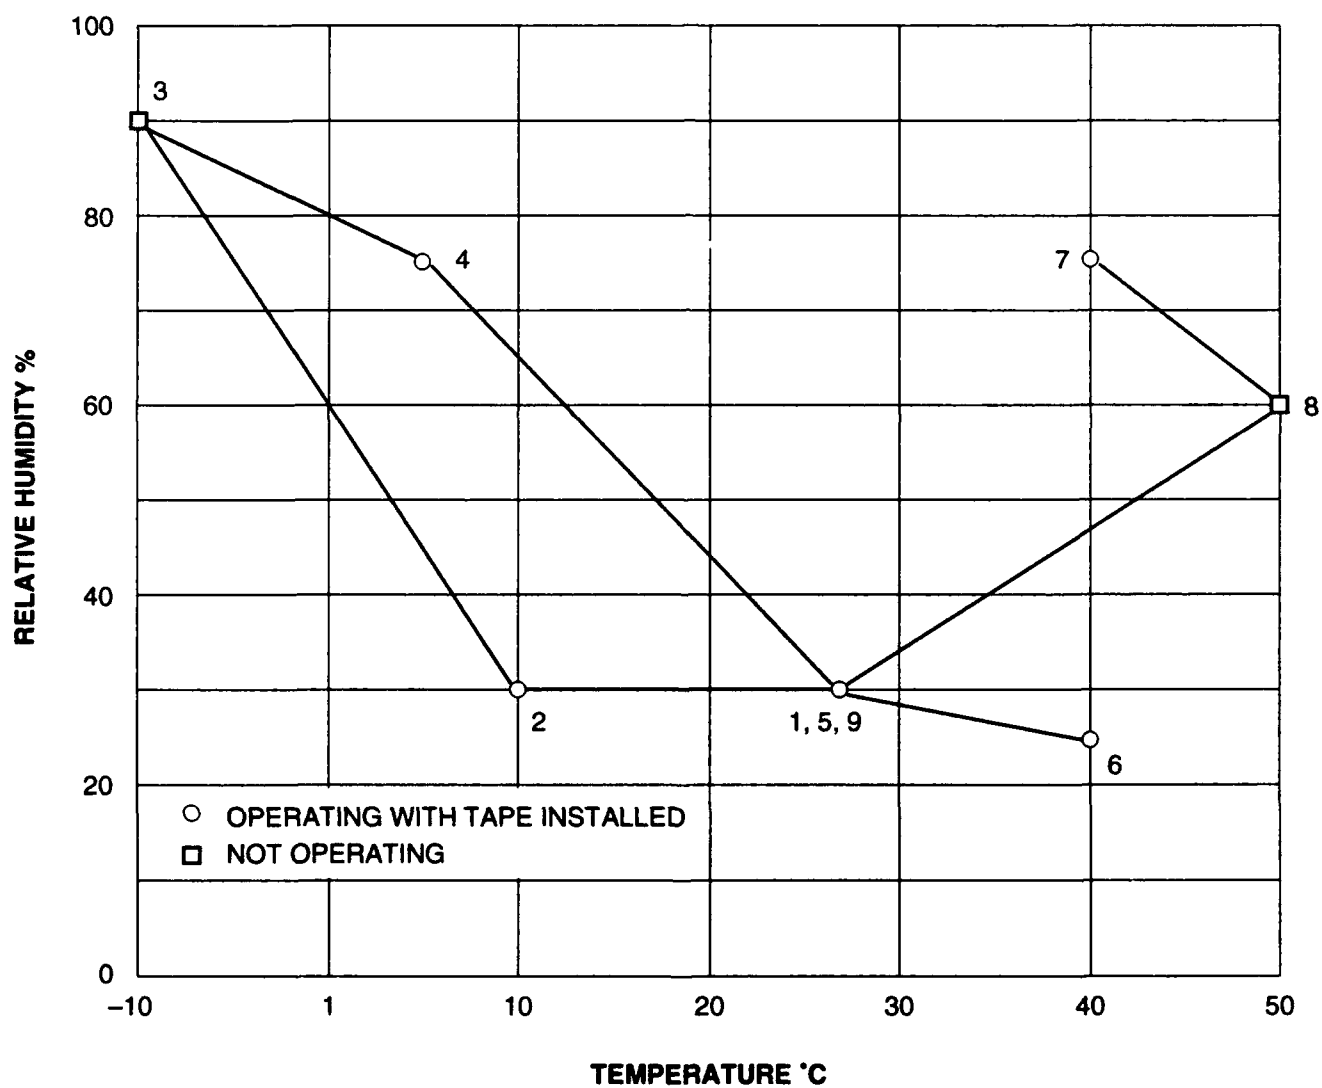
Figure A-5.

Figure A-5 shows the T/H "path". Note the nine "test points". Also refer to Table II. The word "TRANSIT" as it appears in the Temp and Rel Hum columns of Table II

The Sony Recorder operated successfully (see Table II) during the T/H testing, except for the final BER test. This test actually occurred at "Room Temperature" (27C, 30 % RH), T/H Test Point #9, but was run subsequent to the High temperature Test Point #8. Notice that the test did not require BER evaluation while at Test Pt #8 — it was likely that the failure occurred at this time, but was unobservable until the BER evaluation at Test Pt. #9.

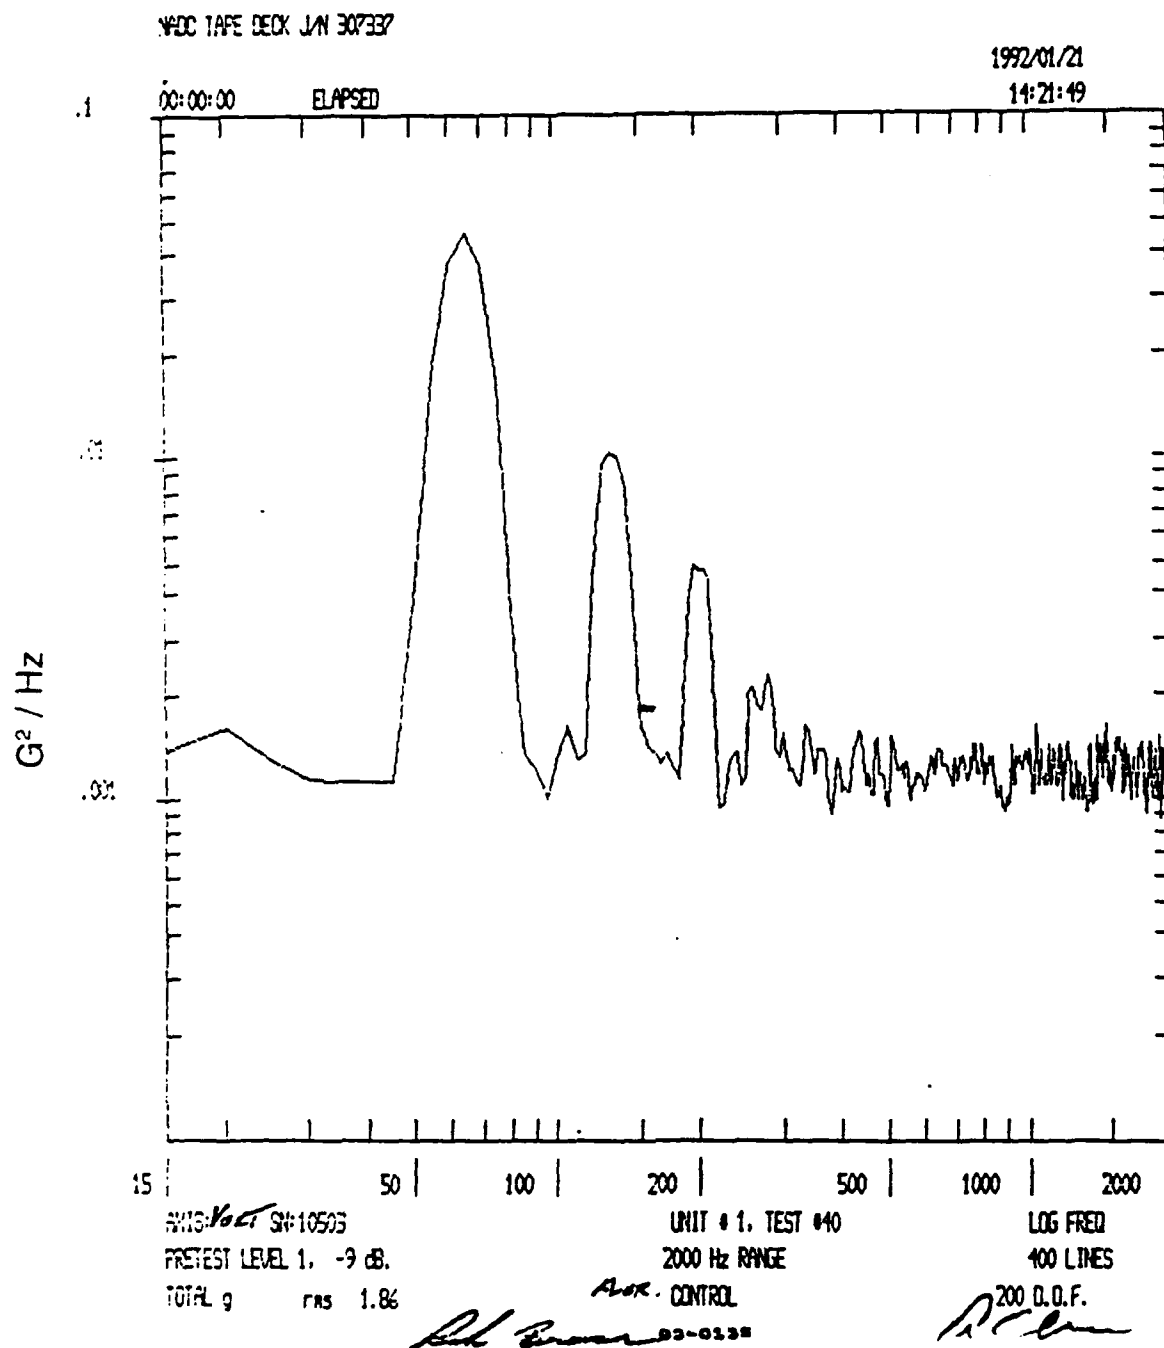
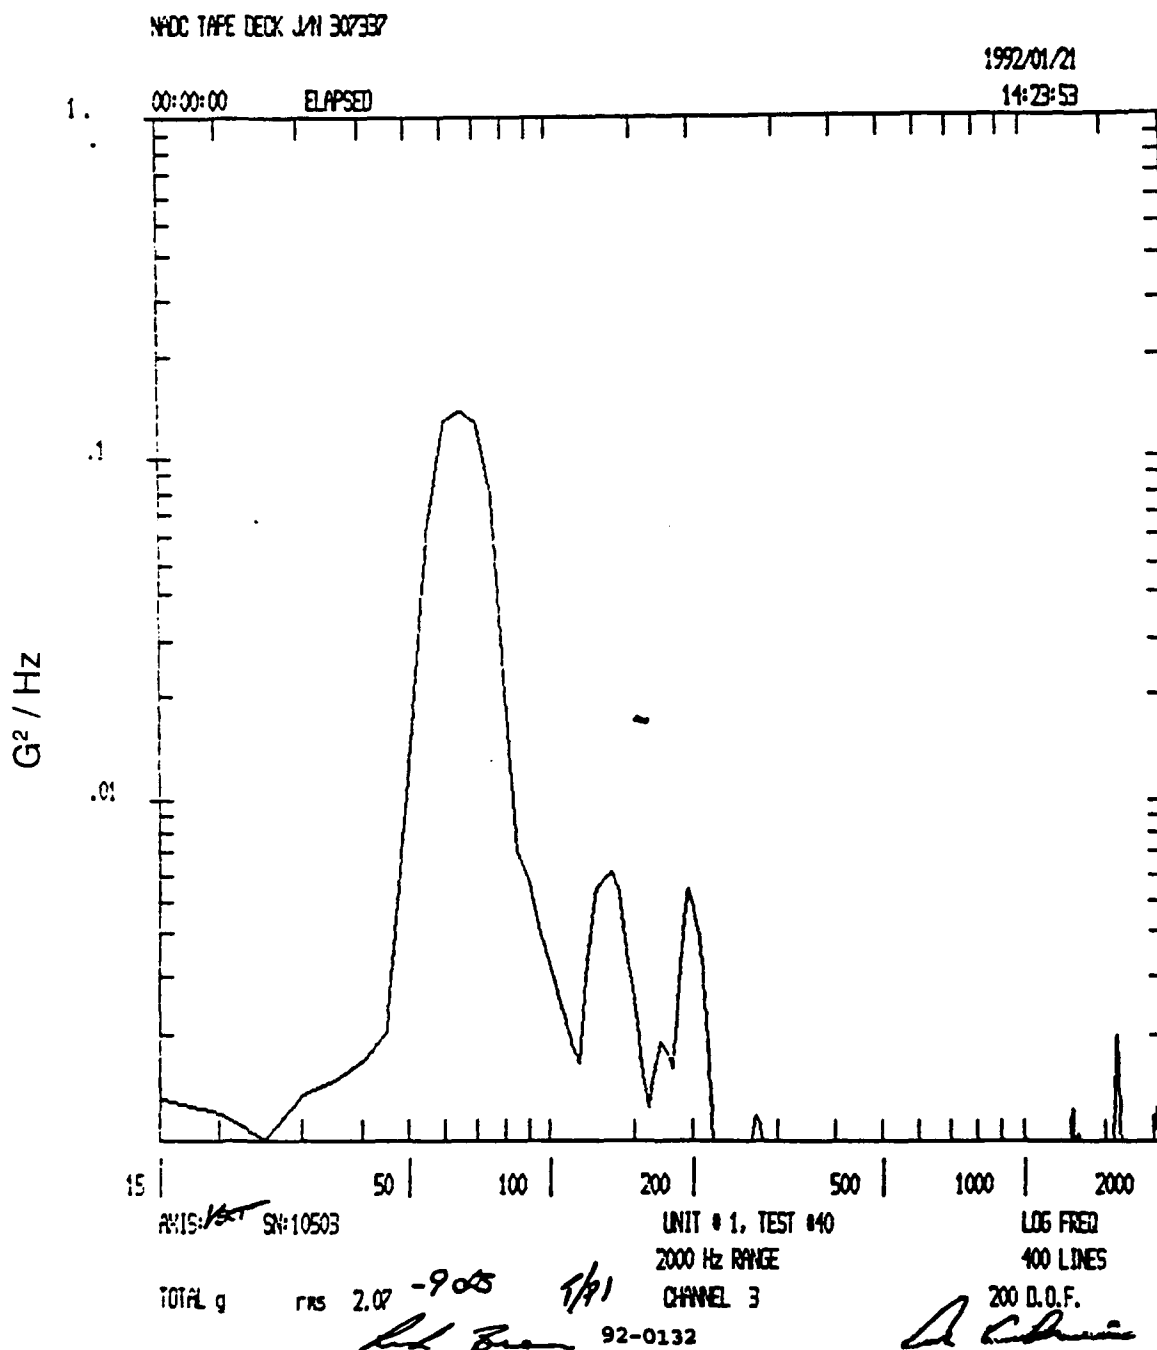
Referencing Table I, it is seen that the Sony DIR-1000 **successfully** Recorded/Reproduced data over the complete "Boeing" vibration profiles (Tests #1 through #12). Figure B-28 (Test #4) shows large errors occurring at the end of the "-9dB" Mil-Std-810E 10 minute test. It was difficult to determine the cause of these errors (test equipment or "real" failure due to vibration); therefore Test #15, a repeat of Test #14, was run. BER performance during Test #15 (figure B-30) was much better than that of Test #14, although a small amount of errors did occur (160 errors total, for a CBER =  $8.0 \times 10^{-9}$ ). It was decided to continue on to the "- 6 dB" Mil-Std shake.

| VIBRATION<br>TEST# | TAPE # | VIBRATION<br>PROFILE<br>APPLIED<br>[FIGURE#] | AXIS | MODE<br>REC/PLAY | ECC<br>ON/OFF | BER TEST<br>FIGURE # | EVALUATION<br>(PASS/FAIL) |
|---|---|---|---|---|---|---|---|
| 14 | 42 | B-26, B-27 | [Z] VERT | PLAYBACK | ON | B-28 | — |

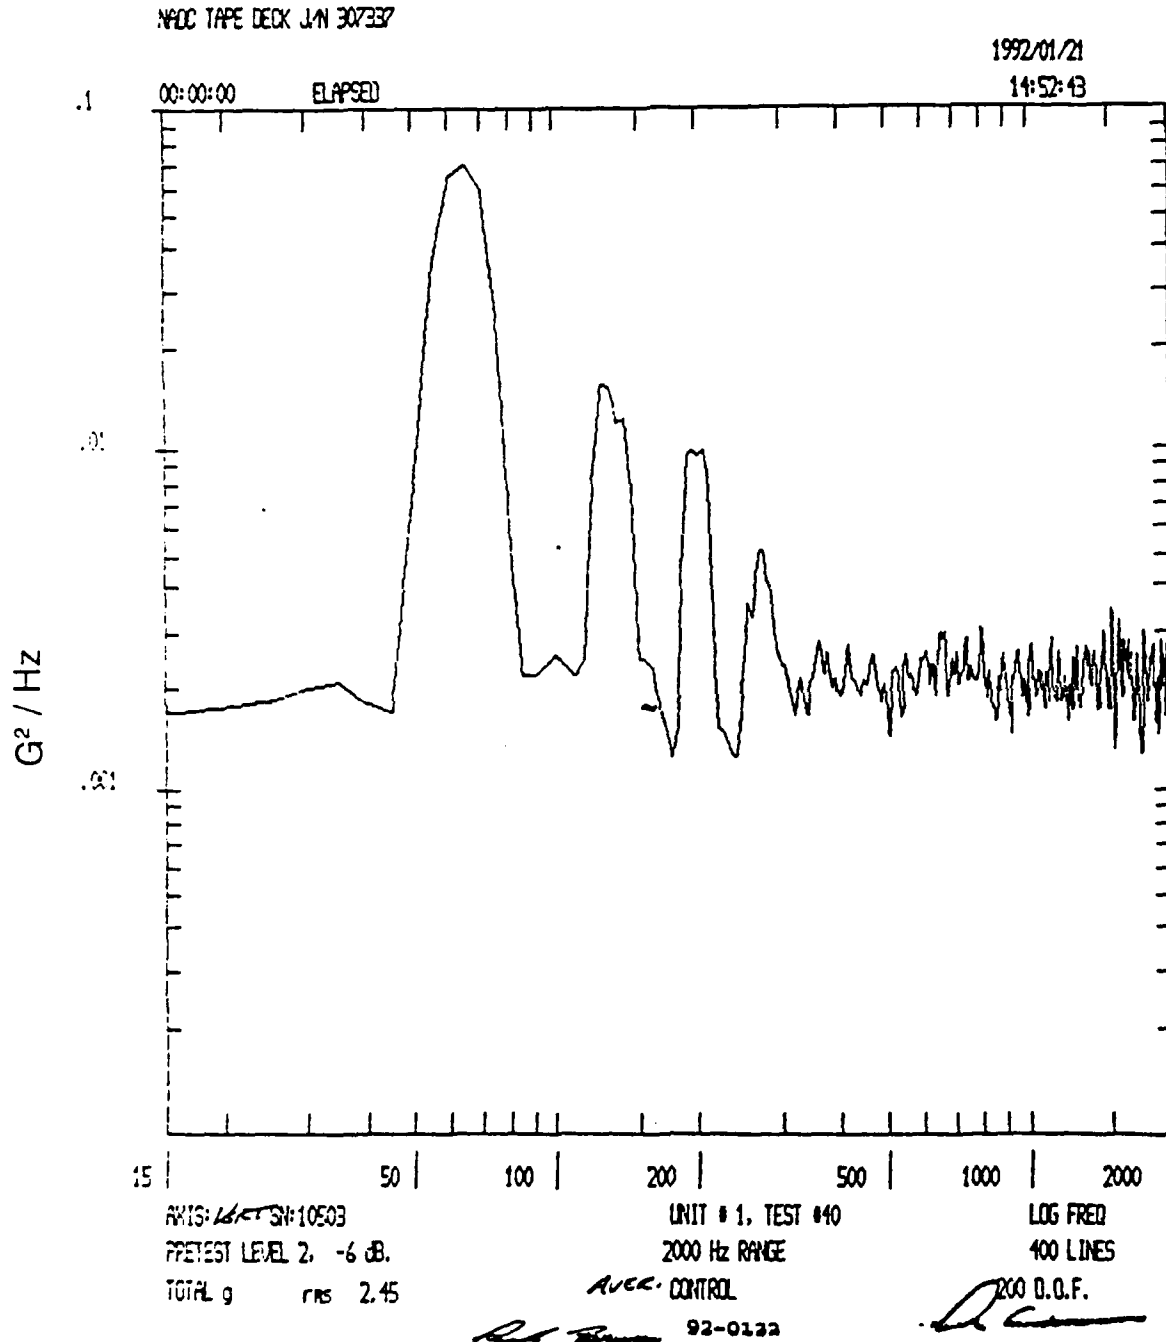
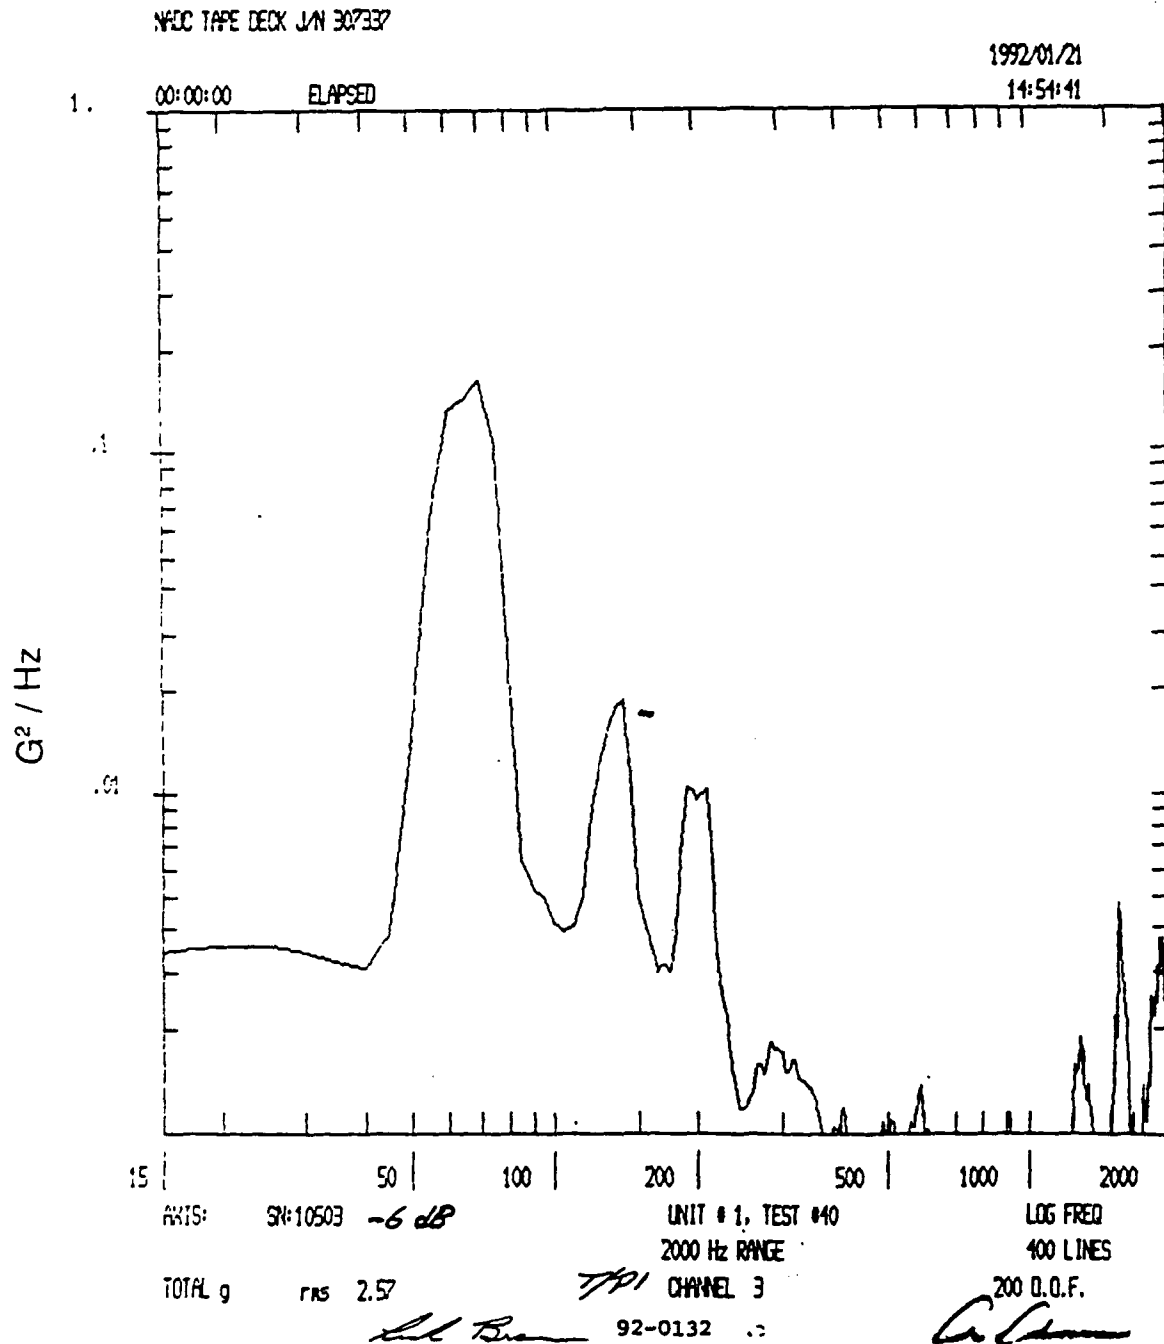
In Figure B-33, the BER plot for Test #16, *all* the BER samples were "Tau-Tron Overflows", or large amounts of errors. However, during Test #16, the Recorder shook itself loose from the mounting spacers (spacers part of Dayton T. Brown's fixture), and therefore the vibration test was not valid. The recorder was remounted, and Test #17, a repeat of #16, was run. **This test showed that the Sony DIR-1000 Failed the- "-6 dB" Mil-Std-810E profile, in the Z (vertical) axis.** The BER data (figure B-36) showed all "Tau-Tron Overflows", and the Recorder's Self-Diagnostics reported "Uncorrected Errors", "Servo Lock Loss", and "Motor FG Defective".

| VIBRATION<br>TEST# | TAPE # | VIBRATION<br>PROFILE<br>APPLIED<br>[FIGURE#] | AXIS | MODE<br>REC/PLAY | ECC<br>ON/OFF | BER TEST<br>FIGURE # | EVALUATION<br>(PASS/FAIL) |
|---|---|---|---|---|---|---|---|
| 16 | 42 | B-31, B-32 | [Z] VERT | PLAYBACK | ON | B-33 | FAIL |

The Sony DIR-1000 Recorder operated satisfactorily throughout the in-flight vibration test spectra provided by Boeing. It failed Playback Performance testing under vibration, to a Mil-Std-810E spectra derated 6 dB, but passed the derated 9 dB test. Vibration isolators are recommended for any installation aboard P-3C aircraft to reduce risk of failure and facilitate installation/removal of this unit.

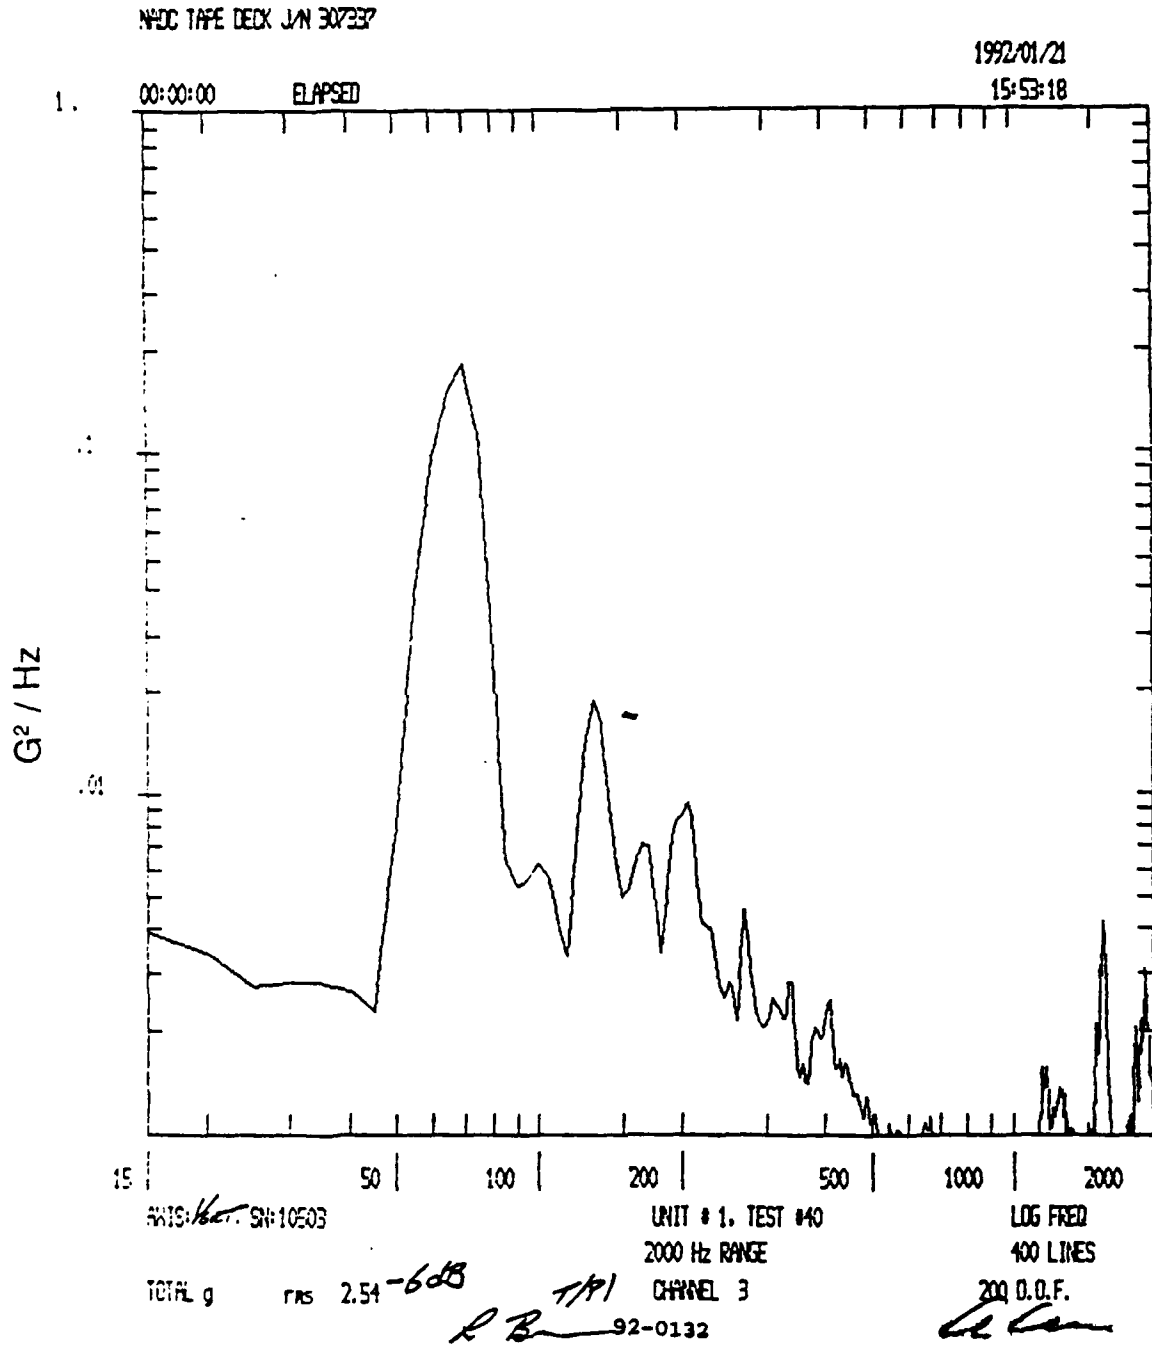
After Test #17, the recorder power was cycled, and all warning messages were extinguished. When powered up, the BET immediately showed no errors, indicating that the test equipment was functional. Then, with no vibration applied, the Sony was briefly put in Record Mode, and performed successfully with no errors/warnings. It is therefore concluded that the errors in Test #17 *were* vibration induced.

| VIBRATION<br>TEST# | TAPE # | VIBRATION<br>PROFILE<br>APPLIED<br>[FIGURE#] | AXIS | MODE<br>REC/PLAY | ECC<br>ON/OFF | BER TEST<br>FIGURE # | EVALUATION<br>(PASS/FAIL) |
|---|---|---|---|---|---|---|---|
| 17 | 42 | B-34, B-35 | [Z] VERT | PLAYBACK | ON | B-36 | FAIL |
