Aircraft Structures Report 449

**DAMAGE TOLERANCE ASSESSMENT OF BORON/EPOXY  
REPAIRS TO FUSELAGE LAP JOINTS**

D. REES  
L. MOLENT  
R. JONES

AUGUST 1992

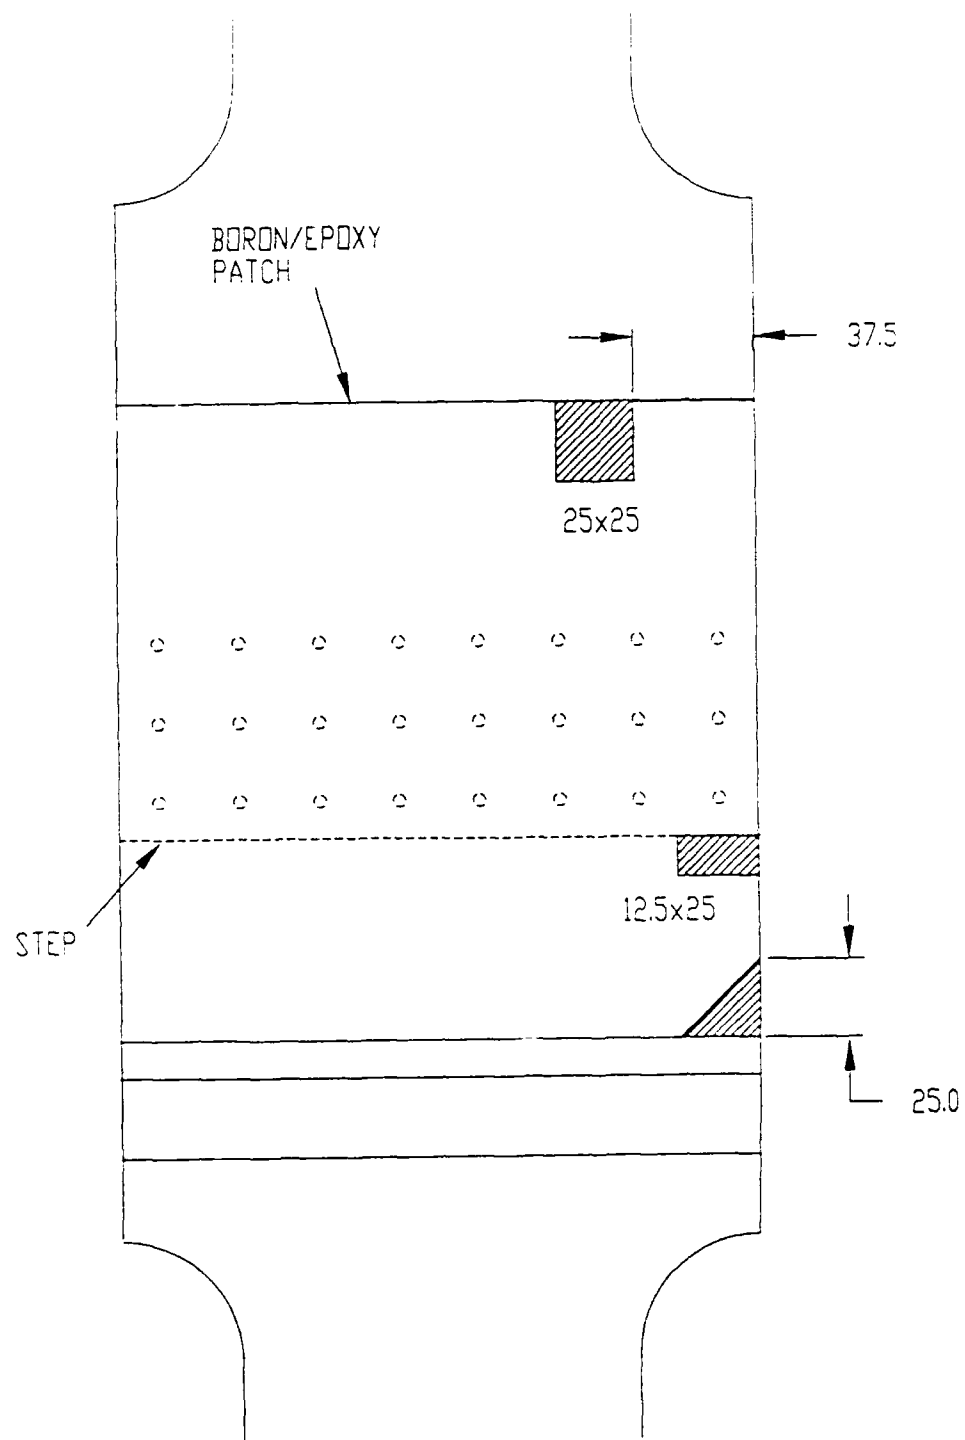
Figure 2. Insert Detail for Specimen A6

In specimen A6 the adhesive disbonds were simulated by inserting teflon release film between the aluminium sheet and adhesive during bonding of the doubler (repair). The size and the location of these inserts is shown in Figure 2.
