FLOOD CONTROL CHANNELS RESEARCH PROGRAM

CONTRACT REPORT HL-92-1

## IDENTIFICATION OF PIPING AND SAPPING EROSION OF STREAMBANKS

D. J. Hagerty

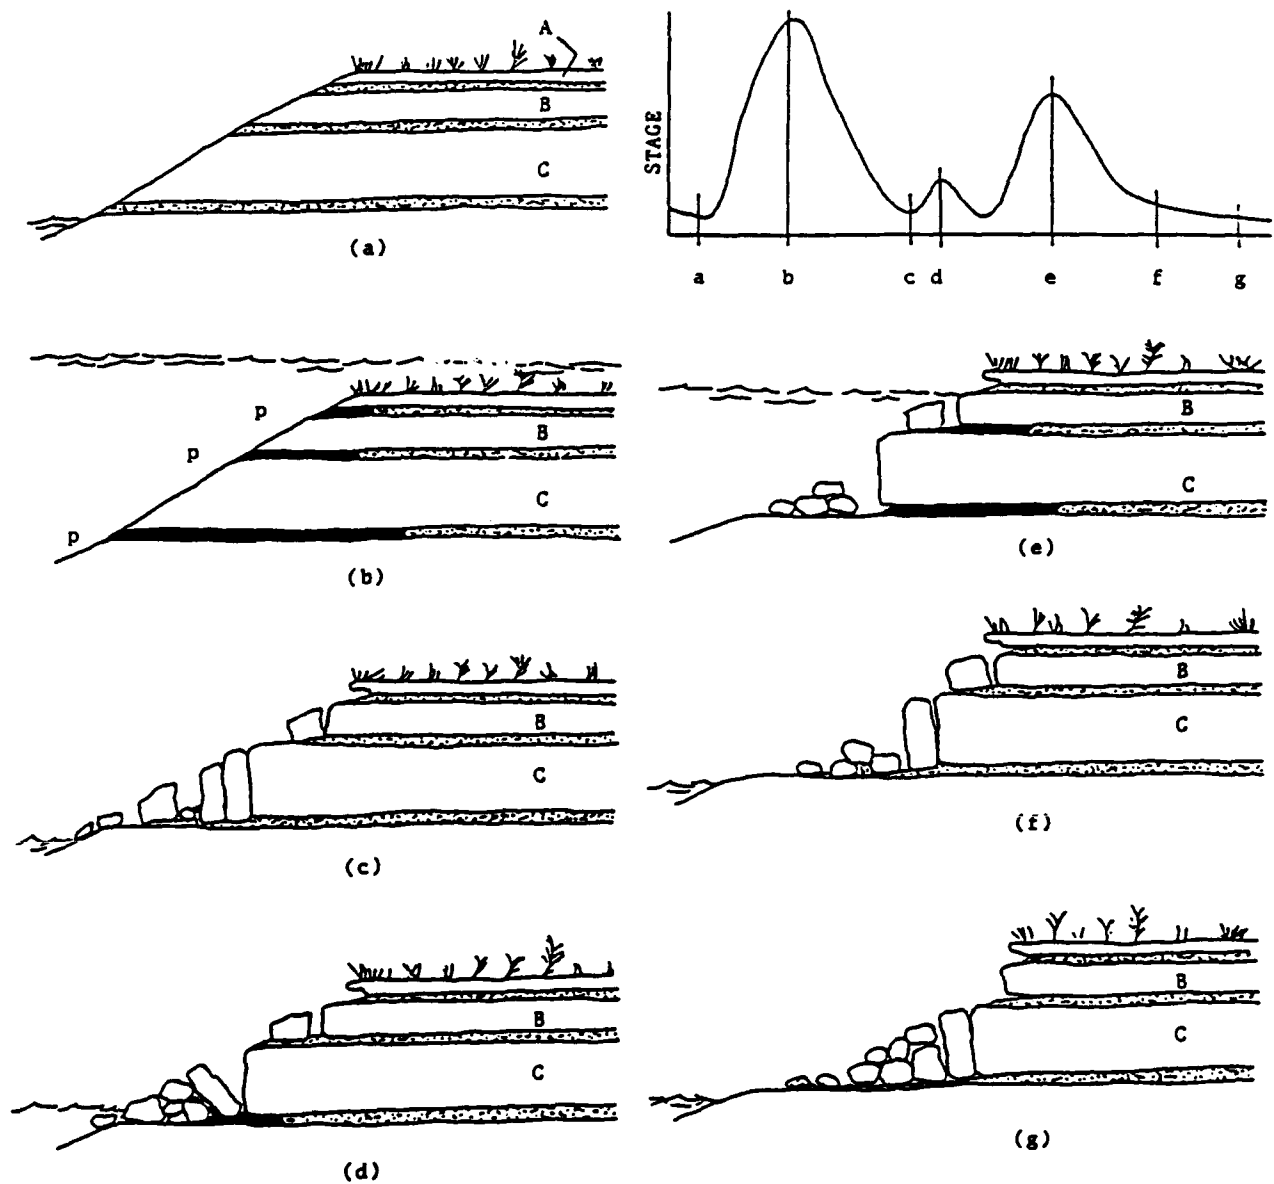
Figure 2. Sequence of stage fluctuation with attendant recharge into pervious zones (sections b, d, and e) and subsequent piping/sapping and failure (sections c, f, and g)

removed (Figures 2c and 2d). Under upper-bank zones fail long after the flood recession (Figure 2c). During a subsequent flood, failed soil blocks are eroded and/or removed and lower pervious zones are recharged. After recession of the second flood, outflow reworks failed soil blocks, deposits fans and extends cavities, with minor delayed failures of undercut zones (Figure 2g).

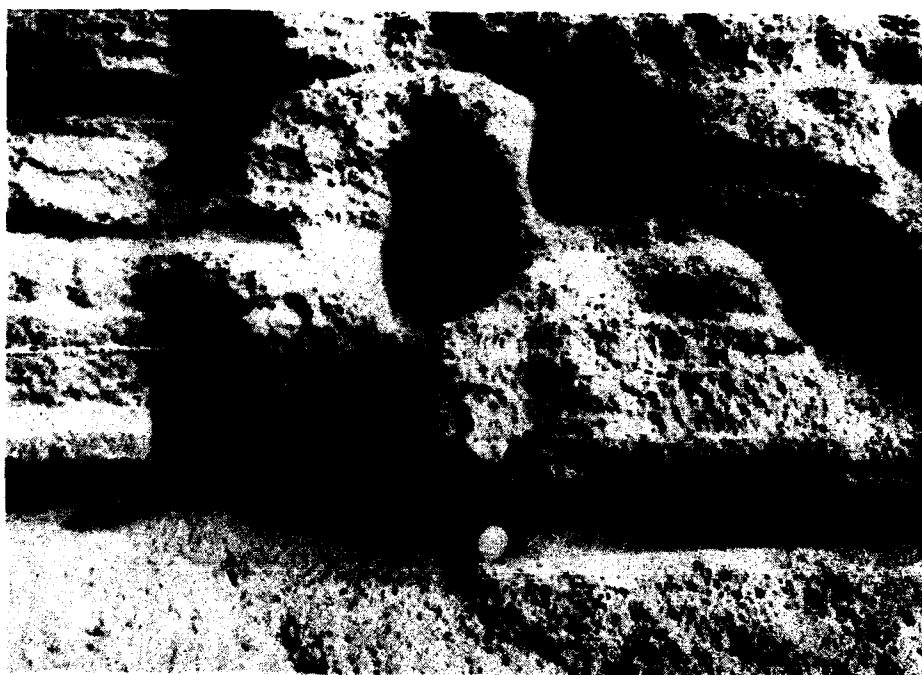
l. Close view of cavities shown in Figure 6k (coin is U.S. dime)

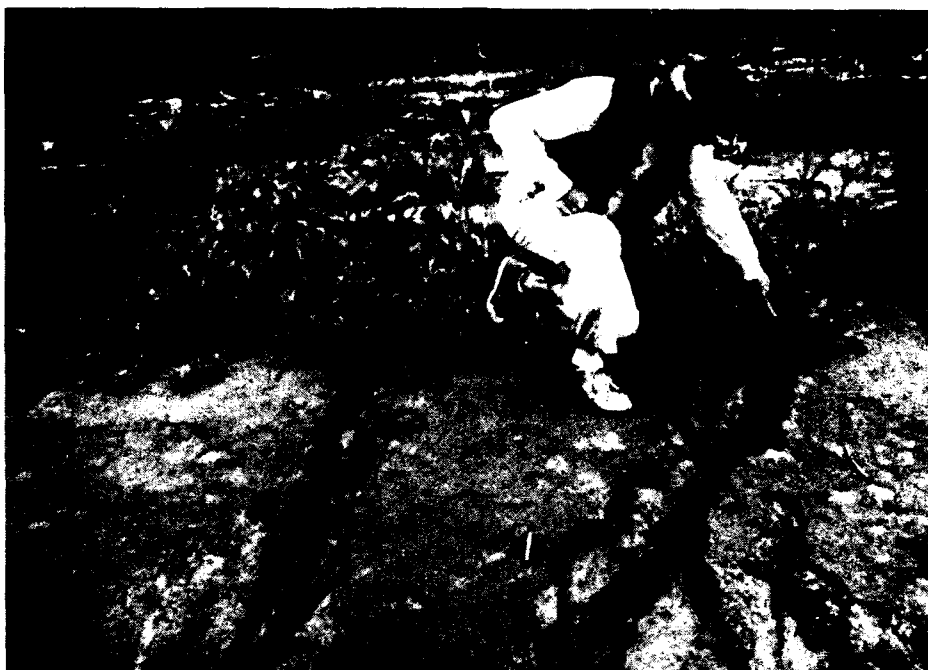
a. Blind gully at piping zone in Ohio River bank
