TECHNICAL REPORT REMR-GT-18

EVALUATION OF THE REHABILITATION PROGRAM  
FOR RELIEF WELLS AT LEESVILLE DAM, OHIO

September 1992

Final Report

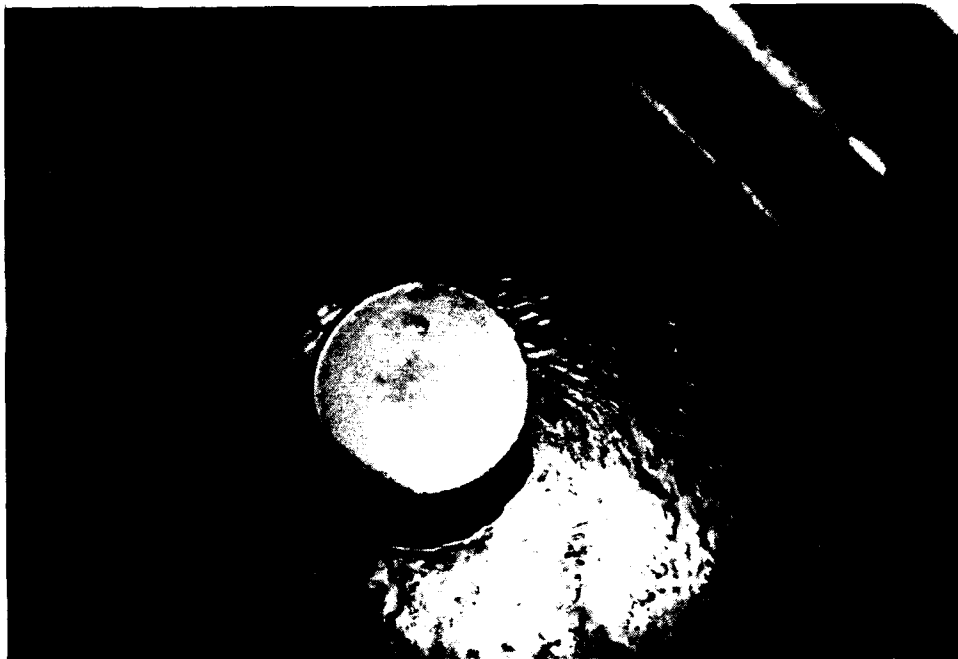
13. During the initial phase of this study, the reddish-brown, mucilaginous deposits occurring around the top of the majority of the relief well casings were sampled in order to confirm the presence of iron bacteria. These samples were collected by gently scraping the encrusting material away from the surface of the well casing. This material was immediately placed in a Nasco Whirl-Pak™ containing water from the well (Photo 6), and the sample was kept cool until analyzed at the contract laboratory.

Photo 5. Reddish-brown, mucilaginous deposits  
in well characteristic of iron-precipitating  
bacteria (Continued)

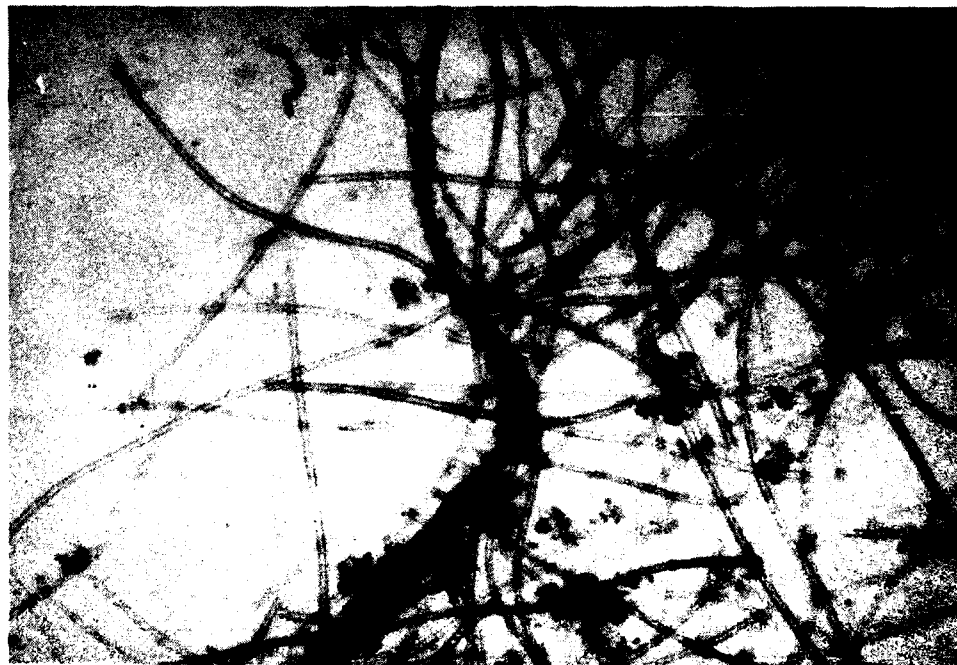
a.  
Photo 18. Photomicrographs of bacterial  
sheaths, *Lepothrix* (Continued)

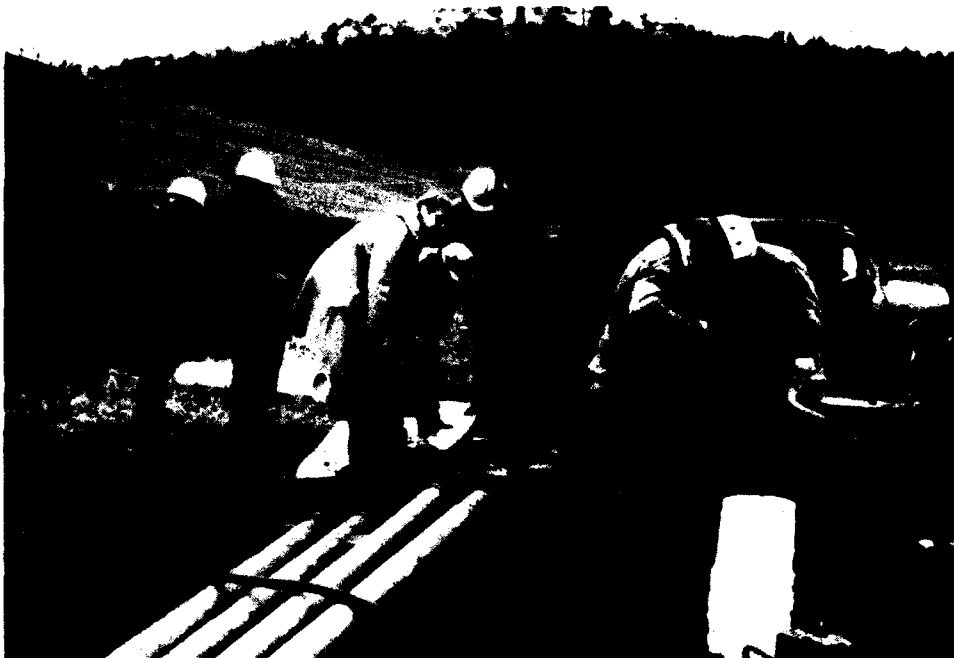
Photo 23. Premeasured volume of phosphate solution pumped into relief well

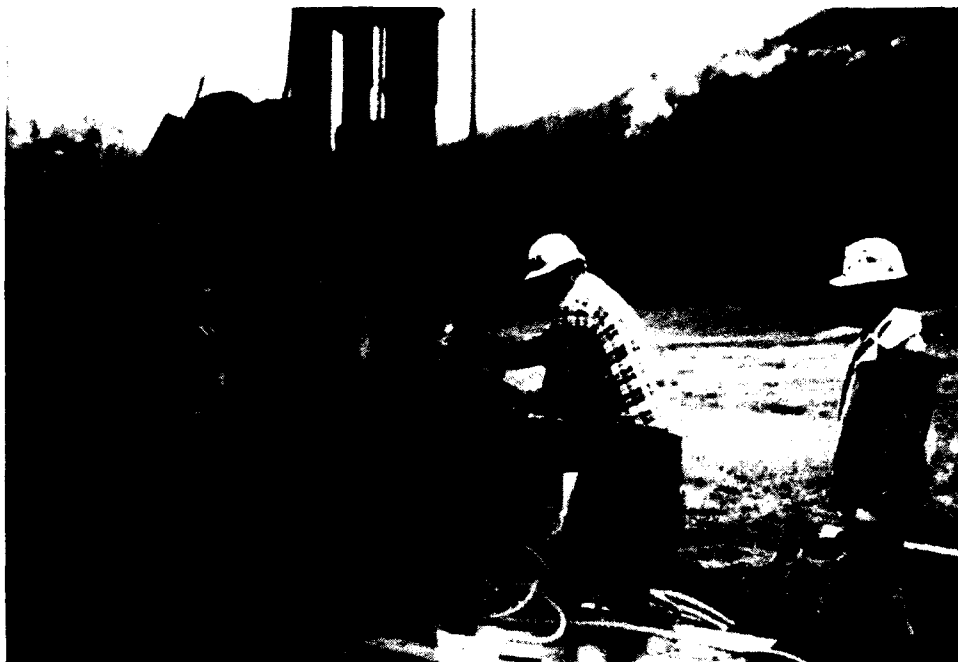
Photo 27. Bailing well to remove accumulated sediment

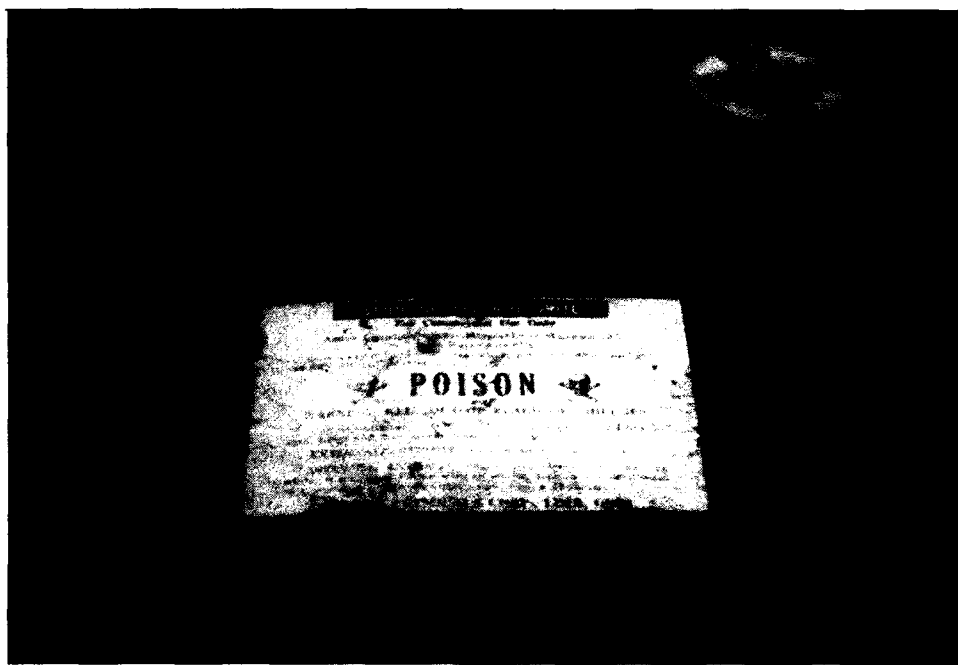
Photo 28. Sodium hypochloride added to the well
