**T-38 FORWARD WINDSHIELD DEVELOPMENT AND PERFORMANCE  
DEMONSTRATION REPORT**

J. W. MYERS  
PPG INDUSTRIES, INC.  
AIRCRAFT PRODUCTS  
P.O. BOX 2200  
HUNTSVILLE, AL 35804

March 12, 1992

Final Report for period June 1982 to September 1989

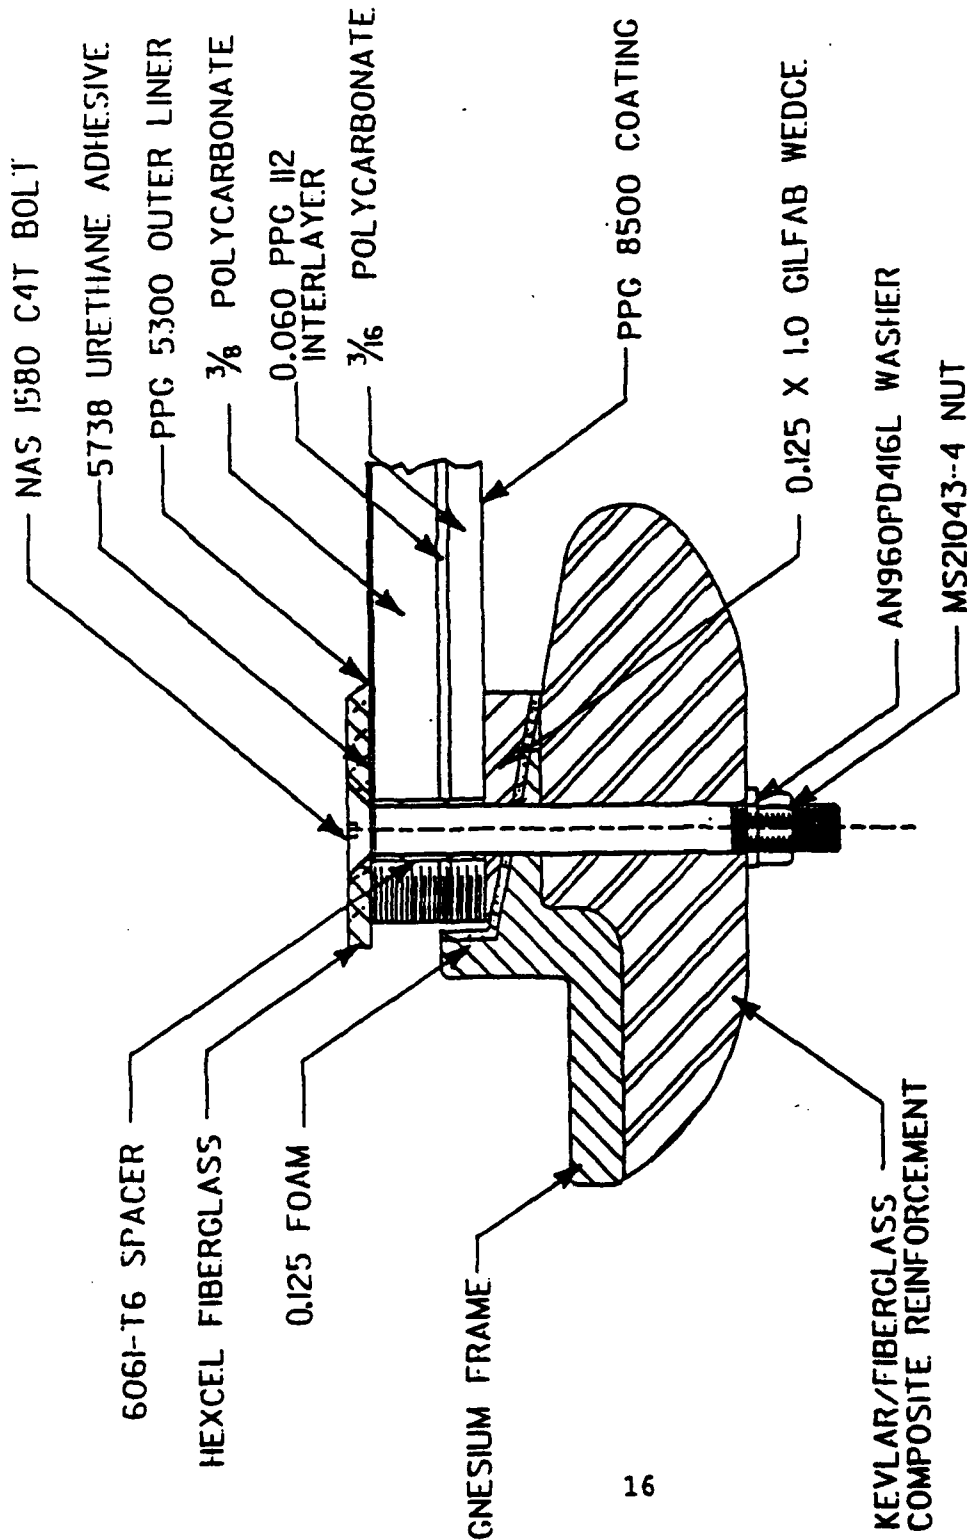
Figure 6. Flight Quality Bird  
Impact Aft Arch & Cross  
Section

Shot #221 was on windshield number 322-80 at the aft arch centerline location. The conducted impact was at room temperature with a 4.008-pound bird, at a velocity of 393.6-knots. The impact was determined to be successful. Some minor bird debris penetrated into the cockpit, but the debris entered over the aft arch as it deflected during impact.

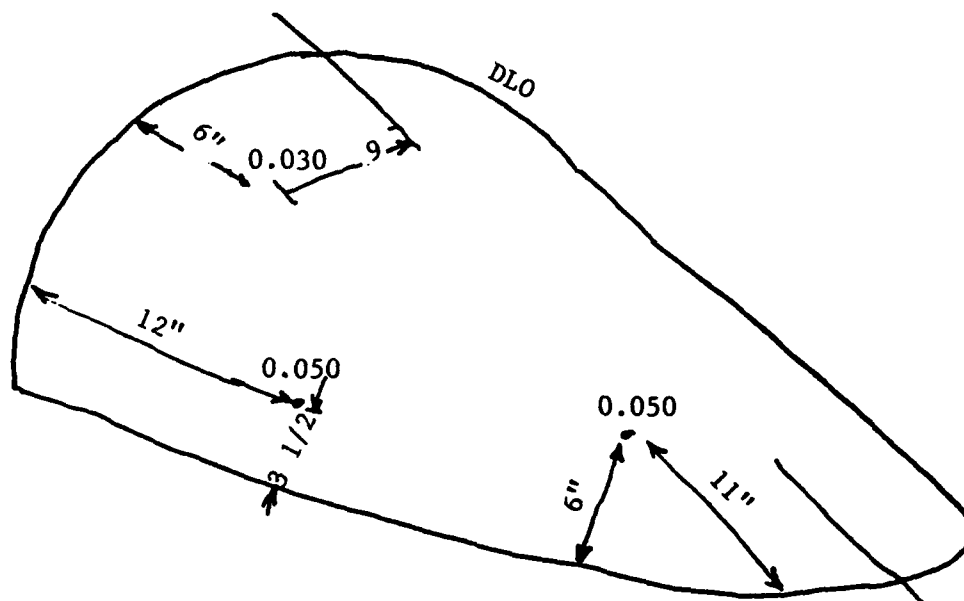
BUBBLES IN 5300 LINER

No change in PPG 5300 liner small bubbles noted during manufacturing (Figure 10). Very clean windshield.

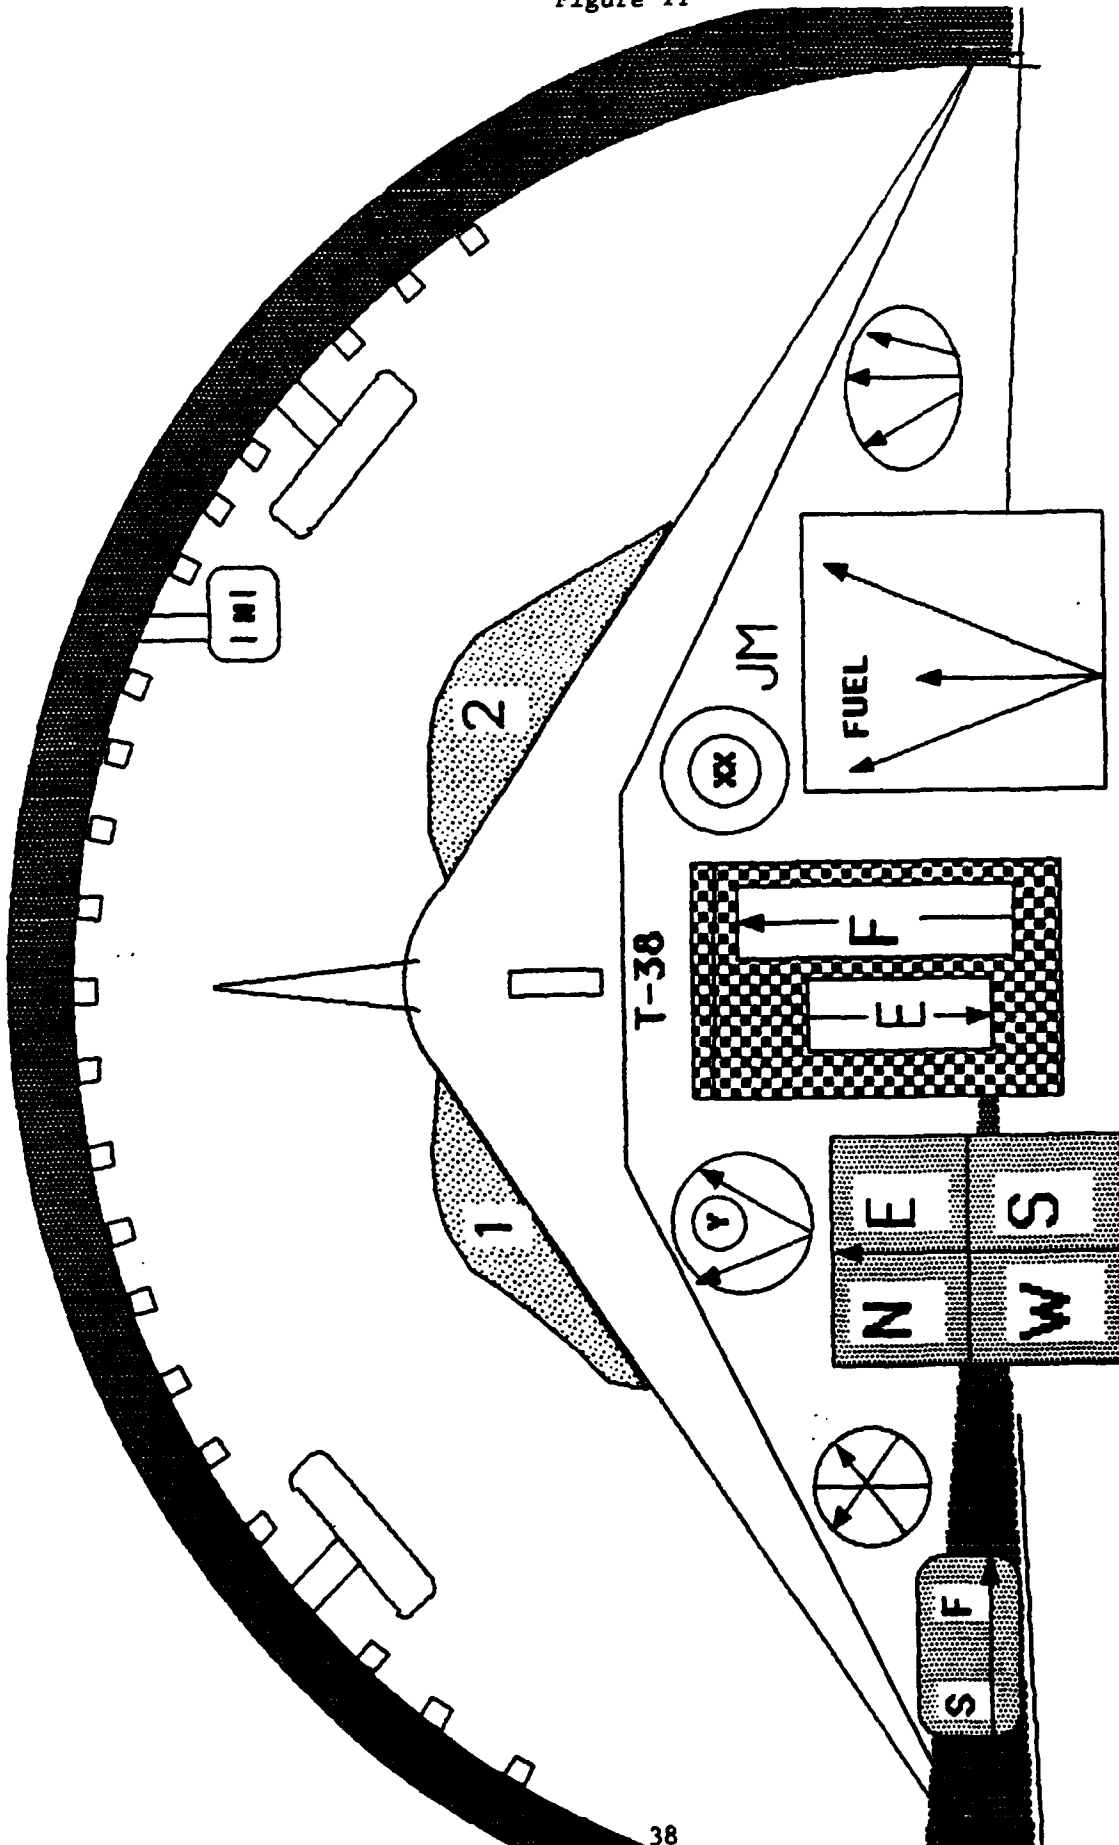
Figure 11. Pilot View Of Forward  
Windshield

- o Major St. Sauver complained of visual problems from the front seat. Areas 1 and 2 (Figure 11) were distorted causing the ground to ripple as observed from front cockpit only. At night, the lights would twinkle as they passed through these areas. During transition to flair, it was very difficult to judge depth perception because of this distortion. If covered without correction, downward visibility would be greater reduced. The pitot tube, which is visible on aircraft with old windscreens, could not be seen as it connects to aircraft nose.

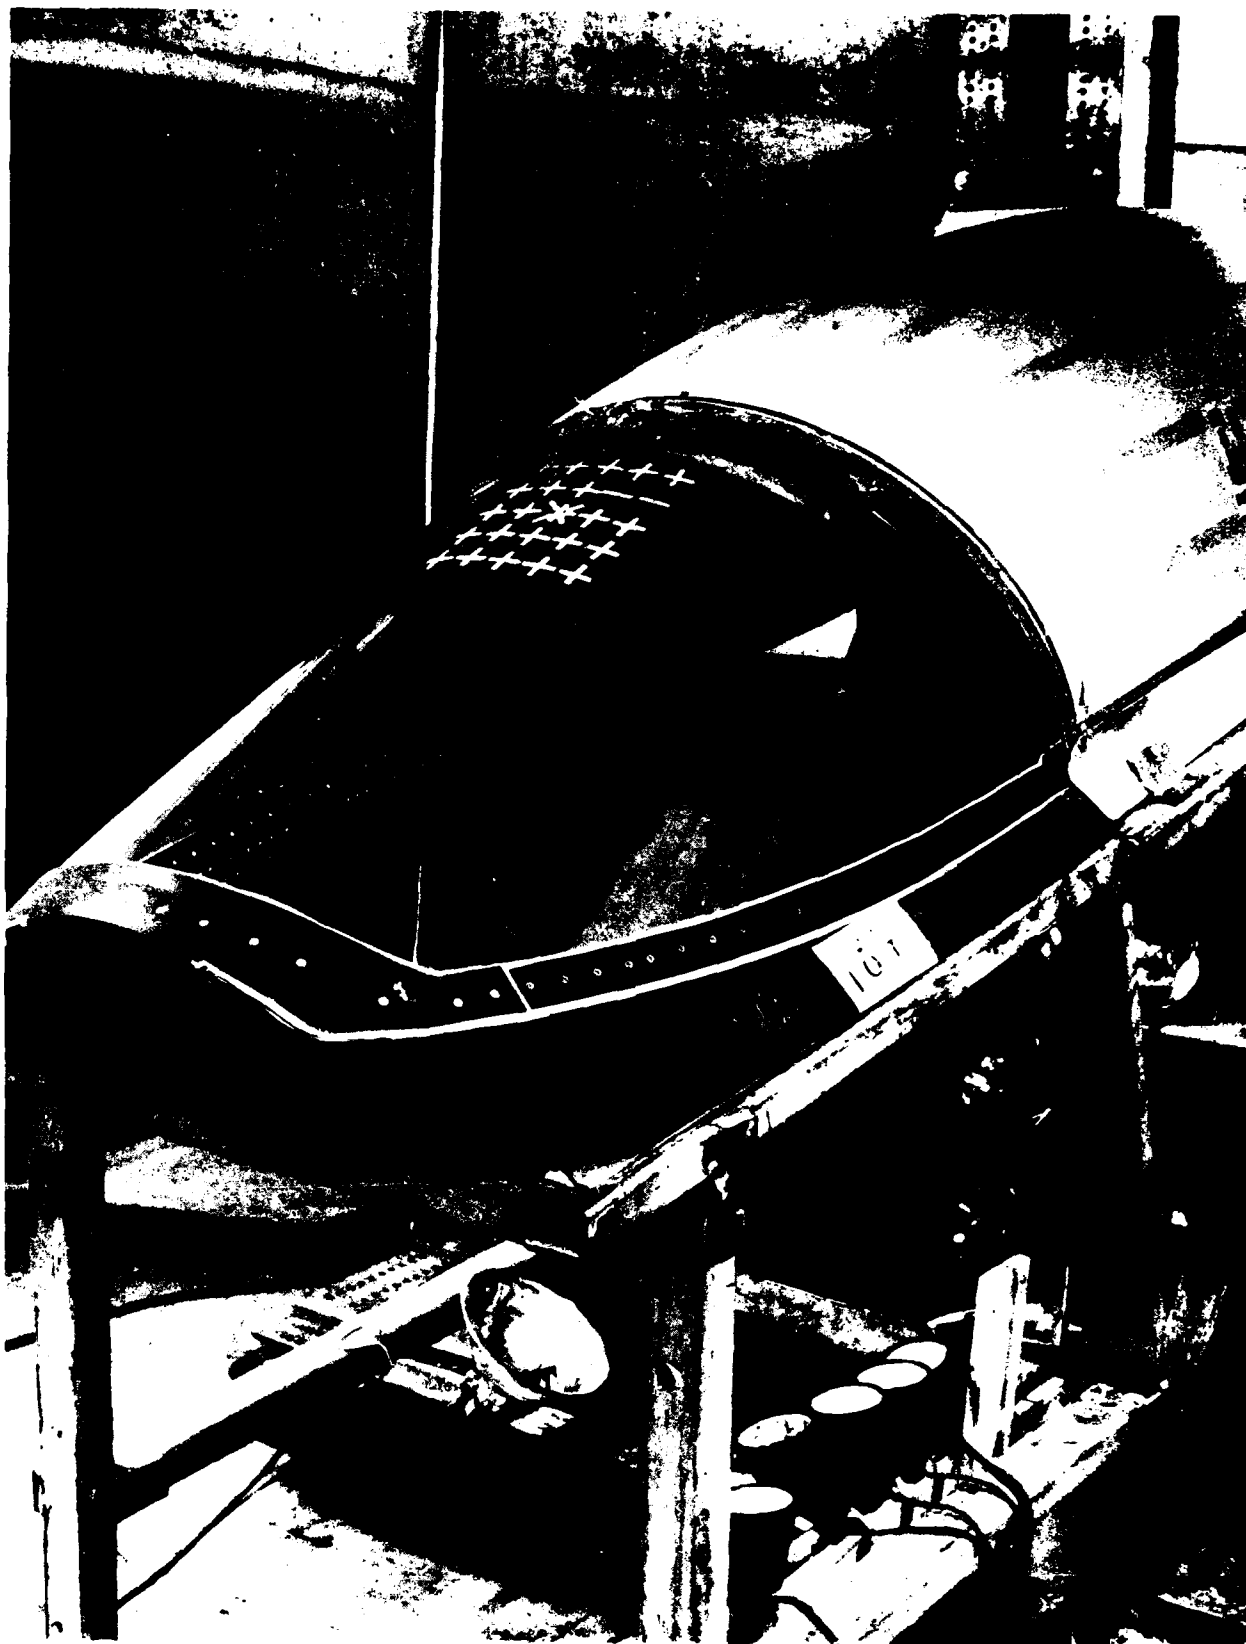
PHOTOGRAPH #2  
POST TEST RESULTS  
SHOT #184

Shot #184 was 393.1-knots on windshield number 322-54, with a 4.002-pound bird at room temperature of 70°F. The window passed with no major damage, other than an approximate permanent deflection of 0.25-inch in the aft arch. Several pieces were removed from the arch material by the impact. The test also permitted a few pieces of bird residue to hit the witness plate.

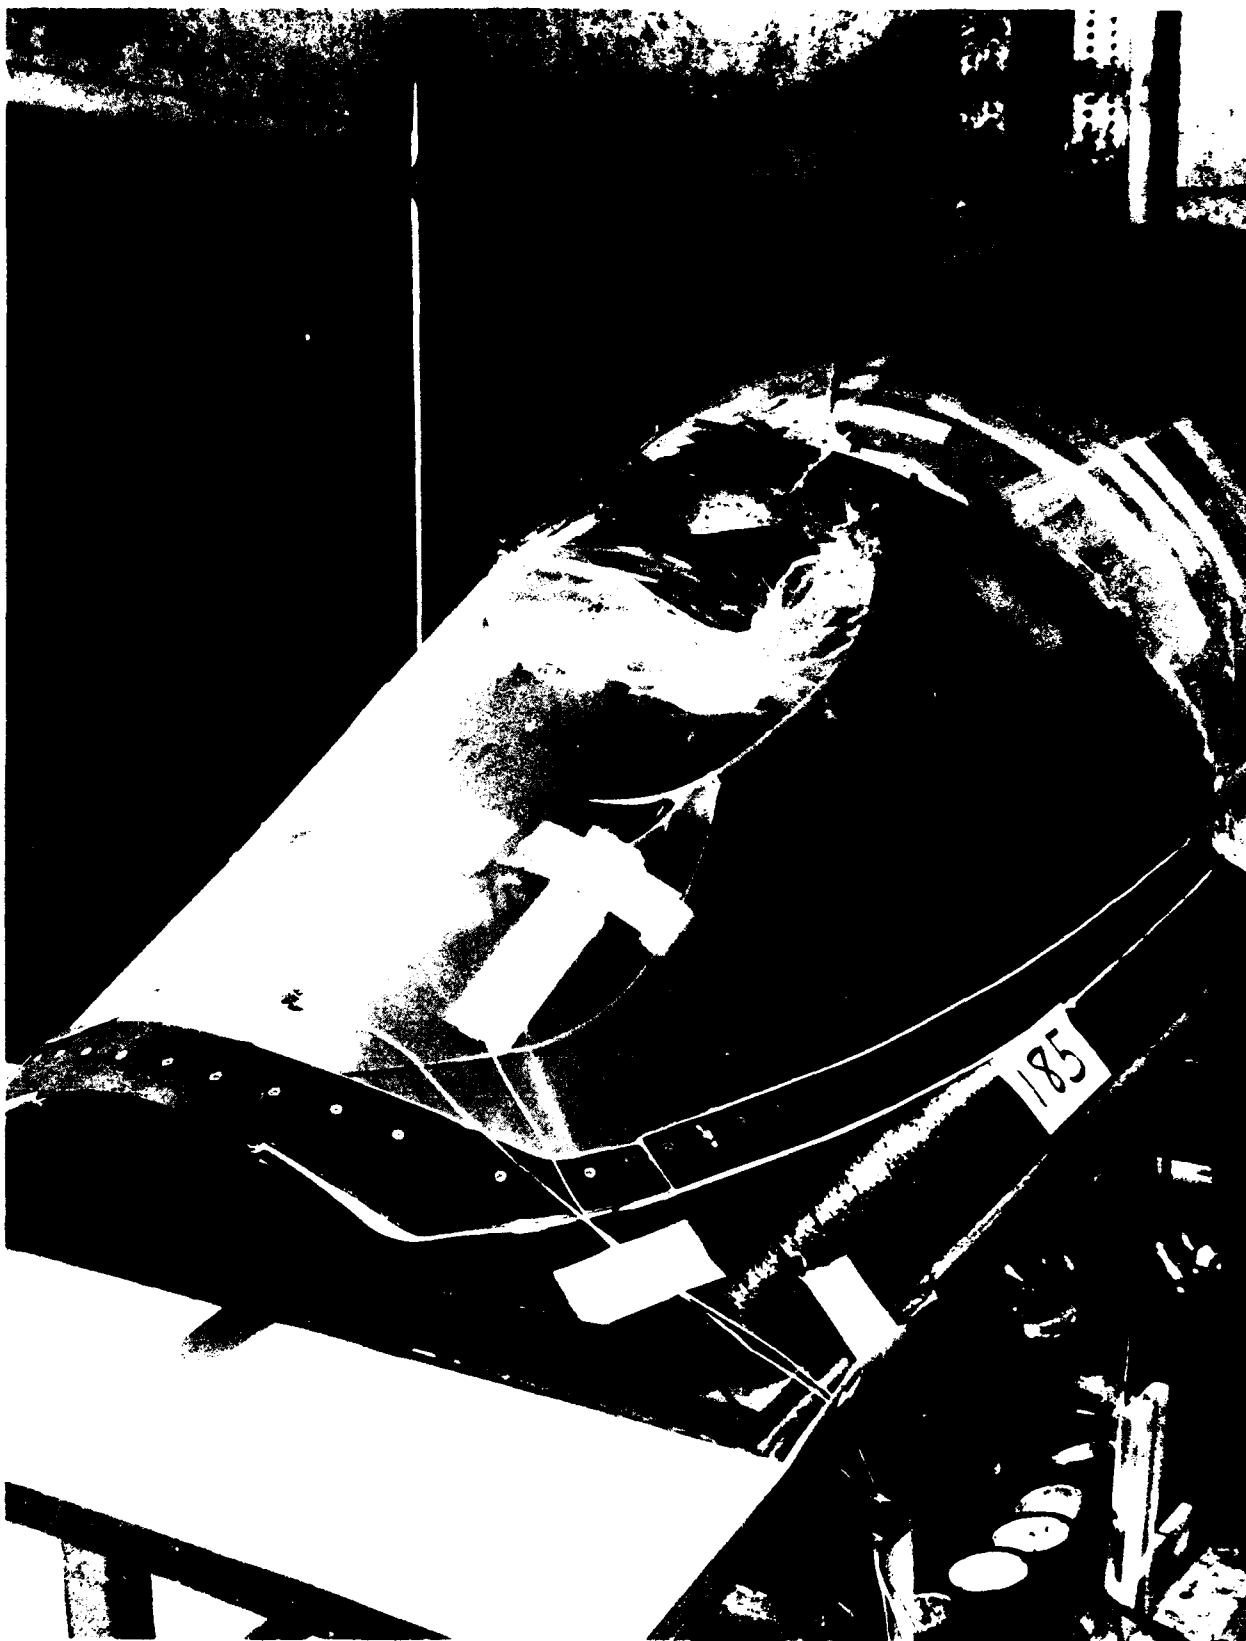
PHOTOGRAPH #3  
POST TEST RESULTS  
SHOT #185

Shot #185 was on windshield number 322-72 with a 4.012-pound bird at 400.9-knots, test was a failure. Impact was after cold soaking the panel at +25°F for 15-minutes. A flap of some 12-inches by 8-inches opened in the impact area and allowed bird debris to enter cockpit.

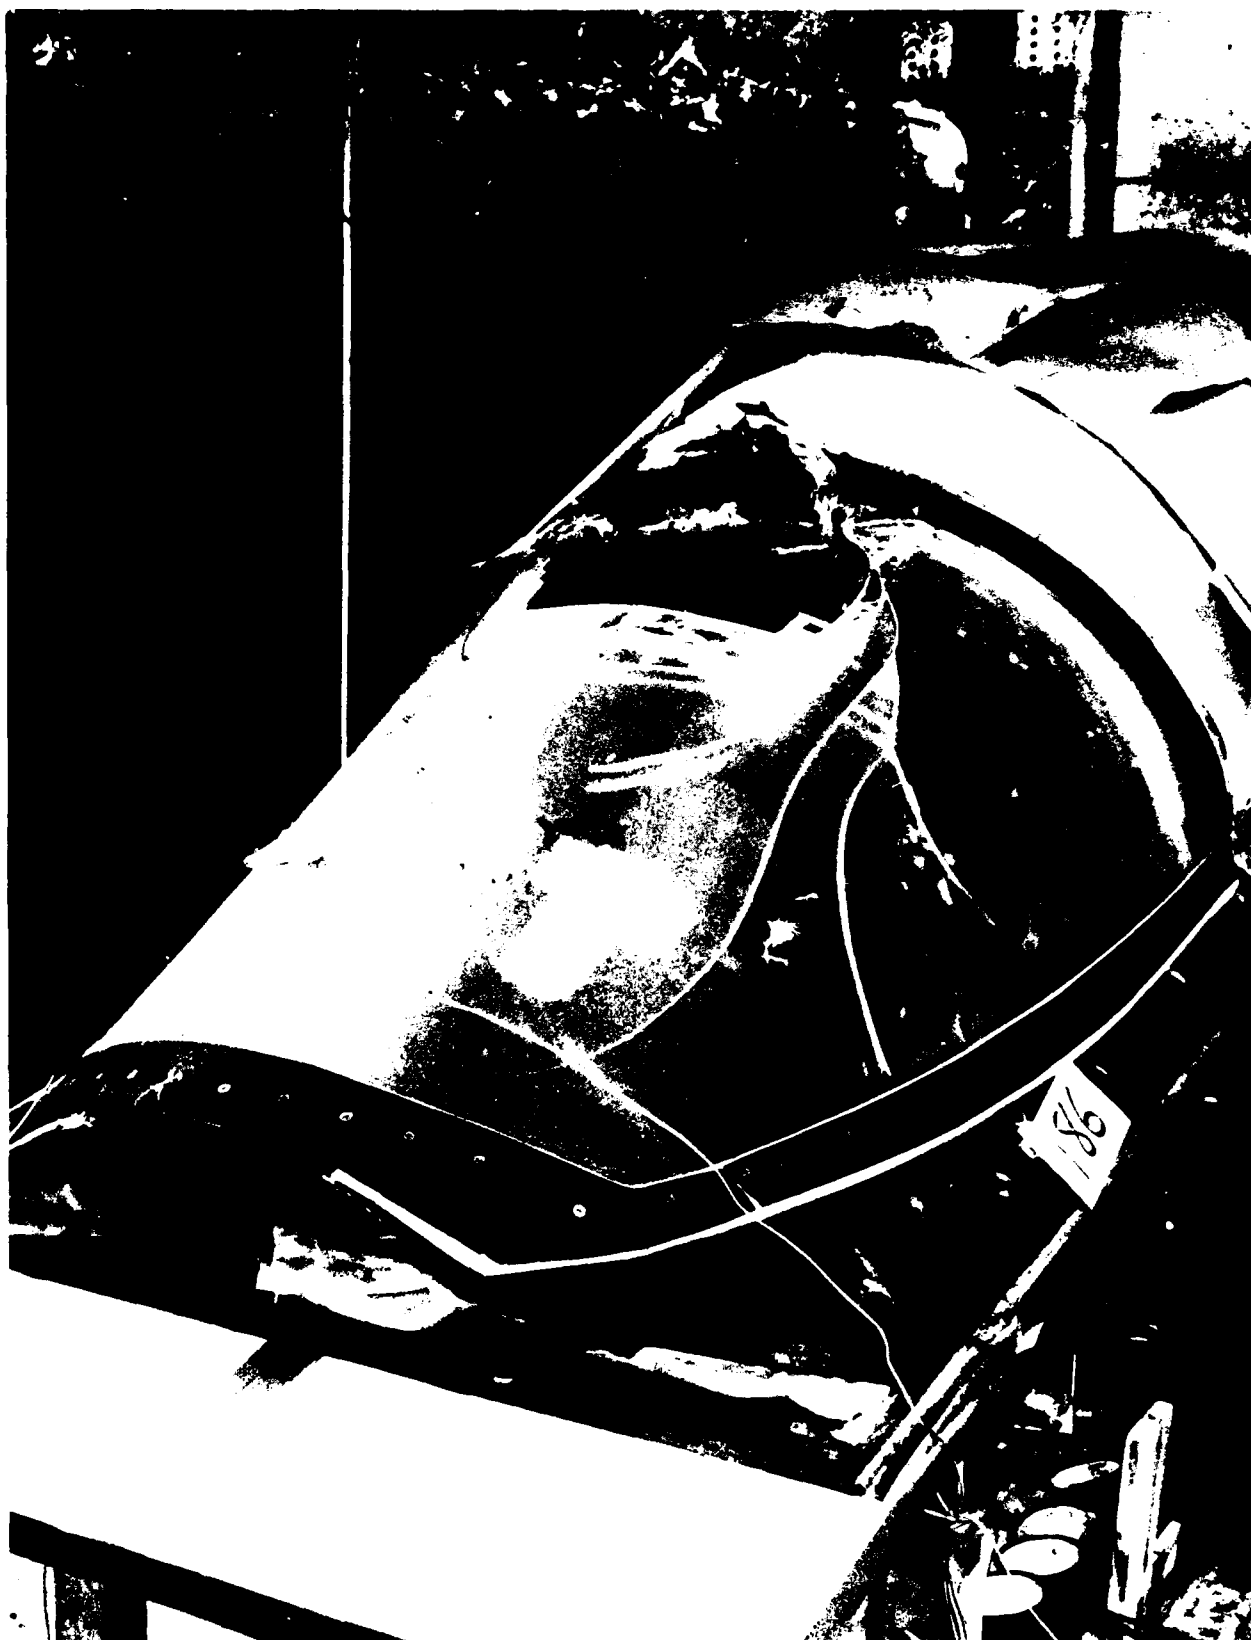
PHOTOGRAPH #4  
POST TEST RESULTS  
COLD SHOT #186  
149

Shot #186 was on windshield number 322-57 after a cold soak at +25°F for 15-minutes. Speed was 393.2-knots with a 4.014-pound bird and was a failure. Again an approximate 12-inch by 8-inch flap opened allowing some bird debris to enter cockpit area. Several cracks generated from flap area toward forward arch. These first three shots were at a location 9-inches forward of aft arch on windshield center line. Removal of stainless steel inboard buffer before test shot #186 may have caused some inboard polycarbonate ply damage.

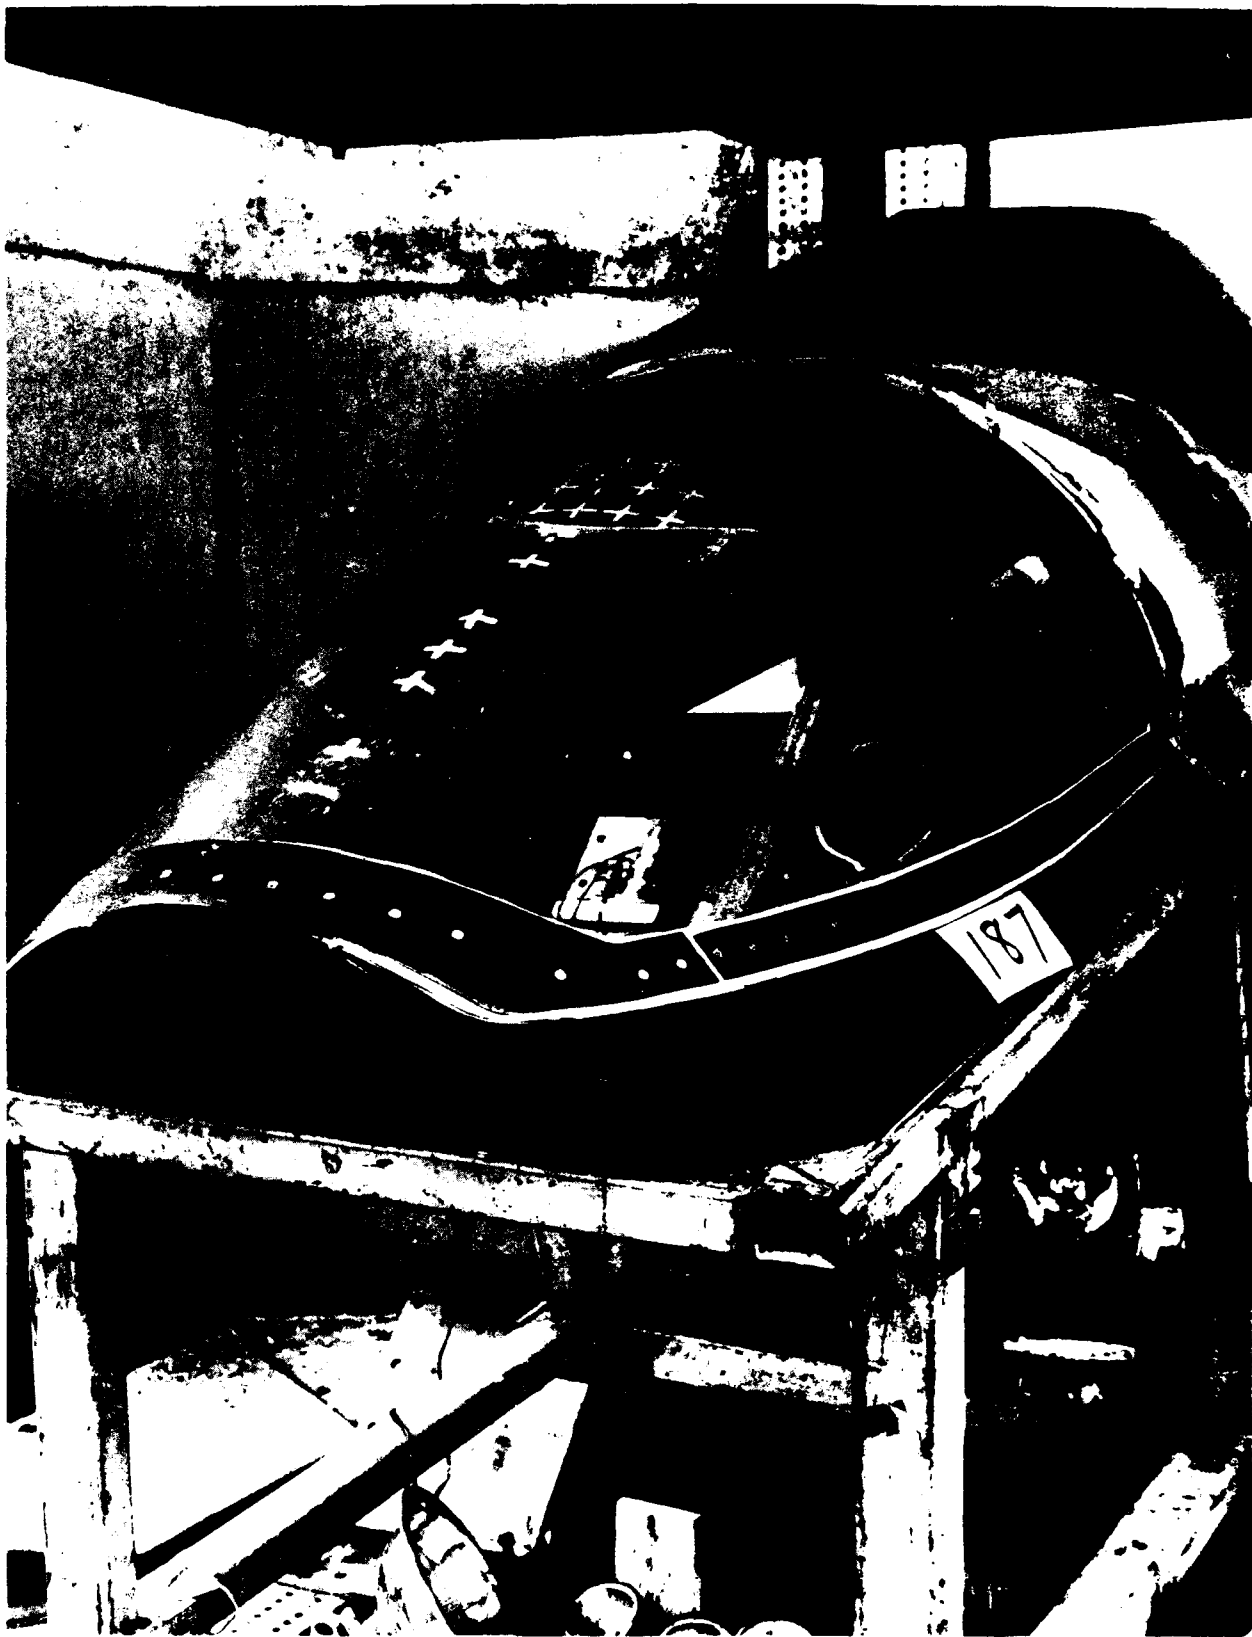
PHOTOGRAPH #5  
POST TEST RESULTS  
SHOT #187

Shot #187 was on windshield number 322-54, previously impacted on shot #184. Impact location point on this test was 6-inches aft of the forward sill on windshield center line. Shot was at room temperature with a 4.016-pound bird, a velocity of 396.2-knots, and the windshield passed. Previous shot damage cracks propagated across windshield center.

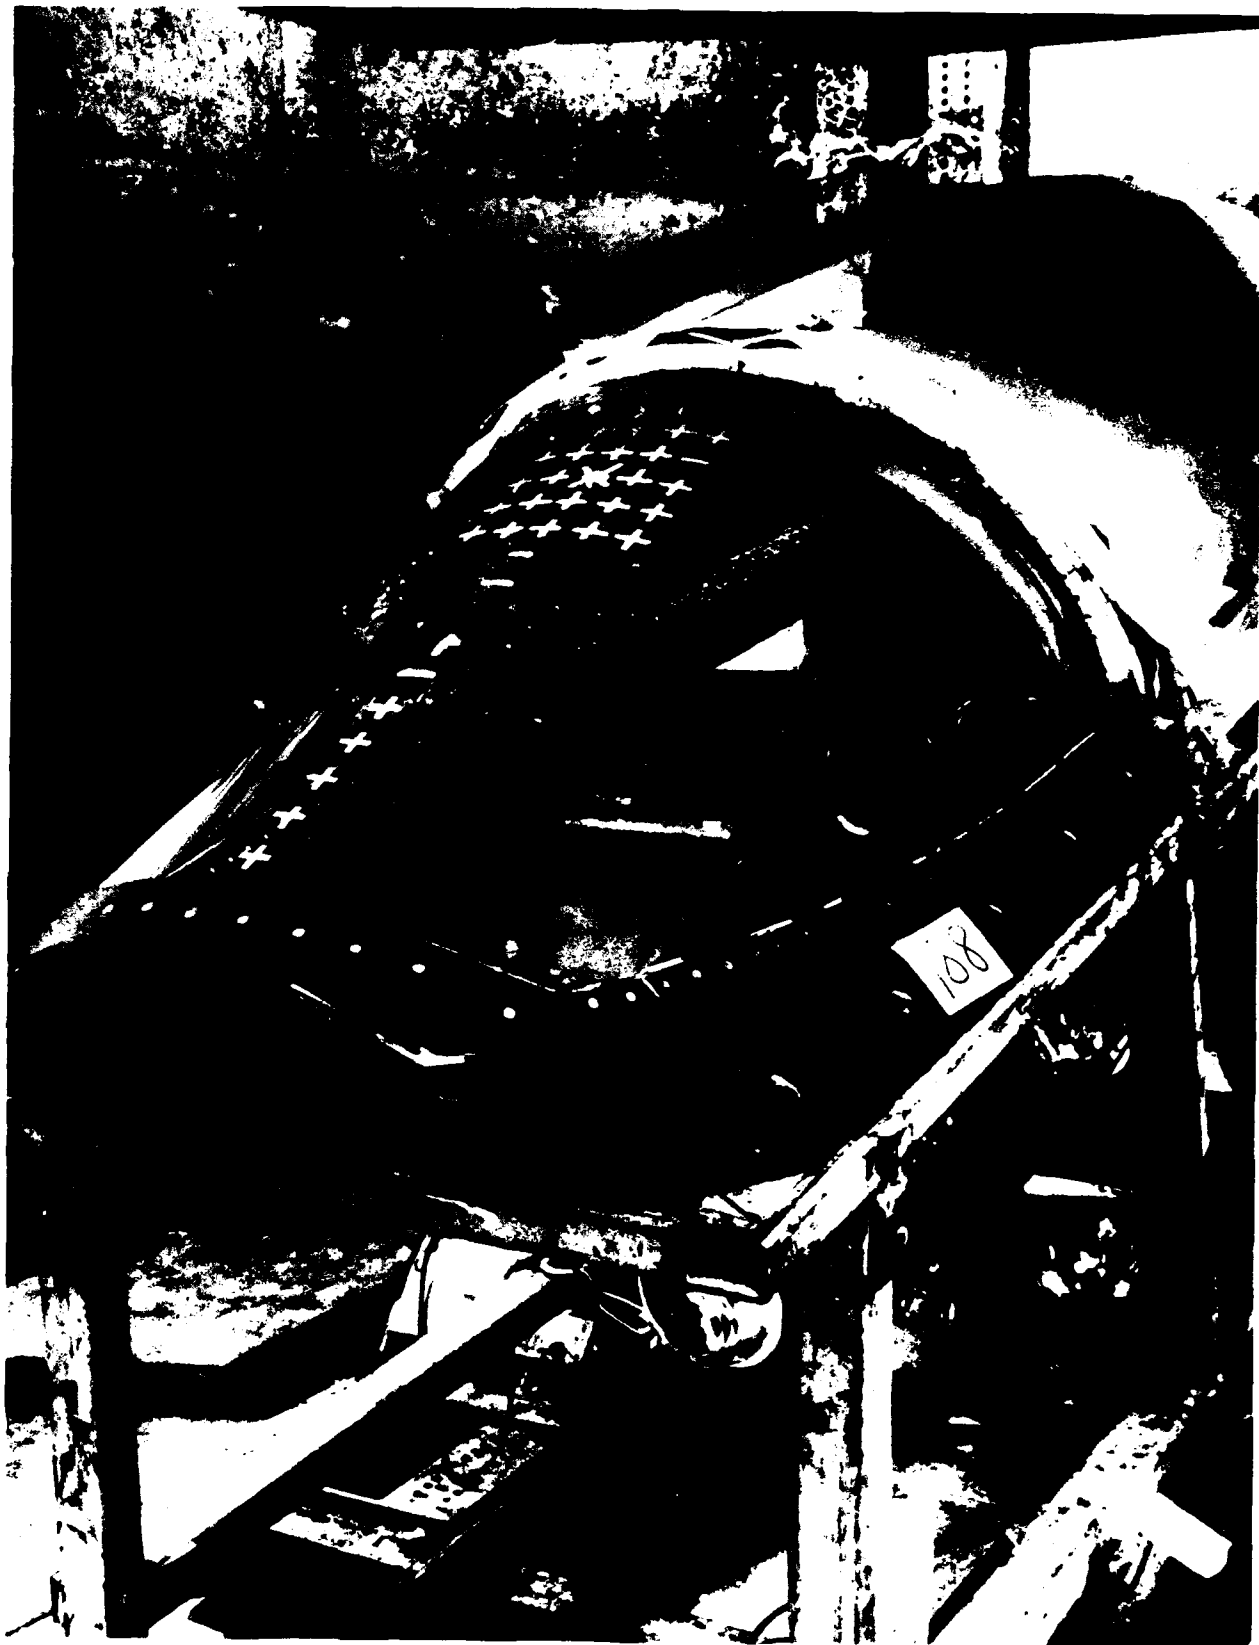
PHOTOGRAPH #6  
POST TEST RESULTS  
SHOT #188

Shot #188 was at room temperature, center of windshield center line. Windshield number 322-52 used for this test was tested before on shot numbers 156, 157, 158, and 159. A 4.002-pound bird impacted the windshield at 392.5-knots without damaging windshield. There was no penetration nor visible damage from the test.

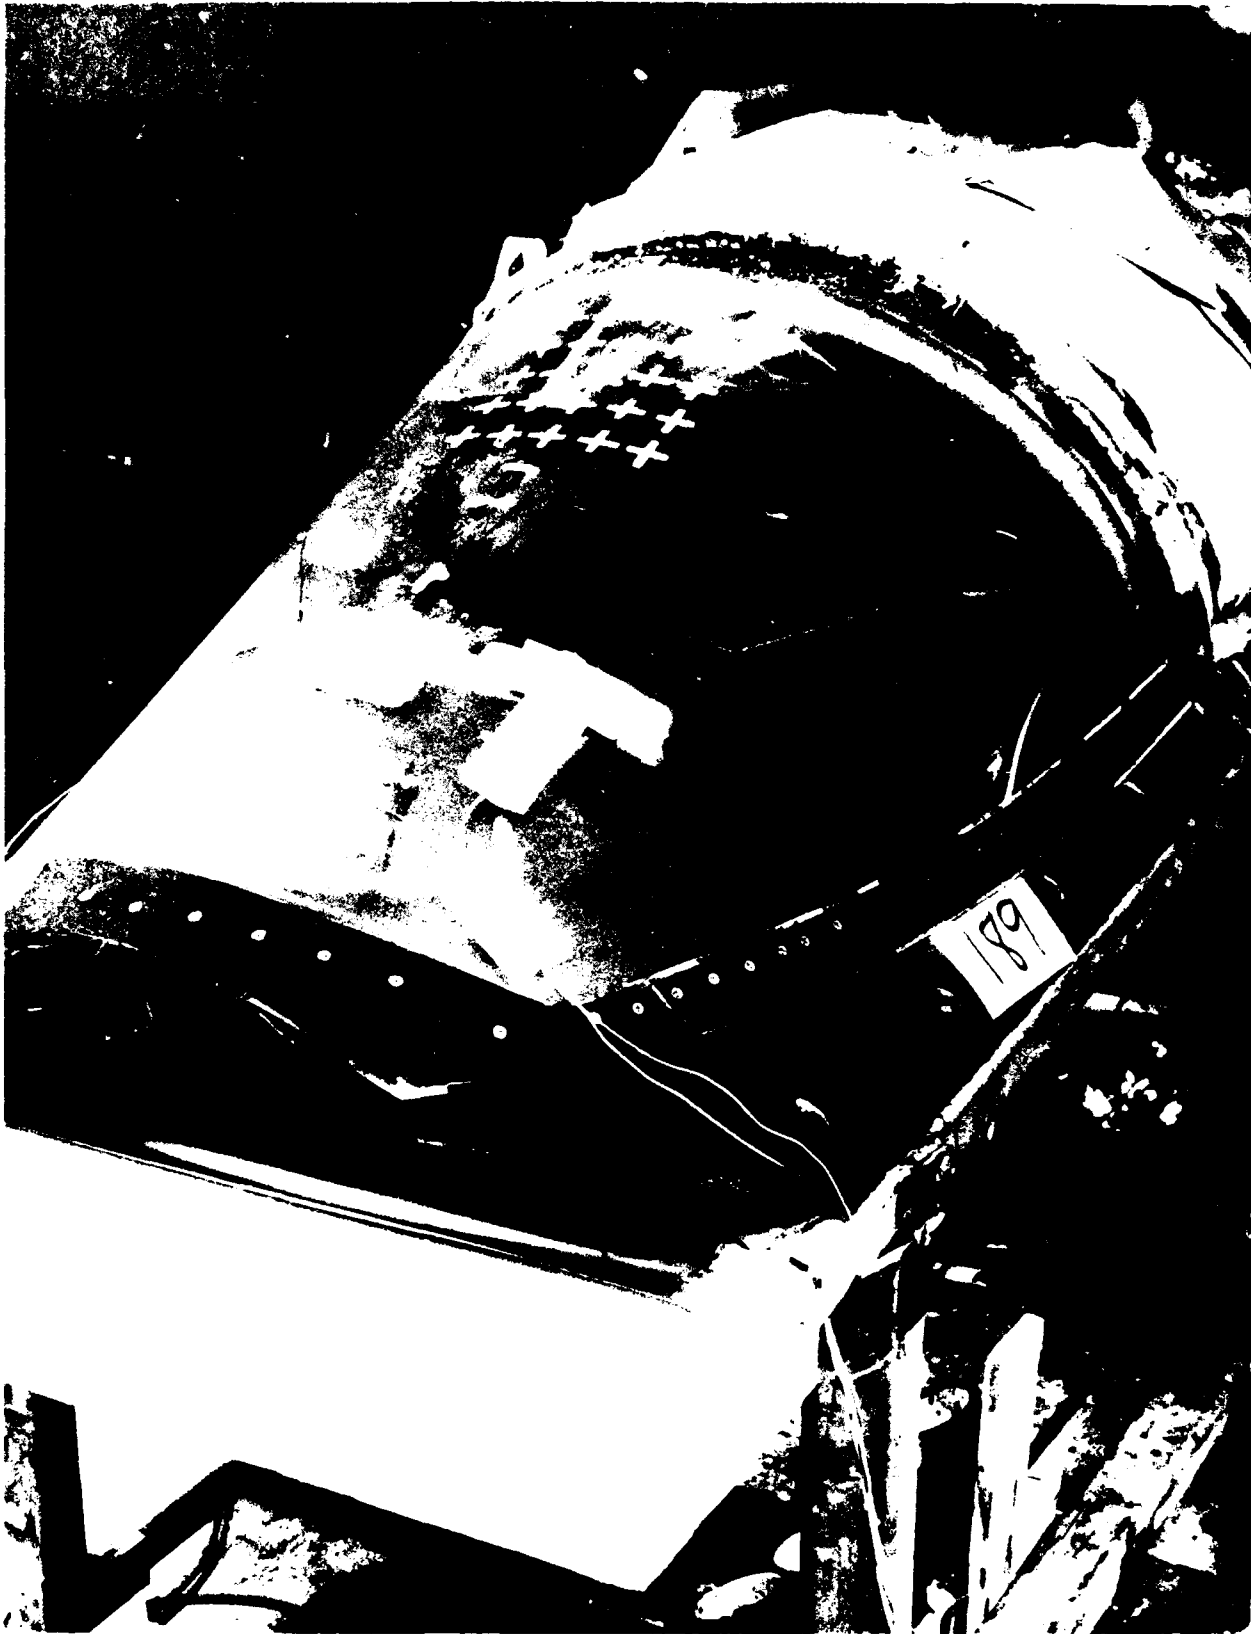
PHOTOGRAPH #7  
POST TEST RESULTS  
COLD SHOT #189

Once more, shot #189 used windshield number 322-52. Impact location was changed to the same position as used in the first three shots, 9-inches forward of the aft arch on windshield windshield center line. This test was after a 15-minute cold soak at +25°F. The impact was at 302.1-knots with a 3.998-pound bird and produced no window damage. Transparency inboard stainless steel buffer was removed before testing.

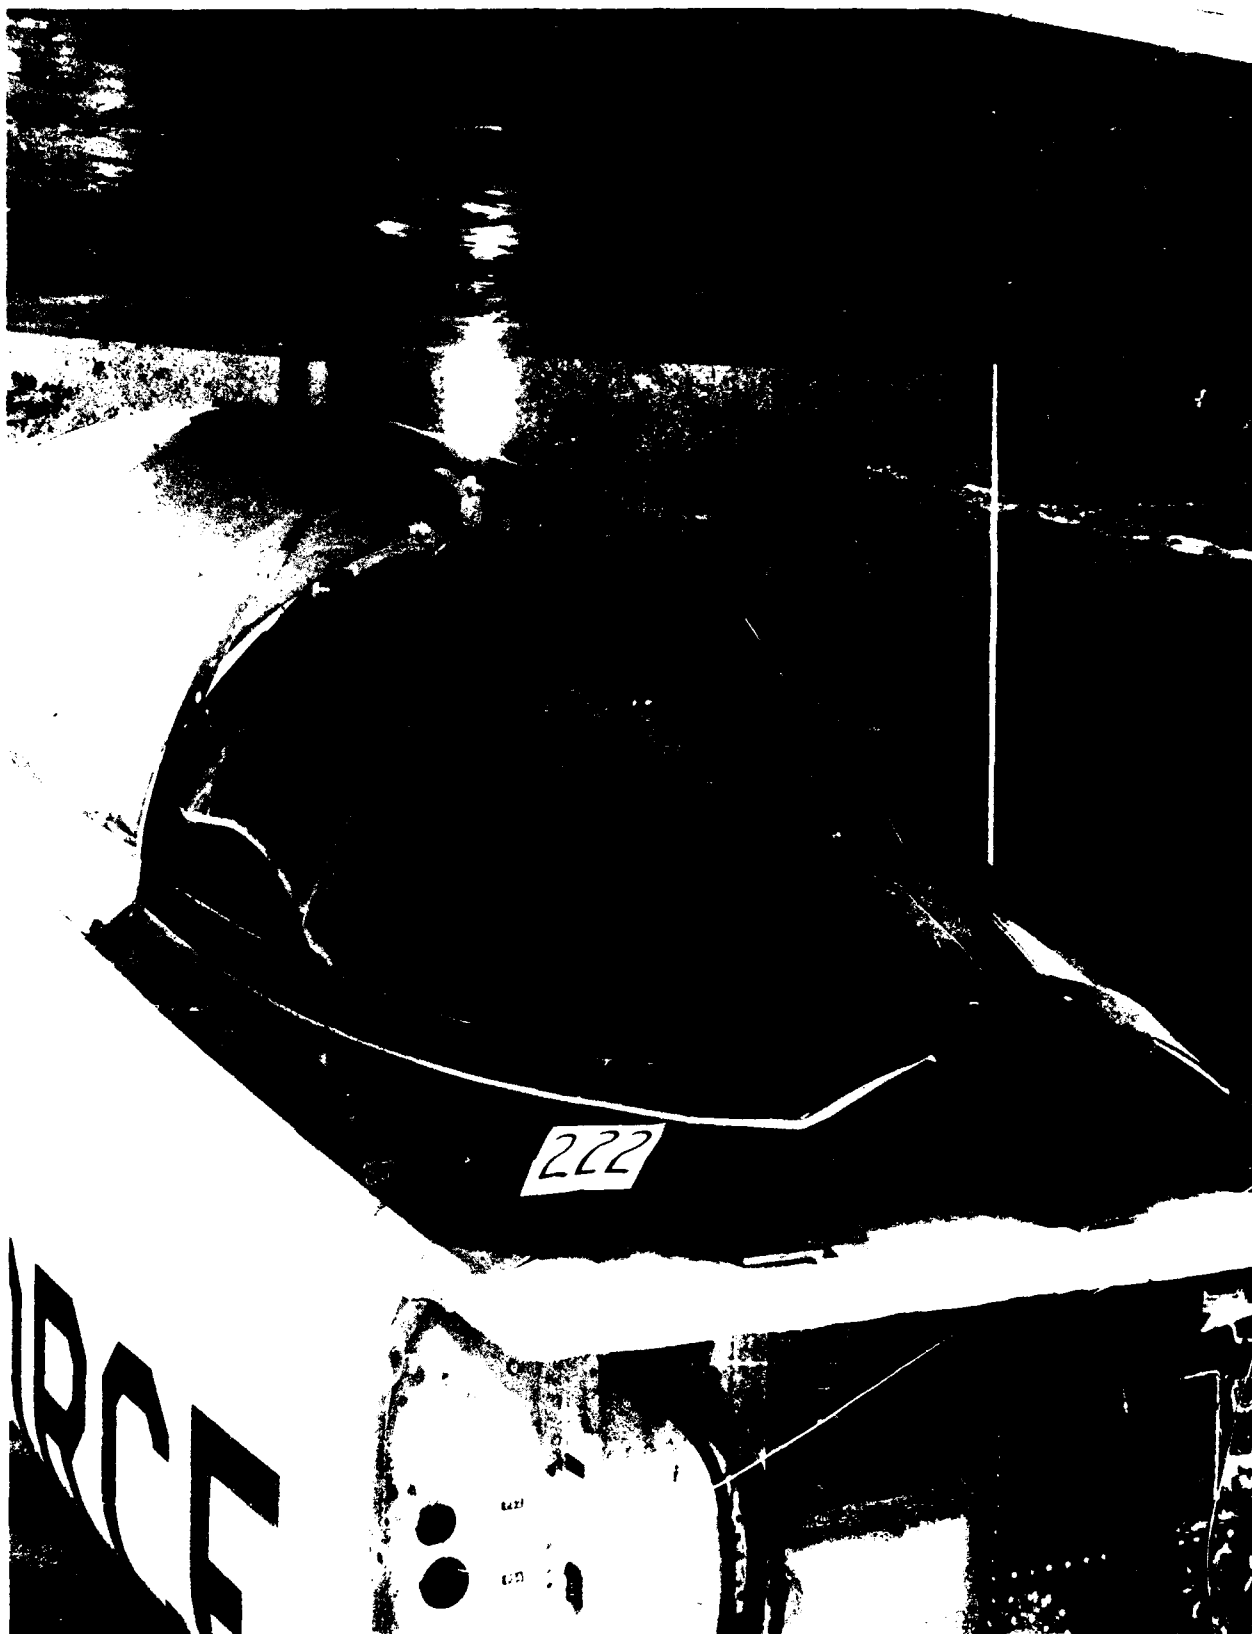
PHOTOGRAPH #9  
HOT SHOT #222  
POST TEST

Shot #222 was a second aft arch centerline location shot on windshield number 322-79 with an outboard surface temperature of 208°F and inboard surface temperature of 159°F. These established temperature values were completed before impact after a 15-minute soak at 210°F. Impact was at 401.5-knots with a 4.008-pound bird. The windshield passed the impact with only a few small outboard ply cracks. Aft arch deflection again allowed some bird debris to enter the aircraft.

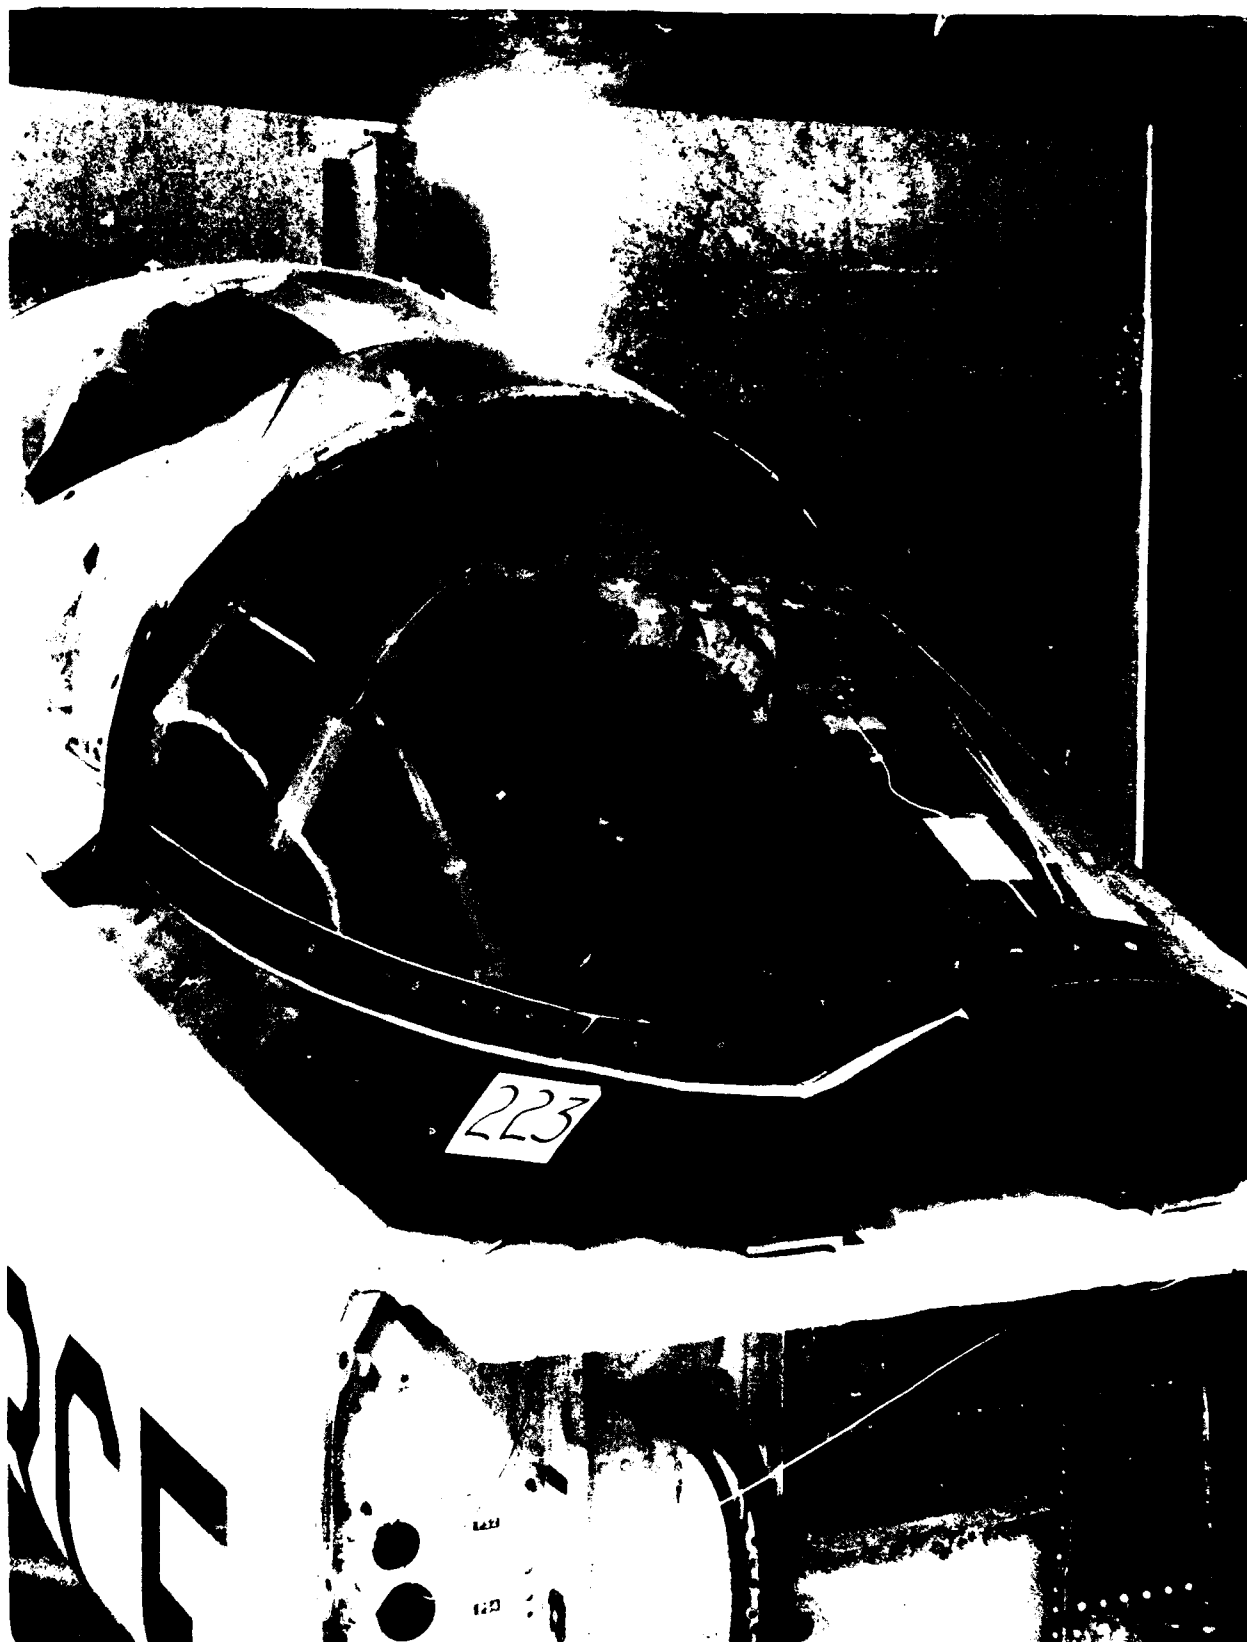
PHOTOGRAPH #10  
SHOT #223  
POST TEST

Shot #223 was on windshield number 322-79, but at an ambient room temperature condition of 75°F. The test was at 132.7-knots with a 4.012-pound bird in the same location as shot #222. Once again the windshield passed the test without any additional panel damage.
