**T-38 FORWARD WINDSHIELD DEVELOPMENT AND PERFORMANCE  
DEMONSTRATION REPORT**

J. W. MYERS  
PPG INDUSTRIES, INC.  
AIRCRAFT PRODUCTS  
P.O. BOX 2200  
HUNTSVILLE, AL 35804

March 12, 1992

Final Report for period June 1982 to September 1989

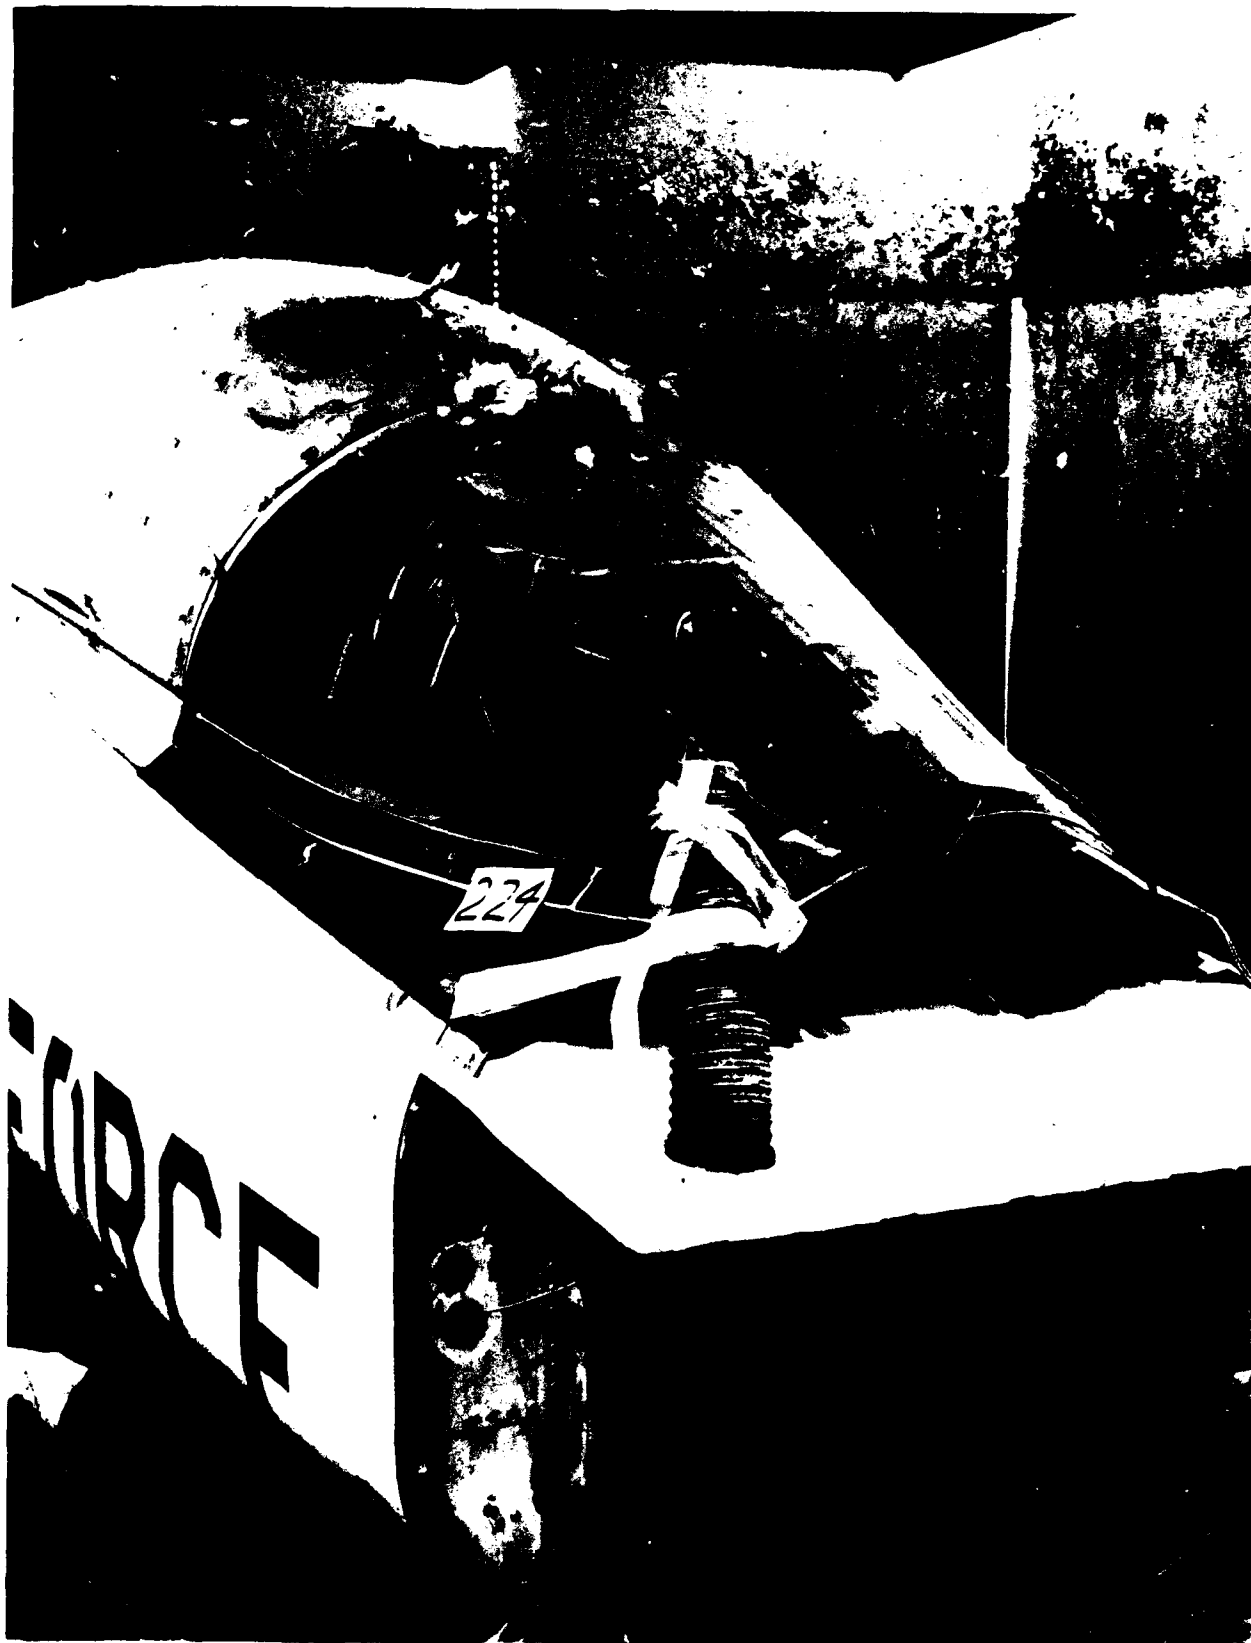
PHOTOGRAPH #13  
COLD SHOT #224  
POST TEST

Shot #224 was an aft arch centerline conducted at low temperature on windshield number 342-10, at a velocity of 351.9-knots, with a 4.010-pound bird test results were good. Temperatures were +26°F on the outboard surface and an inboard surface temperature of +39°F. These values were reached after a 15-minute soak at 25°F. Post-test evaluation revealed several large cracks in the polycarbonate plies of the window. Aft arch deflection allowed a minimal amount of bird debris to enter cockpit area.

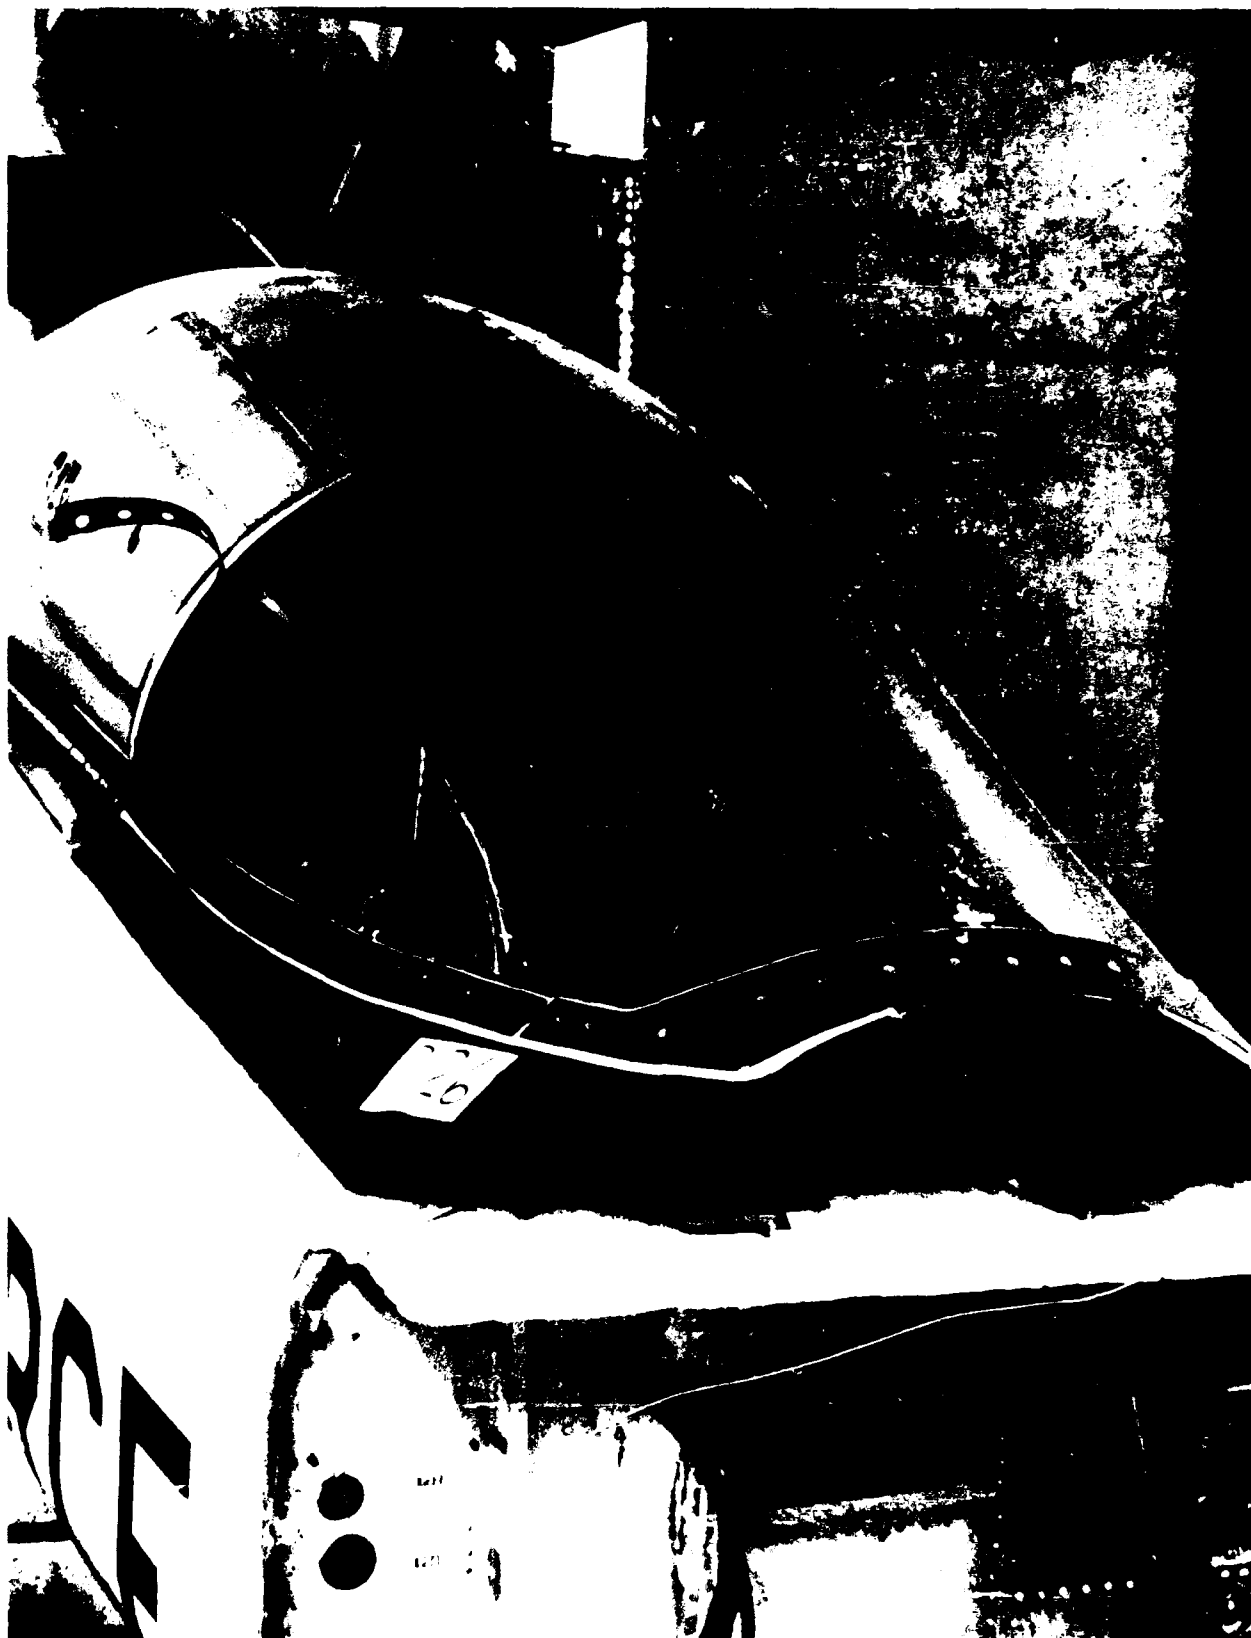
PHOTOGRAPH #15  
SHOT #226  
POST TEST

Shot #226 was at room temperature on windshield number 342-09. Impact occurred at a velocity of 398.9-knots, with a 4.020-pound bird and proved to be a success. The nose impact produced a crack in the 3/8-inch polycarbonate ply that radiated from impact position up to aft arch.
