WL-TR-92-3029

BIRD IMPACT RESISTANT ANALYSIS OF  
THE F-15E PRODUCTION TRANSPARENCY SYSTEM

Guy J. Graening

FEB 1992

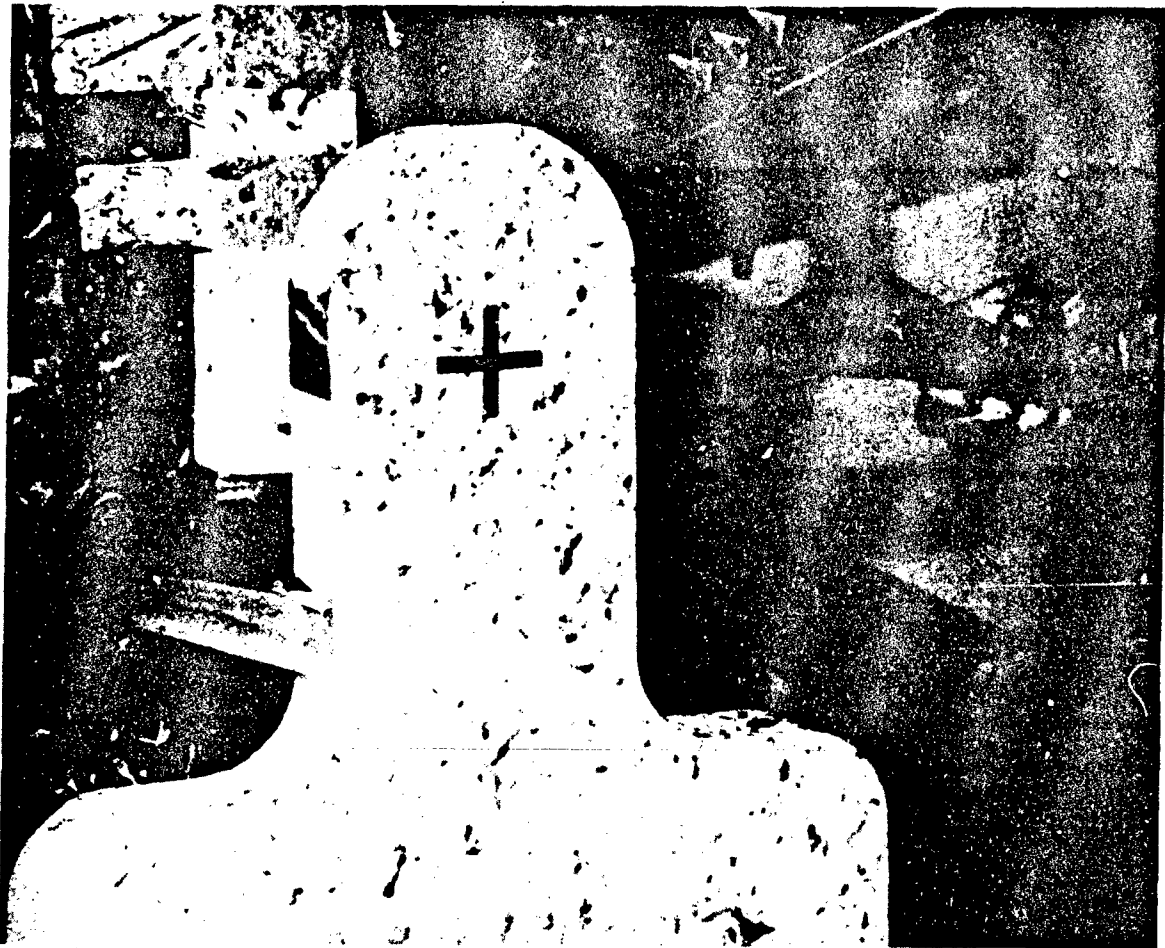
**FIGURE 20**

# **TEST 4: AFT WITNESS PLATE AND BREAKER BAR**

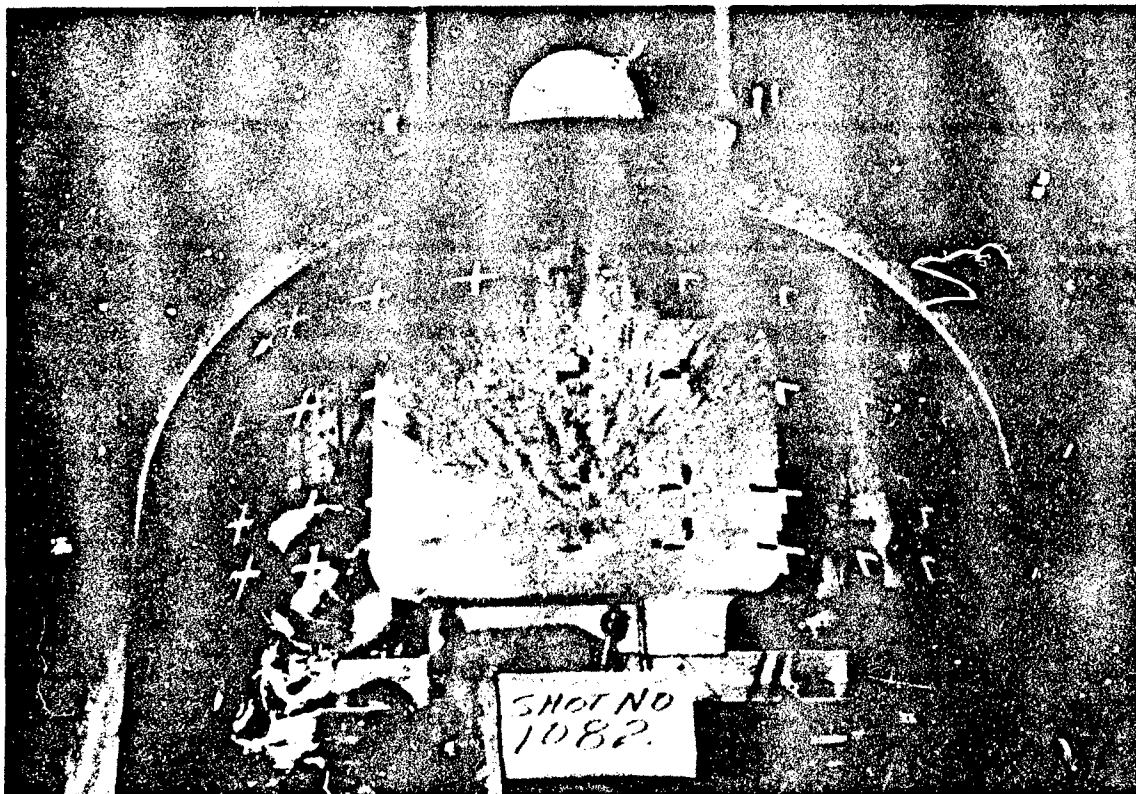
**FIGURE 21**

A 2-pound bird impacted the windshield high quarter location at 536 knots. The impact resulted in the windshield remaining structurally intact. A post-inspection revealed scuff marks on the windshield and minor arch damage (Figure 21). The result indicates that the selected conditions were below the impact tolerance of the system. Test 5 was determined to be a "pass."

**TEST 5:  
SCUFF MARK, ARCH DAMAGE**
