Technical Report SL-93-5  
April 1993

## Investigation of Probable Causes of Cracking, Aircraft Weather Shelters, Kadena Air Base, Okinawa

Prepared for U.S. Army Engineer District, Japan  
Camp Zama, Japan

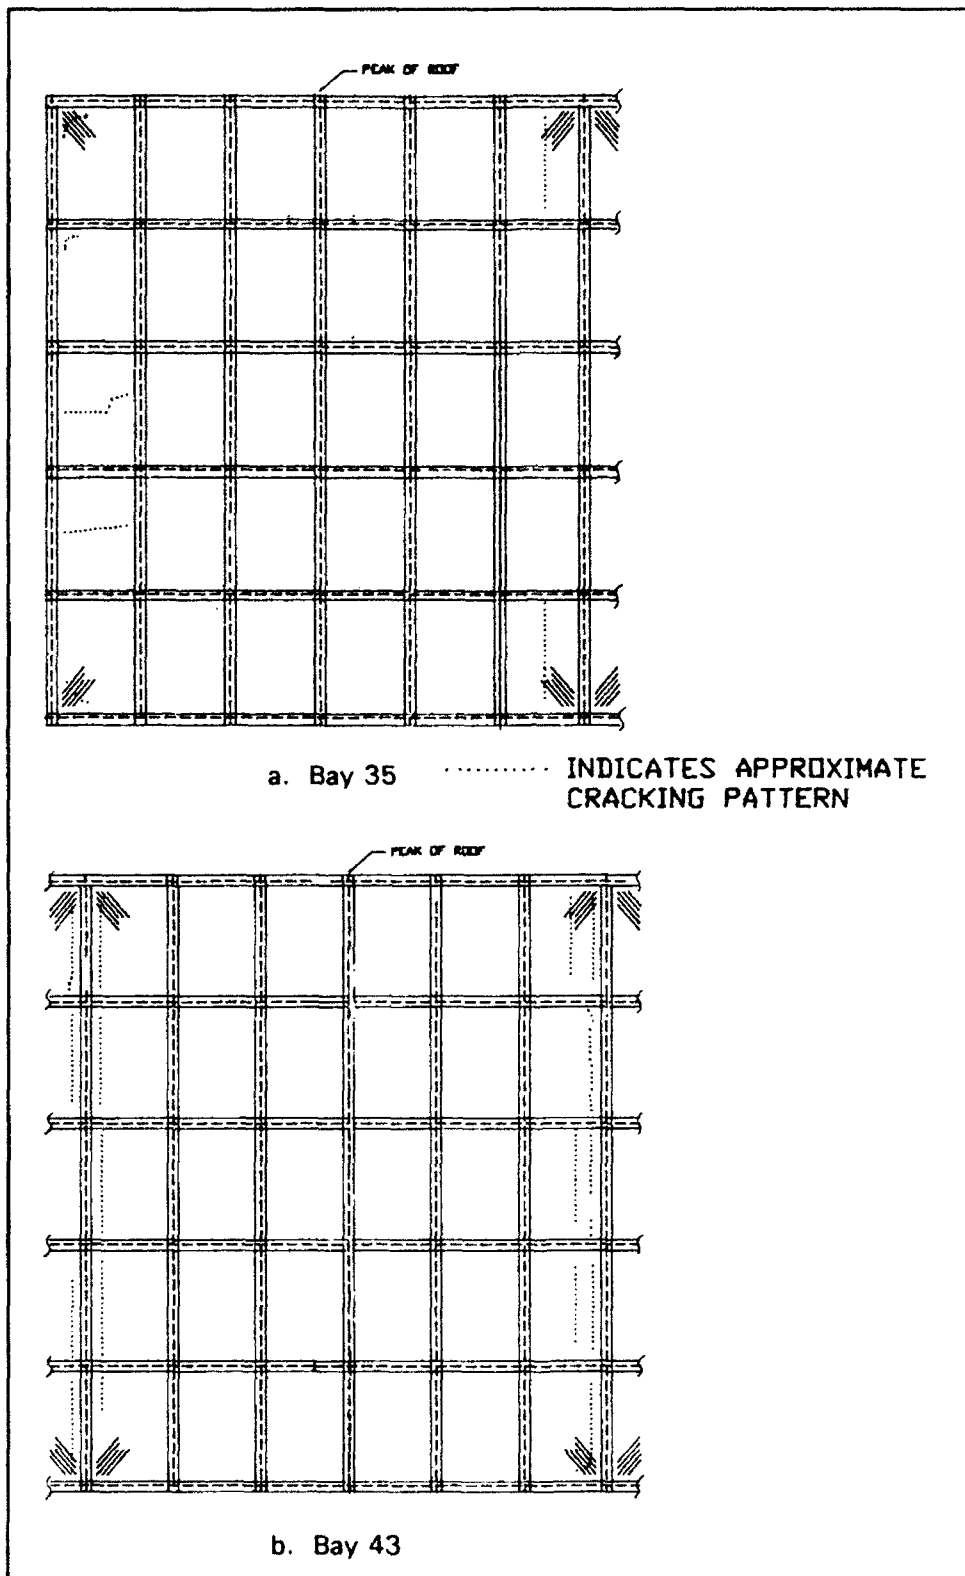
After elimination of the bend and the increase in total reinforcing in the slabs, cracking still occurred. In general, the cracking became less severe and the cracking pattern changed somewhat after the modification. Figure 8 gives a comparison of cracking geometry for two bays of the structure as supplied to WES by USAED, Japan, personnel. It shows a distinct difference in

cracking geometry following placement of additional steel and elimination of the bend just described. Although this is a limited comparison, it appears that in the newer structures (with additional steel) the cracks have been forced farther up the slope. In some cases, the direction of the cracks has changed from parallel to the valleys to perpendicular to the valleys. This points to the flexibility of individual slab "panels" in the structure, but for the comparison given in Figure 8, this could also be the result of boundary conditions. Bay 35 has one "free" edge and one continuous edge while both edges of Bay 43 are continuous. Individual panel flexibility is brought about by the large width-to-thickness ratio of the panels (minimum of approximately 22:1) and the placement of steel with respect to the panel depth.

Further evidence for the above argument is found in the changes in crack orientation following addition of steel at the column heads. In the original nine structures, almost all cracking is parallel to the valleys of the structure and is located near the valleys. Further, the cracks do not appear to extend across the girder areas. This points to excessive stresses in the individual slab panels brought about by negative moment loads at the column heads. The girders are sufficiently reinforced to resist cracking; however, the slab panels appear to crack due to direct tension over the column heads resulting from negative moment at these points (and possibly exacerbated by reversing loads). In the newer structures, it appears that many of the cracks have changed orientation, which indicates that the additional steel may have been adequate to handle the direct tension over the columns but not adequate to handle individual panel loads (probably dominated by wind). No additional steel was added in the orthogonal direction, thus cracking occurred in the weaker direction. For Bay 35, the change in crack orientation at the free edge could also be partially attributable to boundary conditions (Figure 8).

Figure 8. Plan view of Bays 35 and 43, showing locations of beams and cracks; peak of each folded plate is in the center of the bay

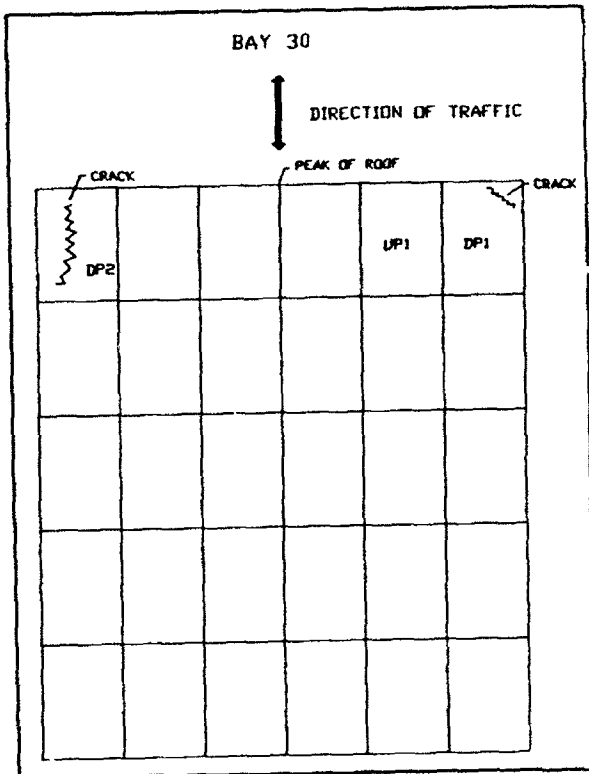
The damaged panels (DP1 and DP2) chosen for impact tests represented two of the more common crack configurations. One panel (DP1 in Figure 15) had a diagonal crack across one corner and penetrating the full depth of the slab. The same procedures were used for this panel as were used for the undamaged panel to define the mode shape. Figure 18 shows the first three experimentally derived modes for DP1. The results for this mode of DP1 appear to be identical to those of the undamaged panel. A minimal effect of the crack on structural behavior is indicated. The second and third modes for this panel compare very well visually with experimental results for UP1 and with calculated results.

DP2 is located as indicated in Figure 15. Damage to this panel consisted of a longitudinal crack running parallel to the long dimension of the slab and approximately 1.5 m from the valley edge of the panel. The experimental fundamental frequency for the first mode was 46.25 Hz, the same as it was for the other two panels. The first three mode shapes are presented in Figure 19. Table 5 gives a comparison of the first three frequencies for the calculations and test results.

Figure 15. Plan view of roof of Bay 30, showing locations of UP1, DP1, DP2, and cracks; arrow marks roof peak and shows direction of aircraft traffic
