Miscellaneous Paper CERC-93-5  
July 1993

## Monitoring of East Breakwater Rehabilitation at Cleveland Harbor, Ohio

by *Joan Pope, Robert R. Bottin, Jr.*  
*Coastal Engineering Research Center*

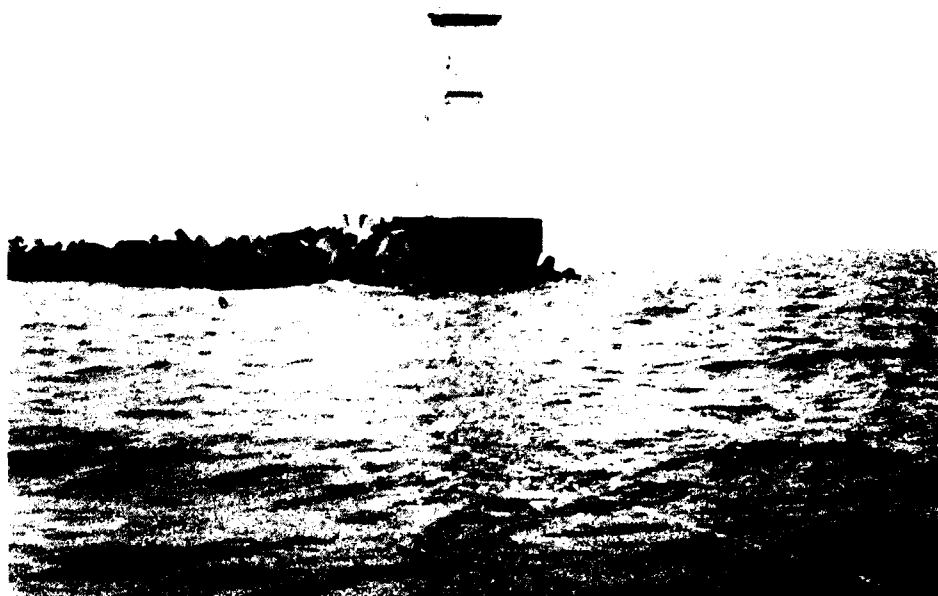
most of the 2-ton dolosse around the head of the lighthouse on the eastern end of the structure were missing (Figure 29). The damage was evaluated and in May 1987, 234 dolos armor units were placed around the head (Figure 30). These were 4-ton units as opposed to the 2-ton units previously used. Several 4-ton dolosse were also placed in low areas along the trunk to bring it back to the correct elevation. The 4-ton units appear to have remained stable around the head of the east breakwater since the 1987 rehabilitation.

It is unclear as to the time and cause of the 1986-87 failure. Immediately west of Cleveland Harbor, it was noted that a recently completed fishing pier at Edgewater Park also was destroyed during February 1987 by wave action. Review of hindcast data (Driver, Reinhard, and Hubertz 1991) indicated that at the peak of a storm on 9 February 1987, a deepwater wave height of 9.5 ft with a 7.1-sec period occurred from the north. Deepwater wave heights ranging from 8 to 9.5 ft occurred for about 10 hr. A slightly more severe storm from the northeast, but with a much longer duration, occurred during early April 1987 (Driver, Reinhard, and Hubertz 1991). This storm had a deepwater wave height of 10.2 ft with a period of 7.7 sec. Wave heights greater than 8 ft occurred for over 24 hr. Another April storm yielded 8-ft and greater waves from the north northeast for about 12 hr, with deepwater heights of 11.2 ft and periods of 8.3 sec.

These 1987 storms were not as severe as the April 1982 event, but caused significantly more damage. Dive inspections in the spring of 1987 revealed a significant number of dolos fragments scattered over the underwater slope.

Figure 29. View of head of east breakwater after the 1986-87 winter. Note most the dolos cover is missing

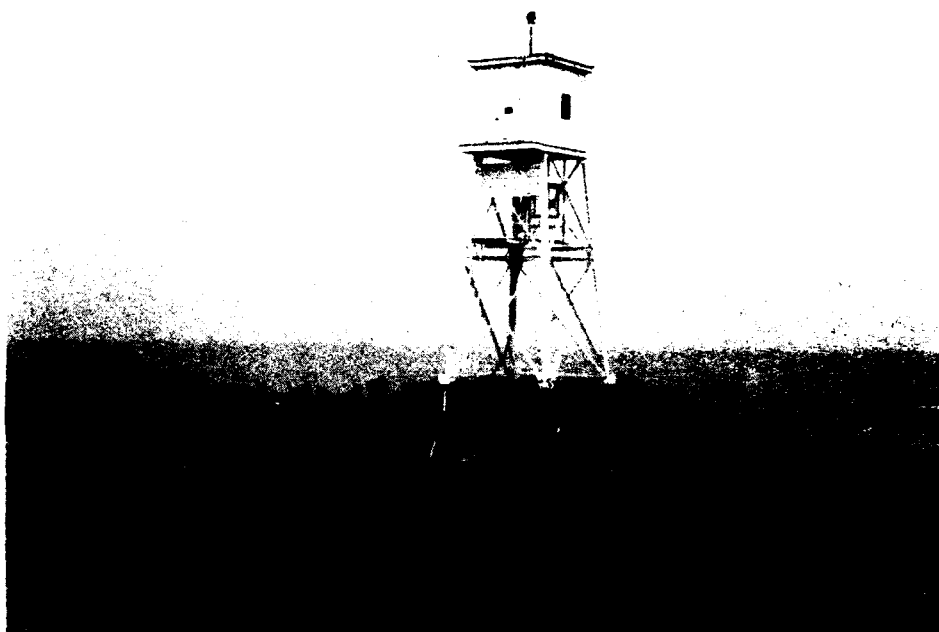
**Figure 30. View of 4-ton dolos units placed around head of structure in May 1987**
