| 4. TITLE AND SUBTITLE<br><br>M825A1 WHITE PHOSPHOROUS MALFUNCTION INVESTIGATION<br>RELATED TO THE M739/M739A1 SAFING AND ARMING MODULE | | | 5. FUNDING NUMBERS | |
| 6. AUTHOR(S)<br><br>Saman F. Khoury | | | | |
| 7. PERFORMING ORGANIZATION NAME(S) AND ADDRESSES(S)<br><br>ARDEC, AED<br>Fuze Division (SMCAR-AEF-F)<br>Picatinny Arsenal, NJ 07806-5000 | | | 8. PERFORMING ORGANIZATION<br>REPORT NUMBER<br><br>Technical Report<br>ARAED-TR-92031 | |

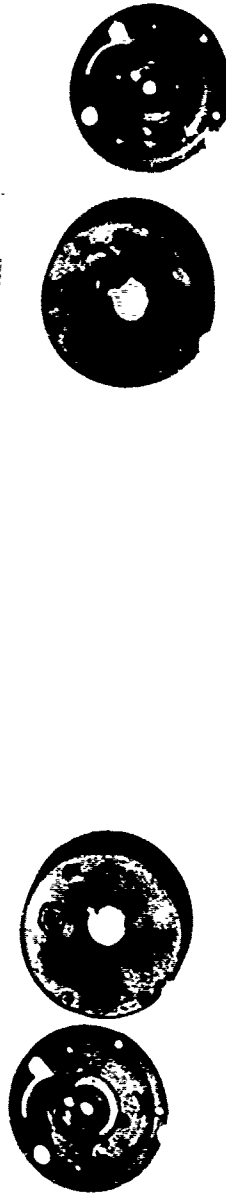
Examination of the recovered canisters revealed evidence that the S&A module fully armed and functioned (fig. 1). The detonator and lead functioned, and the dimension of the output hole on the S&A bottom plate shown on figure 1 are:

Streamer - 0.4 in. x 0.3 in., measured 90 deg apart  
Dud - 0.42 in. x 0.48 in., measured 90 deg apart

Figure 1. M739/M739A1 recovered safe and arm, M825A1 assembly

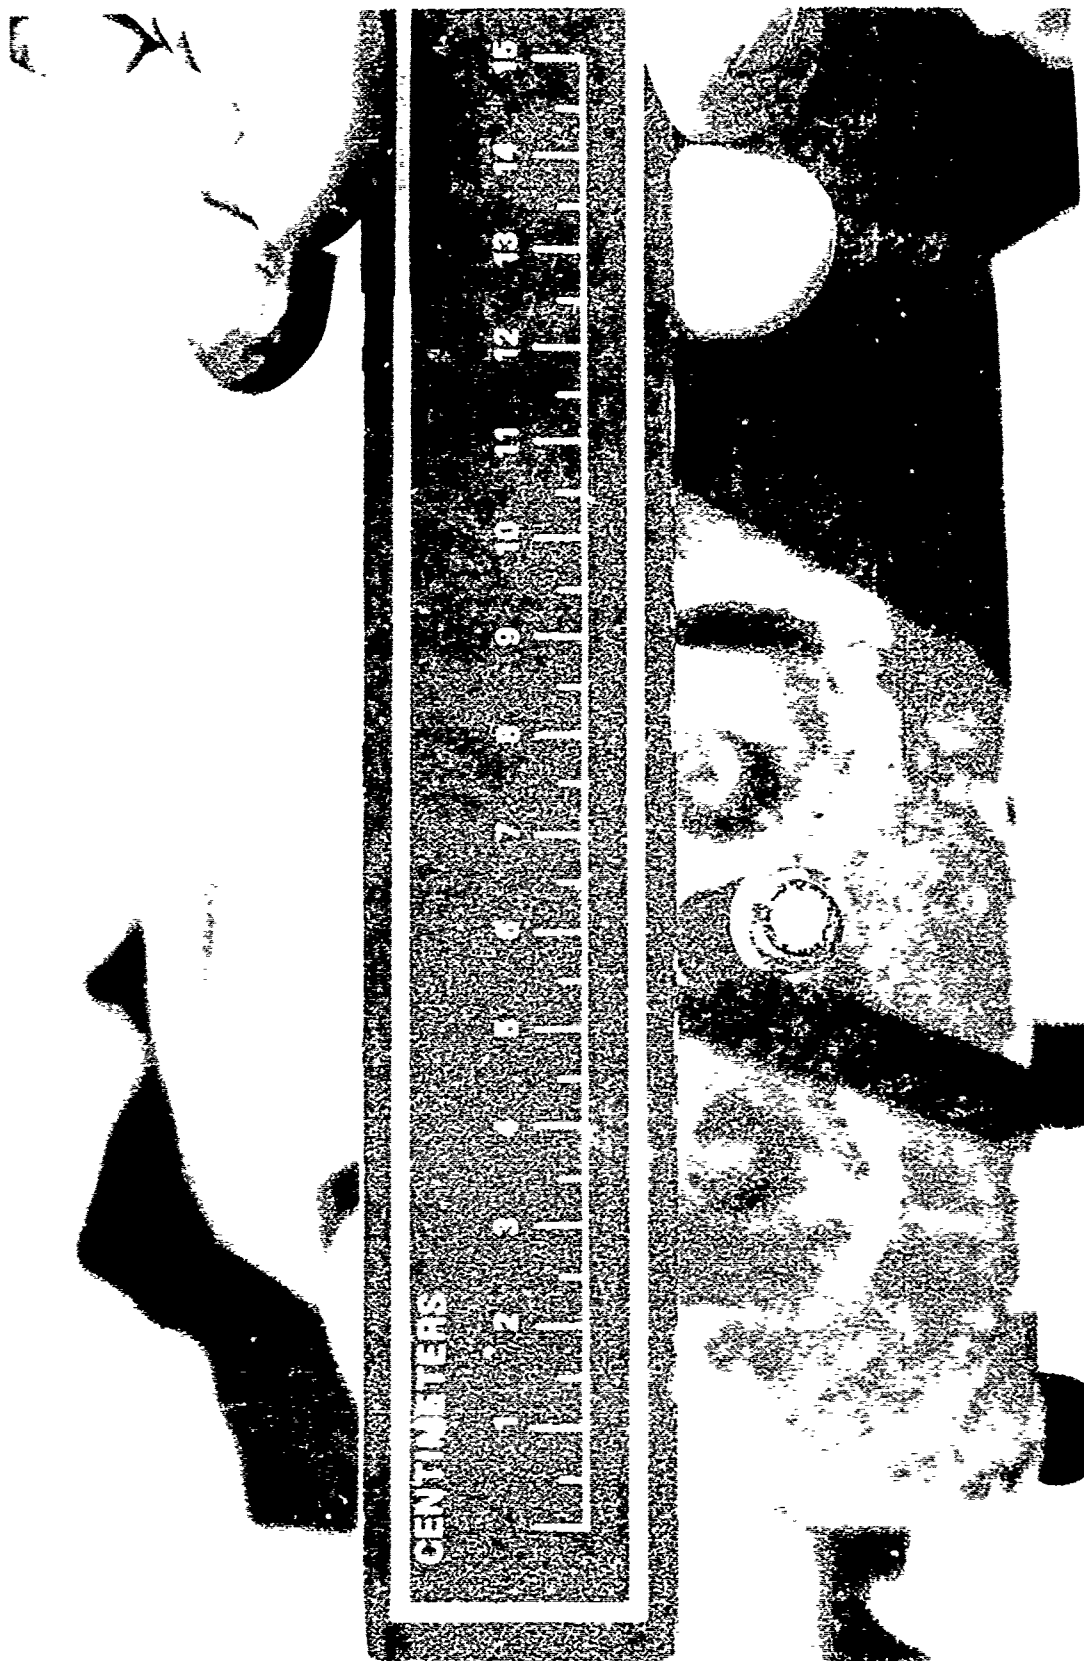
Examination of the burster in the dud unit showed that the composition (Comp) A-5 explosive did not detonate (fig. 2); however, approximately 1 in. of the Comp A-5 was missing. The burster well and burster were mangled as shown on figure 3. Metal parts examination of the streamer showed evidence of Comp A-5 burning rather than detonating. Both rounds did not function high order as intended.

Figure 2. M825A1 recovered burster, lot PB-89J000E005

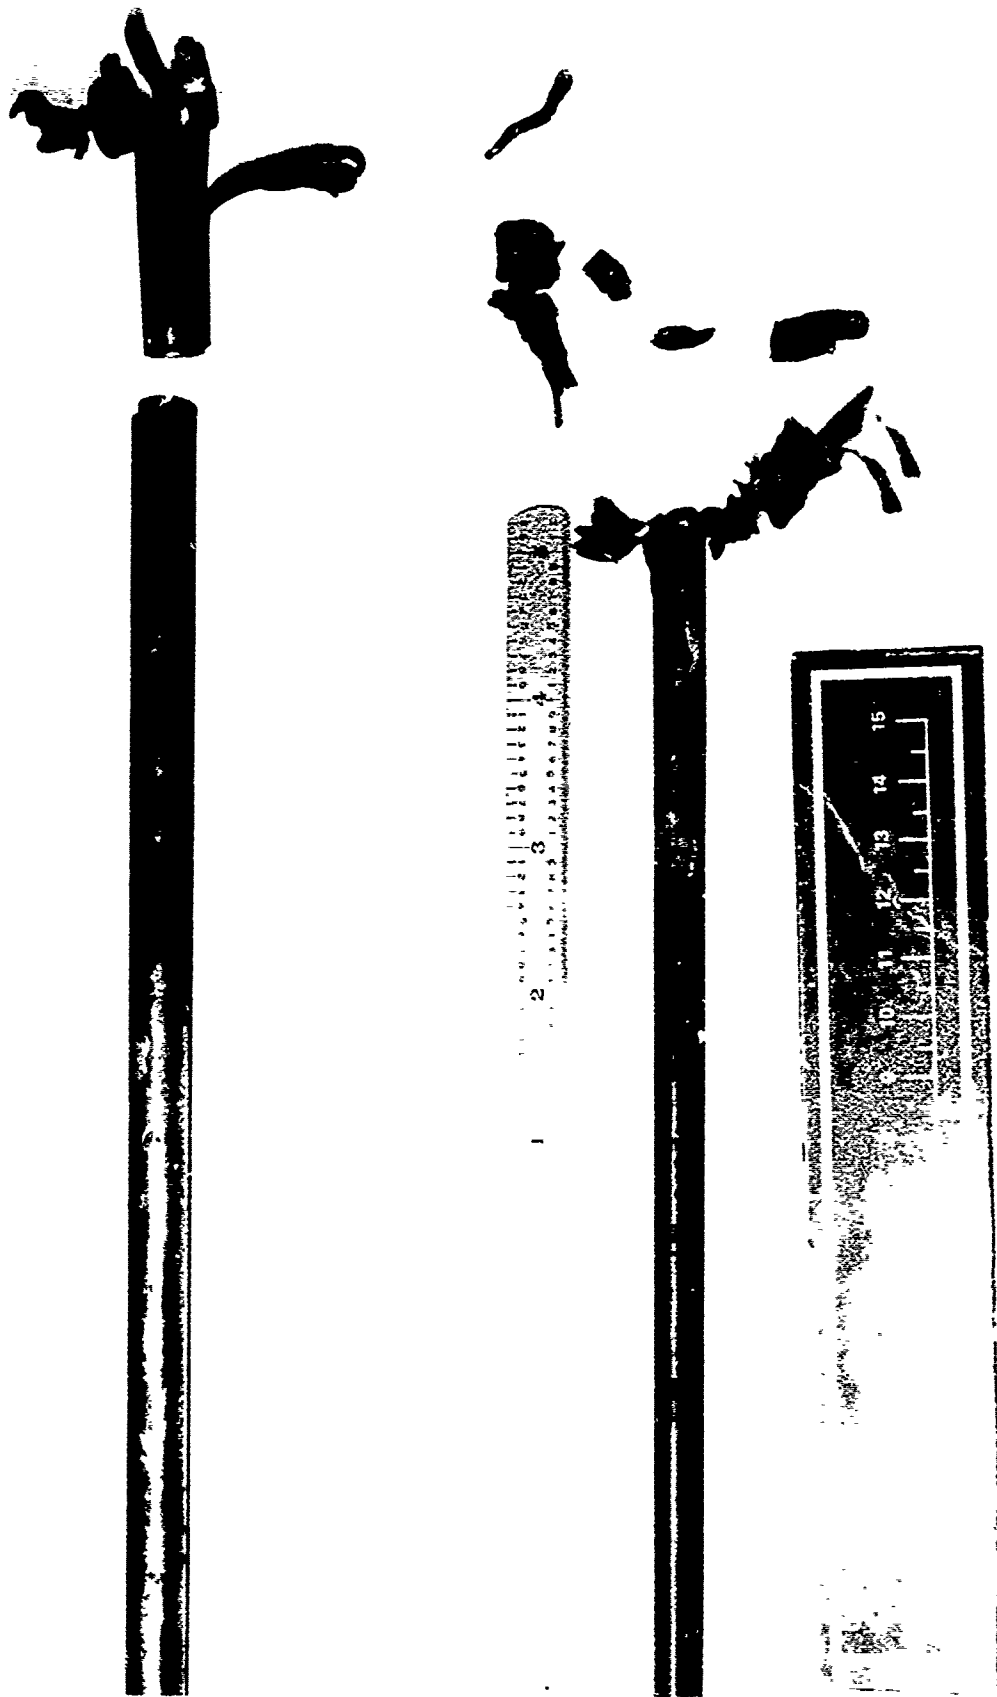
Figure 3. Damage on recovered dud, M825A1, lot PB-89J000E005

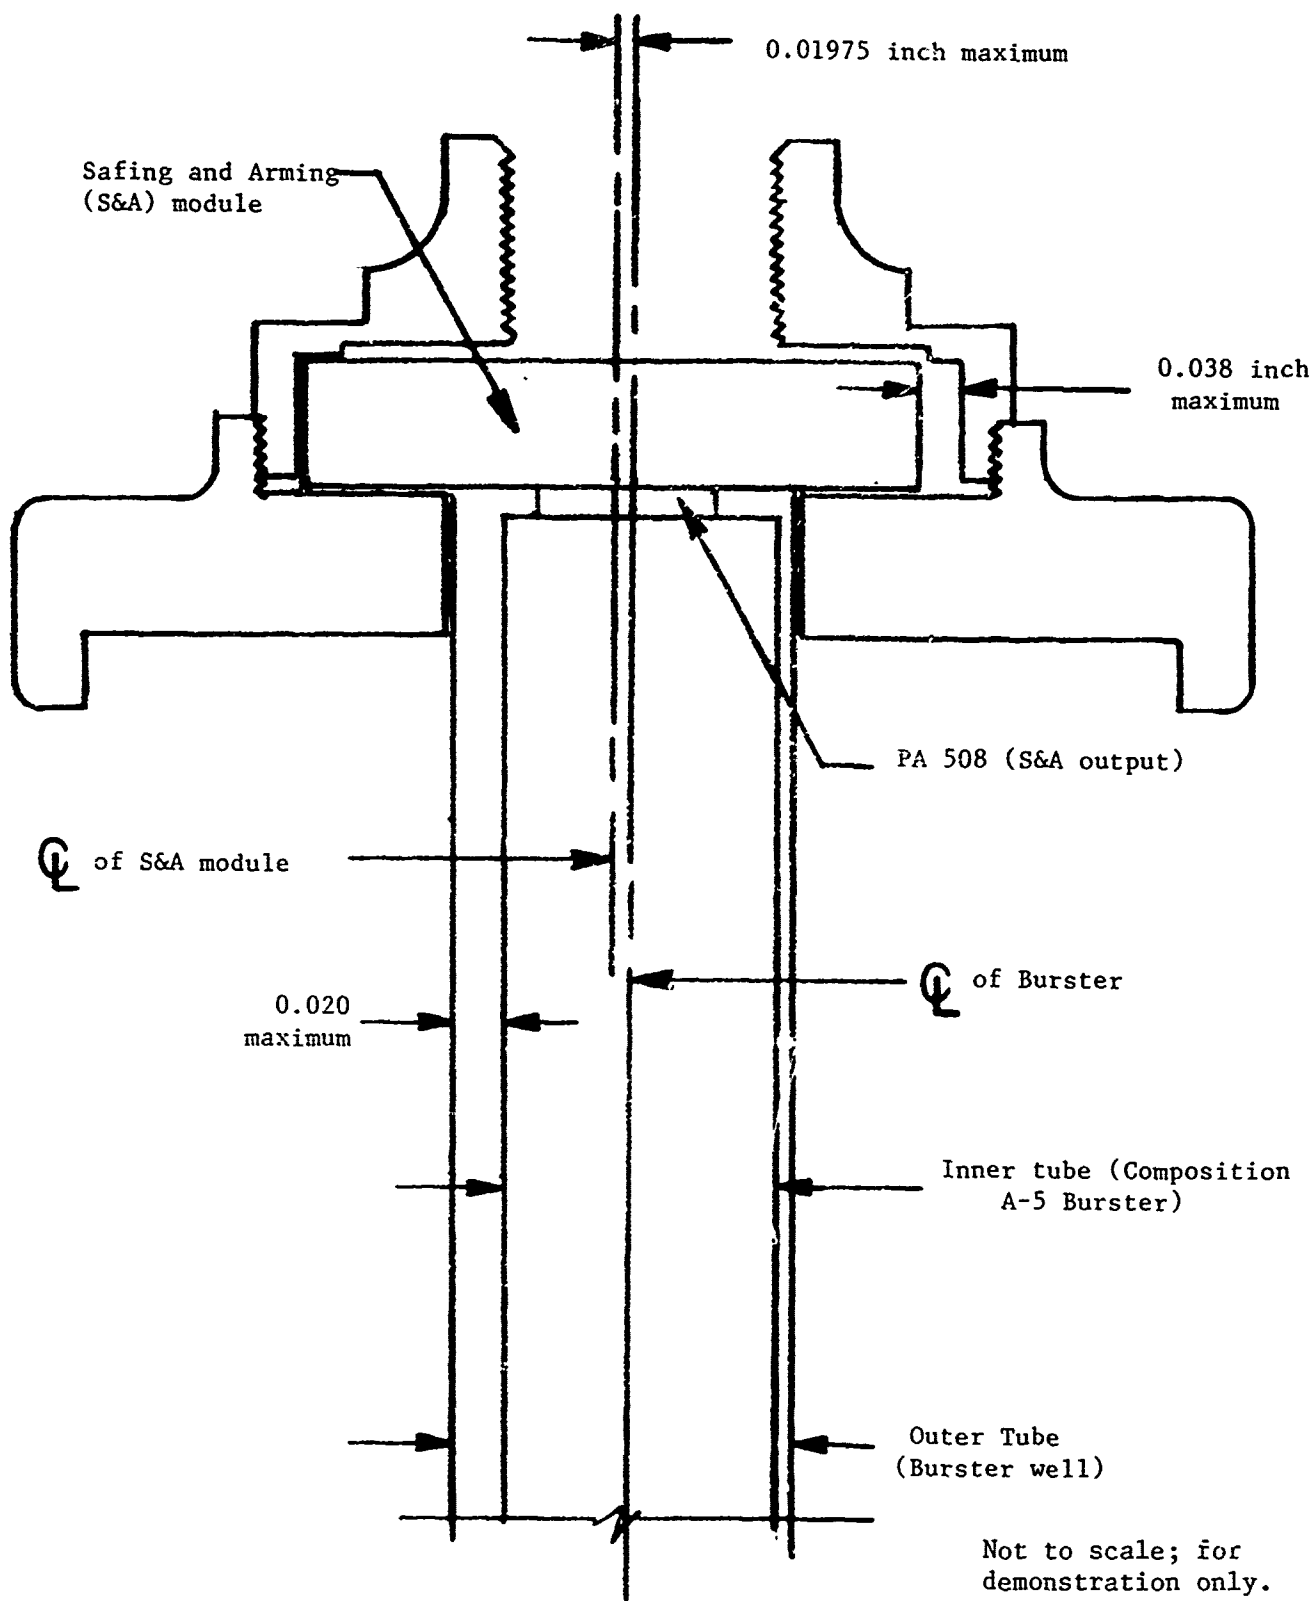
The study focused on horizontal and vertical tolerances between the burster, S&A, and front plate assembly. The study of the horizontal tolerances revealed that the burster and the well may be off center by a maximum of 0.01975 in. It also revealed that the burster and the well may have a maximum side gap of 0.020 in. However, the PA-508 (S&A output lead) is always covering 100% of the Comp A-5 in the burster (fig. 4). Therefore, there was no need to examine this further. The vertical tolerances revealed that a maximum gap between the S&A output and the Comp A-5 is 0.015-in. minimum and 0.17-in. maximum. The maximum gap was determined by assuming that the felt disc is not assembled. An illustration is presented in figure 5. These data were provided to the ARDEC Energetics Division for their gap testing. Their test results showed that this gap variation has no effect on the S&A to burster output.

Figure 4. Horizontal tolerance M825/M825AI assembly

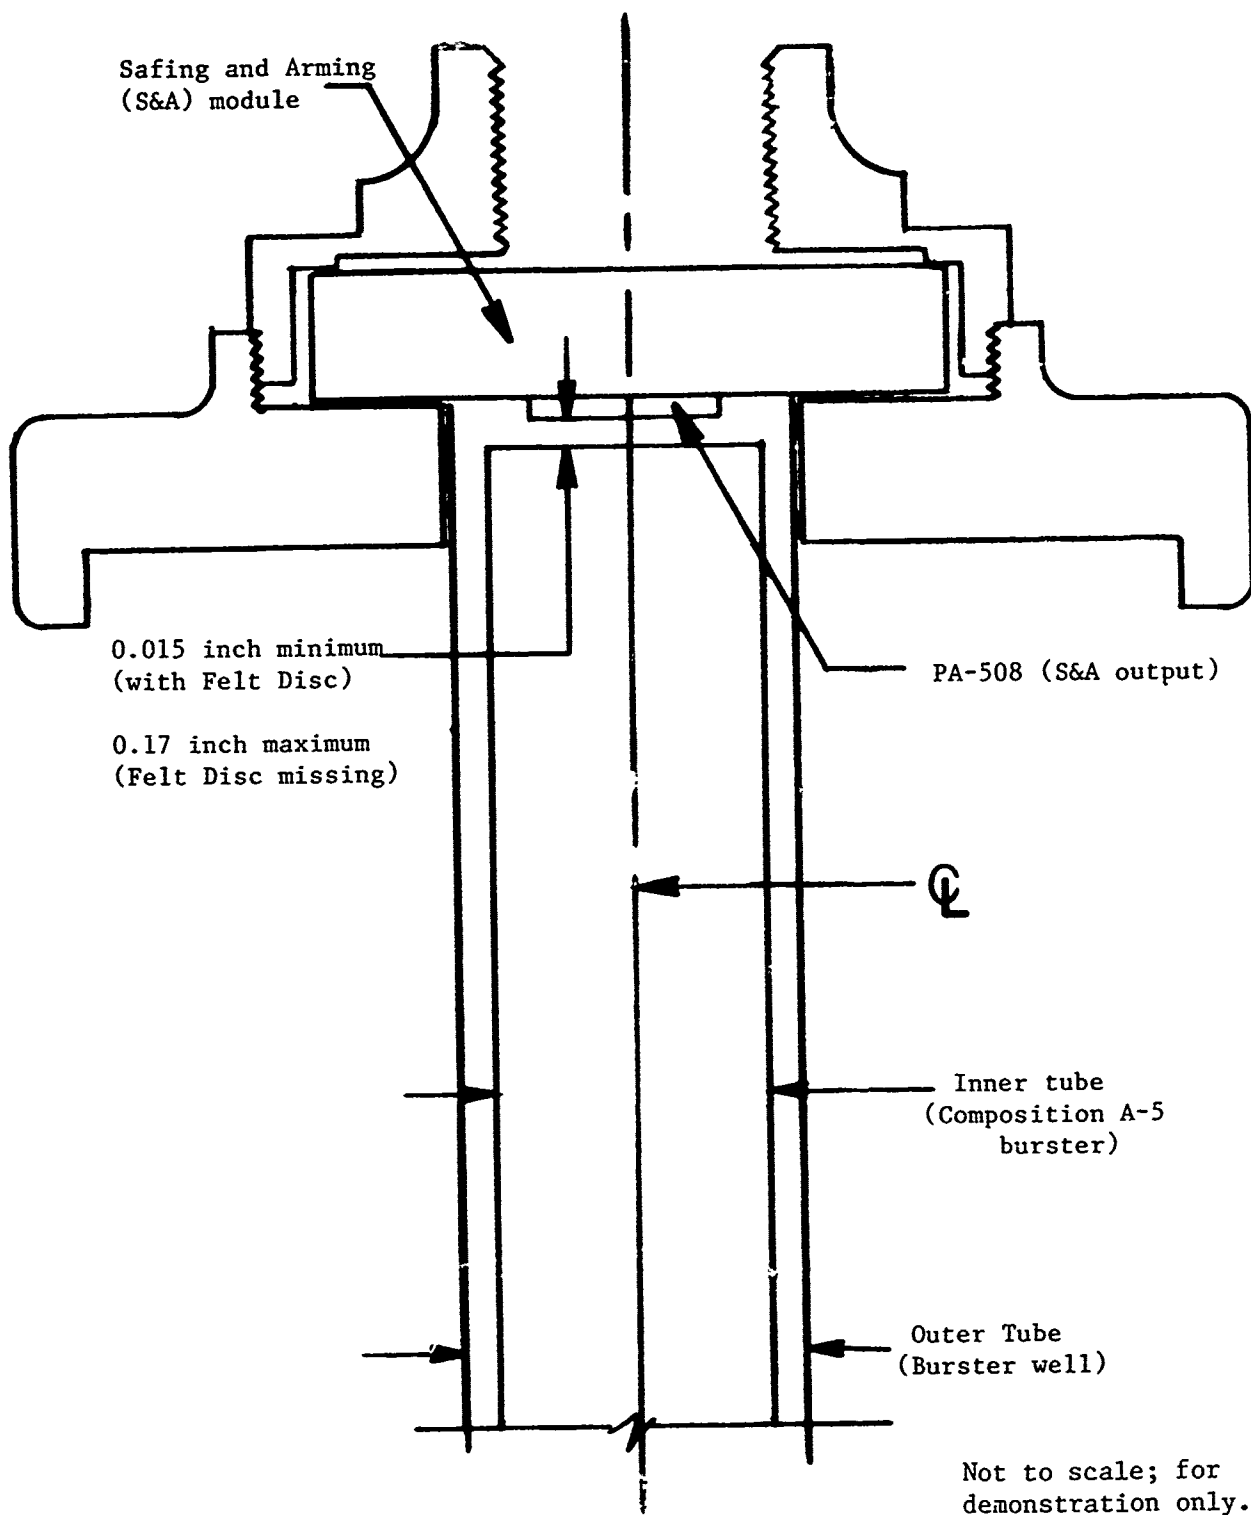
Figure 5. Vertical tolerance M825/M825A1 assembly

2. The S&A is held in place by a retainer in the M825A1 assembly. No height checks or requirements are placed on this assembly to ensure proper alignment of the S&A. This office feels that this is a critical area and should be controlled. Measurements of the retainer heights under various conditions, while conducting the tests, have been recorded. These data may be used as guidance by CRDEC in implementing height requirements and checks.

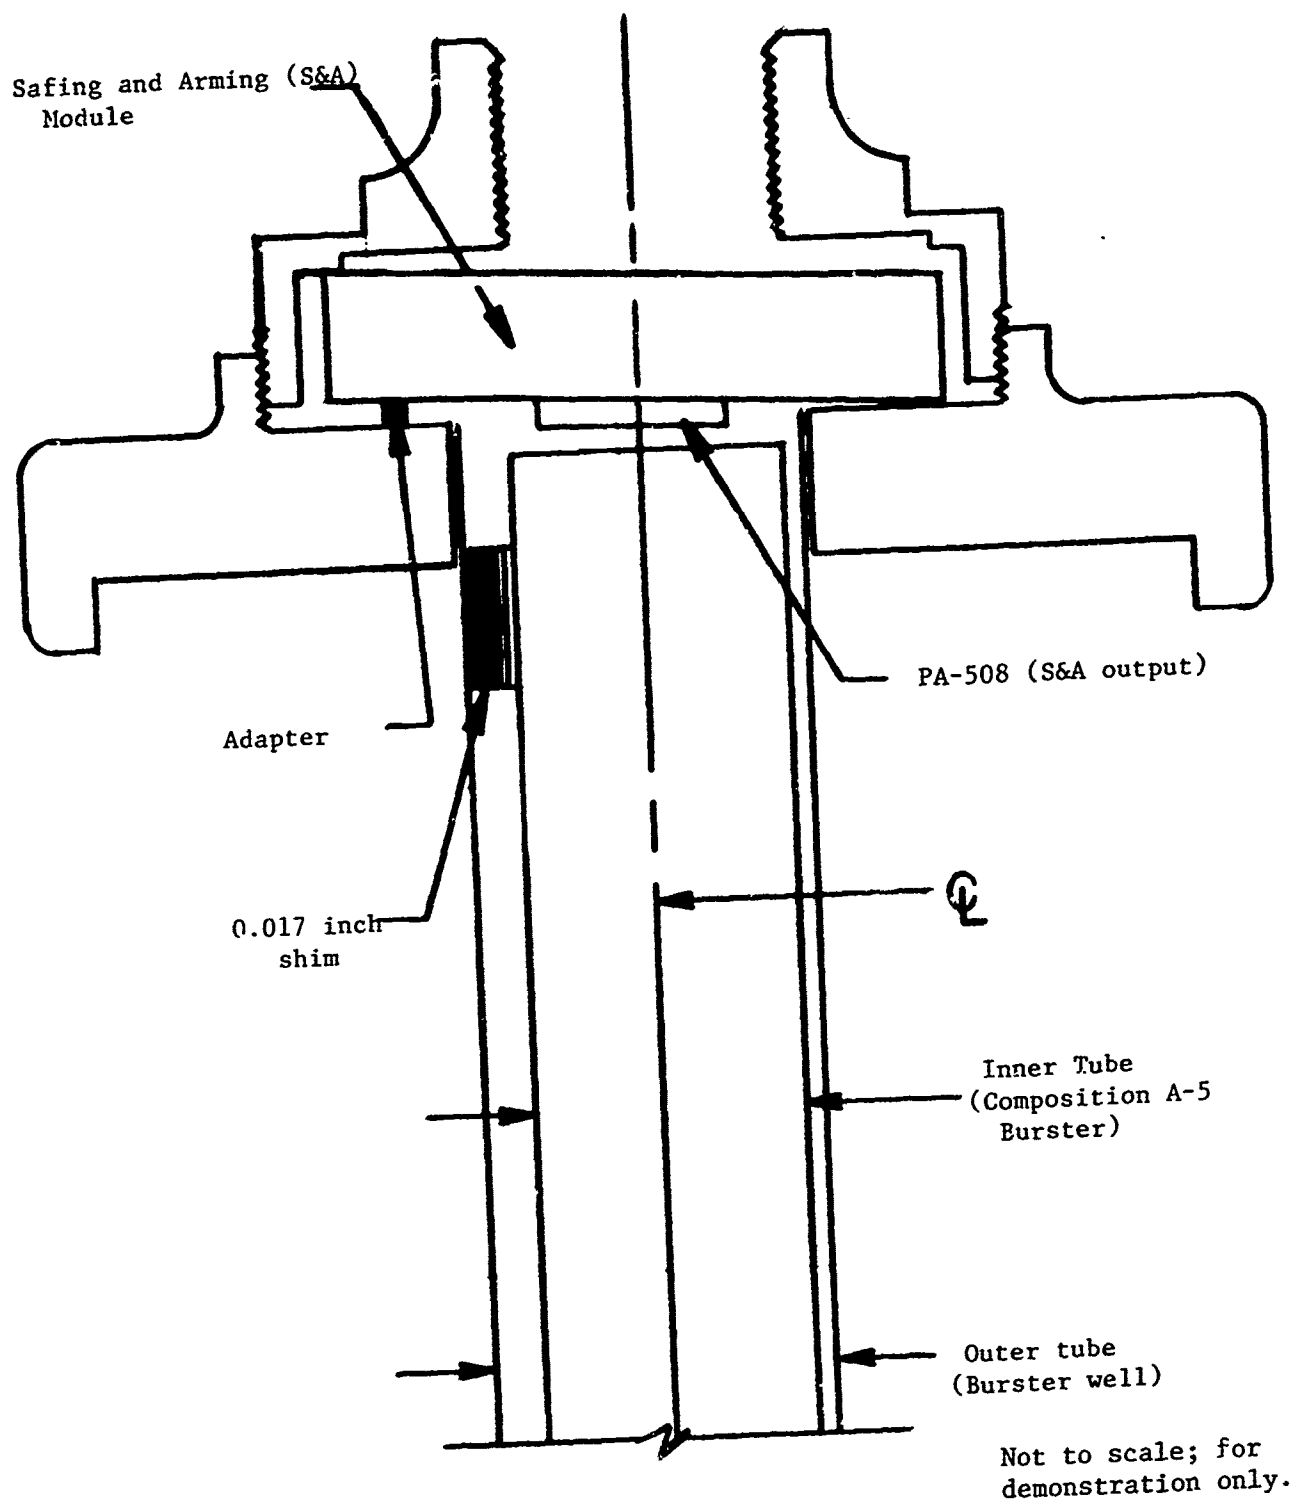
The unit used for the cocked S&A test yielded an output hole dimension of 0.525 in. by 0.496 in., measured 90 deg apart. An adapter was fabricated to ensure that the S&A remained in a tilted position. The gap between burster and the S&A lead was set at a maximum by placing a 0.017-in. shim. the felt disc was also removed from the burster in order to provide a vertical gap. This configuration is illustrated in figure 8. The S&A functioned the burster high order (fig. 9). The S&A output hole was measured to be 0.460 in. by 0.430 in., 90 deg apart. This damage was similar to the DPG recovered units. This penalty test clearly indicates that the S&A used in the M825A1 failures provided sufficient output to function the burster.

Figure 8. Cocked safing and arming M825/M825A1 assembly

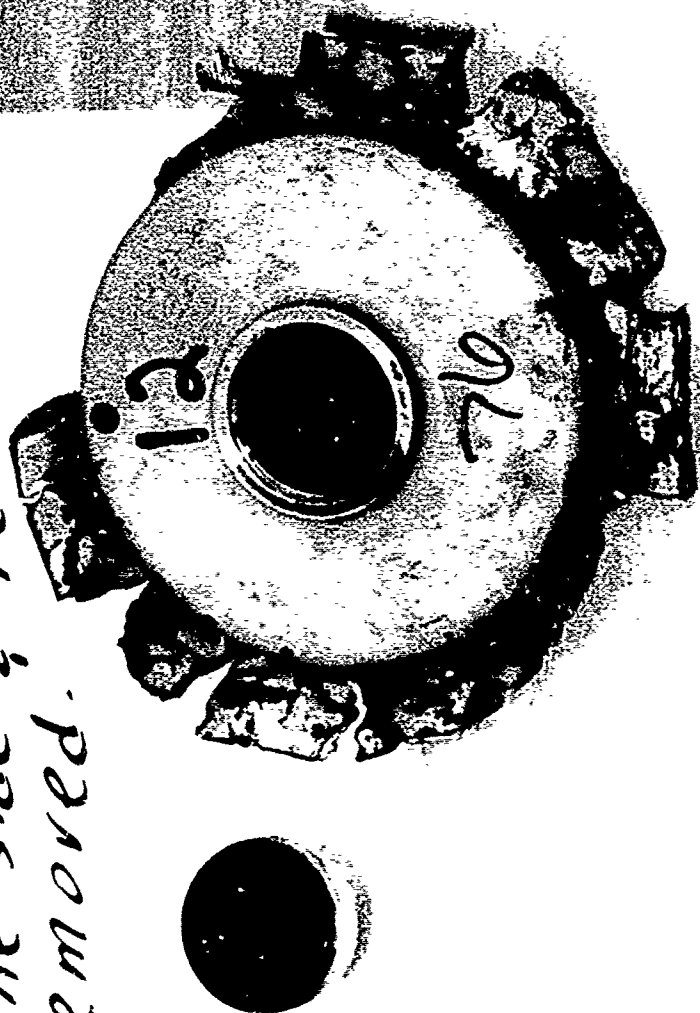
M825 TEST #12  
S&A COCKED  
Bursting Shined .017" ID  
one side & felt Disc  
removed.

Figure 9. Cocked M739/M739A1 safe and arm, M825A1 assembly

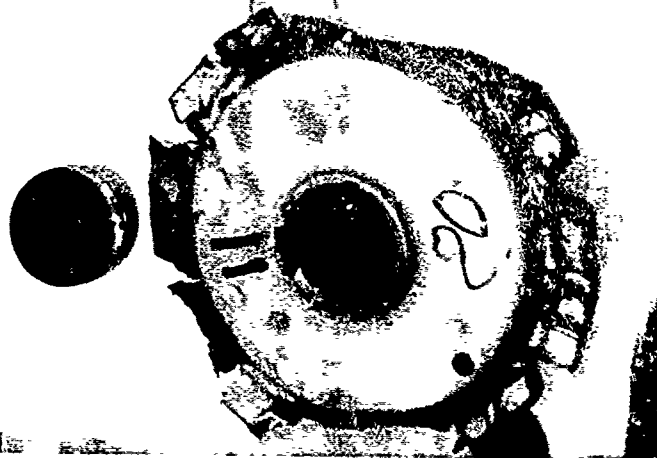
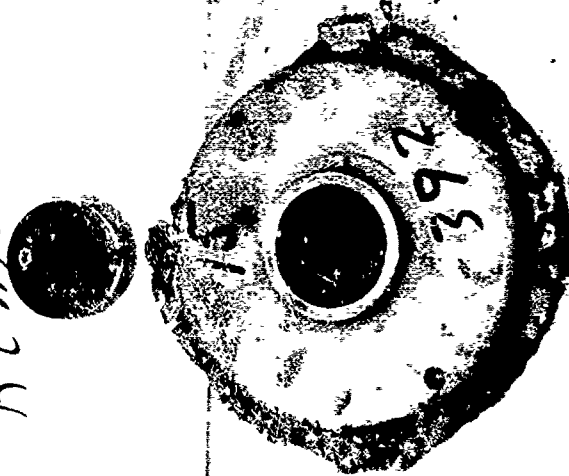
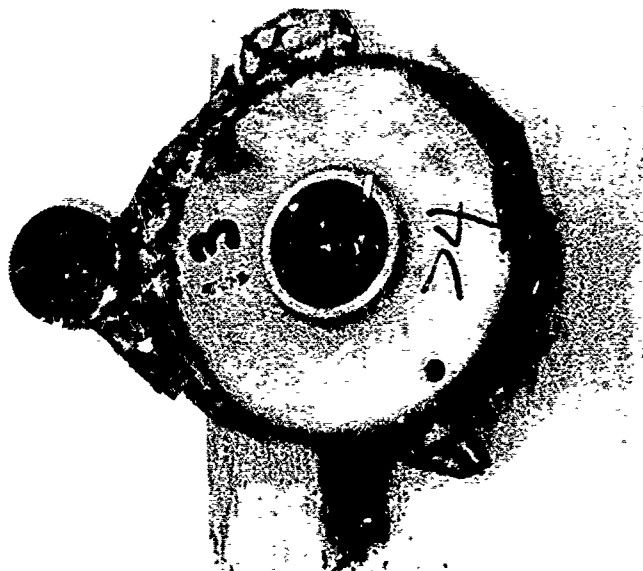
Two S&A were assembled with upside down bursters. The felt disc was removed and the burster was inserted with the green end down. These units functioned high order and the S&A had larger output hole dimensions when compared to the properly assembled test unit (fig. 10). The upside down bursters yielded an S&A output hole of 0.494 in. by 0.571 in. and 0.473 in. by 0.709 in. It also yielded larger front plate assembly hole dimensions when compared to the properly assembled unit.

TEST #11  
NORMAL  
ASSEMBLY

TEST #15  
UPSIDEDOWN  
BURSTER  
FELT DISC  
REMOVED

TEST #13  
UPSIDEDOWN  
BURSTER  
FELT DISC  
REMOVED

Figure 10. Damage comparison M825A1 assembly upside down burster versus normal assembly

4. The results of the upside down burster should not be ignored and should be further analyzed by CRDEC. This office feels that the upside down burster results gave an indication that the design and manufacturing of the burster is the main source of the problem.
