**A CASE STUDY: DAMAGE TO THE METROPOLITAN  
OAKLAND INTERNATIONAL AIRPORT CAUSED BY  
THE LOMA PRIETA EARTHQUAKE**

Barney A. Vallergera

William P. Grogan

Final Report

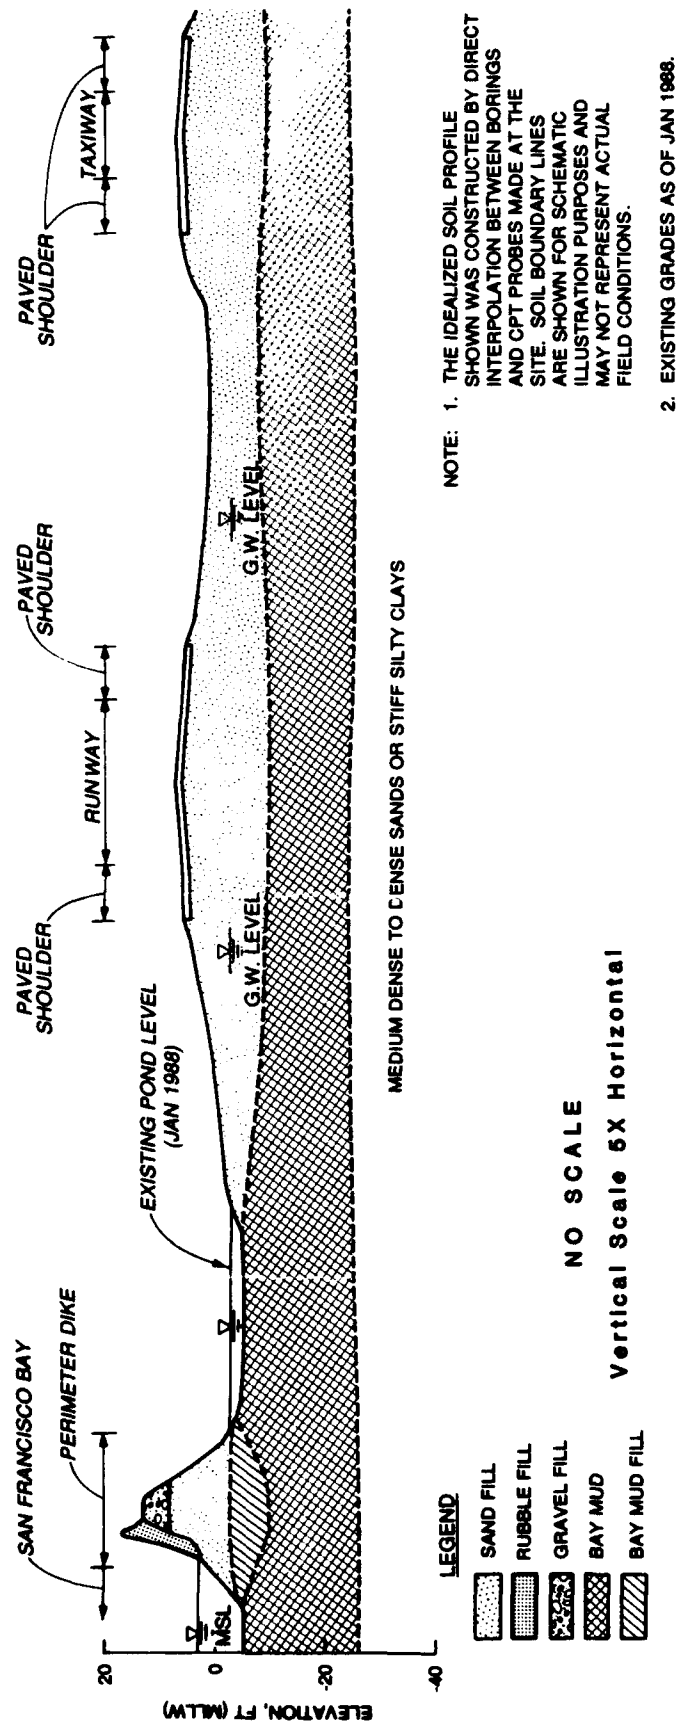
8. A cross section of the airfield through the dike, the runway, and the taxiway is shown in Figure 3. Figure 3 shows some critical items that make this site susceptible to liquefaction damage. The relatively loose hydraulic sandfill with a high water table over bay mud on medium to dense sands or stiff silty clay makes the MOIA site vulnerable to liquefaction. The layers underlying the fill intensified the ground shaking helping to cause the sandfill to liquefy. The mean high sea level at 5.8 ft maintains a high water table in the sandfill. Typically the water table is approximately 7 to 10 ft

32. A final contributing factor causing the last 3,000 ft of runway to sustain damage was the geology of the area. As shown in Figure 3, the last part of the runway was constructed over an area of mud deeper than that over which the rest of the airfield was constructed. This difference in geology led to a different response to the earthquake loading.

Figure 3. Cross section through dike and runway
