Technical Report HL-93-7  
August 1993

# **Scour Protection for Dam No. 2, Arkansas River, Arkansas**

## **Hydraulic Model Investigation**

*by John E. Hite, Jr.  
Hydraulics Laboratory*

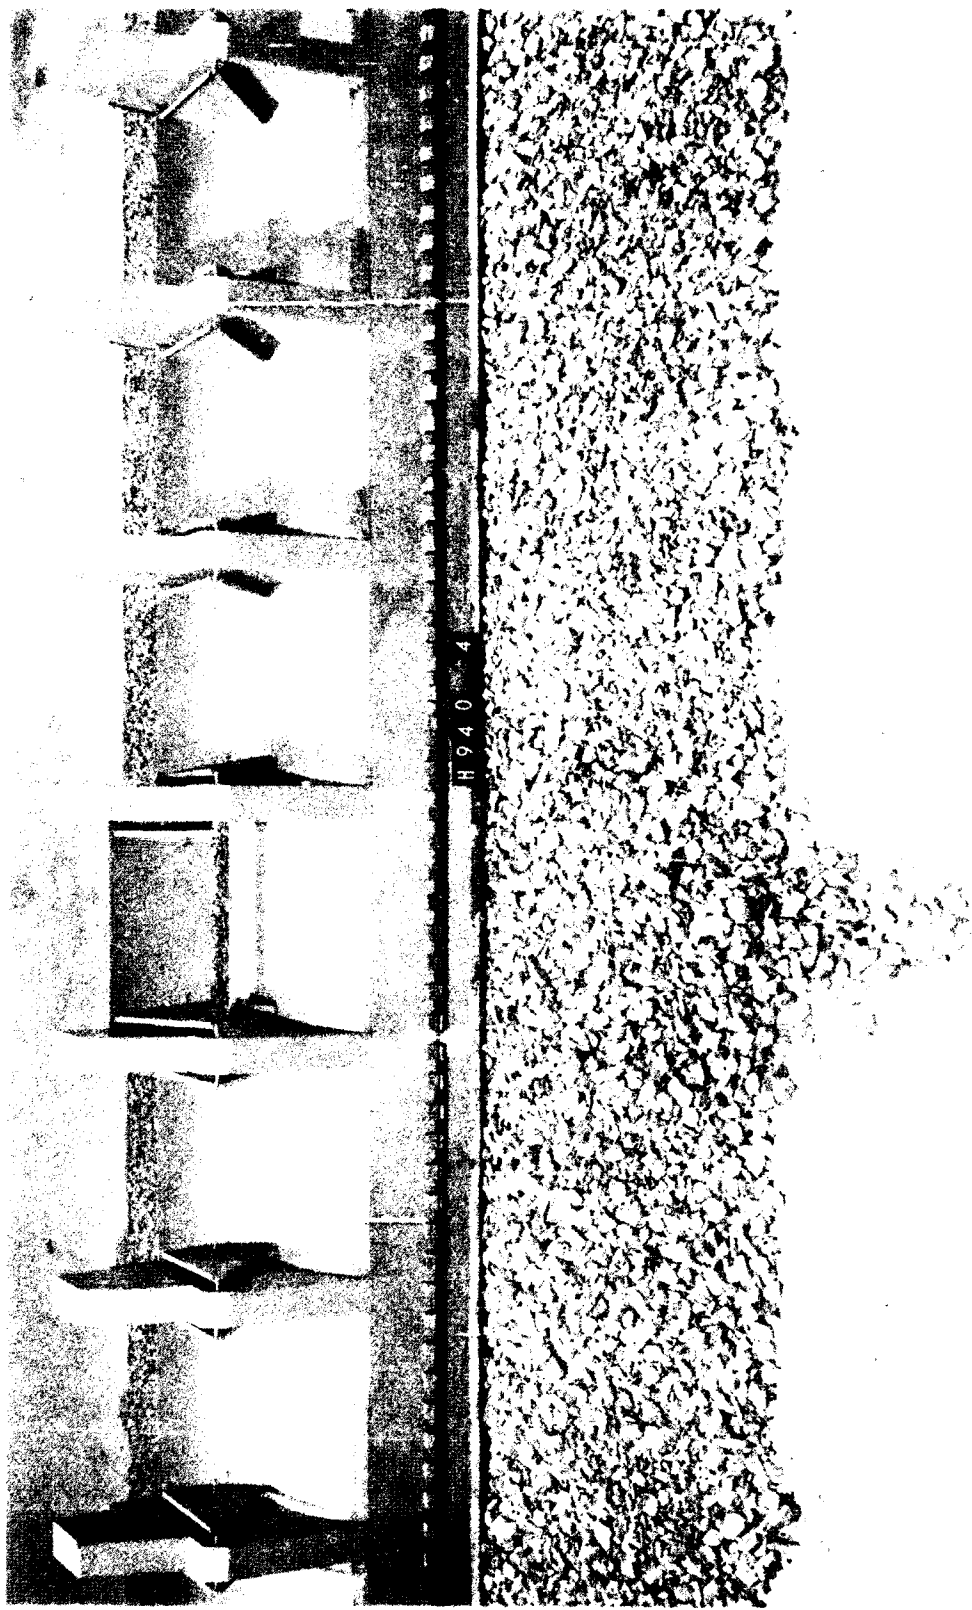
Tests 1-5 were conducted with gate 8 opened 14 ft and the pool and tailwater conditions shown in Table 1. A 14-ft gate opening was considered to be representative of a gate opened half-way. The tests were conducted by setting the appropriate discharge with a high tailwater, lowering the tailwater to the desired elevation, running this condition for a specified time period, turning off the discharge, and draining the model slowly so the riprap and scour pattern would not be disturbed to observe if riprap displacement had occurred. Riprap No. 7 downstream from the stilling basin was found to be unstable with pool el 162 and tailwater el 135 (Test 5, Table 1). The tests indicated that gate openings of 14 ft and greater should not be allowed with the tailwater lower than el 140. Results from Test 5 (Table 1) are shown in Photo 1.

Photo 1. Failure of Riprap No. 7 and scour in the exit channel after 6 hr (prototype) of operation with gate 8 opened 14 ft, normal upper pool el 162, and tailwater el 135

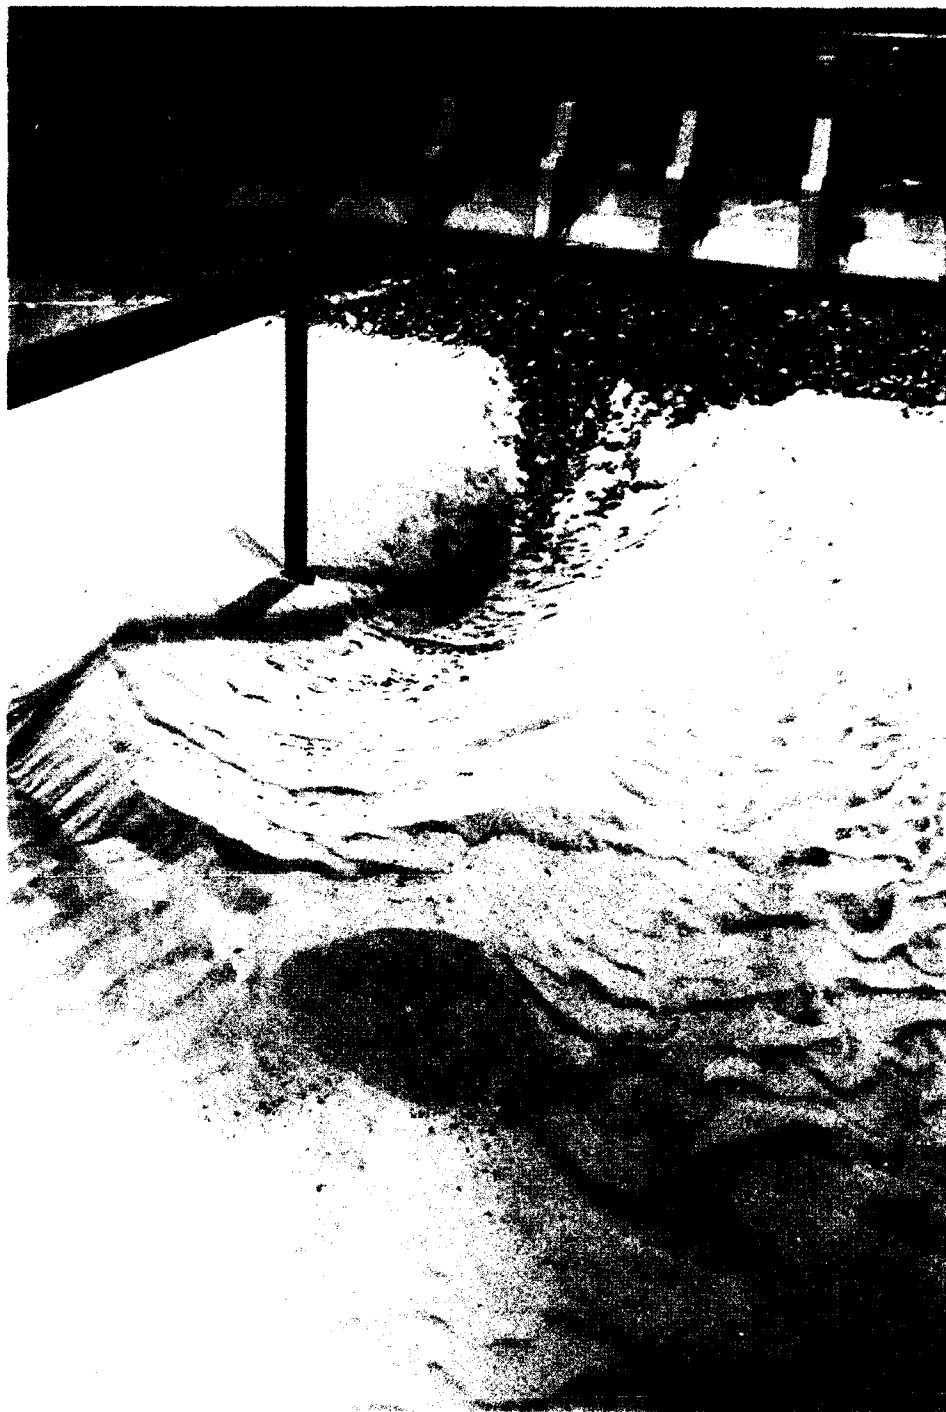
Tests were conducted to determine the stability of Riprap No. 7 downstream from the stilling basin for flow conditions caused by normal upper pool (el 162), one gate fully open, and various tailwater elevations. The riprap was found to be unstable for tailwater elevations below 150. Results from Test 8 (Table 1) are shown in Photo 2.

Photo 2. Failure of Riprap No. 7 and scour in the exit channel after 6 hr (prototype) of operation with gate 8 fully opened to the normal pool and tailwater el 145

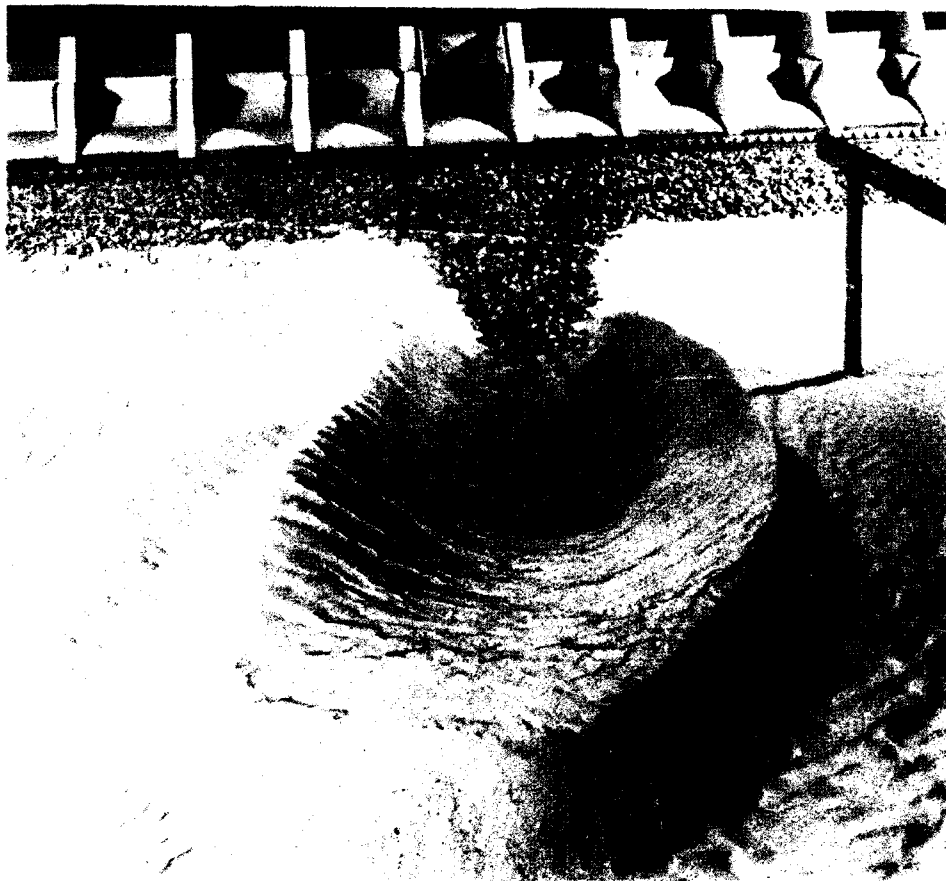
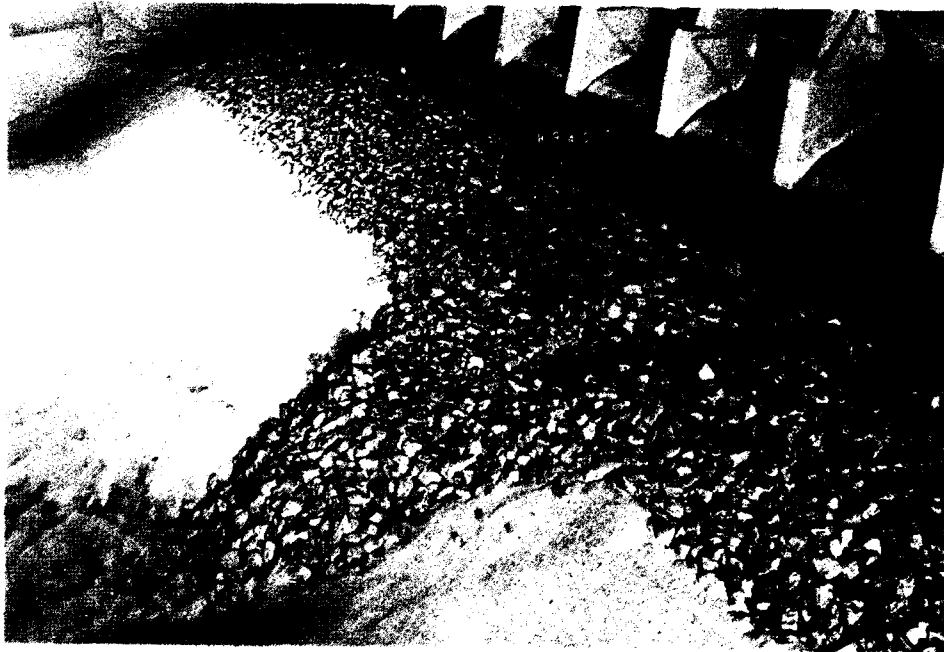
Riprap No. 7 was then tested under abnormal conditions. The first of these tests (Test 9, Table 1) reproduced pool (el 170) and tailwater (el 147.5) elevations that existed during the December 1982 barge accident. The riprap failure for this condition was severe, as shown in Photo 3. The test was conducted with gate 10 fully open for a duration of 4 hr 30 min prototype time (45 min model time).

a. Scour in exit channel

b. Riprap failure

Photo 3. Failure of Riprap No. 7 and scour in the exit channel after 4.5 hr (prototype) of operation with gate 10 fully opened, upper pool el 170, and tailwater el 147.5

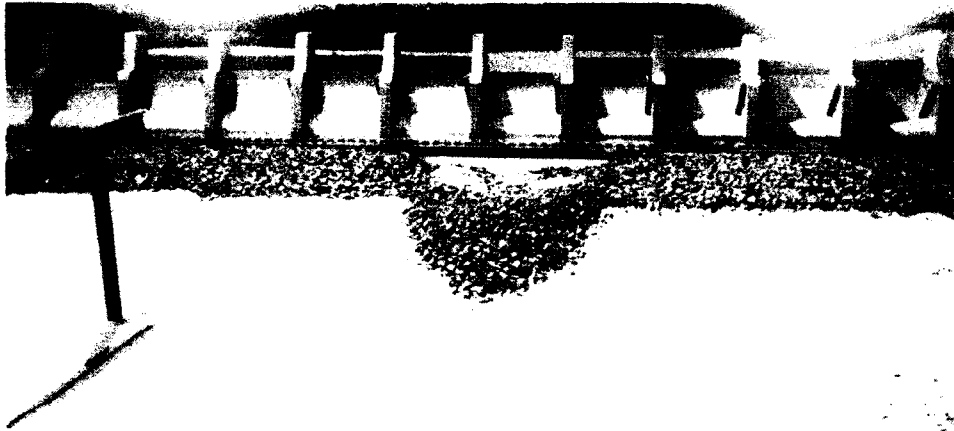
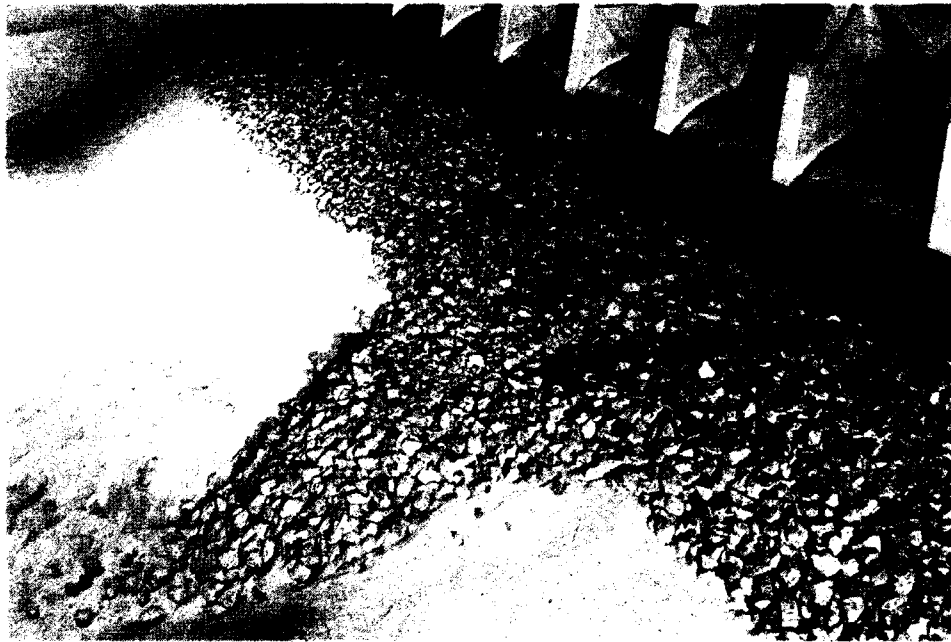
a. Scour in exit channel

b. Riprap failure

Photo 4. Failure of Riprap No. 7 and scour in the exit channel after 8 hr (prototype) of operation with one gate fully open, normal upper pool elevation, and tailwater el 122

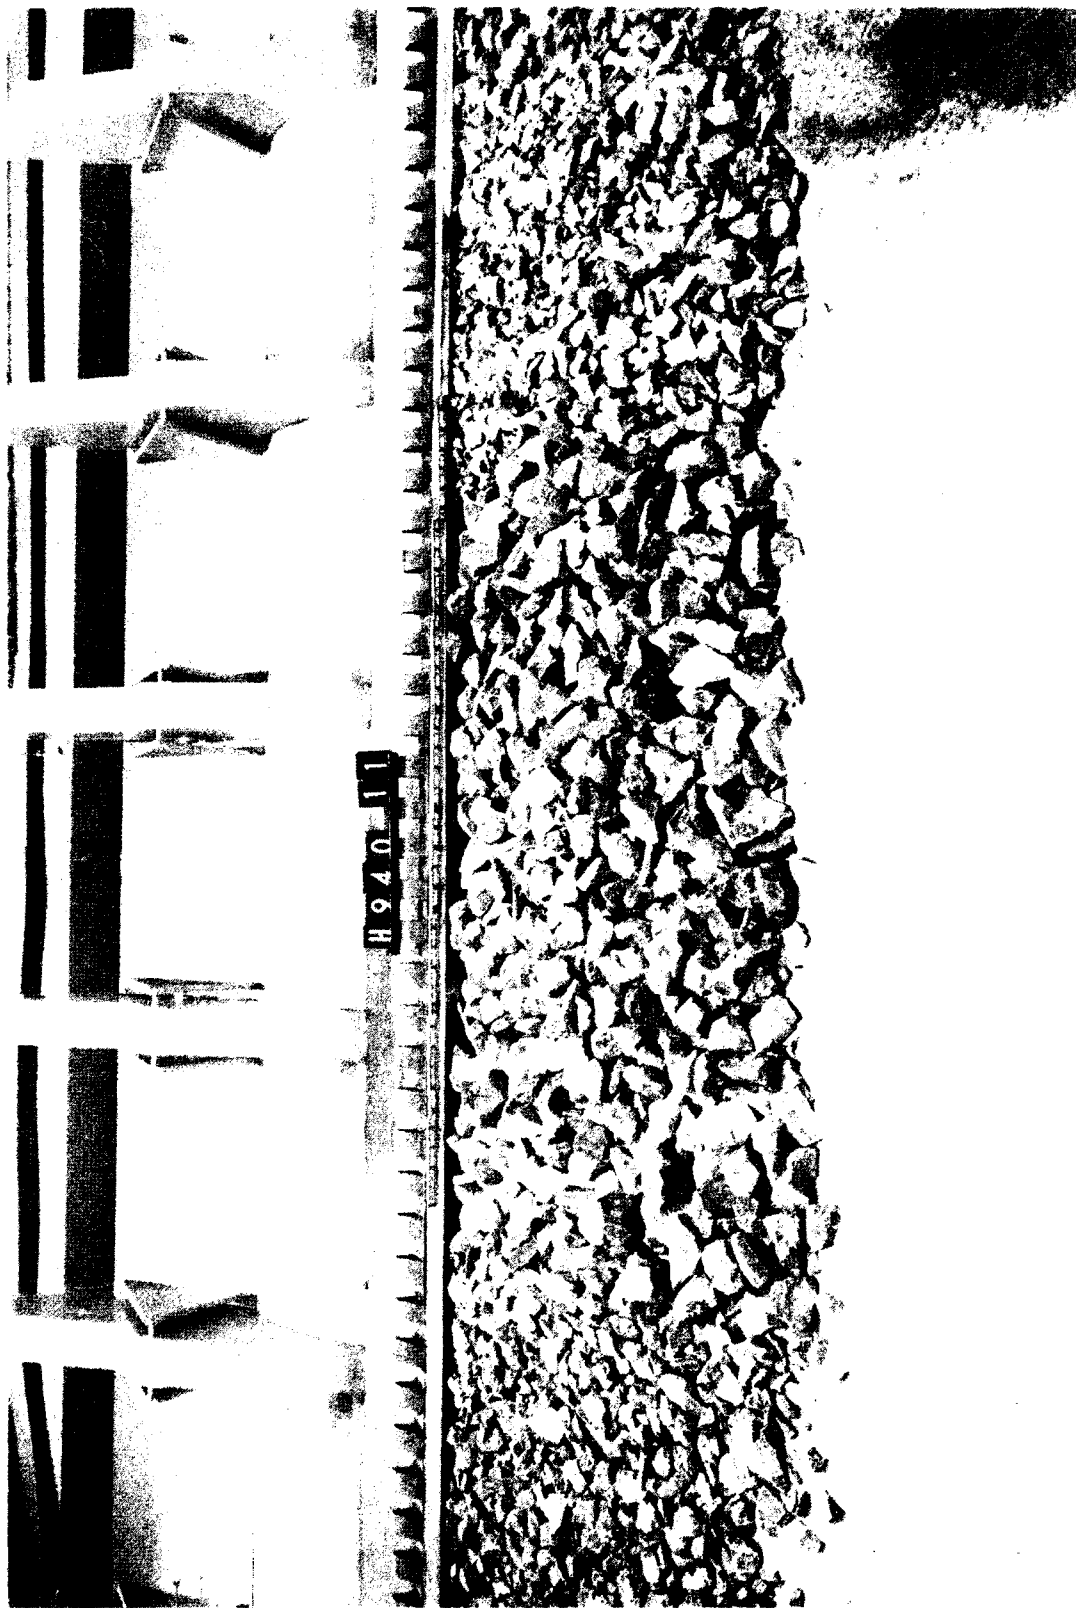
Since failure of the type 2 scour protection occurred with tailwater elevations much higher than the minimum tailwater anticipated at the project, structural modifications were made downstream from the existing stilling basin. The type 3 design shown in Photo 6 consisted of barges, 175 ft long by 26 ft wide by 12 feet deep, filled with grouted rock and placed downstream from the existing stilling basin. This design was tested in an attempt to provide a secondary stilling basin. The basin extended 220 ft downstream as shown in Plate 5 and contained a 6-ft-thick blanket of Riprap No. 7 offset 4.5 ft below the top of the barge for a distance of 125 ft downstream from the end of the barges. The type 3 scour protection design remained stable when tested for 8 hr with one gate fully open, normal upper pool elevation, and tailwater el 118.

Photo 5. Type 2 scour protection design placed downstream of one gate bay

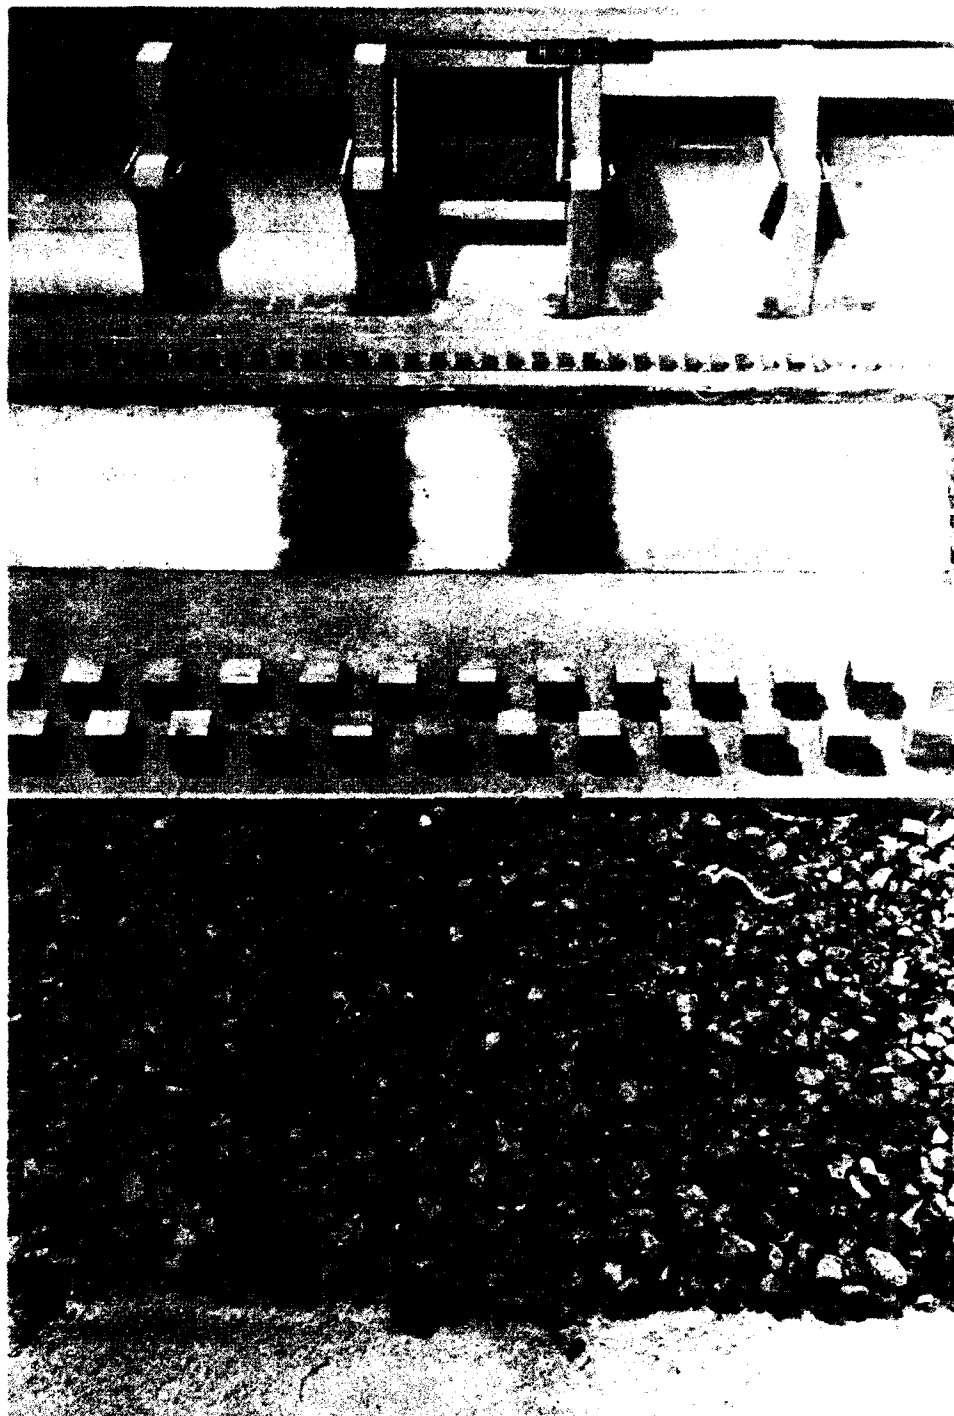
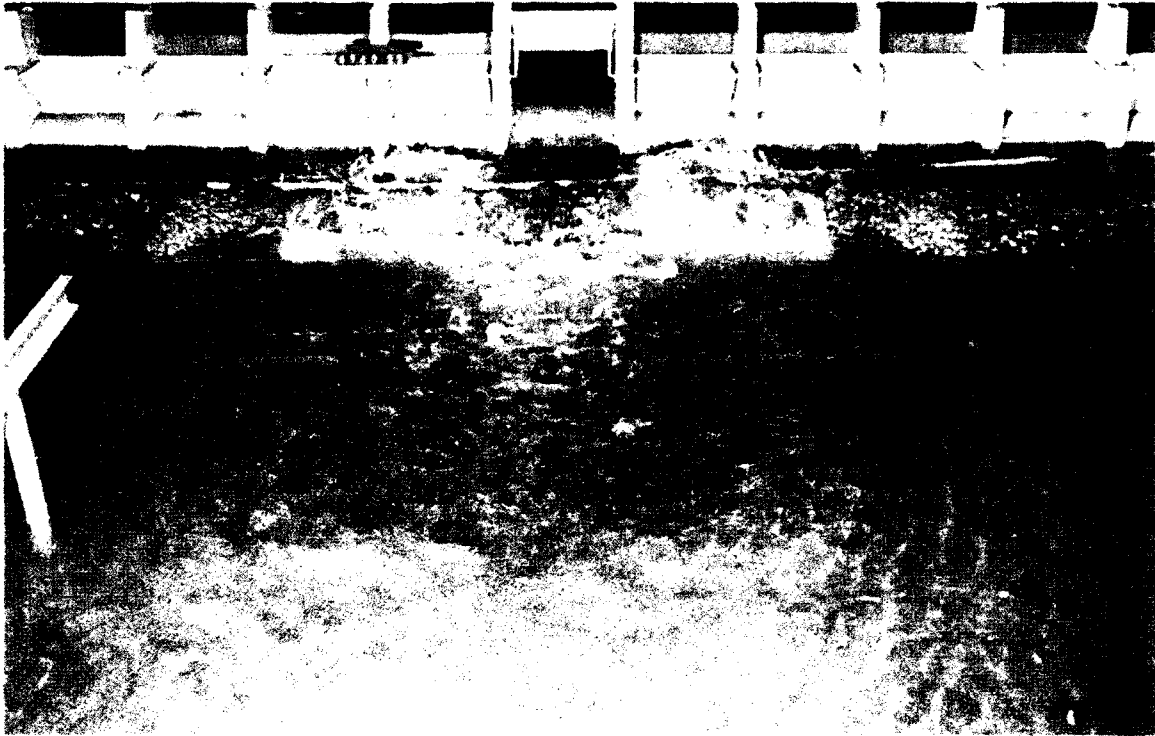
The type 6 scour protection design shown in Photo 10a was a secondary stilling basin located immediately downstream from the existing basin. Details of the basin are shown in Plate 6. The basin design was based on guidance provided in EM 1110-2-1605.<sup>1</sup> Flow conditions with normal upper pool, gate 6 fully open, and tailwater el 113 are shown in Photo 10b. A forced hydraulic jump occurred in the secondary basin, but Riprap No. 7 placed downstream from the basin was stable and scour in the exit channel was minimal. This basin was originally designed to function with upper pool el 170 and tailwater el 132. These are the conditions that would have existed during the barge accident if the tailwater was at its minimum elevation for the discharges that occurred. The basin performed adequately for these conditions. The conditions stated previously, normal upper pool el 162, one gate fully open, and tailwater el 113, were considered more severe and the basin also functioned satisfactorily for these conditions.

Photo 10. Type 6 scour protection design (Continued)

b. Flow conditions with one gate fully open normal upper pool, tailwater  
el 113

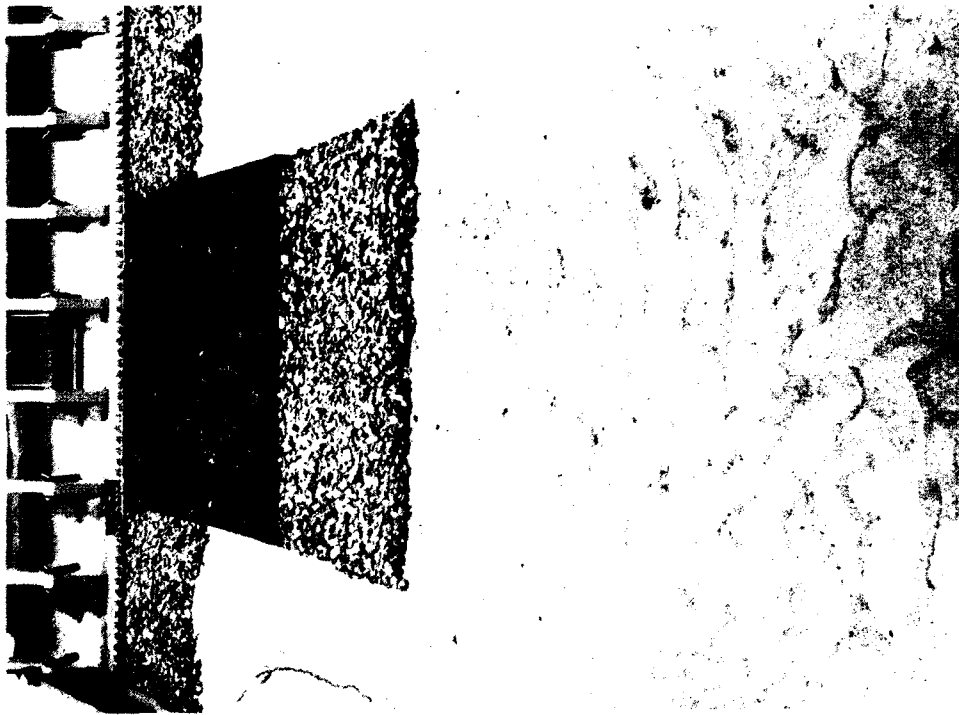
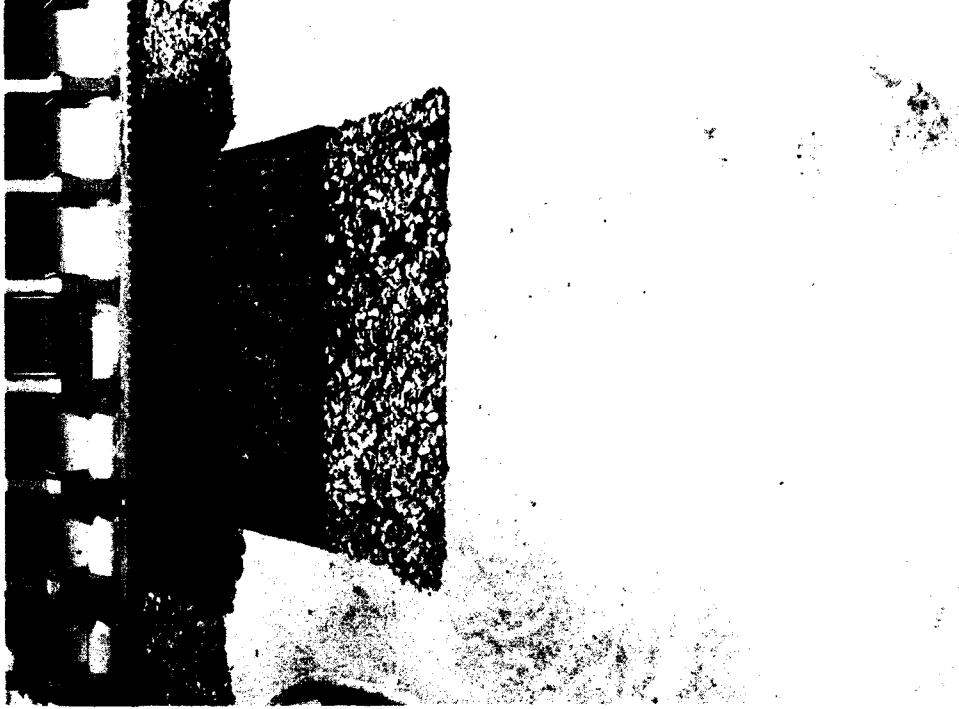
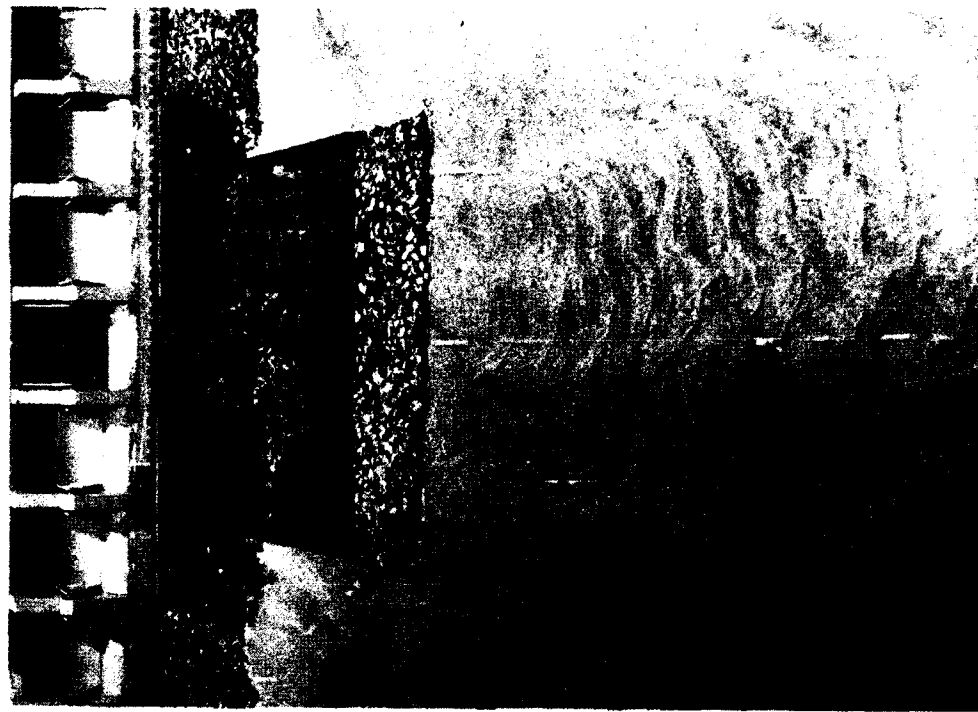
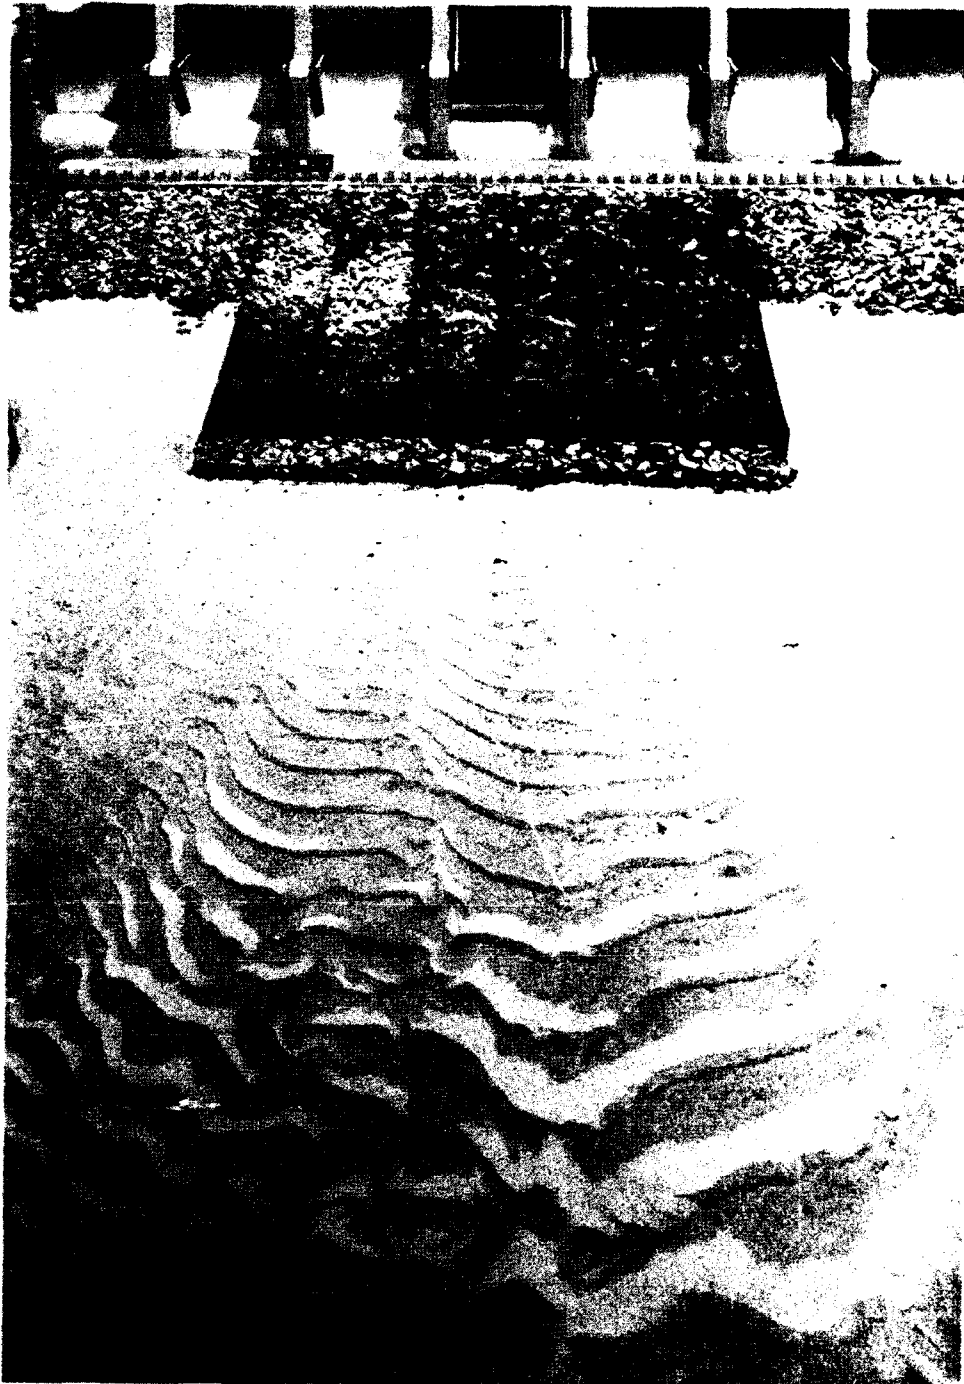
Tests were then conducted to determine the minimum length of Riprap No. 7 needed downstream of the barges. Each of these tests was conducted for 8 hr (prototype) with gate 13 opened fully to the normal upper pool and a tailwater el 113. The results shown in Photo 12 indicated scour downstream from the riprap protection was not excessive for any of the blanket lengths tested. Riprap protection downstream from the barges is essential to prevent local scour and undermining of the end of the barges. The scour observed in the model is only a relative indication; however, the potential exists for greater scour to occur in the prototype.

Photo 12. Scour in exit channel after operations with normal upper pool, one gate fully open, and tailwater 113, for various lengths of Riprap No. 7 placed downstream of barges (Sheet 1 of 3)

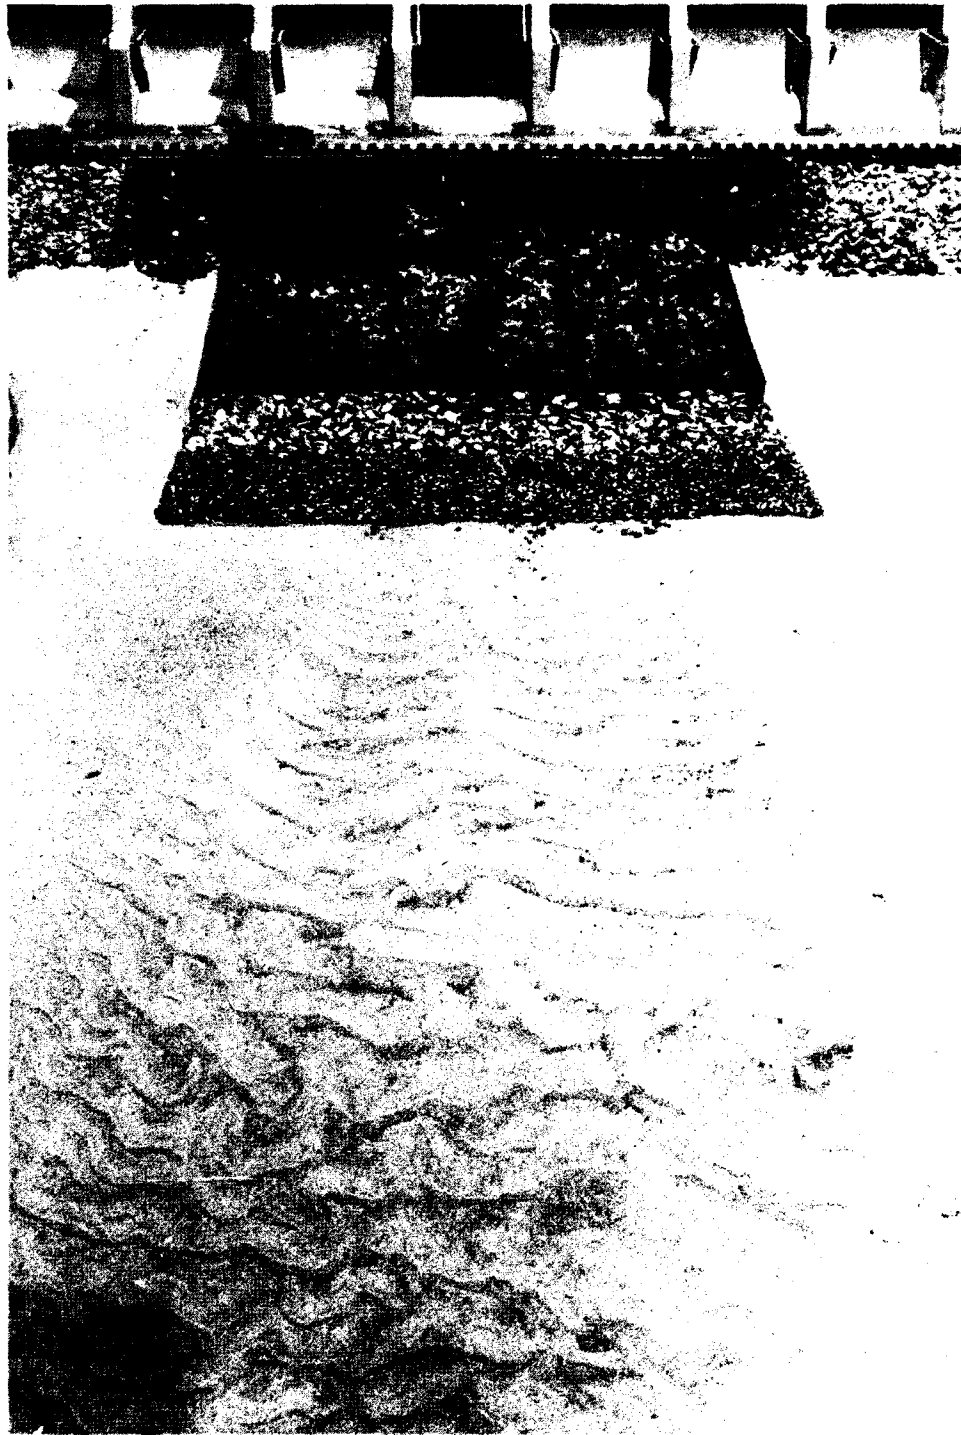
To provide protection for the area immediately downstream from the barges, Riprap No. 7 was placed at el 87 for a length of 50 ft, followed by a 50-ft-long blanket of Riprap No. 8. Riprap No. 8 consisted of a 36-in.-thick blanket of stone with a  $D_{50}$  size of 16 in. and the gradation shown in Plate 8. The purpose of placing the smaller Riprap No. 8 was to reduce the local turbulence above the stone protection downstream of Riprap No. 7 and to transition a less turbulent flow condition on the natural channel bottom. These modifications were designated the type 9 scour protection design. This design was tested with gate 13 opened fully to the normal upper pool and tailwater el 113 for 8 hr (prototype). The results shown in Photo 13 revealed that the riprap was stable and scour was minimal.

Photo 13. Type 9 scour protection design after 8 hr (prototype) of operation with normal upper pool, gate 13 fully open, and tailwater el 113

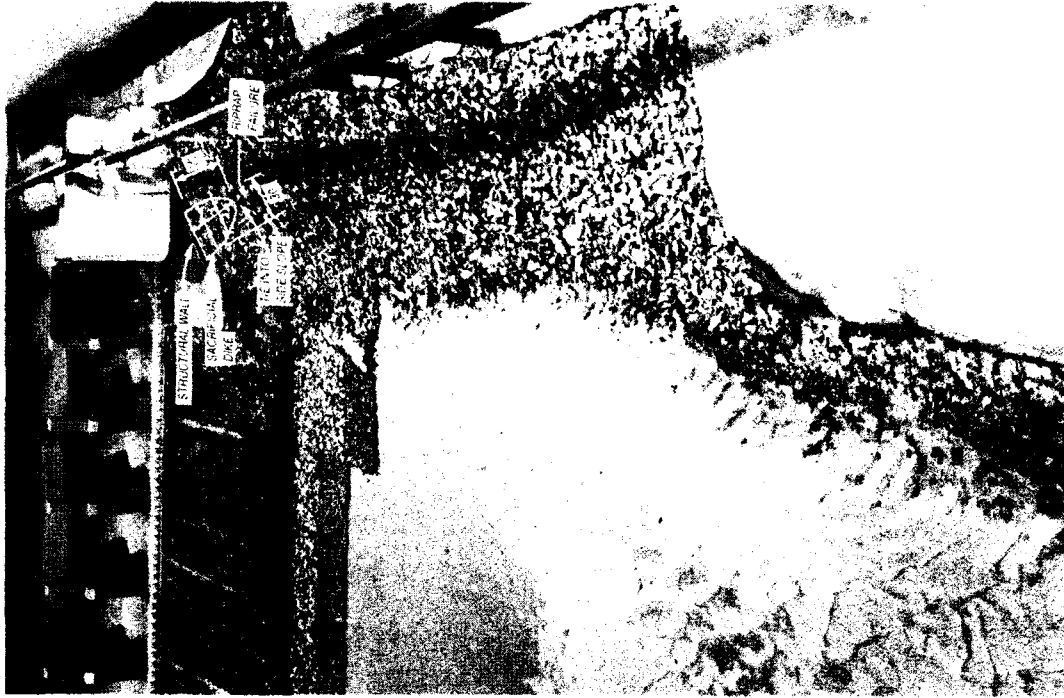
Photo 17. Failure of Riprap No. 7 on left bank

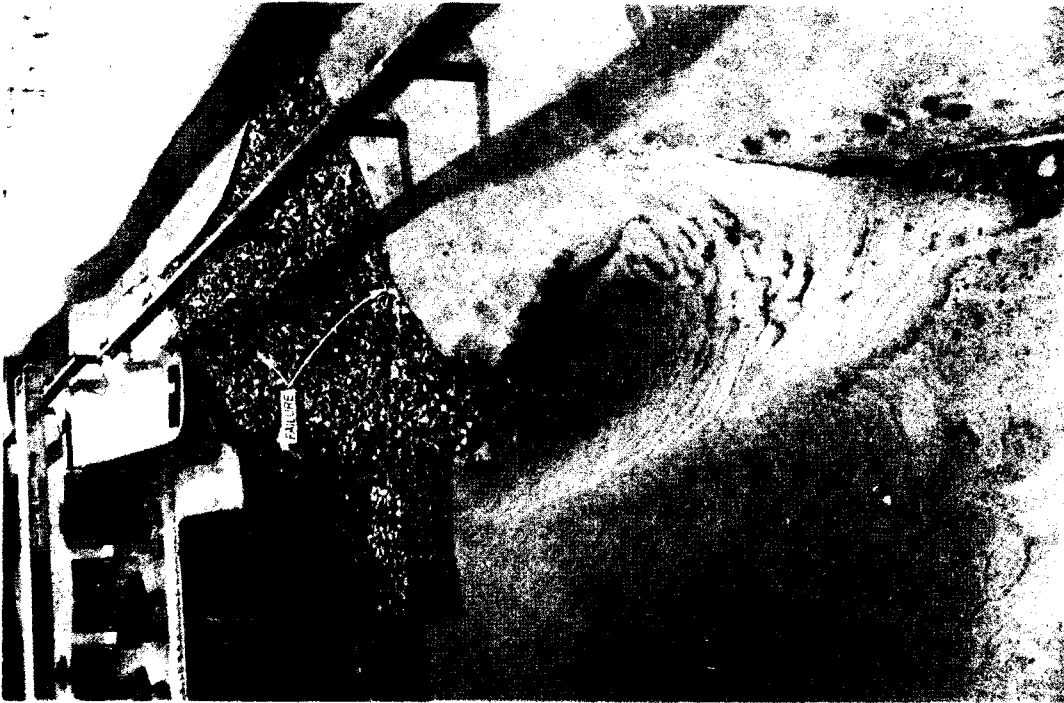
Photo 16. Failure of Riprap No. 7 on side slope

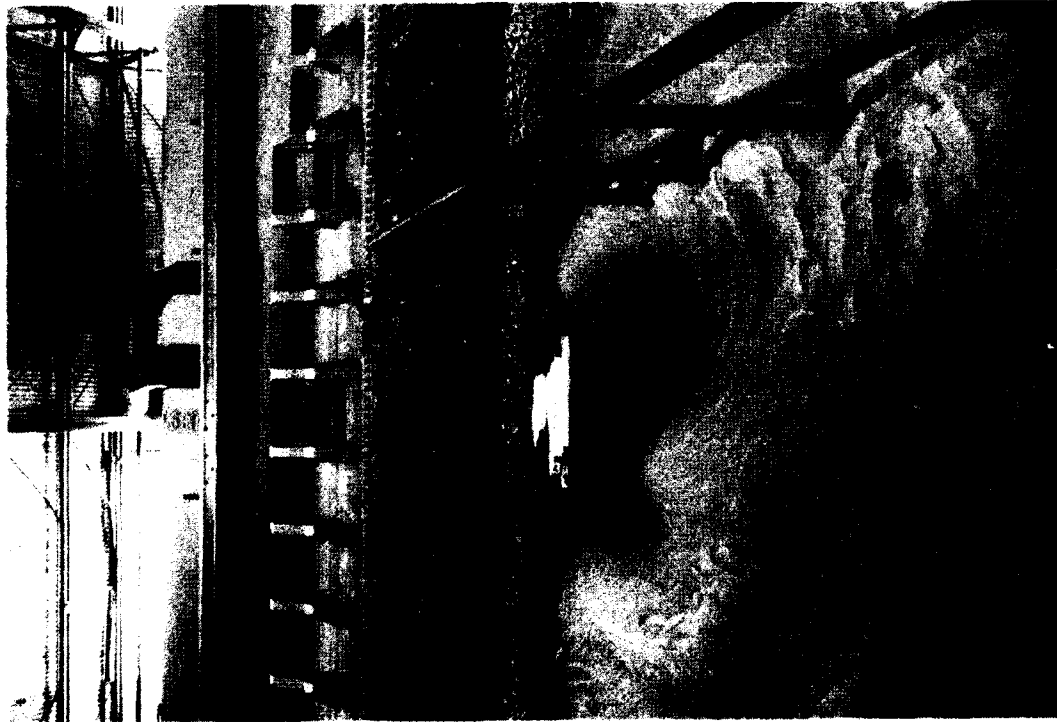
A test was then conducted downstream from gate 10 where the barges were 6 ft higher than their original placement. Riprap No. 8 downstream from the barges failed during this test due to the flow conditions that occurred with gate 10 opened fully to the normal upper pool and tailwater el 135. The entire 50-ft blanket was washed away as shown in Photo 18. An additional 50 ft of Riprap No. 7 (total length of 100 ft) followed by 50 ft of Riprap No. 8 was placed downstream from gate 10 and the test repeated. Again, the Riprap No. 8 was washed downstream. Riprap No. 8 was replaced with Riprap No. 9 ( $d_{50} = 24$  in.). The gradation of this riprap is shown in Plate 11. A test was conducted for 8 hr (prototype) with gate 10 opened fully to the normal upper pool and tailwater el 135. Riprap No. 9 washed downstream as shown in Photo 19. Test results indicated that a significant amount of additional riprap will be required if the downstream ends of the barges are placed much higher than el 91.5. Since the Riprap No. 9 failed with the tailwater at el 135, tests were not conducted with lower tailwater.

Photo 18. Failure of Riprap No. 8 downstream from a group of raised barges

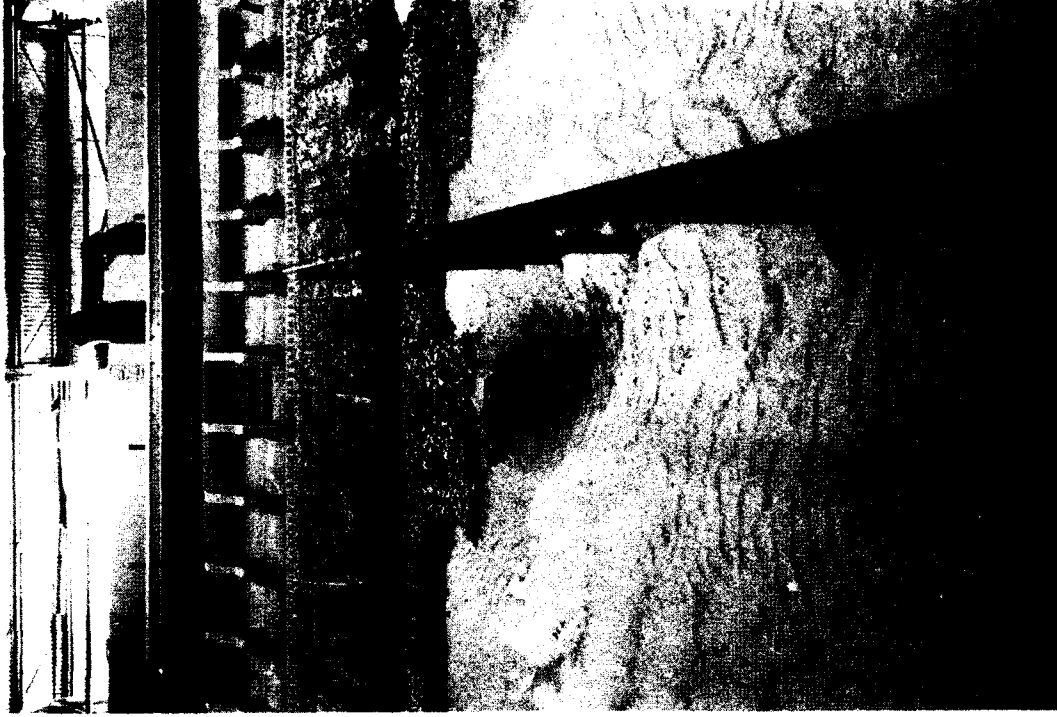
Photo 19. Failure of Riprap No. 9 placed downstream from a group of barges raised 6 ft higher than original placement

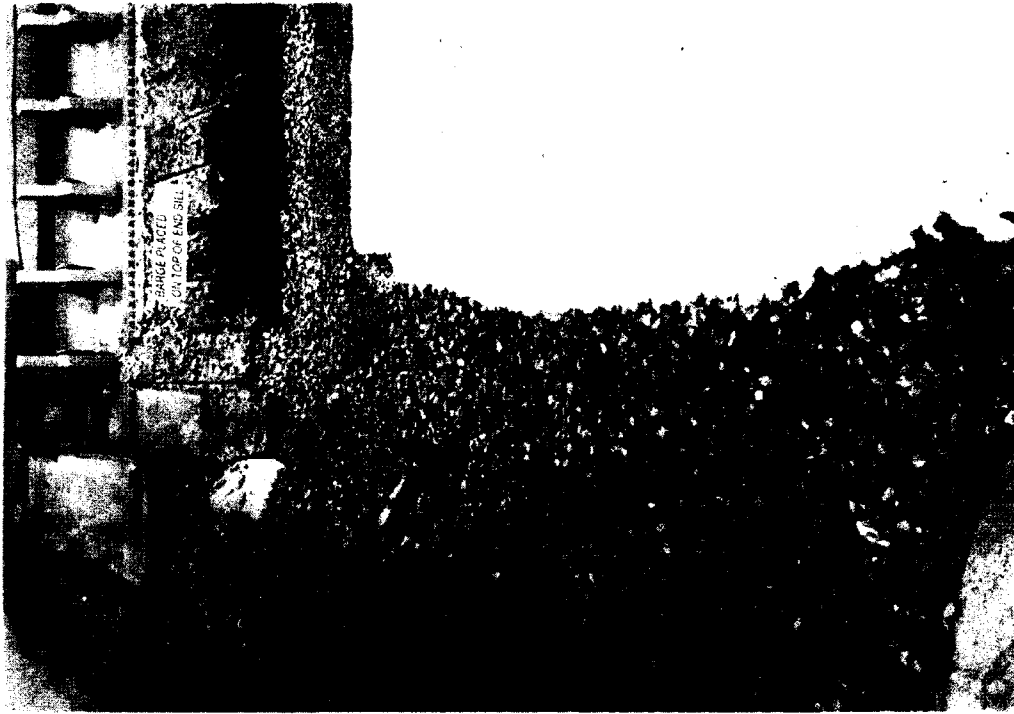
Tests were requested by the Little Rock District to determine the stability of the scour protection in case a barge was not placed properly and the upstream end of the barge became lodged on the end sill. A test was initiated with a barge between gates 15 and 16 placed on the end sill. The test was conducted for 2 hr (prototype) with gate 16 opened fully to the normal upper pool and tailwater el 113. Severe riprap displacement occurred along the side slope as shown in Photo 21. The raised barge concentrated flow downstream from gate 16 and prevented it from spreading out. This caused direct attack on the side slope riprap. Another test was conducted depicting this type placement behind gate bay 7. The same test conditions were observed, but for 8 hr (prototype), and no riprap failure occurred. The end of the barge acted as a baffle deflecting the jet upward and downstream, and the spray falling back to the water surface was not strong and concentrated. Therefore, riprap failure did not occur. The flow conditions caused by the raised barge are undesirable, and much emphasis should be placed on constructing the barge revetment as uniformly as possible.

Photo 21. Failure of Riprap No. 7 on right bank due to barge on end sill

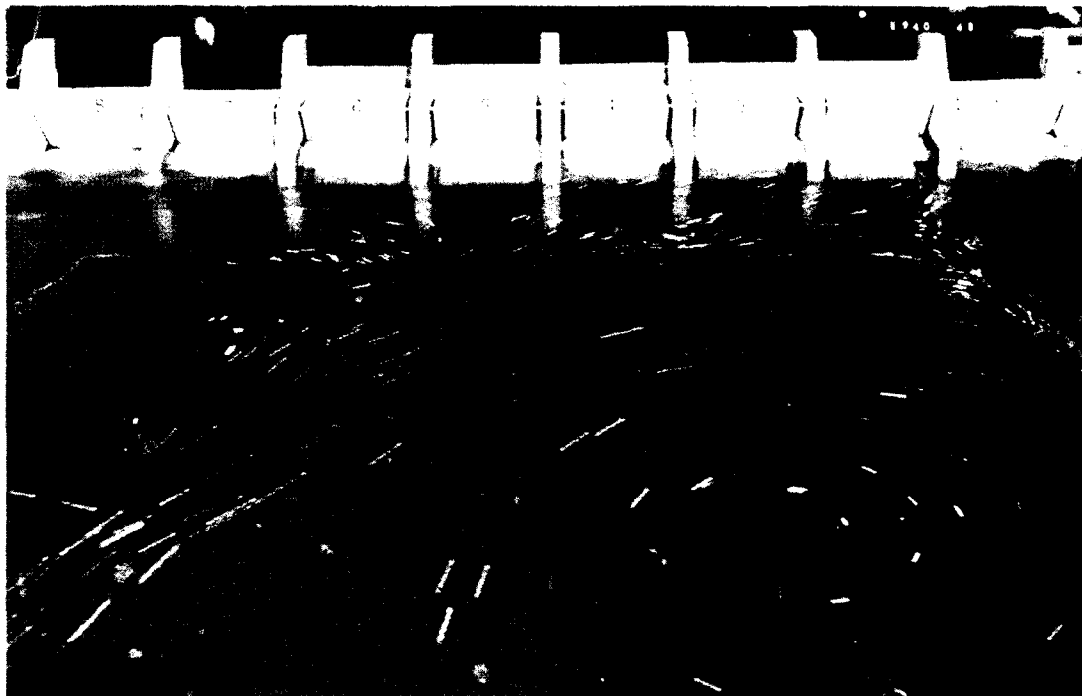
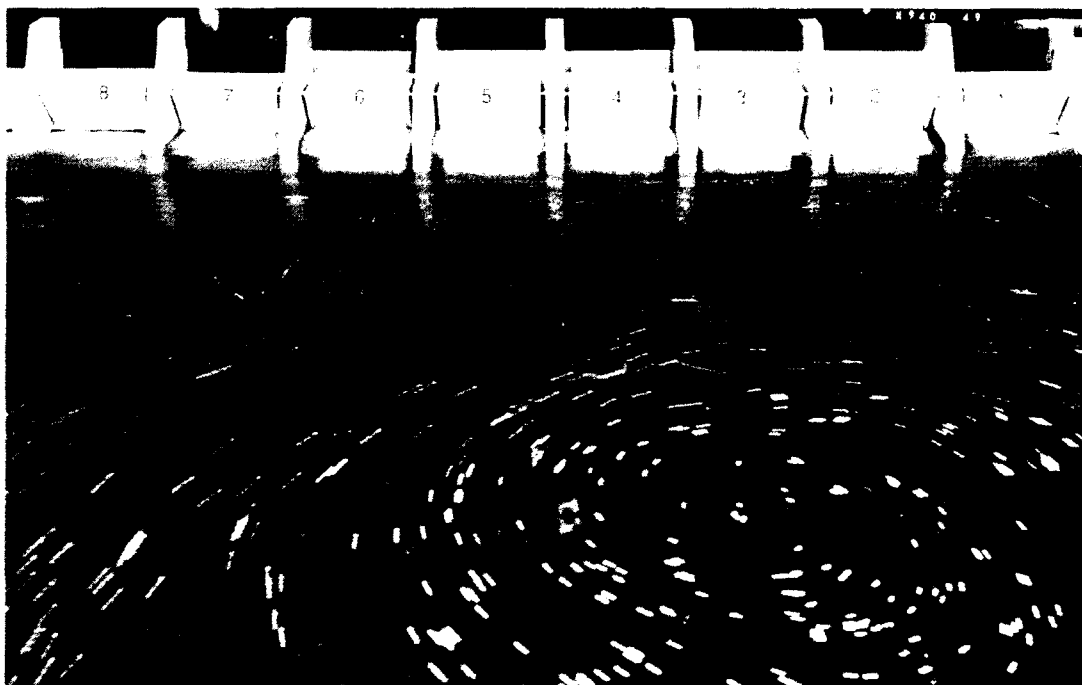
Photo 22 shows flow conditions downstream from gate 4 with a discharge of 50,000 cfs and pool el 162 when gates 2-6 are closed. This condition would exist when barges are being placed in the vicinity of gate 4. No adverse flows were observed and velocities were less than 3.5 fps on the surface. Flow circulation occurred in the working area but was considered slight.

Photo 22. Flow conditions with gates 2-6 closed, a discharge of 50,000 cfs, and pool el 162

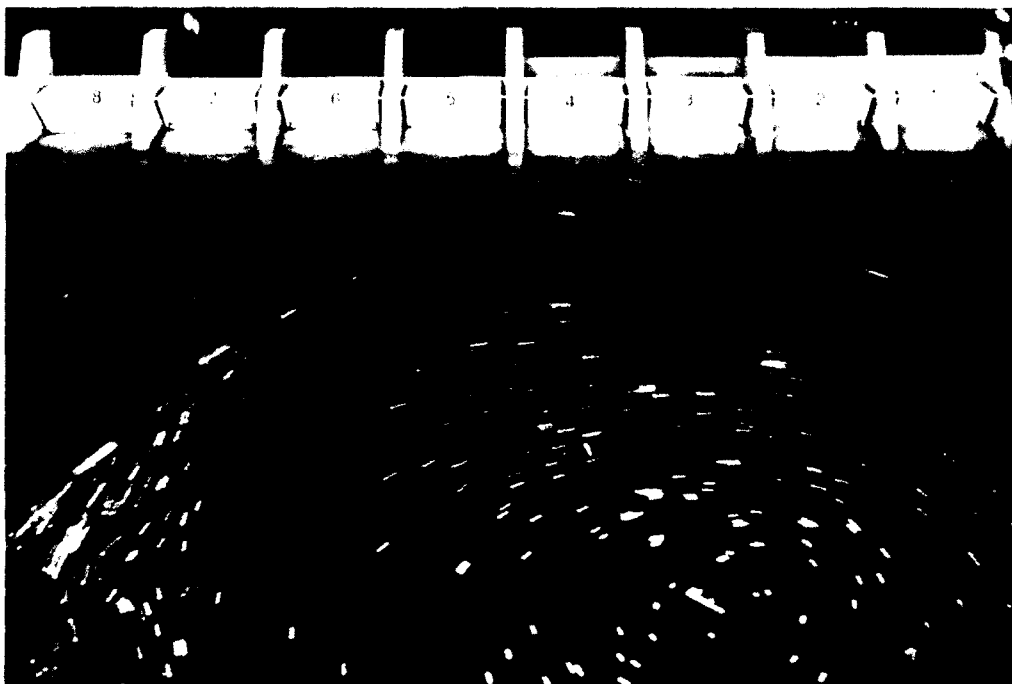
Photo 23 shows flow conditions with gates 1-4 closed for a discharge of 50,000 cfs and pool el 162. These conditions would exist when barges are being placed in the vicinity of gate 2. No adverse flow conditions were observed, flow circulation was minimal, and velocities were less than 3.5 fps. Photos 24 and 25 show flow conditions for a discharge of 15,000 cfs with gates 2-6 and 1-4 closed, respectively. A larger flow circulation pattern was observed with the higher tailwater, but no harmful conditions were observed.

Photo 23. Flow conditions with gates 1-4 closed, discharge of 50,000 cfs, and a pool el of 162
