**DOT/FAA/CT-93/1**

## **Vertical Drop Test of a Metro III Aircraft**

June 1993

Final Report

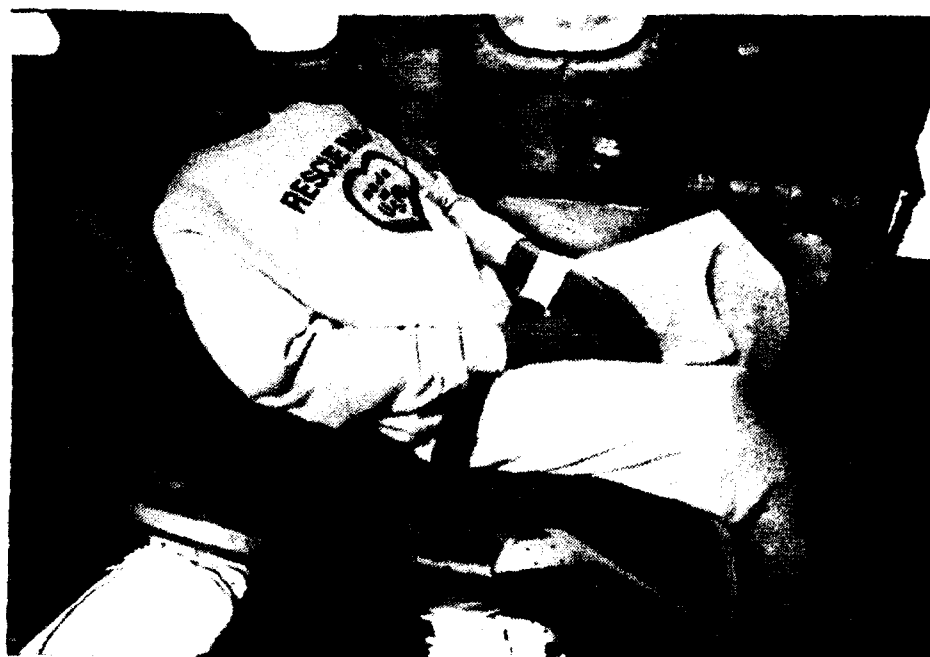
FIGURE 23. POST TEST SEAT 4

DAMAGE: The aft inboard leg was cracked and bent to the point where it was almost broken apart. The aft outboard leg was broken off. The damage to both legs occurred just below the seat pan.

POSITION: The seat remained in its original position; however, the front legs slid forward approximately 4 inches and the seat-back was leaning rearward at approximately 45 degrees and resting on the legs of the dummy in seat 6. The broken outboard aft leg remained in the seat track.

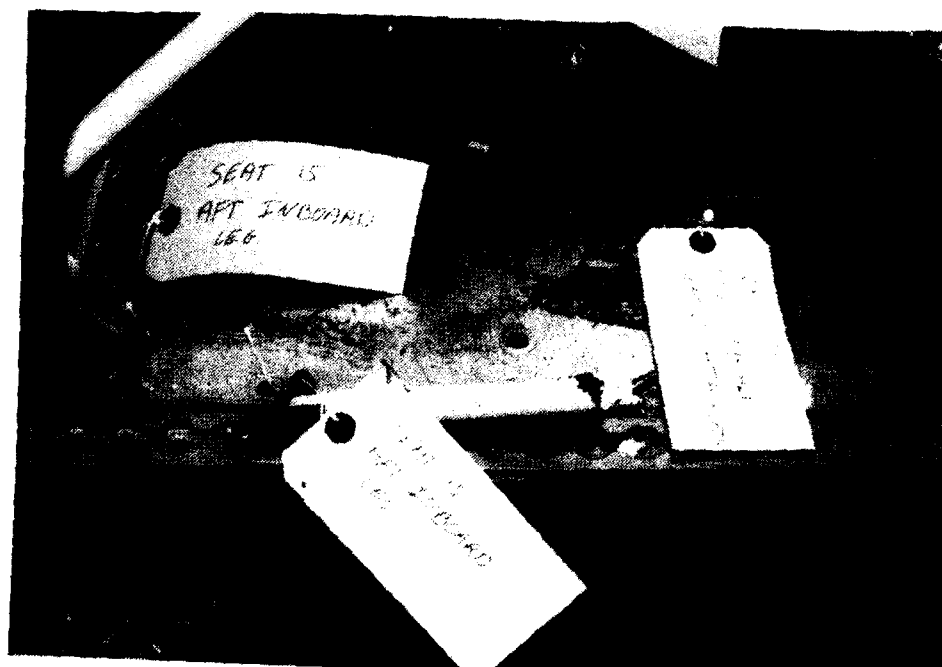
The damage to seat 15 can be seen from a variety of angles in figures 49, 50 and 51

FIGURE 49. POST TEST SEAT 15 - 1

FIGURE 50. POST TEST SEAT 15 - 2

FIGURE 51. POST TEST SEAT 15 - 3

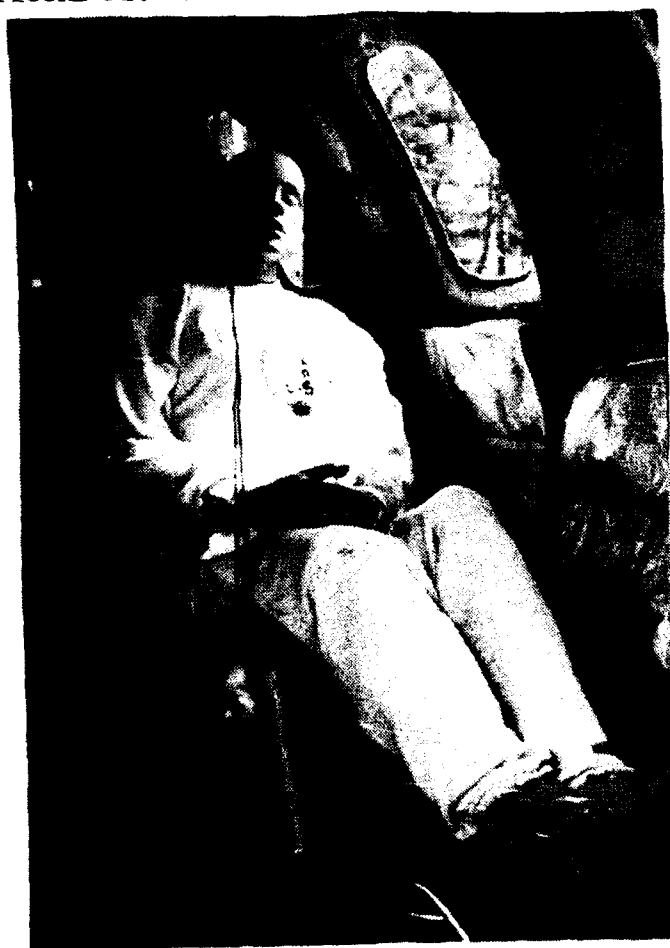
FIGURE 53. POST TEST SEAT 16

**DAMAGE:** Both forward legs (normally aft) were damaged. The inboard leg was completely broken, while the outboard leg was severely bent.

**POSITION:** The seatback was bent forward slightly. It was also resting against the back of seat 14. The broken leg remained in the seat track.
