| 4. TITLE AND SUBTITLE<br>ANNUAL ASSESSMENT, NORTH BOUNDARY CONTAINMENT TREATMENT SYSTEM, FY 83 | | | | 5. FUNDING NUMBERS | |

**ANNUAL ASSESSMENT**  
**NORTH BOUNDARY CONTAINMENT**  
**TREATMENT SYSTEM**

**FY '83**

**Rocky Mountain Arsenal**

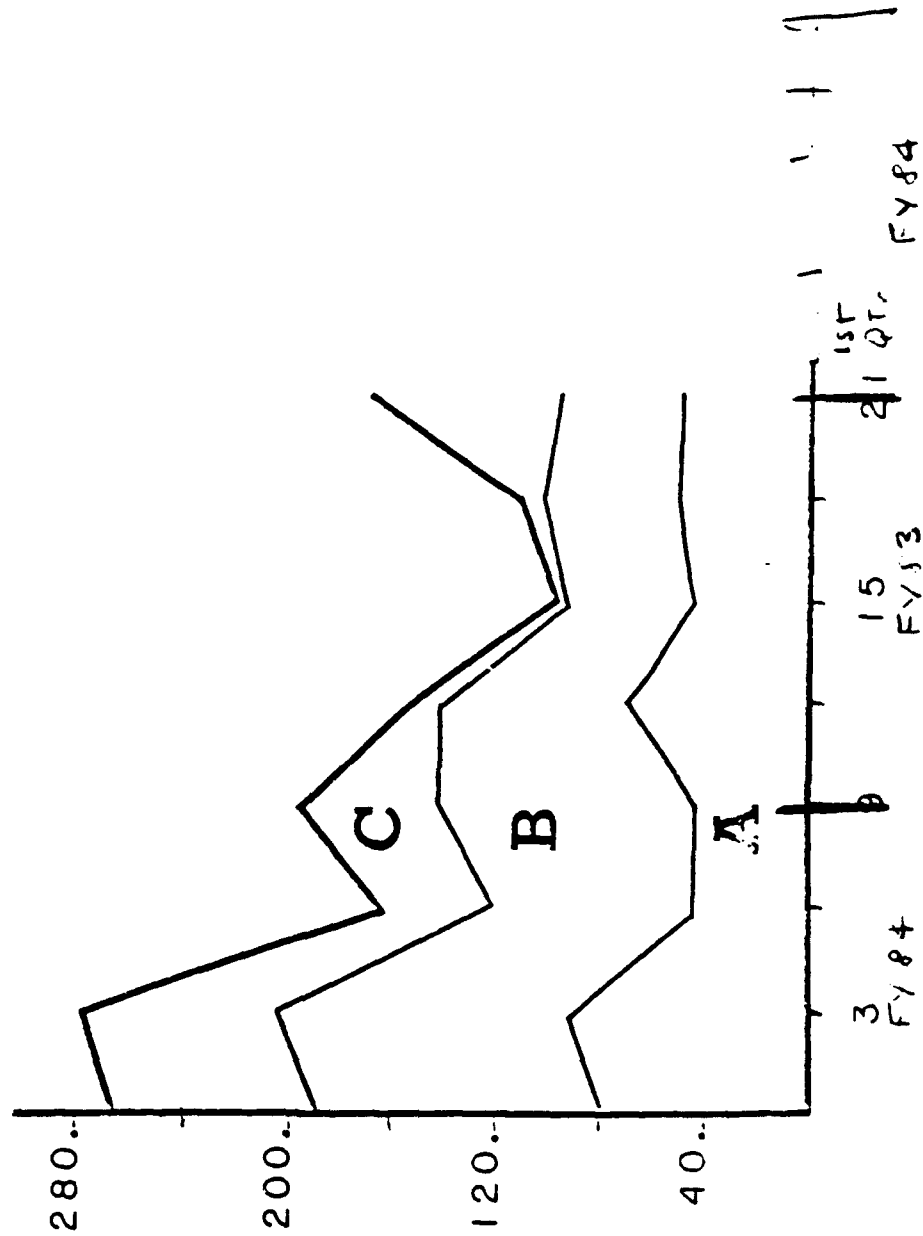
Figure 14 indicates the continued downward trend of ground water production from an average flow of 270 gpm upon system startup to 170 gpm at present. It is difficult to determine if the initial production was due to stressing of the aquifer or drawdown of backed up water due to the fact that the barrier was in place approximately six months before the startup of the entire system. At the present time, the dewatering system appears to be pumping all the water available at the wells, however, deterioration of the aquifer or well packing could also account for the reduction in production.

The most drastic change was noted in the "C" section. It appears the east end of the system does not in itself have an alluvial source, but instead, derives a majority of its flow from the sanitary sewer plant and First Creek drainage.

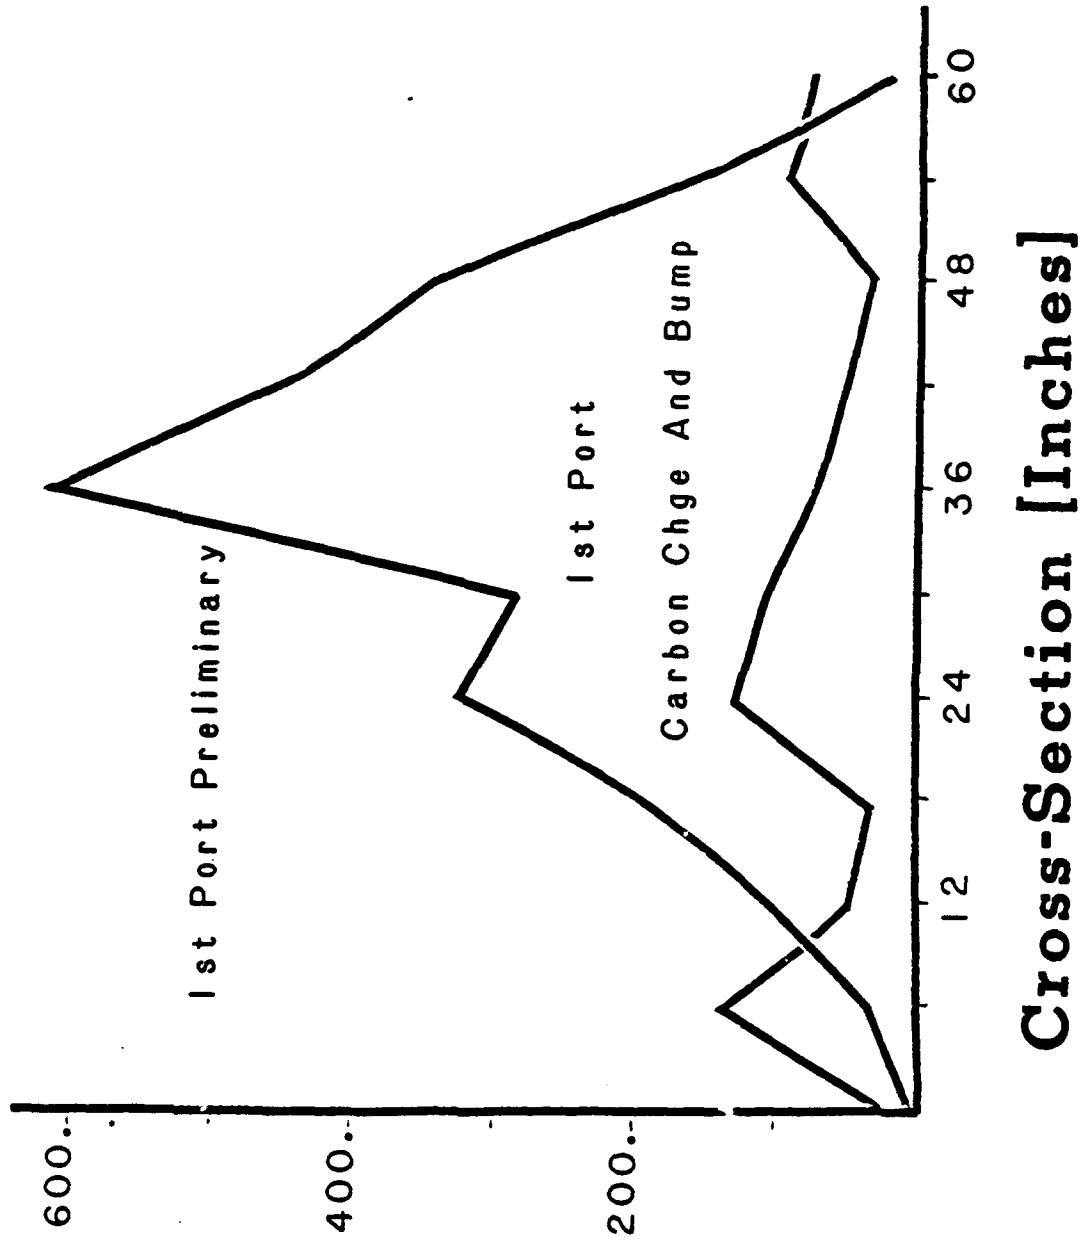
# A Adsorber Cross-Section Study

Adsorber dynamics study. During the year a study was conducted to better understand the dynamics and flow characteristics of the pulsed flow contactor. It was noticed early in the operations that the adsorbers under certain conditions would exhibit bleed through. This phenomenon was attributed to channeling of flow through the carbon bed. Studies were conducted to further understand this condition.

One typical experiment (Fig 16) shows the relationship of a normal bed flow condition vs. the effects of a channelized flow condition. As a result, care must be given to proper attention of the condition of the carbon bed if carbon usage is to be minimized and excursions prevented. In another study (Fig 17) the extent of contamination removed as a function of carbon bed depth was investigated to further predict the wave front movement and effective bed depth. Figure 17 shows the effect of uneven distribution to the lower section of the bed (approximately 3 feet depth) vs. the complete removal with uniform flow distribution at the second section (7 feet bed depth).
