ARMY AIRCRAFT FIRE-DETECTION SYSTEMS OPERATION AND RELIABILITY.

**ARMY  
AIRCRAFT  
FIRE-DETECTION  
SYSTEMS  
OPERATION  
AND RELIABILITY**

This report evaluates the results of a July 1993 study of fire indications on board Army aircraft. Although the focus was the aircraft fire-detection system, other areas involving "potential" fire, such as smoke and sparks, were included and evaluated.

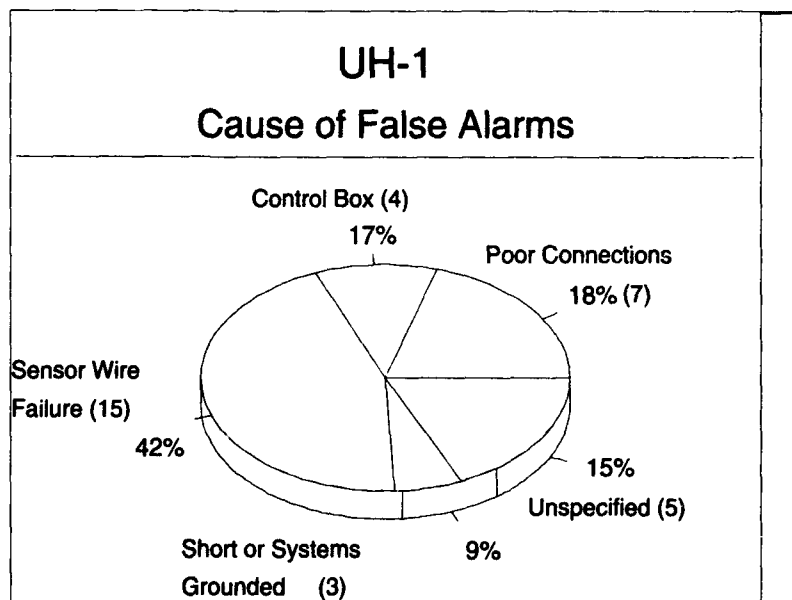
The UH-1 fire-detection system is manufactured by Edison; it has two sensing elements, each 215 inches long. The elements have a single-wire core design, which changes resistance as the element is heated. The element is held in place along the cowling by clamps and is interconnected into the system using connectors/cannon-type plugs. In the 34 fire-warning-system activations, the UH-1 crews landed immediately (as required) in all but two cases. All indications were false. The 34 fire-warning activations could be broken down as shown in the chart below.

The data for fire-warning-light indications has remained generally constant for the past 5 years, accounting for about half of all fire indications.

(2) Replacing or modifying sense elements used on the AH-1, UH-1, and OV-1 with elements having a minimum number of connections, which account for over 15 percent of all false alarms.

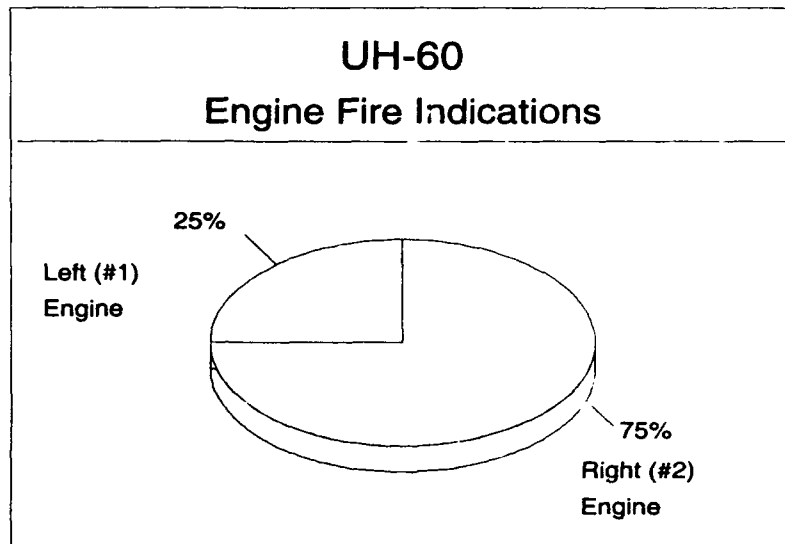
Four (about 10 percent) of the 48 fire-warning-system activations were accurate. Therefore, the false-alarm rate was about 90 percent. Of the four accurately triggered fire-warning activations, one was for the auxiliary power unit (APU) and the other three were for the engine. In two of the three related to the engine, the cause was a leaking fuel line or fitting where vaporizing fuel flashed into a fire. However, due to convective air movement, the fires would self-extinguish and de-activate the fire-warning light. In one of the two cases, the crew landed as soon as possible commensurate with the fire warning annunciation emergency procedures. However, in the second case, the crew considered the light a probable false

The causes of the fire indications could be broken down as shown in the chart below.

(1) Replacing outdated flame detectors currently installed on the UH-60, AH-64, C-12, and U-21 with sensing wire (which use a minimum number of connections), pneumatic detectors, or new generation flame detectors.

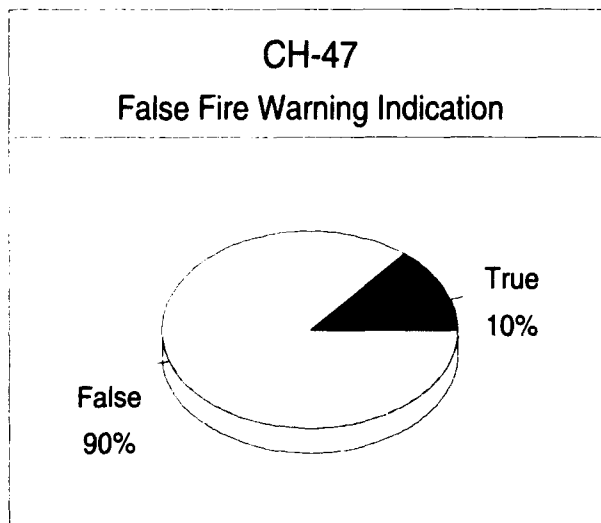
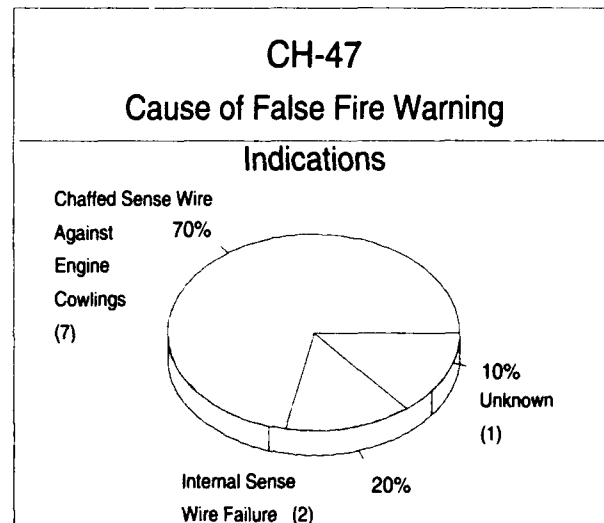
The CH-47 fire-detection system uses a sensing element manufactured by Fenwal. Each engine has three interconnected elements that are attached to the engine itself. The elements are of a core design whose ceramic-insulated center core resistance changes with heat. Of the 11 fire indications by the onboard system, only one was correct. The other 10 (about 90%) were false indications. The false indications resulted from the following:

**Seventy percent of the CH-47's high false alarm rate is easily affected by simple precautions (against chaffing) when the engine nacelles are closed.**

d. Develop a program for the CH-47 engine nacelle cowling installation. The cowlings account for over 70% of all CH-47 false alarms due to chaffing against the sense elements.

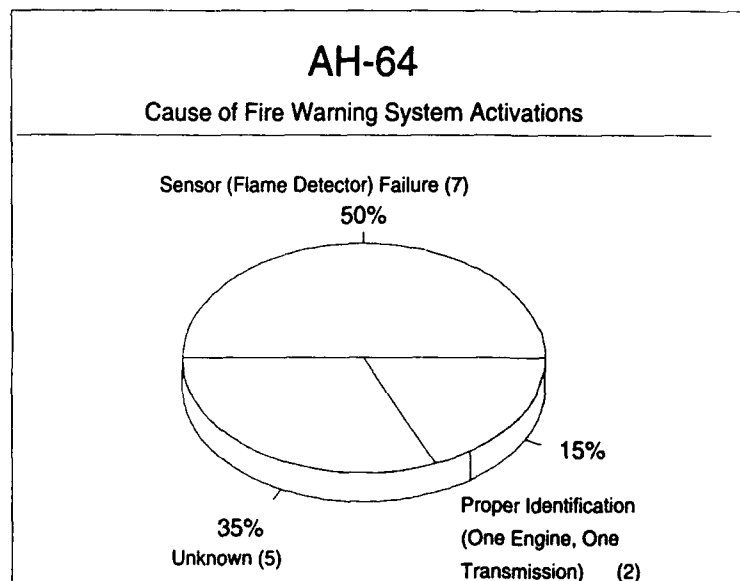
identified and one of those two properly extinguished. The AH-64 has the lowest false-alarm rate of helicopters—about 85 percent. Its breakdown is as follows:

| 7 | Sensor (flame detector) failures | 50% |
| 5 | Unknown (not reported) failures | 35% |
| 2 | Proper identification (1 engine, 1 transmission) | 15% |
